Natural ground subsidence - Collapsible deposits

Detailed Unexploded Ordnance (UXO) Risk Assessment

Project Name	Oldfield Road, Hampton
Client	Brownfield Solutions Limited
Site Address	Oldfield Road, Hampton, Middlesex TW12 2HR
Report Reference	DA18413-00
Date	11/08/23
Author	MTA
Quality Assurance	ERG
Final Check	AB

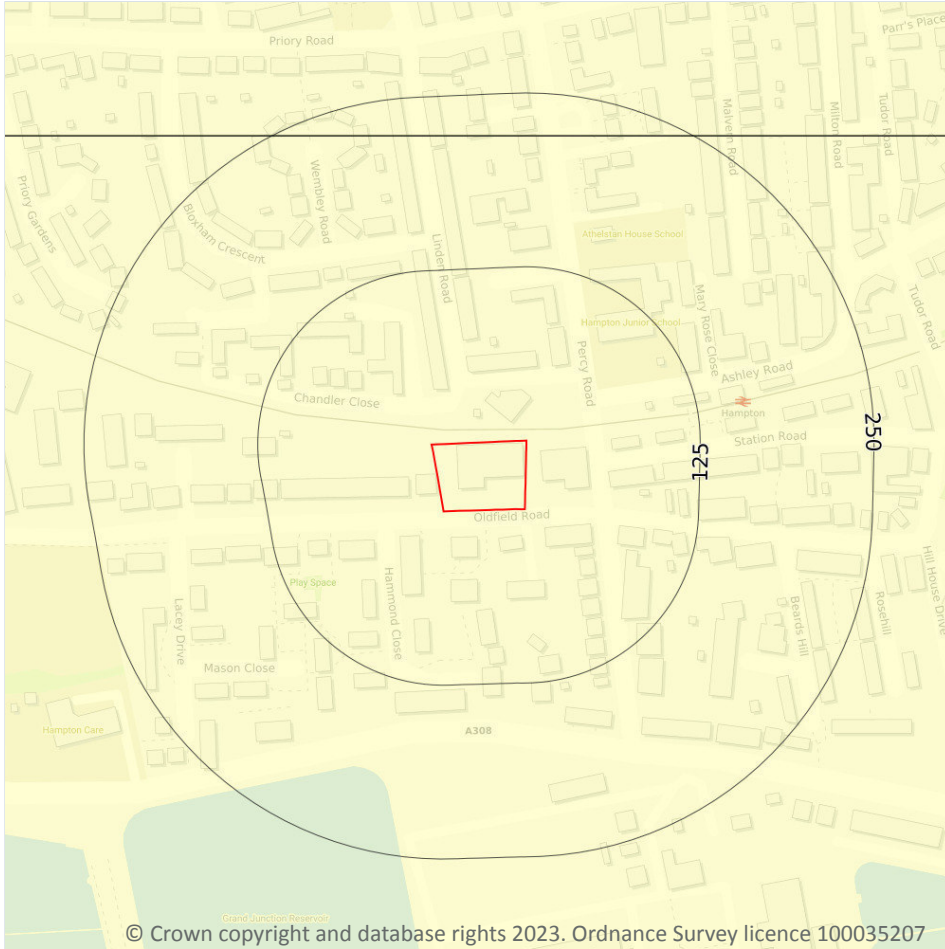
Natural ground subsidence - Ground dissolution of soluble rocks

Location	Hazard rating	Details
On site	Negligible	Soluble rocks are either not thought to be present within the ground, or not prone to dissolution. Dissolution features are unlikely to be present.

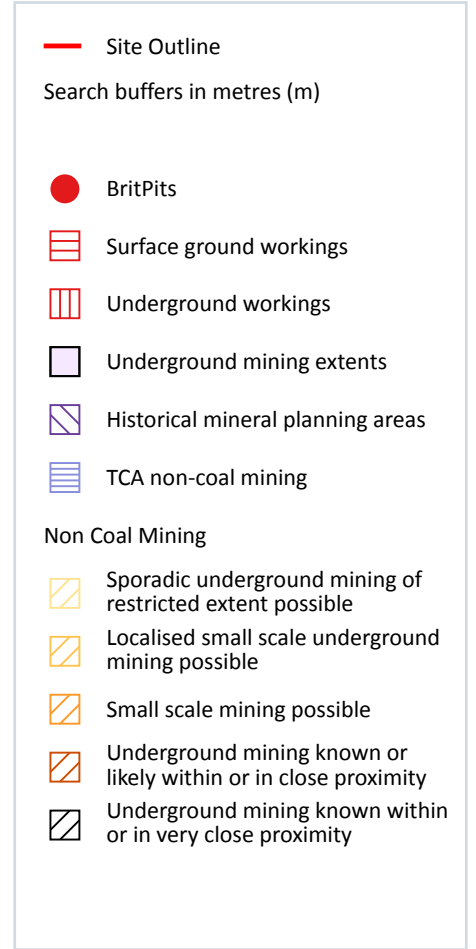
18 Mining and ground workings

ID	Location	Details	Description
N	421m W	Name: Portlane Bridge Gravel Pit Address: Hampton, TEDDINGTON, Greater London Commodity: Sand & Gravel Status: Ceased	Type: A surface mineral working. It may be termed Quarry, Sand Pit, Clay Pit or Opencast Coal Site Status description: Site which, at date of entry, has ceased to extract minerals. May be considered as Closed by operator. May be considered to have Active, Dormant or Expired planning permissions by Mineral Planning Authority

ID	Location	Land Use	Year of mapping	Mapping scale
A	191m SW	Reservoir	1899	1:10560
A	192m S	Reservoir	1990	1:10000
A	192m S	Pond	1962	1:10560
A	192m S	Reservoir	1973	1:10000
A	192m S	Pond	1965	1:10560
A	194m S	Reservoir	1897	1:10560
A	194m SW	Reservoir	1938	1:10560
A	194m SW	Reservoir	1913	1:10560
A	194m SW	Reservoir	1895	1:10560
A	196m SW	Reservoir	1938	1:10560
A	197m SW	Reservoir	1920	1:10560
A	199m S	Reservoir	1913	1:10560
A	200m SW	Reservoir	1938	1:10560
A	200m S	Reservoir	1938	1:10560
A	200m S	Reservoir	1895	1:10560
B	200m S	Unspecified Pit	1962	1:10560
