### 13. The Likelihood of Contamination from Allied Ordnance

## 14. The Likelihood of UXO Contamination Summary

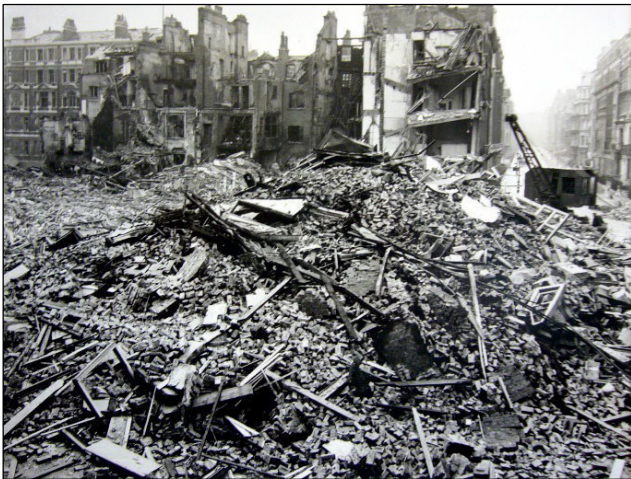
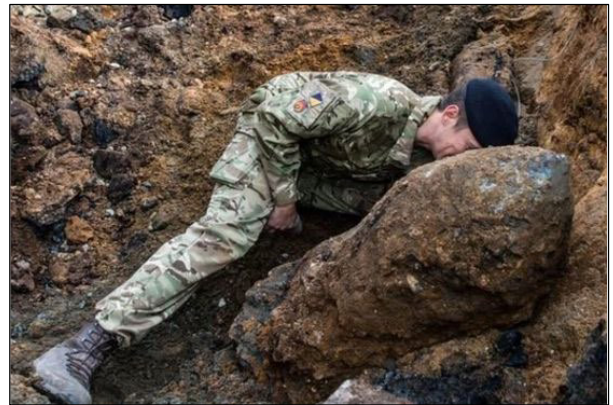
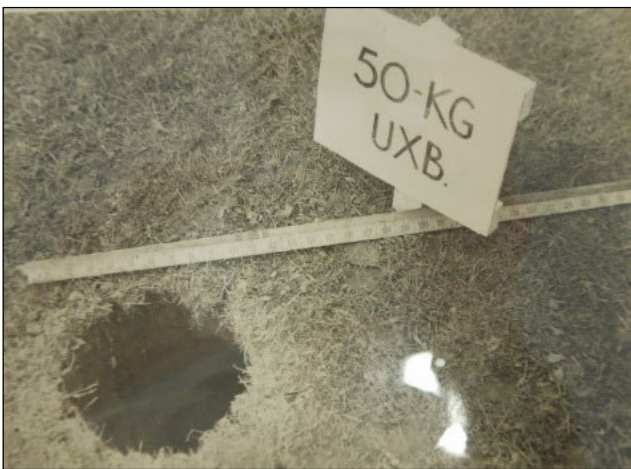
**Top:** J-curve Effect - Due to angle of entry, unexploded bombs would often end their trajectory at a lateral offset from point of entry, often ending up beneath adjacent extant structures/sites.

The photograph **above** shows a 250kg unexploded bomb found in Bermondsey in 2015, pointing upwards, demonstrating 'J-curve'.

One of the most common scenarios for UXO going unnoticed was when a UXB fell into a 'bomb site' (such as the area shown **Top Left**), the entry hole of the bomb obscured by any debris and rubble present. Note that the entry hole of a 50kg UXB could be as little as 20cm in diameter (**Left**).

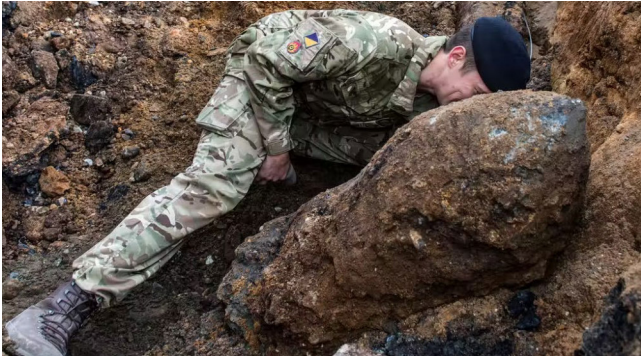
**Bermondsey bomb: World War Two device safely removed**

An unexploded World War Two bomb found in south London has been driven away safely under police and Army escort.

The 500lb (250kg) device was found on a building site in Grange Walk, Bermondsey on Monday.

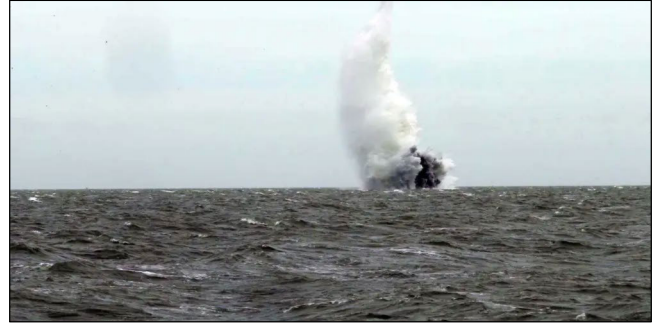
**WW2 bomb found near London City Airport blown up**

An unexploded World War Two bomb found near London City Airport has been detonated.

The 500kg device was discovered at the King George V Dock on Sunday during planned work at the airport.

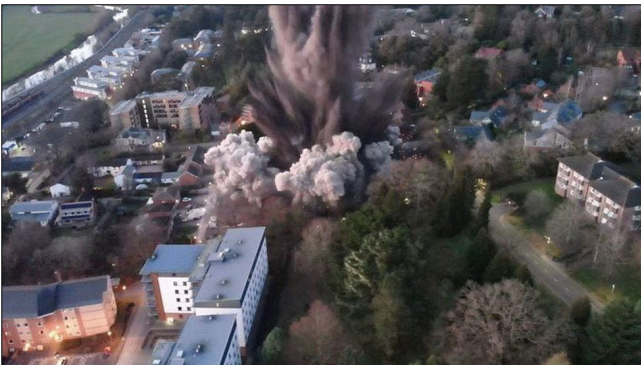
**Exeter WW2 bomb is detonated after homes evacuated**

More than 2,600 households and 12 university halls of residence were cleared before the 2,200lb (1,000kg) device **was destroyed** on Saturday.

Police have reported large pieces of metal debris hitting buildings and said some properties in the 100m (330ft) exclusion zone had sustained "structural damage".

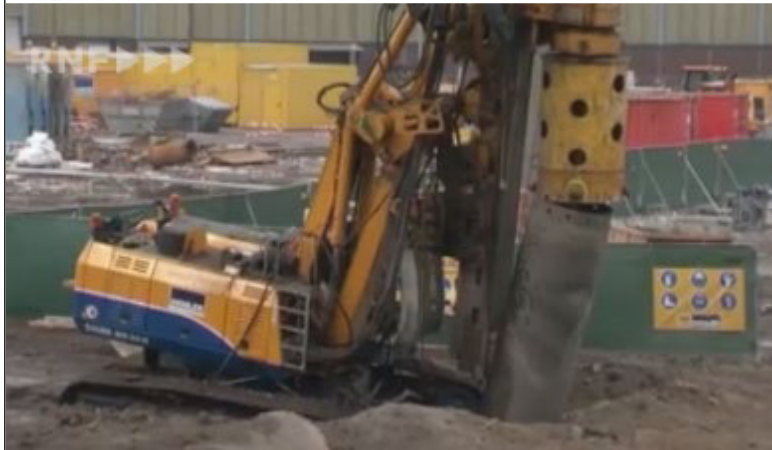
BASF has confirmed that an explosive device, most likely a World War II-era bomb, caused the blast that left one person injured Tuesday at a plant construction site in Germany.

The explosion was reported at BASF's Ludwigshafen toluene diisocyanate (TDI) plant, which recently broke ground for a 300,000 metric tons per year TDI production plant and other construction to expand its facilities.

"Cause of the detonation was an explosive device, presumably a bomb deriving from the Second World War. The device detonated when grounding work was done. No details on [a] delay [are] available. At the moment, the exact circumstances of the incident are [being] evaluated."

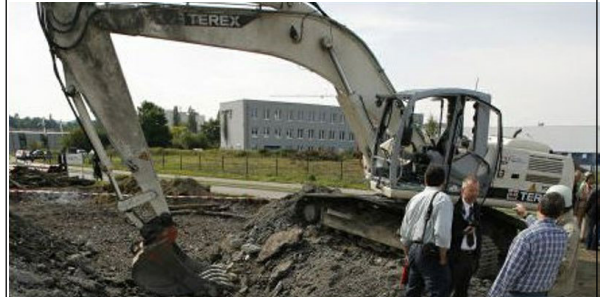
**WWII bomb injures 17 at Hattingen construction site**

**Seventeen people were injured on Friday when a construction crew unwittingly detonated a buried World War II-era bomb in Hattingen.**

An excavator apparently drove over a 250-kilogramme (550 pound) American bomb, damaging surrounding buildings. Most of the injured suffered auditory trauma from the blast, and the excavator operator suffered injuries to his hands, police in the German state of *North Rhine-Westphalia* said.

"The hole was astoundingly small for such a large bomb full of so many explosives," Armin Gebhard, head of the Arnsberg department for military ordnance removal, told *The Local*. "But of course it damaged all the surrounding buildings too. We are really happy it wasn't worse."

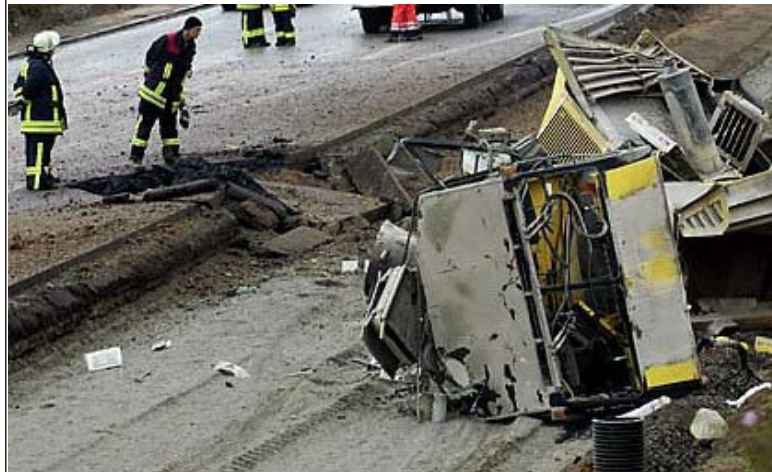
**World War II Bomb Explodes on German Motorway**

A highway construction worker in Germany accidentally struck an unexploded World War II bomb, causing an explosion which killed him and wrecked several passing cars.

A World War II bomb has exploded during construction work on a German highway, killing one worker and injuring several motorists who were driving past, police said.

The worker had been cutting through the road surface near the southwestern town of Aschaffenburg when his machine struck the bomb and triggered it. Police said they weren't sure yet what type of bomb it was. "The explosion seems to have been too small for it to have been an aircraft bomb," a police spokesman said.

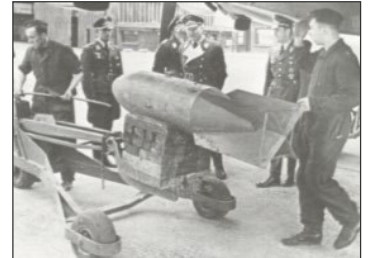
**SC 250kg High Explosive Bomb**

Bomb Weight	245-256kg (540-564lb)
Explosive Weight	125-130kg (276-287lb)
Fuze Type	Electrical impact/mechanical time delay fuze
Bomb Dimensions	1640 x 512mm (64.57 x 20.16in)
Body Diameter	368mm (14.5in)
Use	Against railway installations, embankments, flyovers, underpasses, large buildings and below-ground installations.
Remarks	It could be carried by almost all German bomber aircraft and was used to notable effect by the Junkers Ju-87 Stuka ( <i>Sturzkampfflugzeug</i> , or dive-bomber).

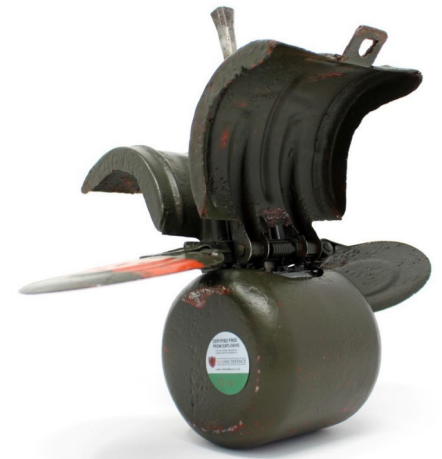
**SD2 Anti-Personnel 'Butterfly Bomb'**

Bomb Weight	Approx. 2kg (4.41lb)
Explosive Weight	Approx. 7.5oz (225 grams) of Amatol surrounded by a layer of bituminous composition.
Fuze Type	41 fuze (time) , 67 fuze (clockwork time delay) or 70 fuze (anti-handling device)
Body Diameter	3in (7.62 cm) diameter, 3.1in (7.874) long
Use	Designed as an anti-personnel/fragmentation weapon. They were delivered by air, being dropped in containers of 23-144 sub-munitions that opened at a predetermined height, thus scattering the bombs.
Remarks	Quite rare. First used against Ipswich in 1940, but were also dropped on Kingston upon Hull, Grimsby and Cleethorpes in June 1943, amongst various other targets in UK. As the bombs fell the outer case flicked open via springs which caused four light metal drogues with a protruding 5 inch steel cable to deploy in the form of a parachute & wind vane, which armed the device as it span.

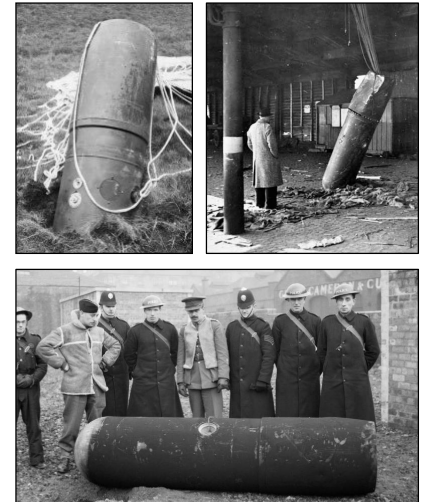
**Parachute Mine (Luftmine B / LMB)**

Bomb Weight	Approx. 990kg (2176lb)
Explosive Weight	Approx. 705kg (1,554lb)
Fuze Type	Impact/time delay/hydrostatic pressure fuze
Dimensions	2.64m x 0.64m (3.04m with parachute housing)
Use	Against civilian, military and industrial targets. Used as blast bombs and designed to detonate above ground level to maximise damage to a wider area.
Remarks	Deployed a parachute when dropped in order to control its descent. Had the potential to cause extensive damage within a 100m radius.

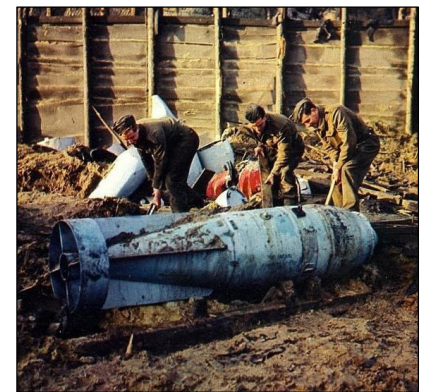
**SC 1000kg High Explosive Bomb**

Bomb Weight	Approx. 993-1027kg (2,189-2,264lb)
Explosive Weight	Approx. 530-620kg (1168-1367lb)
Fuze Type	Electrical impact/mechanical time delay fuze.
Filling	Mixture of 40% amatol and 60% TNT, but when used as an anti-shipping bomb it was filled with Triolen 105, a mixture of 15% RDX, 70% TNT and 15% aluminium powder.
Bomb Dimensions	2800 x 654mm (110 x 25.8in)
Body Diameter	654mm (18.5in)
Use	SC-type bombs were General Purpose Bombs used primarily for general demolition work. Constructed of parallel walls with comparatively heavy noses, they are usually of three-piece welded construction.

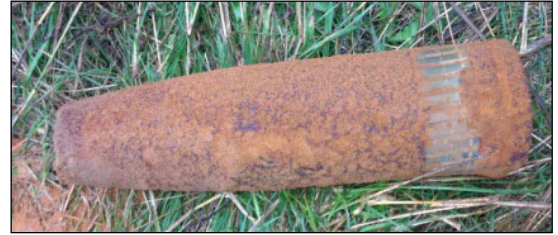
## 3.7 Inch QF Anti-Aircraft Projectile

Projectile Weight	28lb (12.6 kg)
Explosive Weight	2.52lbs
Fuze Type	Mechanical Time Fuze
Dimensions	3.7in x 14.7in (94mm x 360mm)
Rate of Fire	10 to 20 rounds per minute
Use	The 3.7in AA Mks 1-3 were the standard Heavy Anti-Aircraft guns of the British Army and were commonly used on the Home Front.
Ceiling	30,000ft to 59,000ft

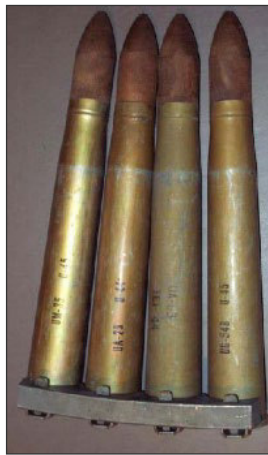
## 40mm Bofors Projectile

Projectile Weight	1.96lb (0.86kg)
Explosive Weight	300g (0.6lb)
Fuze Type	Impact Fuze
Rate of Fire	120 rounds per minute
Projectile Dimensions	40 x 180mm
Ceiling	23,000ft (7000m )
Remarks	Light quick fire high explosive anti-aircraft projectile. Each projectile fitted with small tracer element. If no target hit, shell would explode when tracer burnt out. Designed to engage aircraft flying below 2,000ft.

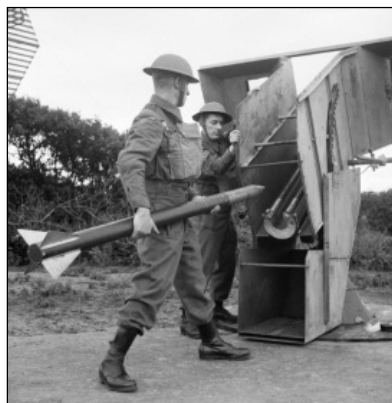
## 3in Unrotated Projectile (UP) Anti-Aircraft Rocket ("Z" Battery)

HE Projectile Weight	3.4kg (7.6lb)
Explosive Weight	0.96kg (2.13lb)
Filling	High Explosive – TNT. Fitted with aerial burst fuzing
Dimensions of projectile	236 x 83mm (9.29 x 3.25in)
Remarks	As a short range rocket-firing anti-aircraft weapon developed for the Royal Navy. It was used extensively by British ships during the early days of World War II. The UP was also used in ground-based single and 128-round launchers known as Z Batteries. Shell consists of a steel cylinder reduced in diameter at the base and threaded externally to screw into the shell ring of the rocket motor.

Figure 185—3-in. U.P. Antiaircraft Rocket Components
