## Preliminary Ecological Appraisal and Roost Assessment

Avalon House, 72 Lower Mortlake Road, Richmond TW9 2JY

Barings Real Estate

27<sup>th</sup> March 2024

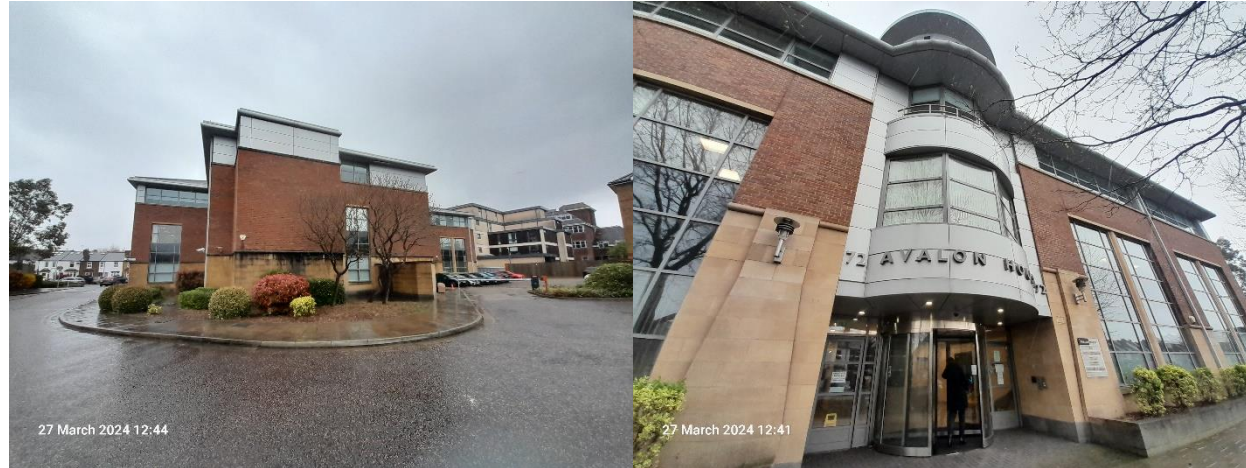
The majority of the site consists of developed land, with sealed surfaces including car parking, and tarmac paving walkways. There are <10% vegetated areas which have sparse introduced shrubs, and two small young Japanese Cherry trees with no features. Therefore, this has limited ecological value.

The majority of the site is hardstanding with sparse vegetation (left) and the one commercial building (right).

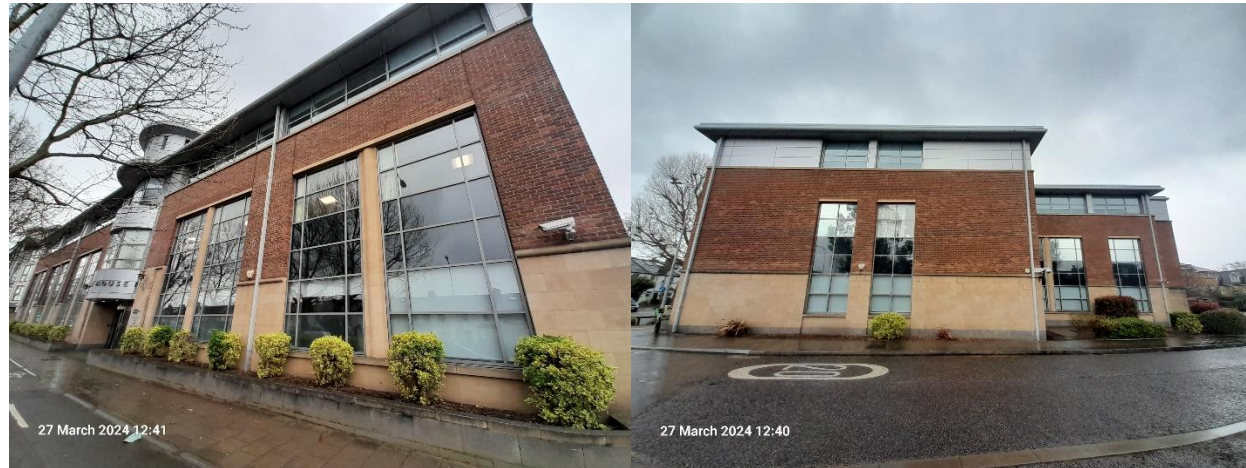
The external walls of the complex present no roosting opportunities for bats, or nesting opportunities for birds.

Northern (left) and western elevation (right).

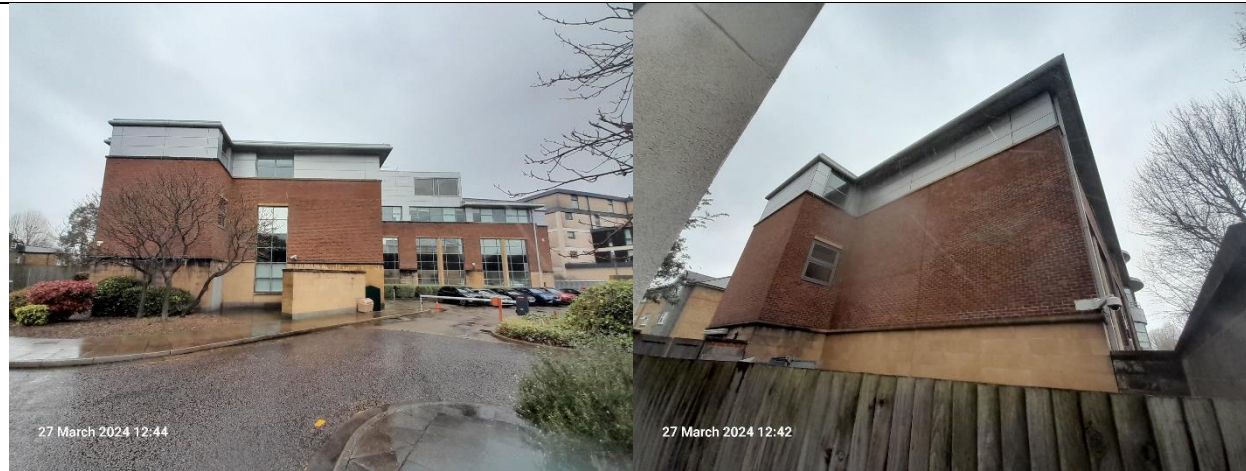
Southern (left) and eastern elevation (right).

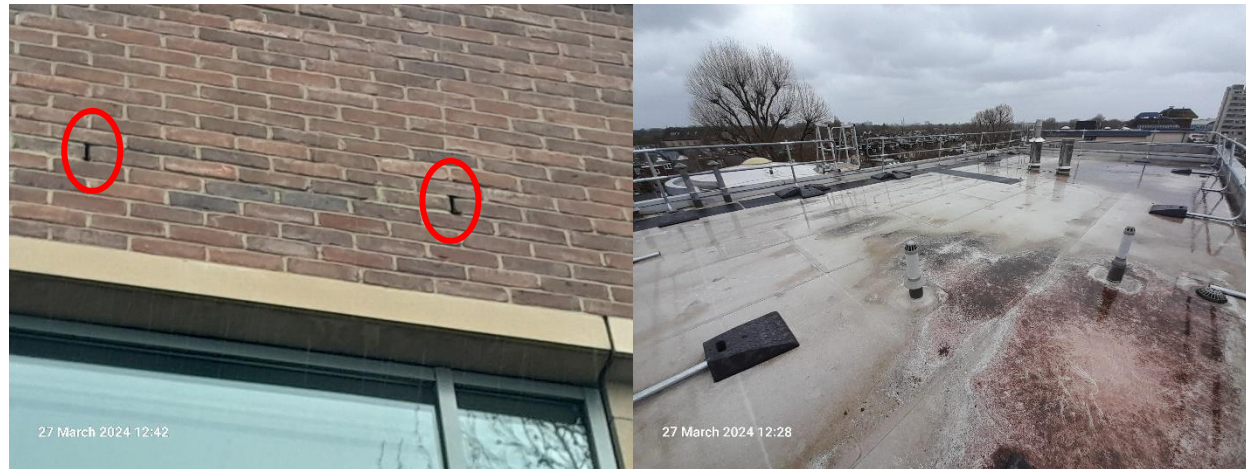
B1 is a three-storey commercial building, with a flat roof and sections of mono-pitched slate roof. The flat roof was inspected up close from the flat roof, and appears to be in good condition with no lifted tiles. There is no loft space. There are no eaves or soffits. The walls appear in good condition, There is a few holes of missing mortar in the brickwork on the northern and southern elevation. These gaps provide crevices in which crevice dwelling bats could roost. There are no other features present which bats could use. If these features prove to be shallow and not suitable for roosting bats, the habitat value would reduce.

Gaps in the mortar which provide crevice habitat for bats (left) and the flat roof (right).

B1 is assessed as having **low** value for roosting bats due to the gaps in the mortar.

<i>Recommendations</i>	<p><u>Bat habitat – foraging and commuting</u></p> <p>A low impact lighting strategy will be adopted within the proposed development. This should be designed in accordance with Guidance Note GN08/23 Bats and Artificial Lighting at Night (Institution of Lighting Professionals, 2023). Avoidance of light spill on to key habitats or features which bats could use for roosting, foraging or commuting. A luminaire specification which reduces the effects of light spill on bats should be chosen where feasible. The installation of physical screening features, and the use of dimming or part night lighting could also be considered, where appropriate.</p> <p><u>Bat habitat – roosting</u></p> <p>One bat emergence or re-entry survey is required during the active bat season (optimal May to August, suboptimal September) to confirm presence or likely-absence of a bat roost in the building. Five surveyors are required to provide full coverage of the bat suitable roosting features on the building. If the absence of a bat roost cannot be determined during the first visit, then further surveys will be required. If bat roosts are confirmed in the building two additional surveys may be required to characterise the roost and to inform an EPSL application to Natural England. Surveys should be a minimum of three weeks apart. The EPSL application requires that surveys have been undertaken within the most recent active bat season and planning permission must have been granted and all relevant wildlife-related conditions have been discharged prior to submission.</p> <p>Alternatively, the features can be fully inspected with an endoscope for bat suitability. This may require the use of a Mobile Elevated Working Platform. If the features inspected are found to be too shallow for bats to roost within, the habitat value will be negligible for bats, and no further surveys will be required. However, further survey may be required if the features are found to provide suitable habitat for bats.</p>
