REMEDICATION STRATEGY & VERIFICATION PLAN
of a site at
REAR OF 39 SECOND CROSS ROAD, TWICKENHAM
for
ANTHONY C BIANCHI

**Project No 1985
Report ref: 1985-P3E-1-
Issued: 24 April 2024
Revision:**

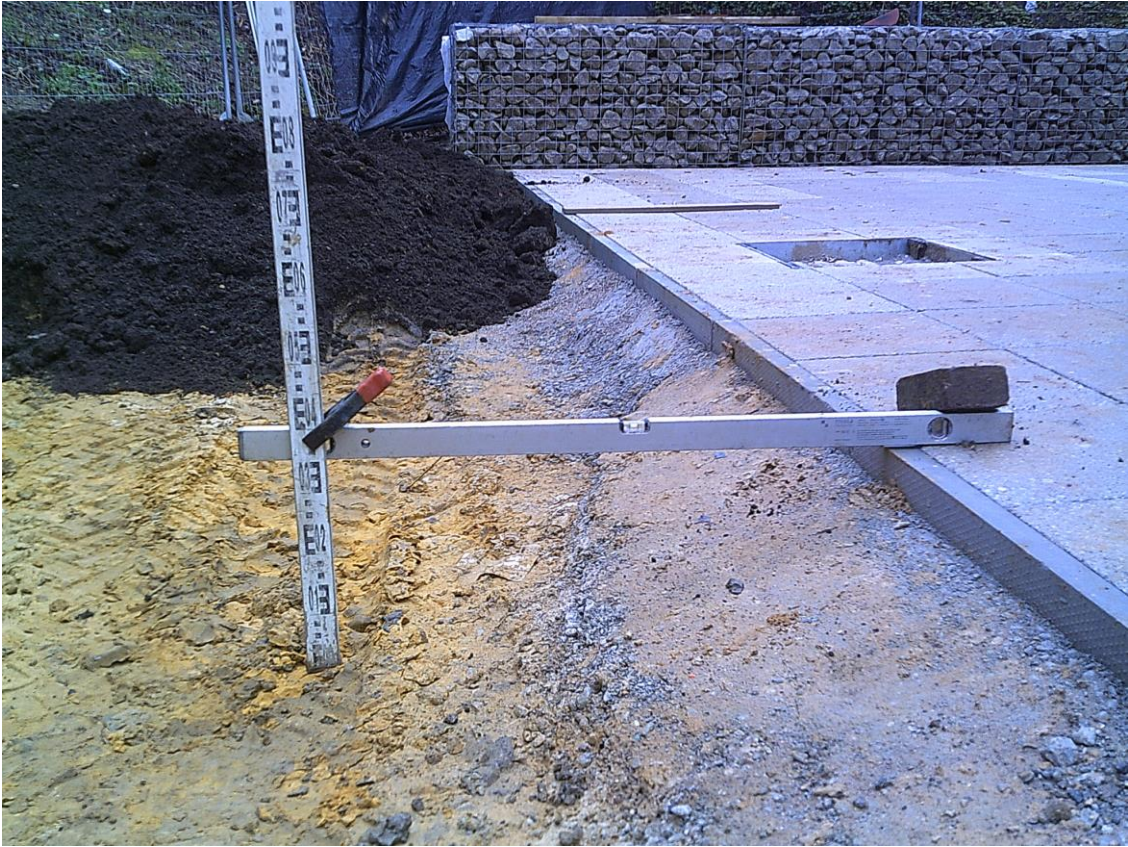
Example A: Close up, showing the depth clearly.

To demonstrate that the made ground within the soft landscape and permeable areas has been removed to a depth of 600mm or to natural strata, photographs will be taken of the proposed soft landscaped areas following removal of made ground. Examples of how to take photographs showing depth and locations are contained in appendix G. A plan showing the locations of the photographs will be prepared for inclusion in the verification report.

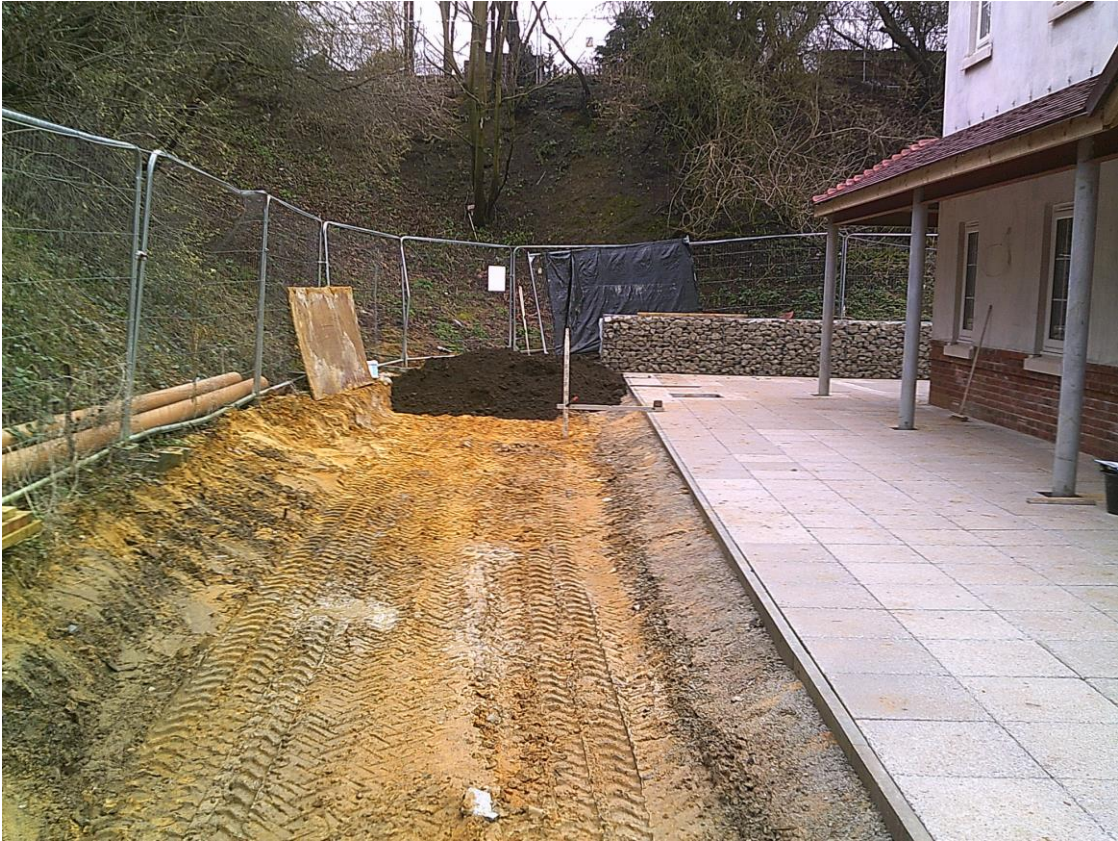
Example A: Showing the location of the close up

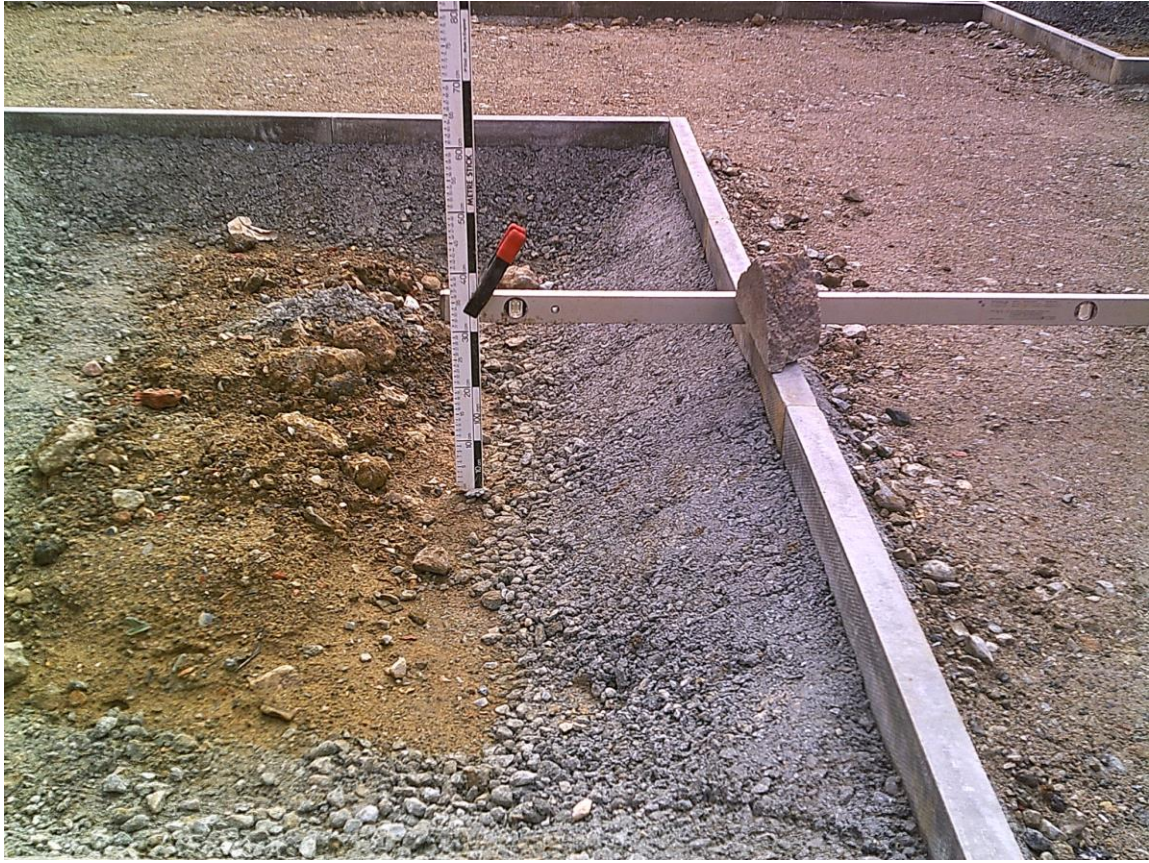
Example B: Close up, showing the depth clearly

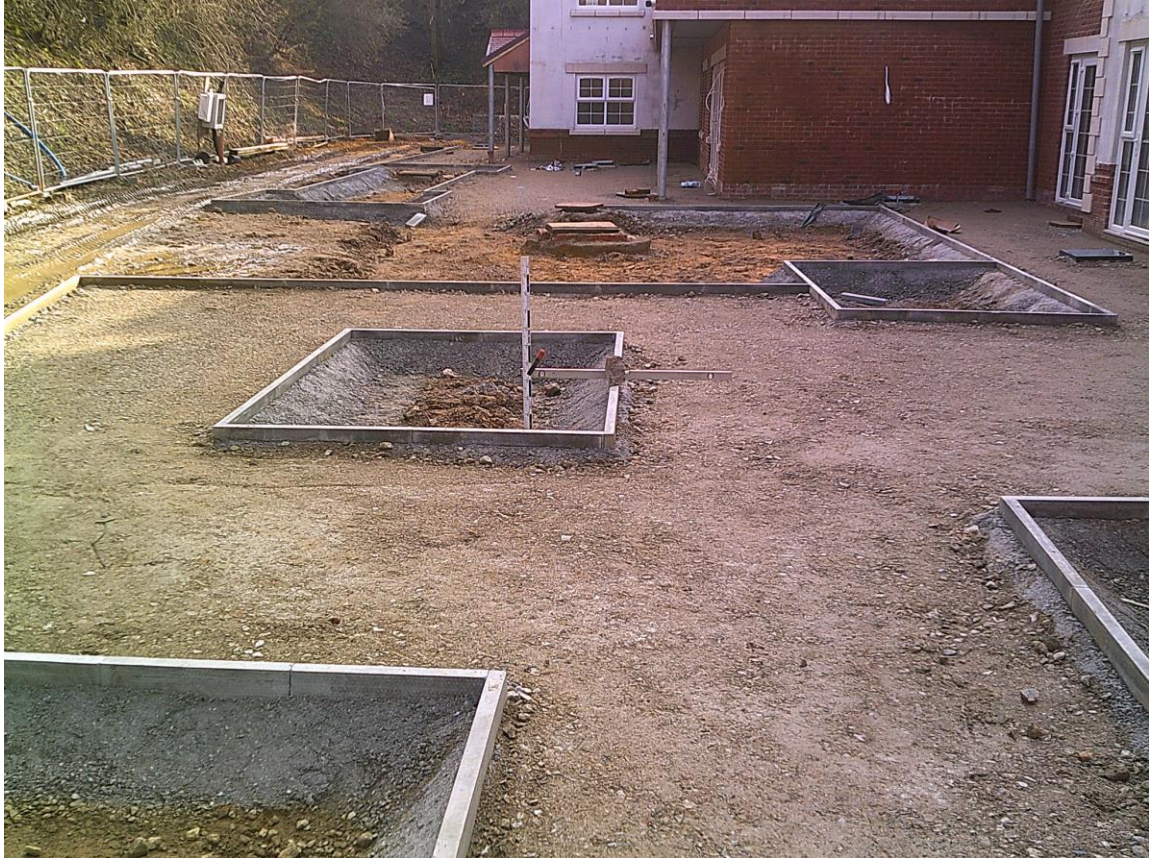
Example B: Showing the location of the close up
