GEOTECHNICAL SITE INVESTIGATION of a site at REAR OF 39 SECOND CROSS ROAD, TWICKENHAM, TW2 5QY for ANTHONY C BIANCHI

Project No 1985

Report ref: 1985-SI-1 Issued: 24 April 2024

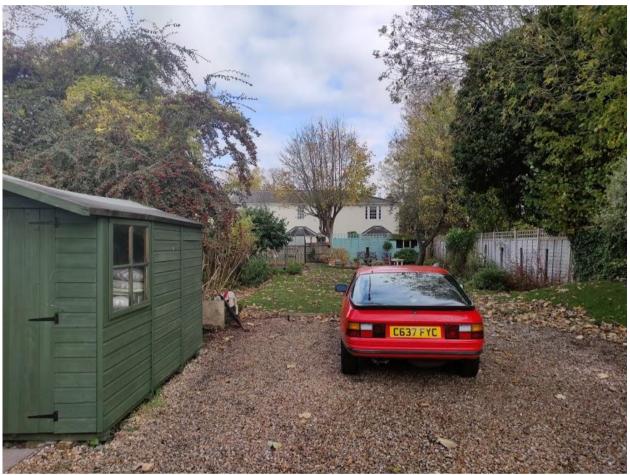
Photograph 1: View of the site looking NE from the SW border

Towards the southern end of the lawn, where it meets the driveway there is a mound of excavated soil placed against the fence. A wooden shed sits adjacent to the fence on north west side of the driveway.

Beyond the driveway is a lawn which accounts for half of the site area and extends to the patio, greenhouse and second shed at the northeast end of site.

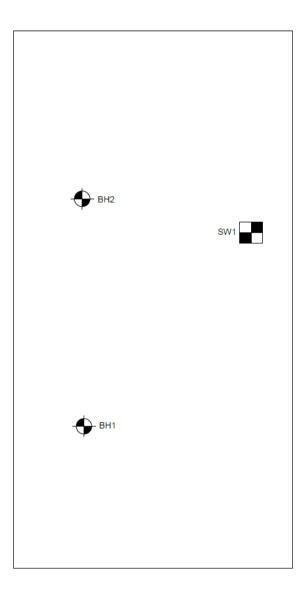
SITE PLAN

The site investigation work was carried out on 26/03/24 and comprised of the drilling of 2No. boreholes across the site to a maximum depth of 6.00m and the excavation of a single soakaway pit. The locations of the boreholes carried out are marked on the site plan within Appendix B.

The results can be seen in appendix E and the test locations are marked on the site plan in appendix B.

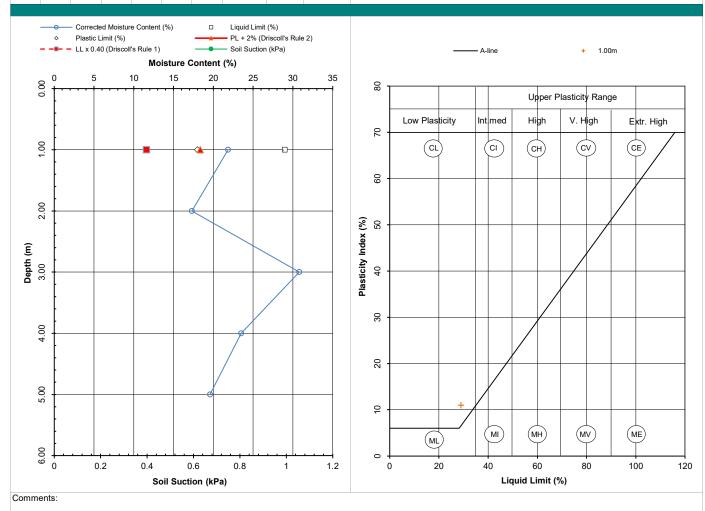
Atterberg Limits Testing found that the underlying CLAY falls into soil class CL of the British Soil Classification System. The results show the samples to be of low plasticity. The plastic indices were found to range from 9-11%, this indicates that the Clay is of generally low susceptibility to shrinkage and swelling with changes in moisture content. The results are presented in appendix E.

BORE	EHOLE 1
Depth (m)	MC (%)	Corr. MC (%)	LL (%)	PL	PI (%)	Class	% Retained (425µm)	Soil Suction (kPa)	Condition of test	Soil Description
1.00	20.3	21.85	29	18	11	CL	7.1	,	Natural	Dark brown sandy CLAY containing gravel
2.00	9.6	17.3					44.5		Washed	Brown clayey SAND containing gravel
3.00	22.2	30.79					27.9		Washed	Orange / brown clayey SAND containing gravel
4.00	22.8	23.51					3		Natural	Orange / brown clayey SAND containing gravel
5.00	19	19.59					3		Natural	Orange / brown clayey SAND containing gravel

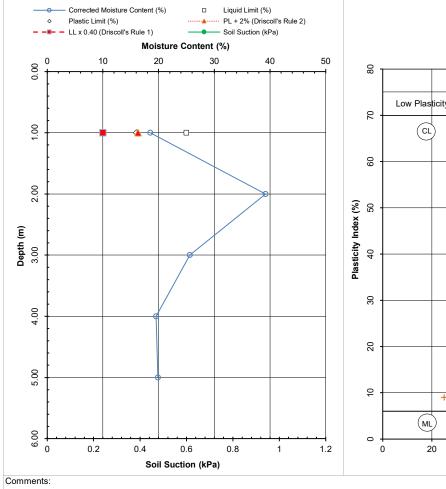
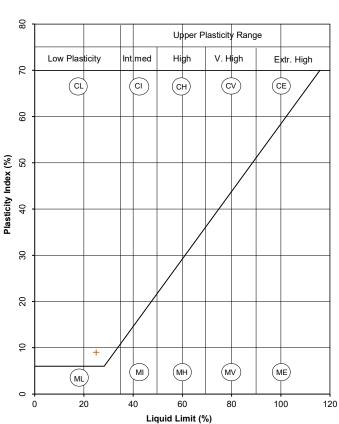
EHOLE 2	BOR									
Soil Description	on of test	Soil Suction (kPa)	% Retained (425µm)	Class	PI (%)	PL (%)	LL (%)	Corr. MC (%)	MC (%)	Depth (m)
Brown sandy CLAY containing gravel	Natural		4.3	CL	9	16	25	18.5	17.7	1.00
Orange / brown clayey, sandy GRAVEL	Washed		58.16					39.2	16.4	2.00
Orange / brown clayey SAND containing gravel	Washed		25.82					25.61	19	3.00
Orange / brown clayey SAND containing gravel	Natural		10					19.56	17.6	4.00
Orange / brown clayey SAND containing gravel	Natural		10					19.89	17.9	5.00

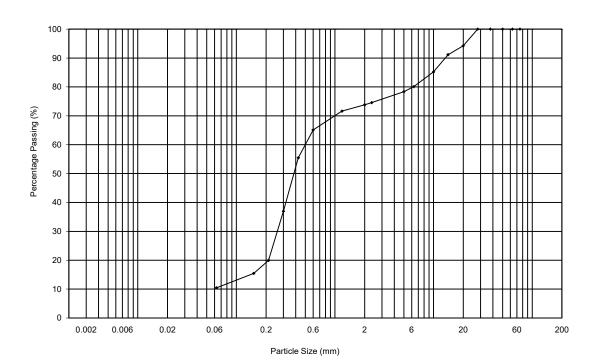
PARTICLE SIZE DISTRIBUTION: BOREHOLE 1 at 2.00m

Particle size distribution tests were carried out on samples from BH1 at 2.00m and 3.00m, BH2 at 2.00m and 3.00m. The results of the tests confirm that the stratum above the Kempton Gravel Member is medium SAND and GRAVEL. The results are shown on the graphs in appendix E.

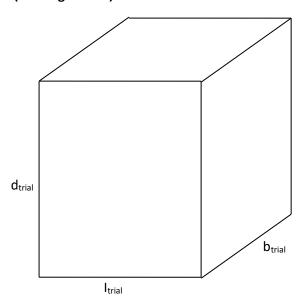
SOAK AWAY TEST NO: 1

One soakaway test were carried out on this site. The test pits were 300mm x 300mm and 900mm to 1000mm deep. Soakaway test pit 1 (SW1) drained 500mm from ground level in 22 minutes and 34 seconds in test 1, 31 minutes and 33 seconds in test 2 and then 38 minutes and 31 seconds in test 3. Using the slowest of the three rates a soil infiltration rate of $28.20 \times 10^{-6} \text{ m/s}$ is calculated for this location. The calculation can be seen in appendix C and the test pit locations can be seen on the site plan in appendix B.

Length of Trial Pit $I_{trial} =$ **0.30m** Width of Trial Pit $b_{trial} =$ **0.30m** Depth of Trial Pit $d_{trial} =$ **1.00m** Free Volume (if fill used) $V_{trial} = 35\%$

Soil infiltration rate = F = V_{p75} ₂₅ / (A_{p50} x T_{lg}) = **28.20 x 10**⁻⁶ m/s
