PHASE 2 ENVIRONMENTAL INVESTIGATION
of a site at
REAR OF 39 SECOND CROSS ROAD, TWICKENHAM
for
ANTHONY C BIANCHI

**Project No 1985
Report ref: 1985-P2E-1
Issued: 24 April 2024
Revision:**

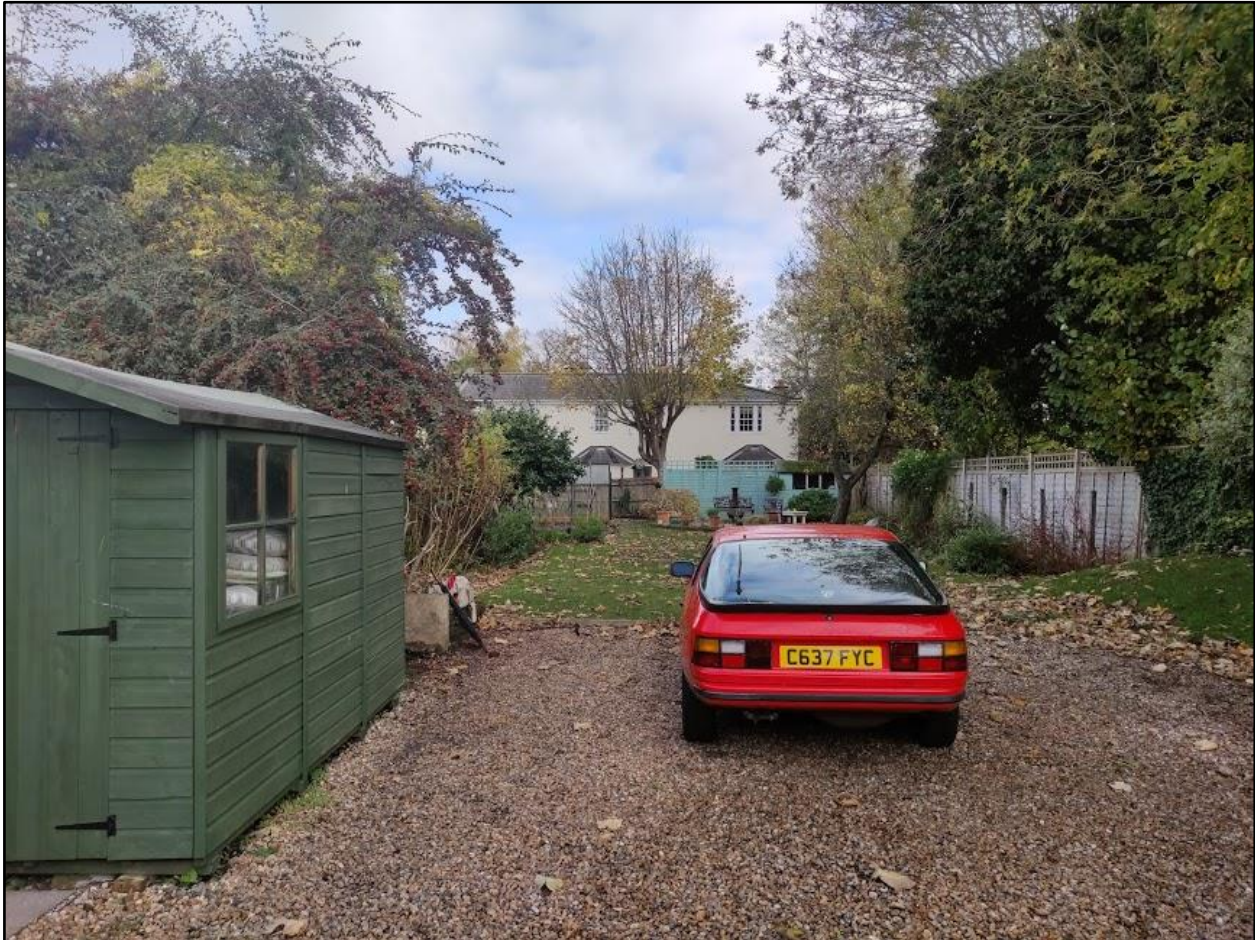
Photograph 1: View of the site looking NE from the SW border

Towards the southern end of the lawn, where it meets the driveway there is a mound of excavated soil placed against the fence. A wooden shed sits adjacent to the fence on north west side of the driveway.

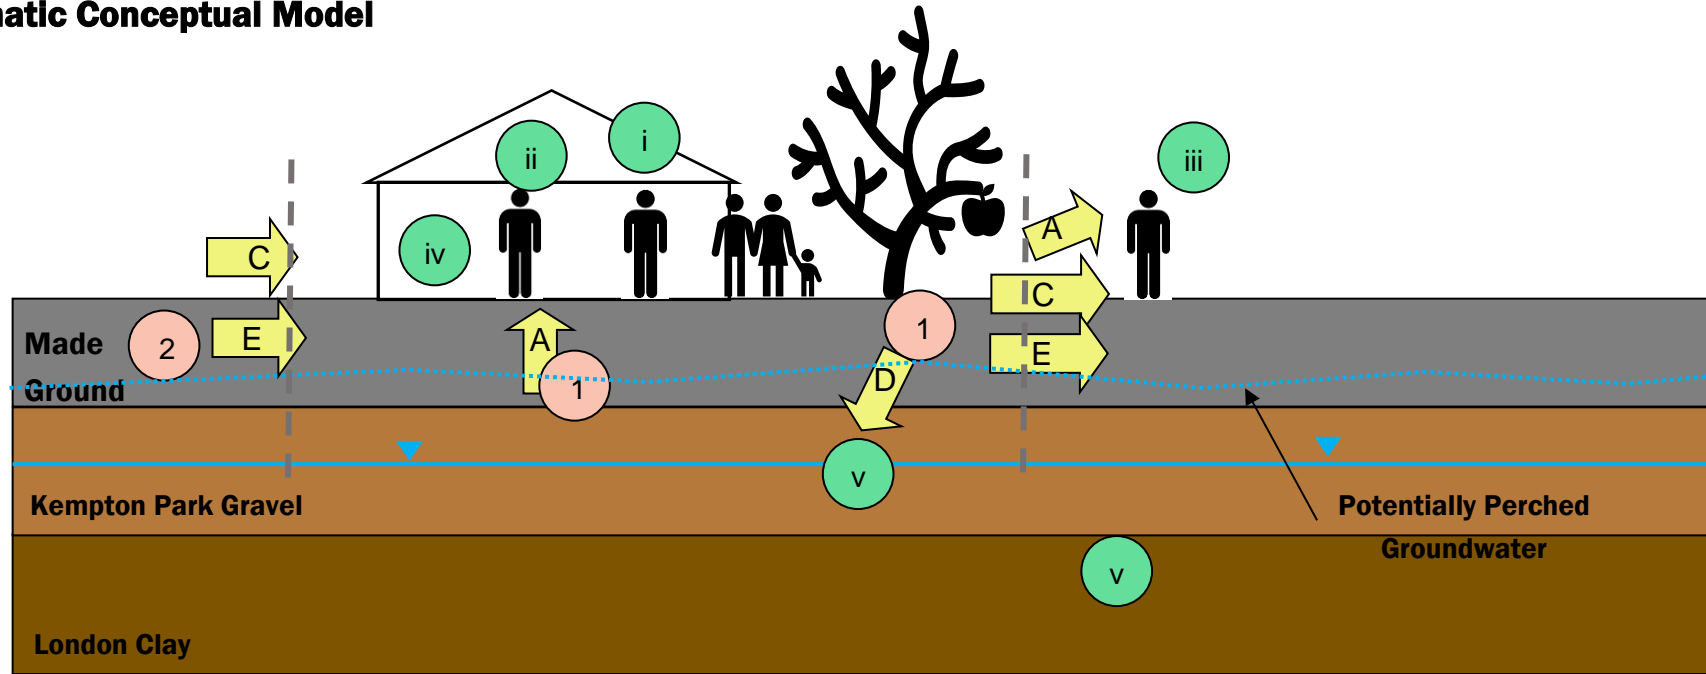
Schematic Conceptual Model

Sources		Pathways	Receptors
1	Made Ground (Lead) (On Site)	A → Inhalation, ingestion, dermal contact	i Site Users
2	Army surplus yard and smithy (Lead) (Off Site)	B → Drinking contaminated water supply	ii Ground Workers
		C → Surface water run-off	iii Neighbours
		D → Surface water percolation to groundwater	iv Proposed Building
		E → Migration via groundwater	v Groundwater (Principal Aquifer)
