PLANNING
PROJECT
8 Montpelier Row
Twickenham
TW1 2ND

PROPOSED ROOF SCHEMATIC

SCALE	PAPER SIZE	DATE	DRAWN BY
1:50	A3	JUNE24	SH
DRAWING N°	REVISION	24.02.271	00

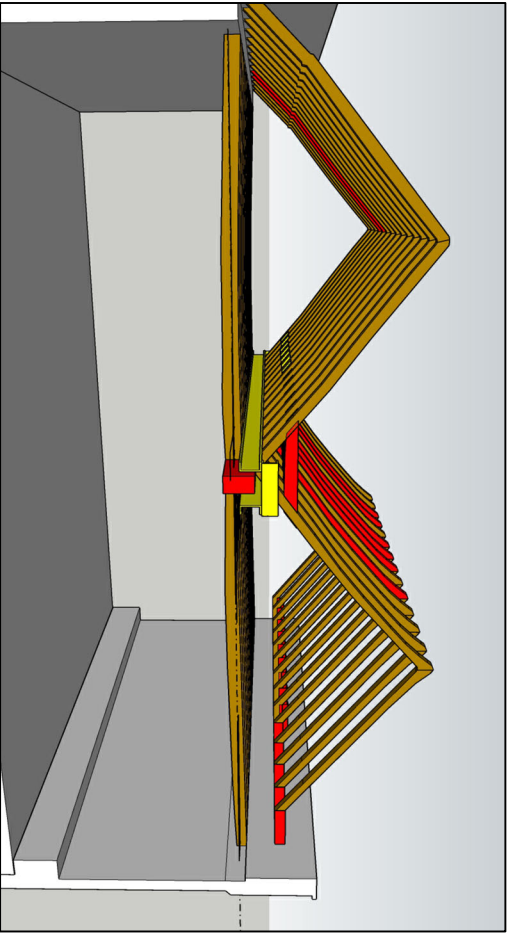
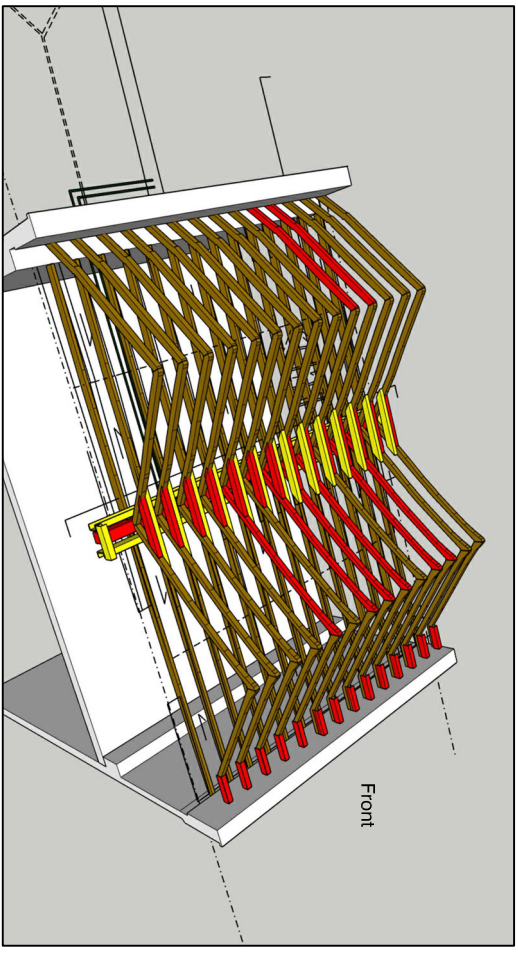
3D sketch showing proposed solution (valley access dormer omitted here for clarity)
Yellow indicates new additions

Rafters and joists. Rafters are joined at ridge with Mortice and Tenon Detail.
-

Rafters (and beams) that are rotten or damaged. Rafters that are rotten, damaged will be repaired. The same timber reclaimed, dating from a similar period will be used. Reclaimed timber from 'antiquebuildings.co.uk'
-

New steel PFC beams are proposed to sit either side of the damaged valley beam (to support the ceiling joists, rafters, gutter and self weight of the beam). New valley gutter bearers will sit alongside decayed existing bearers. Rotten ends of joists/rafters will be splices as necessary. Refer to structural engineers detail.

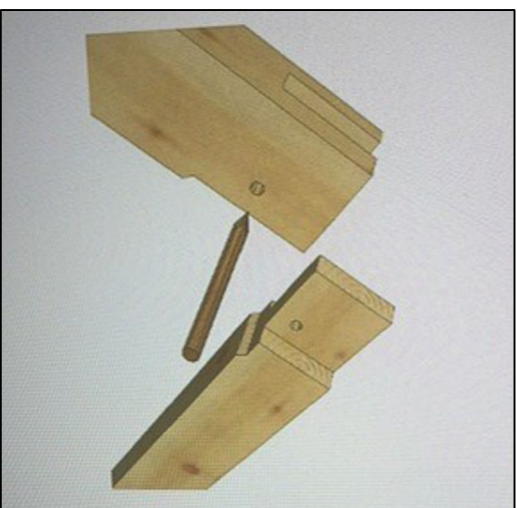
The rafters are joined at the ridge with a traditional tongue and fork type T+G joint.
Retained rafters to use this joint. If this joint is in poor condition it will be repaired with a splice detail to ensure that connections are made in the traditional manner.

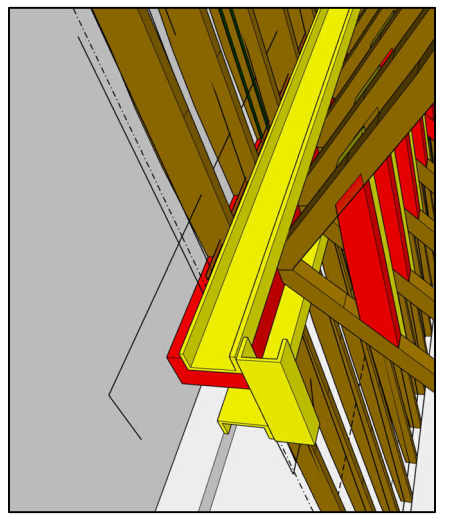
New steel PFC beams are proposed to sit either side of the damaged valley beam (to support the ceiling joists, rafters, gutter and self weight of the beam). They will be connected into the party wall at either end with a min. 500mm L PFC spreader (shown here in this sketch). This will mean that the existing corning can be retained as far as possible (and refurbished when the roof works are complete).

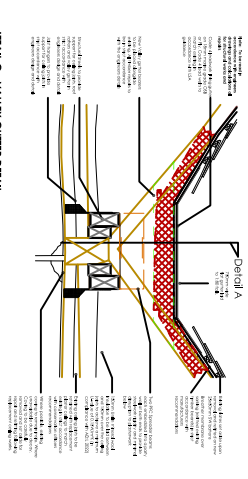
Detail A - VALLEY GUTTER DETAIL
Refer to drawing 24.02.300 for the valley detail
