8 MONTPELIER ROW, TWICKENHAM TW1 2NQ

Heritage, Design and Access Statement

Rev.00

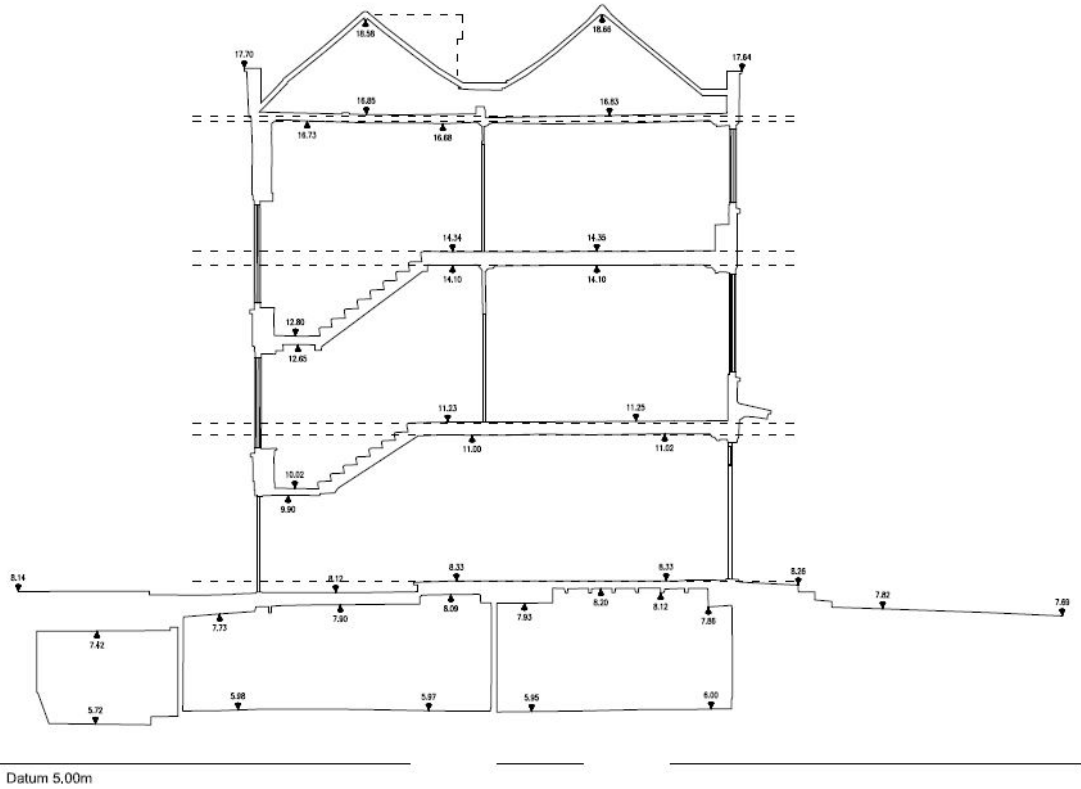
Above: Cross section of the existing property. The front of the property is on the right of this image.

The property has a double pitched roof arrangement with access to the central valley via a small dormer on the front pitch of the rear slope.

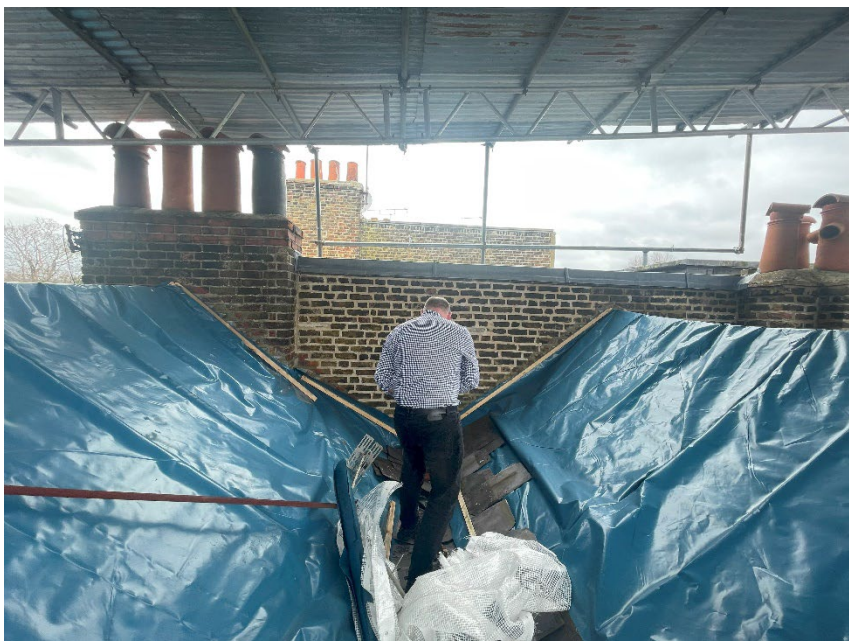
The property is currently covered by a temporary scaffold roof over the main roof (to provide some protection from rain temporarily) and some protective polythene sheeting covers the slate finishes and gutters at present while this application is being prepared.

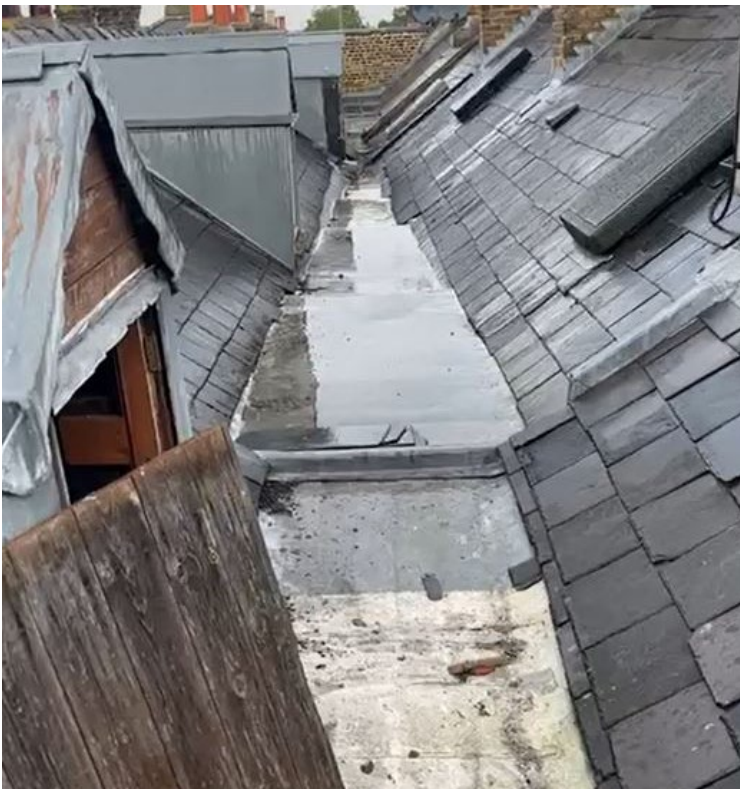
Left: Photograph standing in the valley between the two roof pitches looking down the row (numbers 7 and 6 can be seen here with their access dormers). Number 8's dormer is immediately to the left here.

The stepped valley gutter is dilapidated at Number 8. Its valley gutter bearers are decayed and will require new support alongside the existing (to retain the historical fabric).

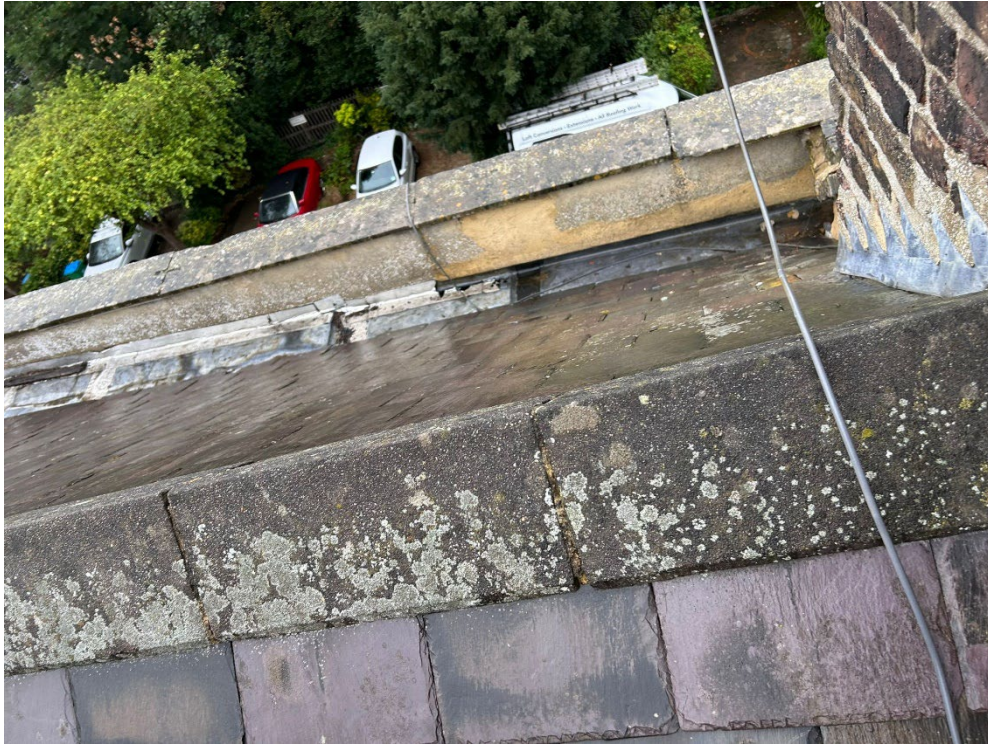
Above: An image that was taken prior to the scaffold being erected. This shows the dilapidated front lead gutter behind the parapet.

New lead flashings, gutters and valleys as well as new lead to the access dormer will provide a robust solution to the water ingress problems that have taken place via the dilapidated roof over the years.

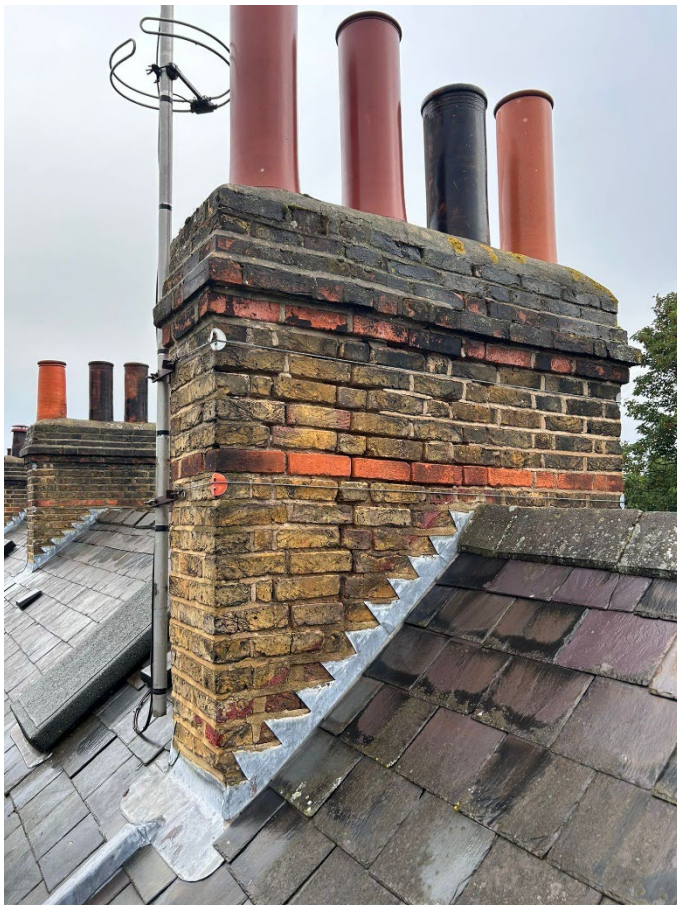
Left: The chimney pointing is missing.

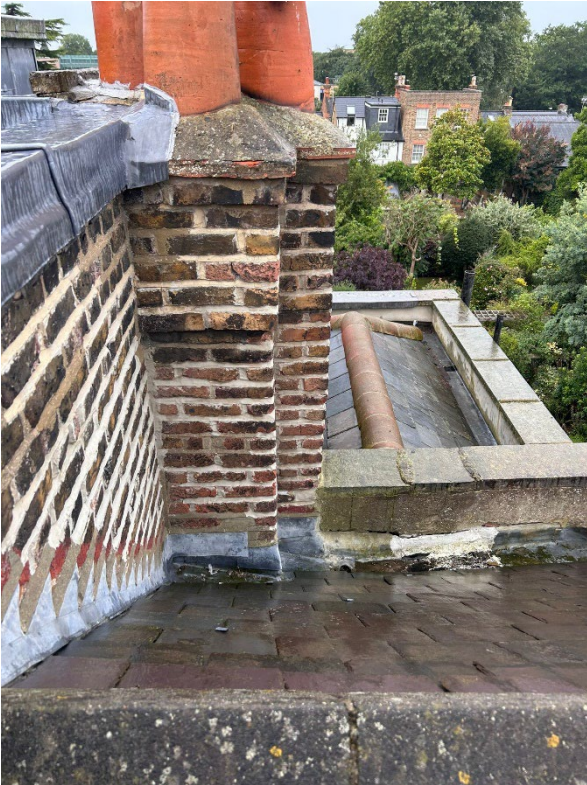
Left: An image that was taken prior to the scaffold being erected. This shows the dilapidated rear lead gutter behind the parapet.

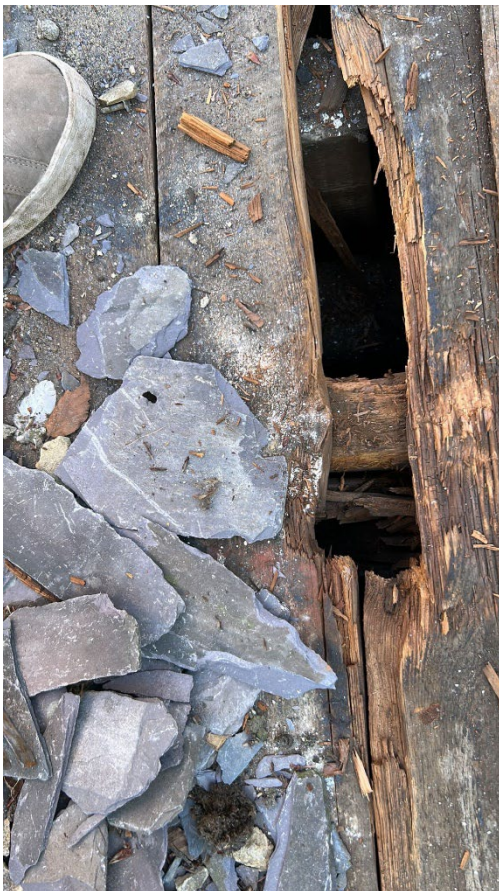
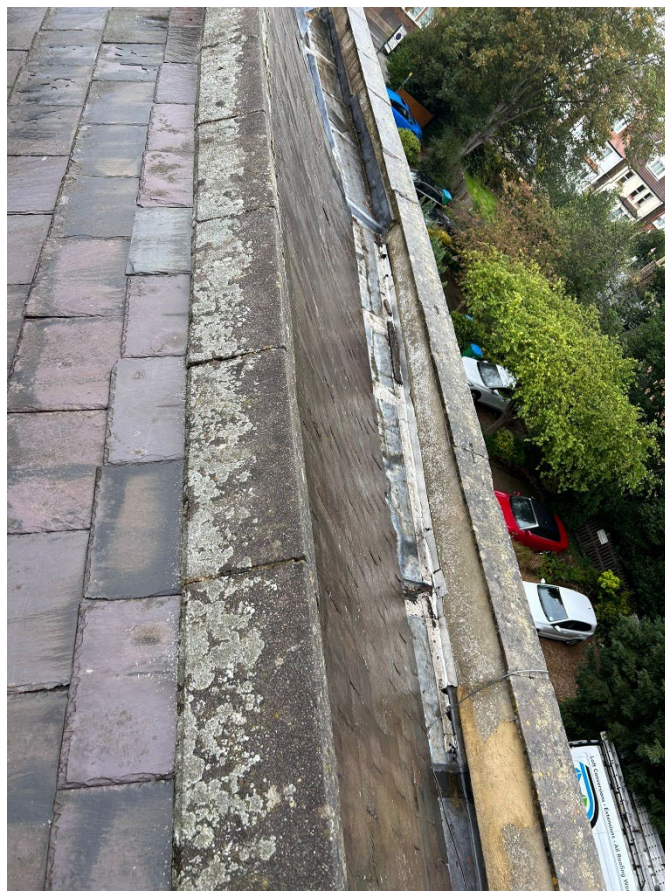
Below: Images of rotten timber to rear gutter and gutters that are not able to drain effectively.

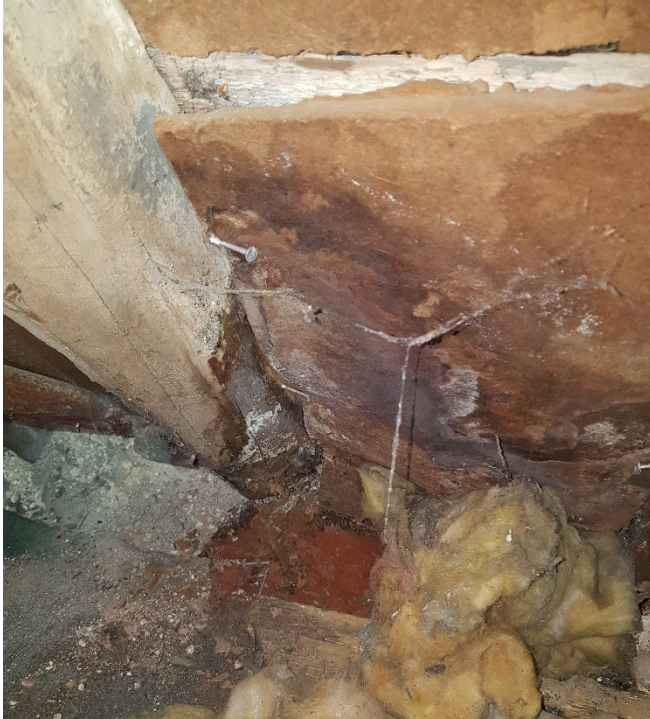
Left: Picture taken in the roof void. Some of the bearing ends of the rafters are rotten/decayed and need to be supported.

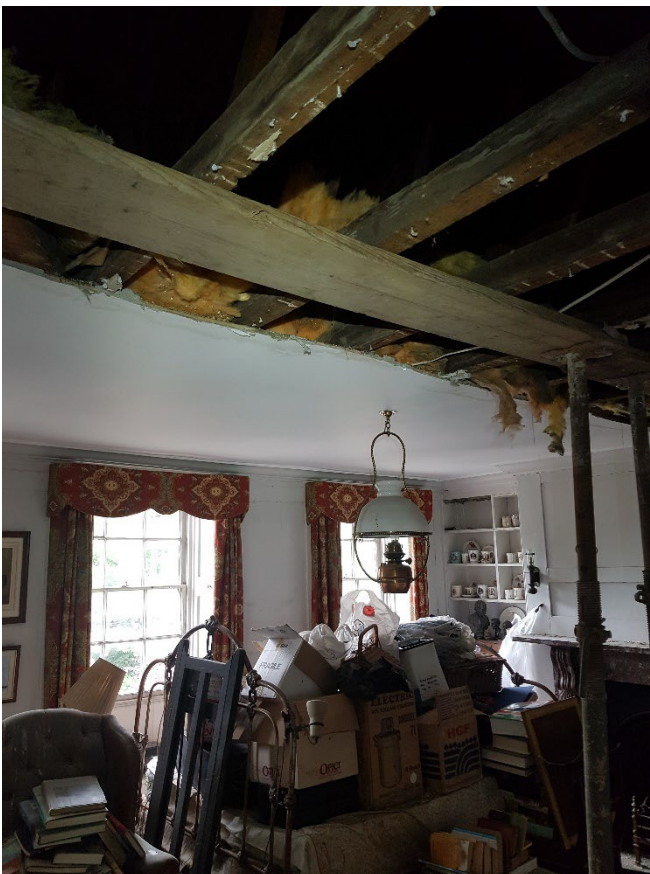
Left: The second floor ceiling has collapsed.

The area has been made temporarily safe with props so that the structure could be measured and inspected.

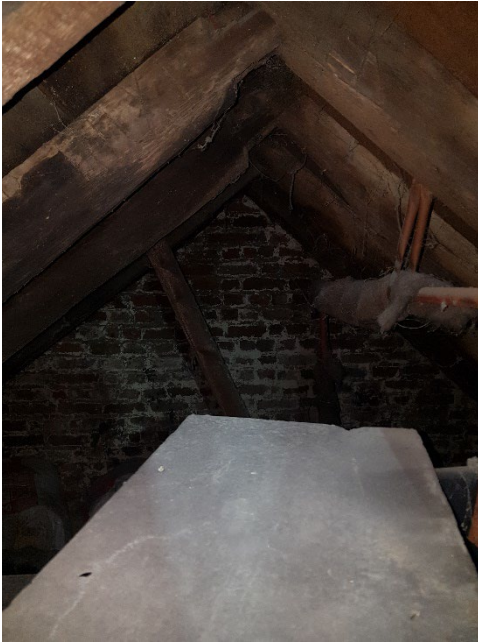
Left: The rafters to the rear roof slope.

A survey of the timber has been undertaken (by Tapco HomeDry) and it has showed the presence of an active infestation of the Woodworm, Common Furniture Beetle (*Anobium punctatum*) that was found affecting the ceiling joists. Timber preservation treatment has been recommended to all the accessible roof timbers.

There was also found an attack of the Wet-Rot Fungus (*Coniophora puteana*) affecting the box gutter timber wall plate and joist ends due to defects with the roof coverings. Timber preservation treatment will be required.

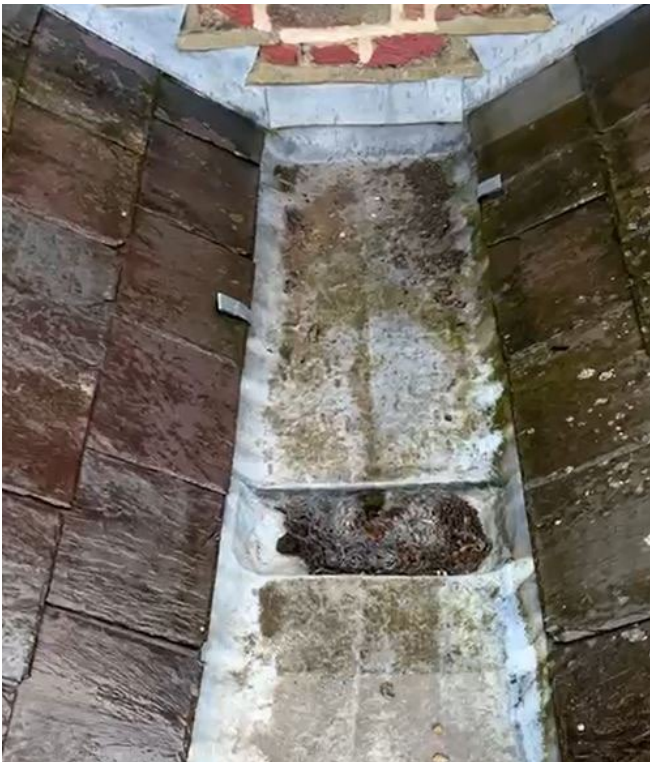
Above Left: The valley has a gully at its southern end that connects into an open timber chute within the attic space and the rear closet wing roof and out to its rainwater hopper and downpipe. We would like to retain this chute for historical value but install a drainage pipe within it to ensure drainage is robust.

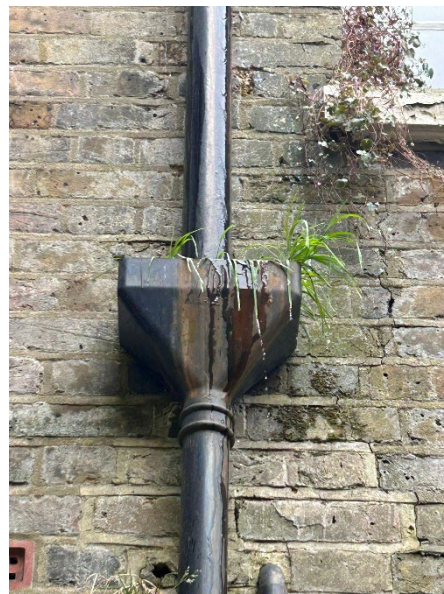
Above Right: Hoppers are blocked and downpipes are dilapidated. These should be renewed like for like.

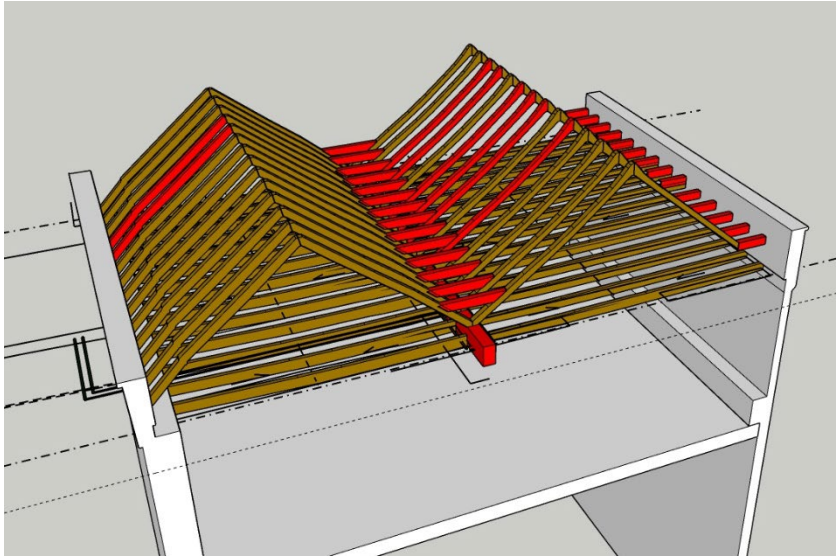
- Significant decay and loss of section to the central timber valley beam, particularly in the area of the dormer access/loft hatch, extending both sides of the intermediate support post.
- Ceiling joists to one side of the valley beam pulled out (loss of bearing via tenon)
- Ends of rafters at eaves with localised decay +/- or loss of bearing
- Ends of ceiling joists at valley beam with localised decay.

Above: 3D sketch showing existing roof structure. The red members are those that are decayed and may require additional support.

In order to retain as much of the historical fabric as possible, we believe the most suitable solution is to retain the historical timbers and repair/re-support them where necessary. As such, new steel PFC beams are proposed to sit either side of the damaged valley beam (to support the ceiling joists, rafters, gutter and self weight of the beam).
