**STAGE 1 & 2 BASEMENT IMPACT ASSESSMENT
(SCREENING & SCOPING)
REPORT**

26 AMYAND PARK ROAD
TWICKENHAM
TW1 3HE

Job No: P5802J3027/HAH

Date: 20 June 2024

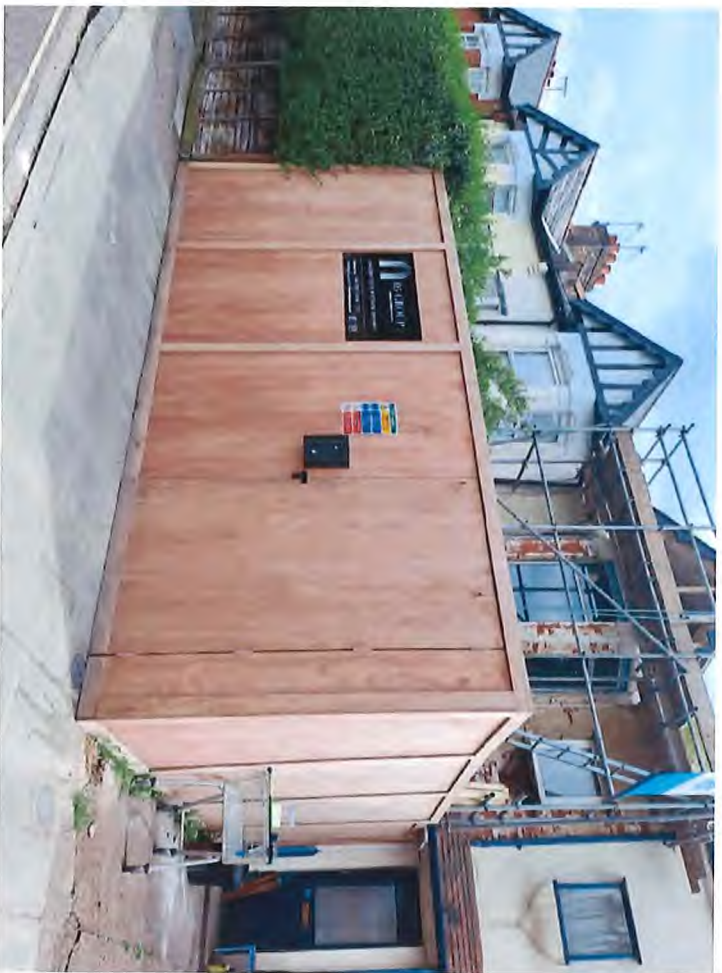
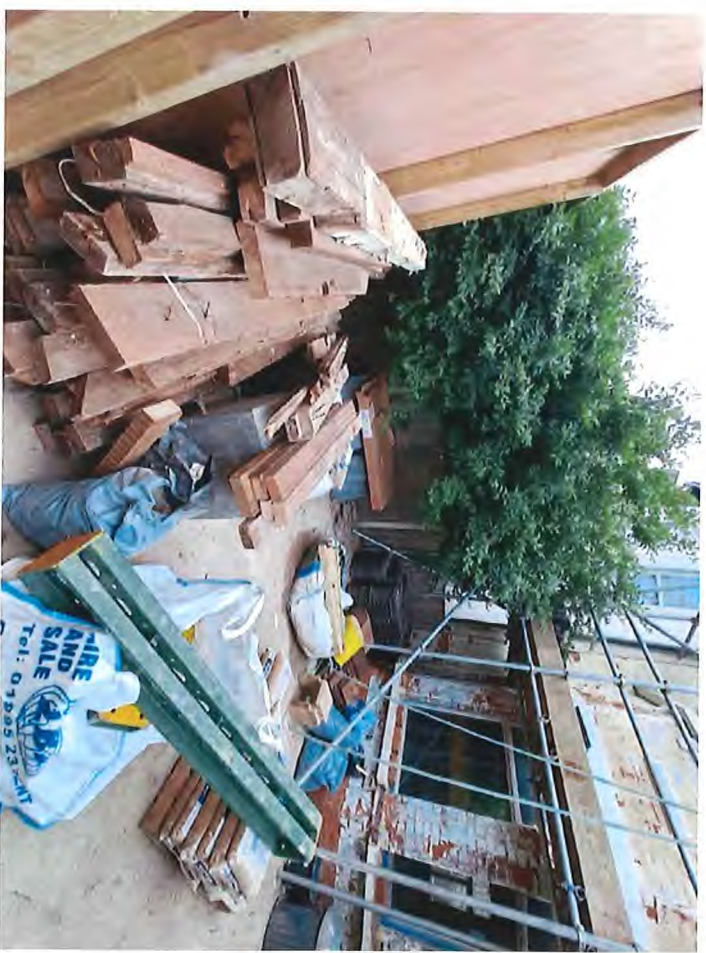
PROJECT NAME	26 Amyand Park Rd, TW1 3HE	CLIENT	05 Group Ltd
TITLE	Walkover Photo Plan	FIGURE	3
Photo 1: Overview of front of site.		Photo 2: Overview of front garden of site.

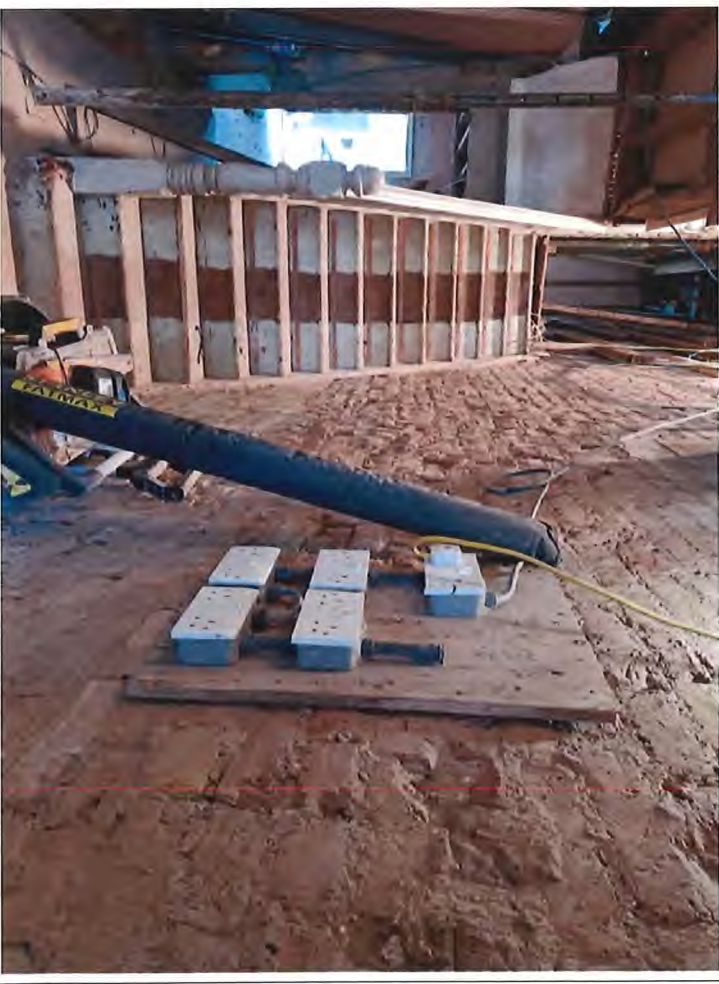
PROJECT NAME	26 Amyand Park Rd, TW1 3HE	CLIENT	05 Group Ltd
TITLE	Walkover Photo Plan	FIGURE	3
Photo 3: Main living room of site.		Photo 4: Site is connected to electrics.

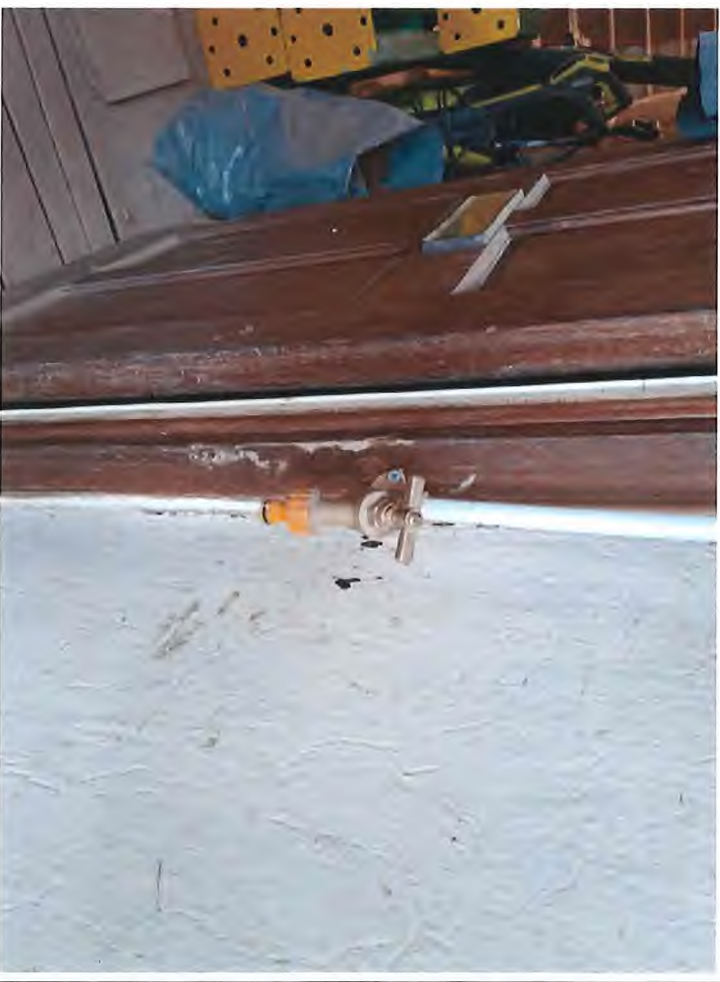
PROJECT NAME	26 Amyand Park Rd, TW1 3HE	CLIENT	05 Group Ltd
TITLE	Walkover Photo Plan	FIGURE	3
Photo 9: Back garden of site from gate.		Photo 10: External water supply by front door.

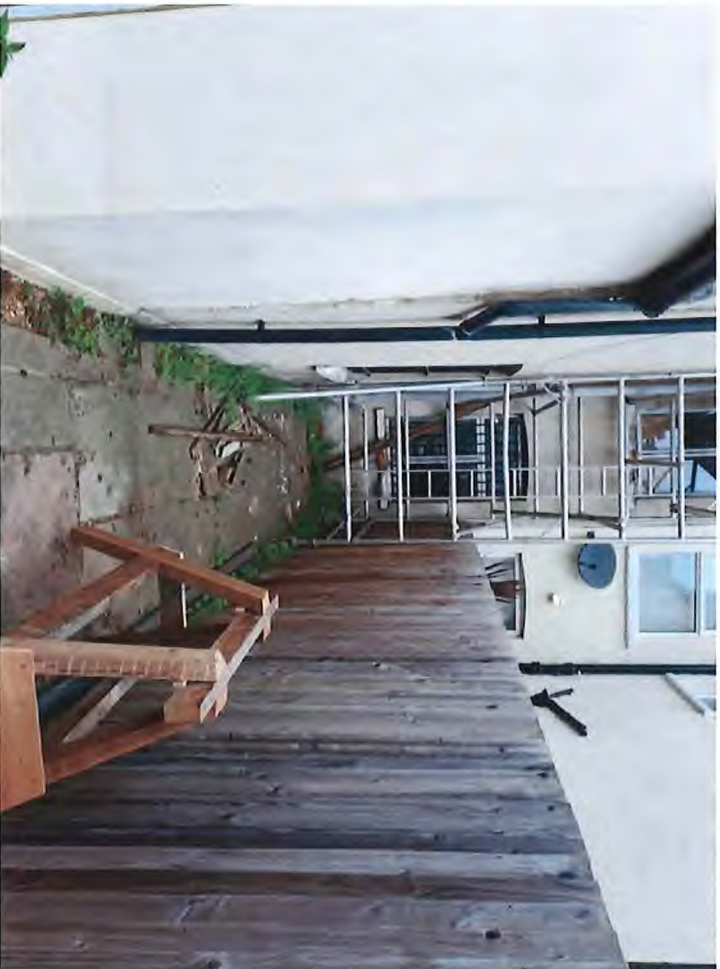
PROJECT NAME	26 Amyand Park Rd, TW1 3HE	CLIENT	05 Group Ltd
TITLE	Walkover Photo Plan	FIGURE	3
Photo 11: Drainage in back garden.		Photo 12: Alleyway leading to back gate.
