Greggs Bakery / Twickenham

Phase I Environmental Assessment

Prepared by AP Geotechnics

GREGGS BAKERY SITE & No. 2 GOULD ROAD TWICKENHAM TW2 6RT

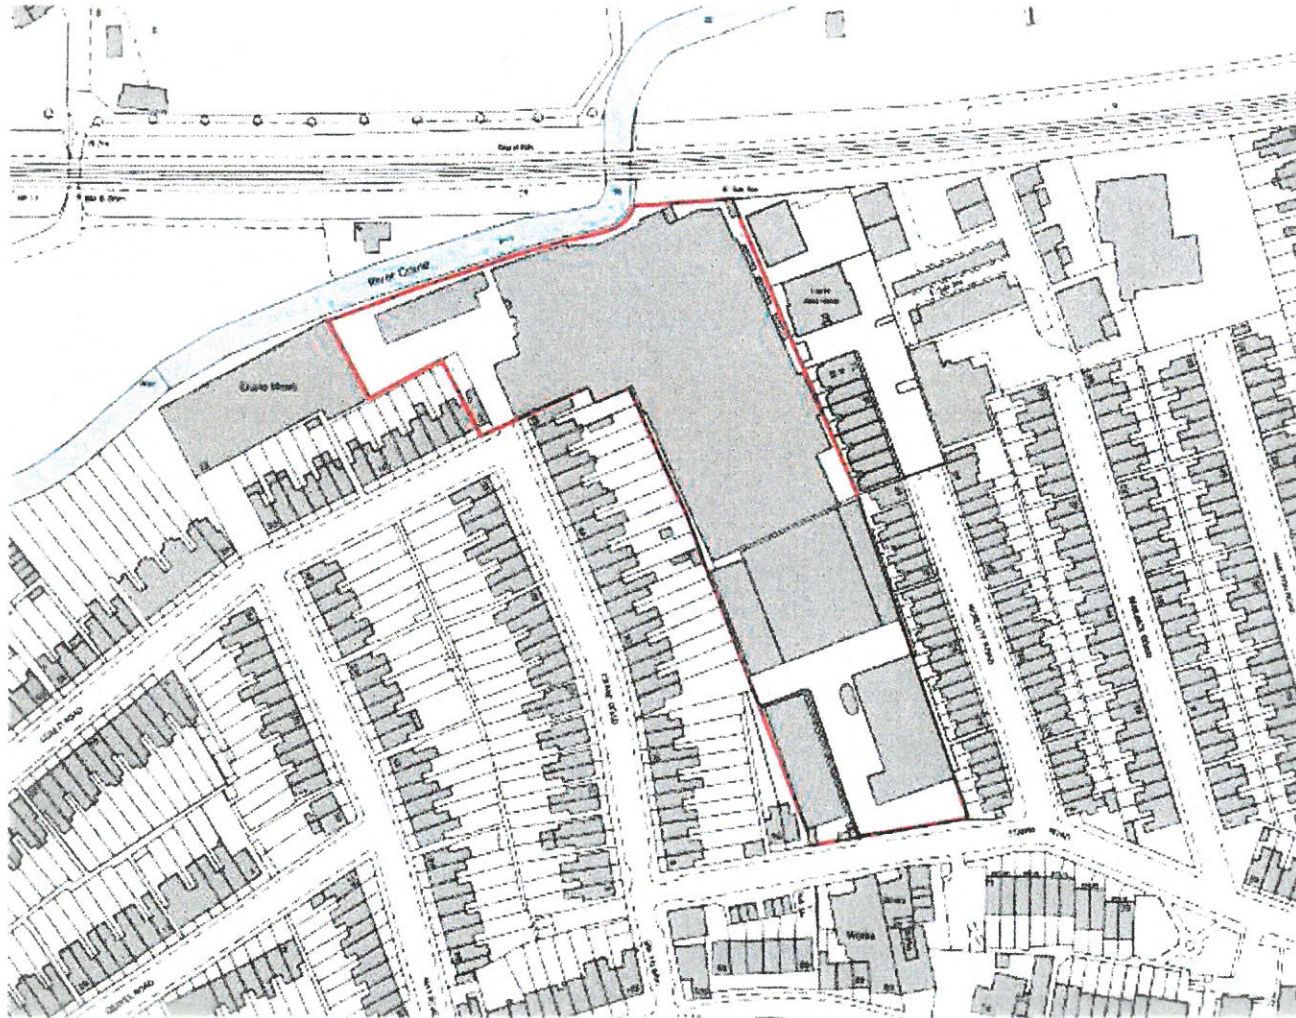
The area under investigation is an approximate 'L' shaped plot of land extending to some 1.12 hectares, as shown on Figure 1 at Appendix A. The site was, from 1953 until November 2016, a bakery and distribution depot for Greggs.

Existing site plan
