Contamination Investigation Report

**Hampton Wick Infants & Nursery School, Normansfield Avenue,
Teddington, Greater London TW11 9RP**

**Reference: 21324/CIR Rev1.0
April 2024**

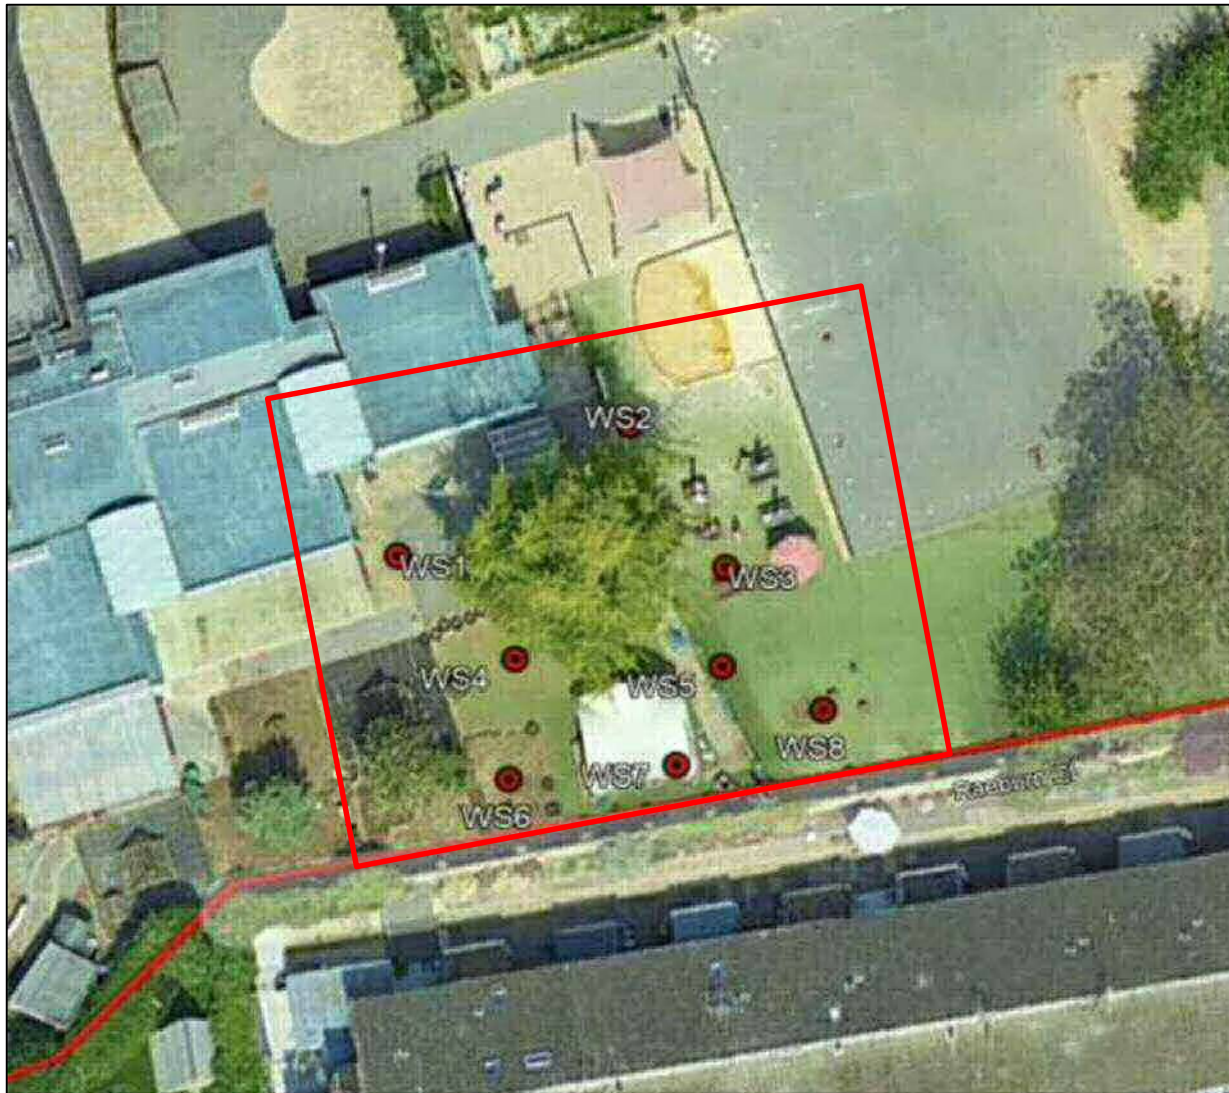
Figure 3 – Exploratory Hole Plan

Eight windowless sampler boreholes (WS1 – WS8) were backfilled with gravel. Exploratory hole locations have been presented in Figure 3.
