Appendix C – Thames Water Asset Plans

Appendix D – Topographical & CCTV Survey

Project Description: WinCan Import in Miraculix WRc4 Standard

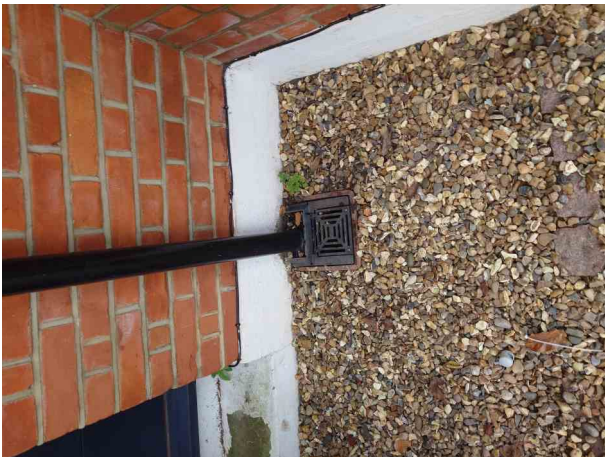
front gully

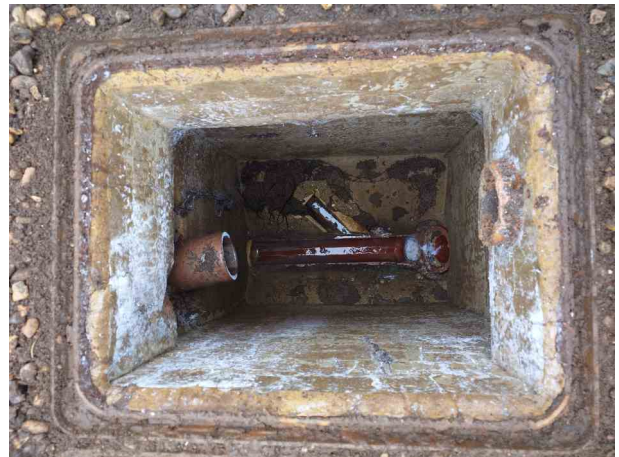
fwmh

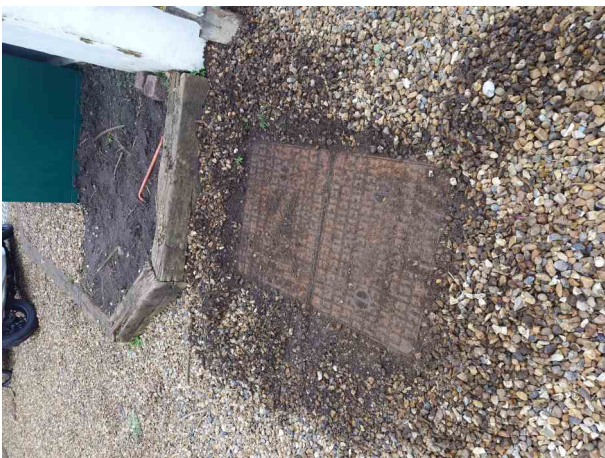
Manholes exposed

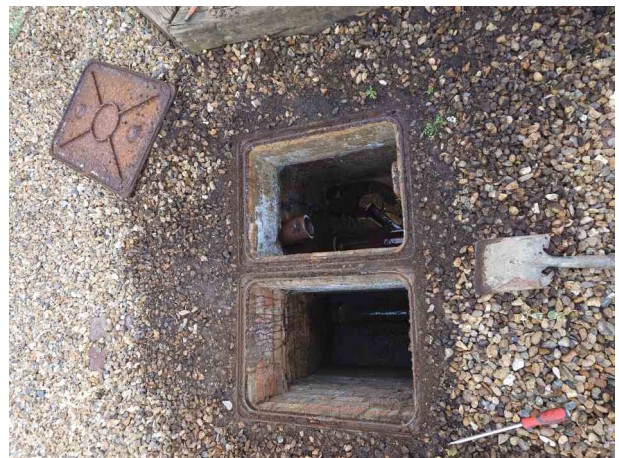
Manholes

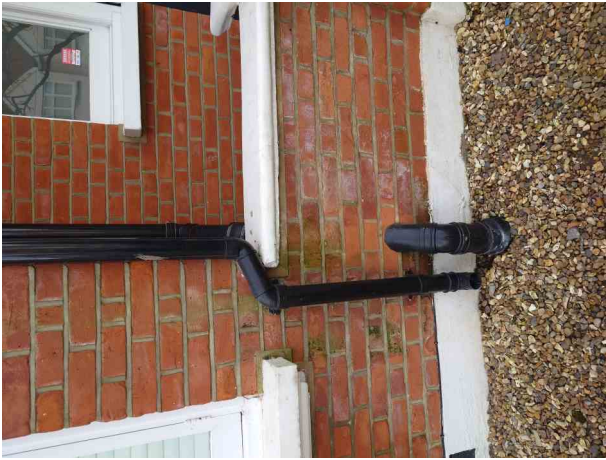
svp1

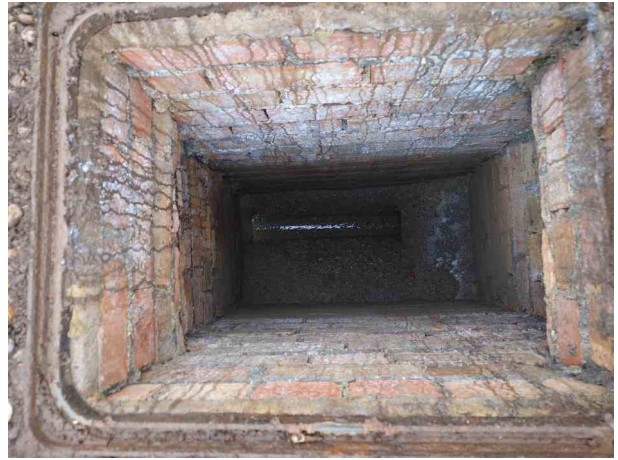
swmh

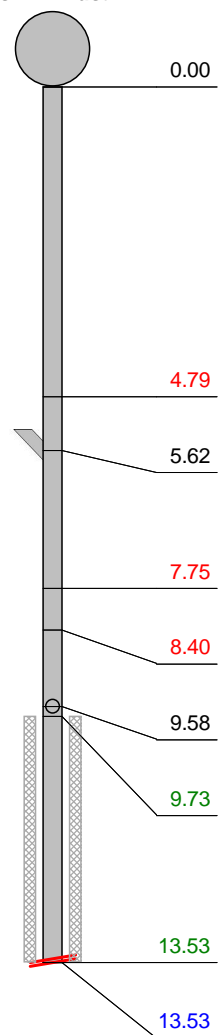
0.00	MH		Start node, manhole, reference: swmh1 ust	00:00:00	swmh1 ustX_575e 0cbc-3c57-

4.79	CC		Crack, circumferential from 10 o'clock to 3 o'clock	00:00:43	swmh1 ustX_744d b1a9-66bf-	2
	5.62	JN		Junction at 3 o'clock, diameter: 100mm: RW GULLY FRONT	00:01:01	swmh1 ustX_ddc1 52bf-132d-

7.75	CC		Crack, circumferential from 9 o'clock to 2 o'clock	00:01:23	swmh1 ustX_9934 facb-32d6-	2
	8.40	CC		Crack, circumferential from 9 o'clock to 4 o'clock	00:01:31	swmh1 ustX_88fb 792e-55b9	2

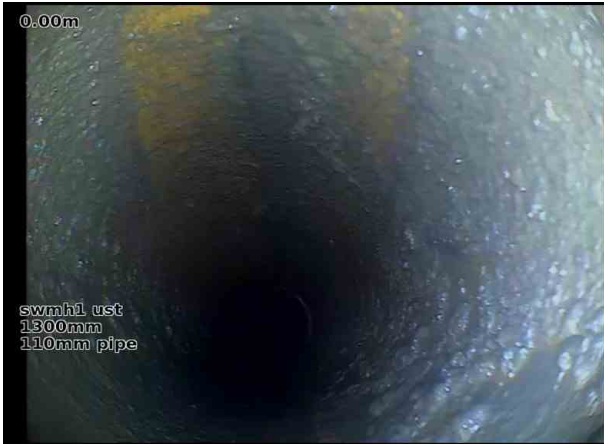
swmh1
ustX_575e0cbc-3c57-432e-9542-33f1bea78013_20240207_221
616_731.jpg, 00:00:00, 0.00 m
Start node, manhole, reference: swmh1 ust

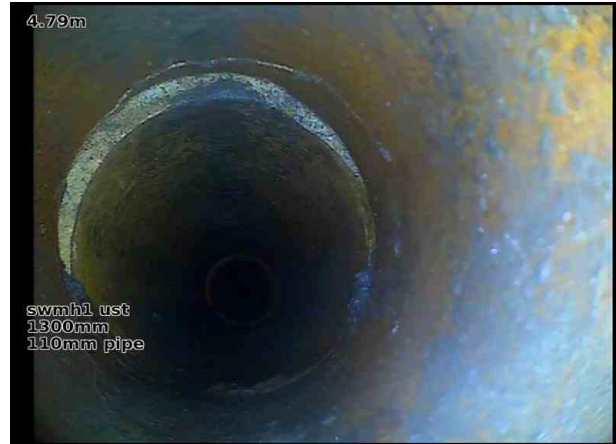
swmh1
ustX_744db1a9-66bf-4853-be06-8646d82032f3_20240207_221
800_805.jpg, 00:00:43, 4.79 m
Crack, circumferential from 10 o'clock to 3 o'clock

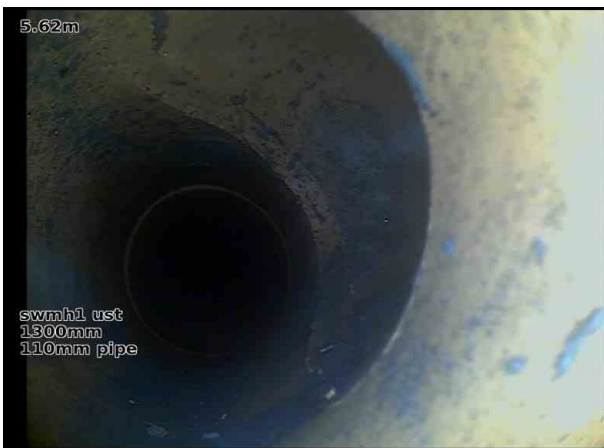
swmh1
ustX_ddc152bf-132d-4025-a85d-9dd618a7cd65_20240207_22
2312_190.jpg, 00:01:01, 5.62 m
Junction at 3 o'clock, diameter: 100mm, RW GULLY FRONT

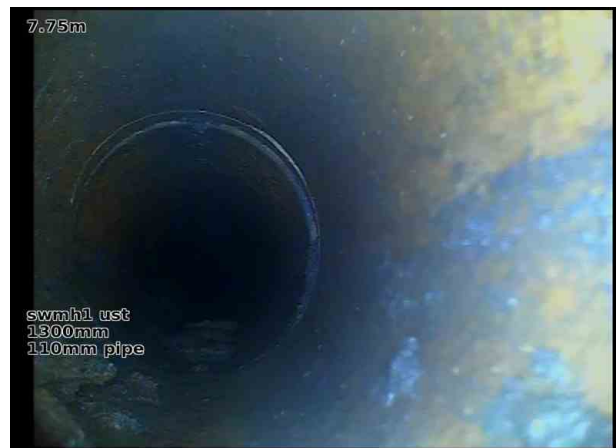
swmh1
ustX_9934facb-32d6-4f6c-9b6a-c3d7c3e11067_20240207_222
401_502.jpg, 00:01:23, 7.75 m
Crack, circumferential from 9 o'clock to 2 o'clock

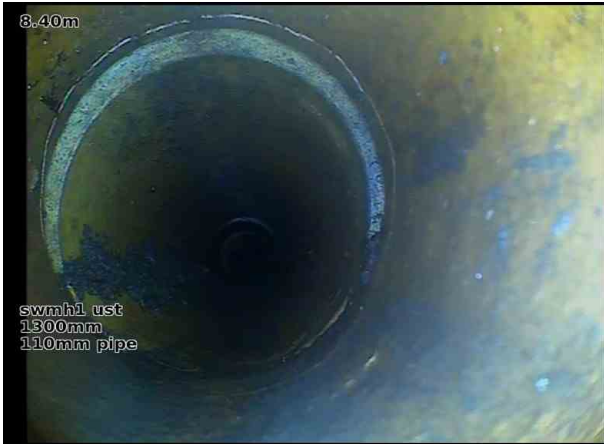
swmh1
ustX_88fb792e-55b9-48ef-bc98-570d9852f815_20240207_222
441_859.jpg, 00:01:31, 8.40 m
Crack, circumferential from 9 o'clock to 4 o'clock

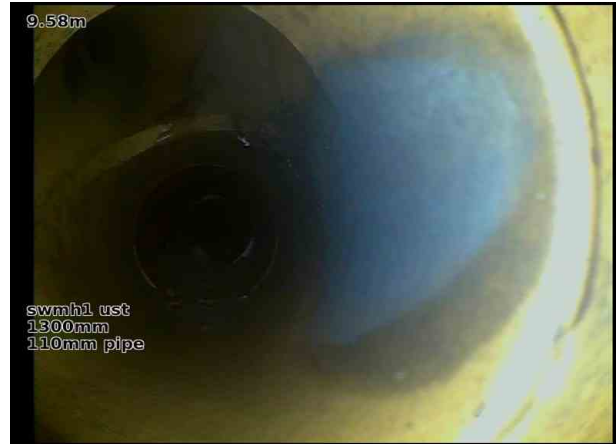
swmh1
ustX_0260c911-b0a5-43b6-a559-8199e072db75_20240207_22
2522_039.jpg, 00:01:42, 9.58 m
Junction at 12 o'clock, diameter: 100mm

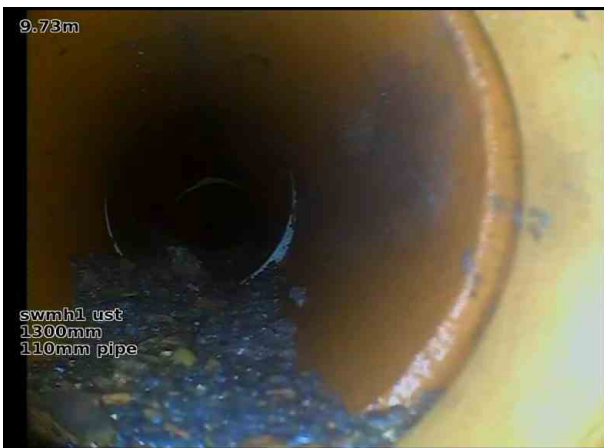
swmh1
ustX_234c706c-b2e1-4624-b9bc-79ff22d21aa0_20240207_222
604_259.jpg, 00:01:49, 9.73 m
Settled deposits, coarse, 25% cross-sectional area loss, start

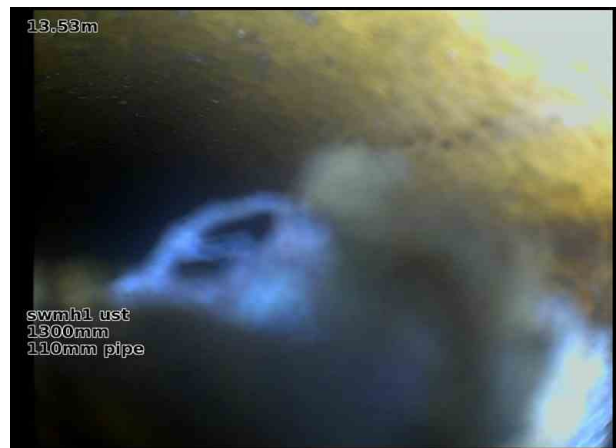
swmh1
ustX_ea60d295-071d-4961-abab-0d2ce511bfaa_20240207_222
849_671.jpg, 00:02:22, 13.53 m
Settled deposits, coarse, 60% cross-sectional area loss, finish

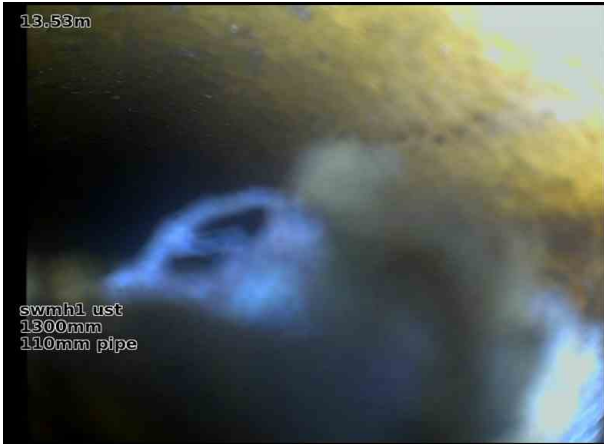
swmh1
ustX_6634cadc-a9b0-4104-a63f-66d5dcec7ec6_20240207_222
929_225.jpg, 00:02:22, 13.53 m
Survey abandoned, Survey abandoned due settled deposits
coarse in the pipe

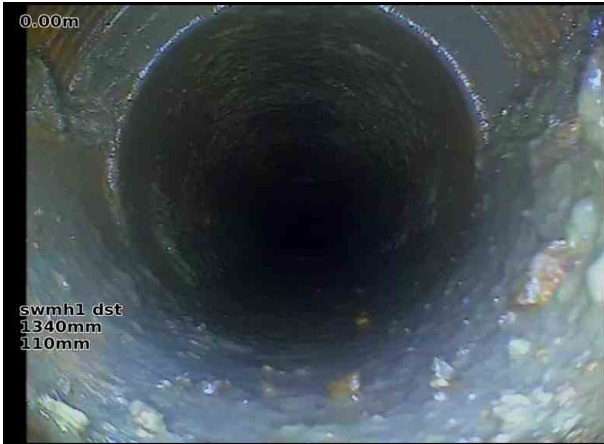
swmh1
dstX_6a475711-0d06-4ae5-8729-b93e5636e4bb_20240207_22
3101_845.jpg, 00:00:00, 0.00 m
Start node, manhole, reference: swmh1 dst

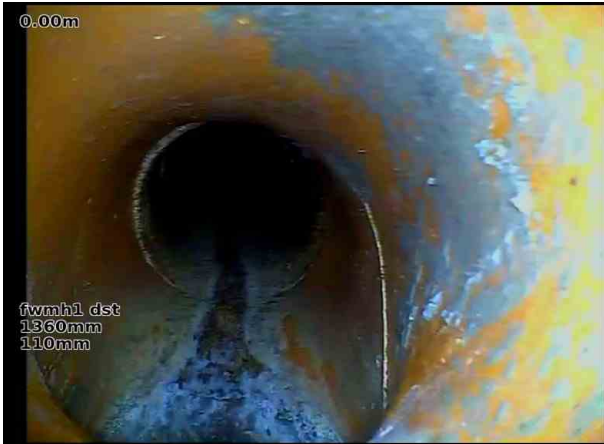
fwmh1
dstX_b4e23b4b-b114-4f0f-874c-64836493a88c_20240207_223
518_988.jpg, 00:00:00, 0.00 m
Start node, manhole, reference: fwmh1 dst

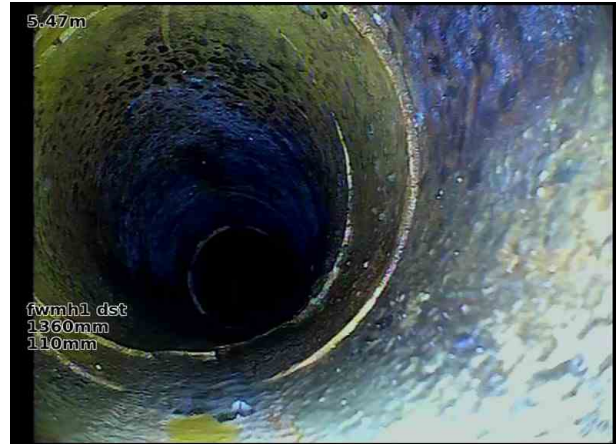
fwmh1
dstX_096bf927-93a1-4fe4-b8ad-7e2d9b055c24_20240207_223
712_243.jpg, 00:00:34, 5.47 m
Fracture, circumferential from 3 o'clock to 7 o'clock

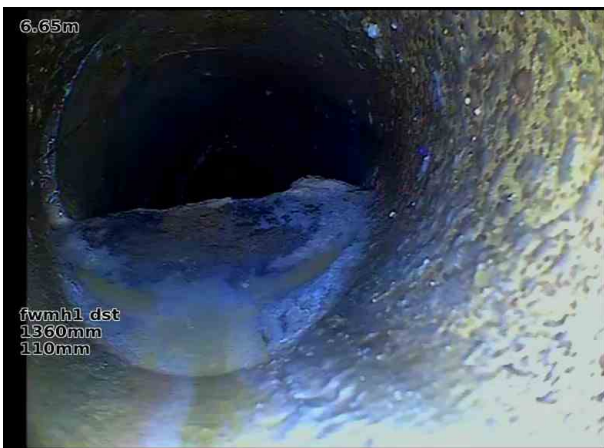
fwmh1
dstX_83d30b6c-5624-4347-8e81-75e390a2cda4_20240207_22
3828_574.jpg, 00:00:41, 6.65 m
Attached deposits, encrustation from 4 o'clock to 8 o'clock, 40%
cross-sectional area loss

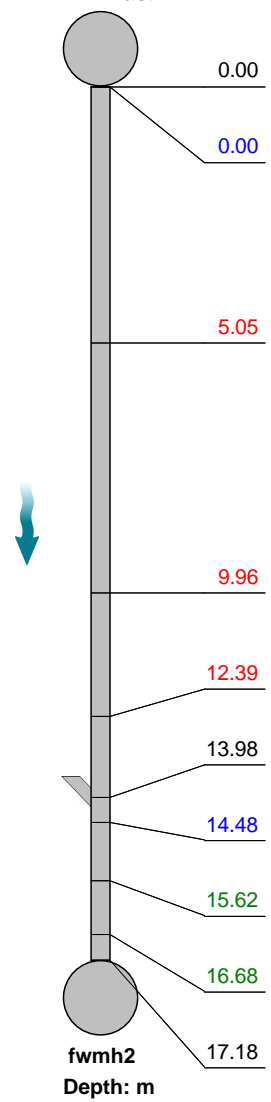
0.00	MH	Start node, manhole, reference: fwmh1 ust	00:00:00	fwmh1 ustX_a5fdf eea-6f2e-4

0.00	WL	Water level, 10% of the vertical dimension	00:00:44	fwmh1 ustX_380a f52e-14c3-	
		5.05	CC	Crack, circumferential from 9 o'clock to 2 o'clock	00:00:36	fwmh1 ustX_b9be 31e4-d4da	2

9.96	CM	Cracks, multiple from 11 o'clock to 2 o'clock	00:01:21	fwmh1 ustX_470b 1b70-0fa4-	3
		12.39	CC	Crack, circumferential from 9 o'clock to 3 o'clock	00:01:44	fwmh1 ustX_7772 0550-3be4	2

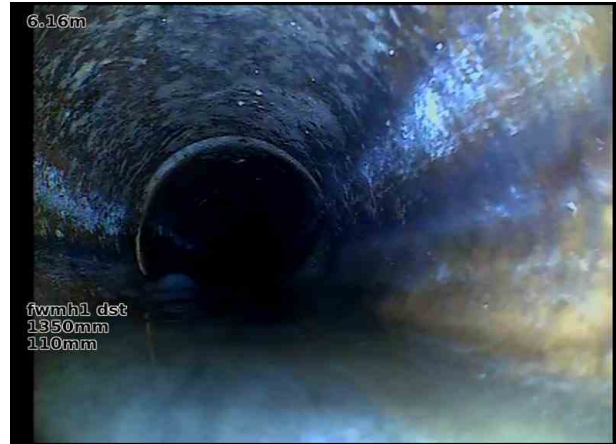
fwmh1
ustX_380af52e-14c3-486b-93ff-29d7bd52e557_20240207_224
604_407.jpg, 00:00:44, 0.00 m
Water level, 10% of the vertical dimension

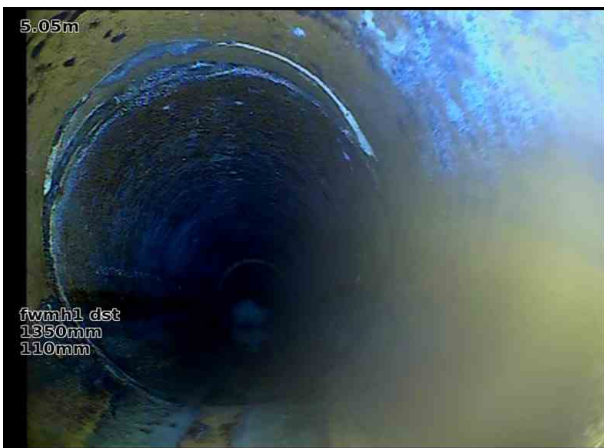
fwmh1
ustX_b9be31e4-d4da-4770-a288-e532082d8efe_20240207_224
342_831.jpg, 00:00:36, 5.05 m
Crack, circumferential from 9 o'clock to 2 o'clock

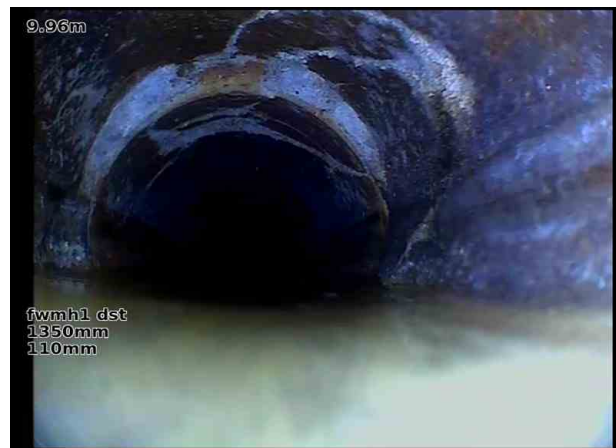
fwmh1
ustX_470b1b70-0fa4-41ef-996a-31671add2df9_20240207_225
139_933.jpg, 00:01:21, 9.96 m
Cracks, multiple from 11 o'clock to 2 o'clock

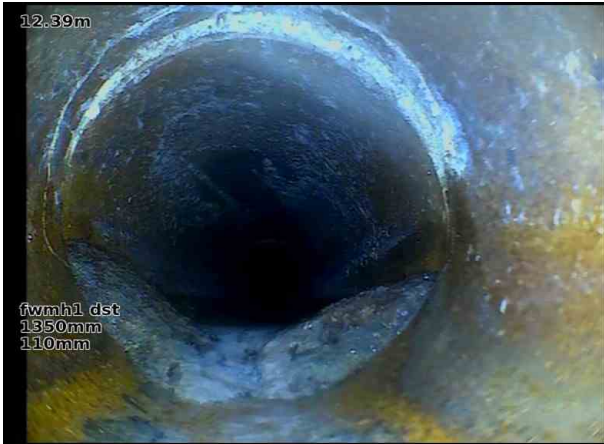
fwmh1
ustX_77720550-3be4-41dc-984a-ca4aefc549b7_20240207_225
230_182.jpg, 00:01:44, 12.39 m
Crack, circumferential from 9 o'clock to 3 o'clock

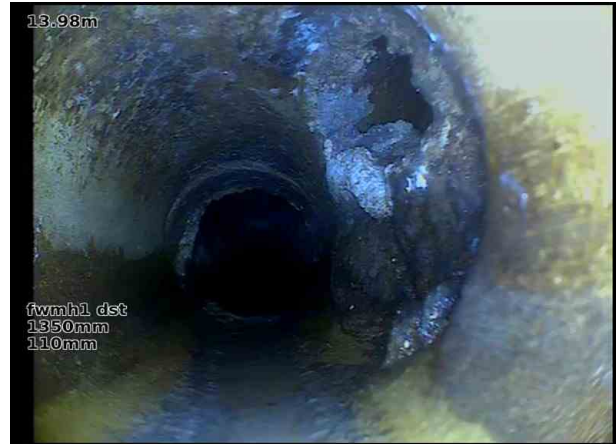
fwmh1
ustX_6f7f92c5-4e28-4a54-a6c5-e3c877256071_20240207_225
328_659.jpg, 00:01:57, 13.98 m
Junction at 3 o'clock, diameter: 100mm, Redundant junction

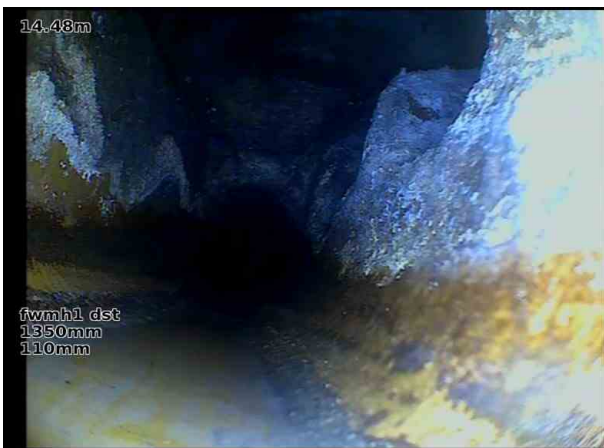
fwmh1
ustX_58cc0362-8061-4ce3-9e34-90d3158d4cc3_20240207_22
5435_937.jpg, 00:02:16, 14.48 m
General remark, fwmh2 reached.survey will proceed

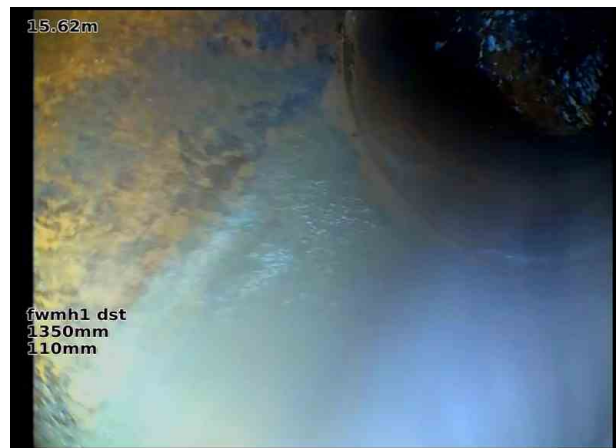
fwmh1
ustX_f3409cce-d124-43a1-8347-99480b4b0e70_20240207_225
539_679.jpg, 00:02:27, 15.62 m
Line deviates right, full

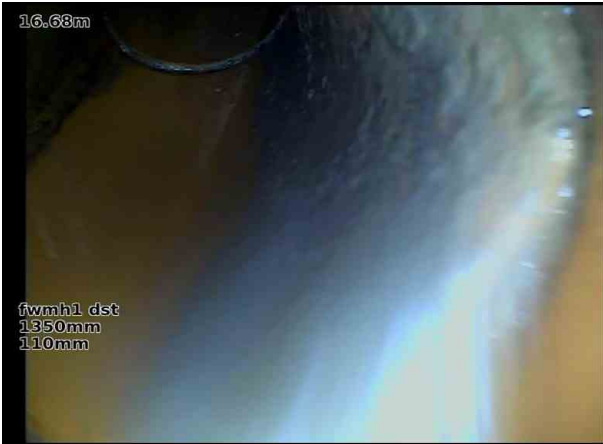
ustX_ad428c48-da88-4916-b6ed-07c9621359a0_20240207_22
5631_587.jpg, 00:02:38, 16.68 m
Line deviates up, full

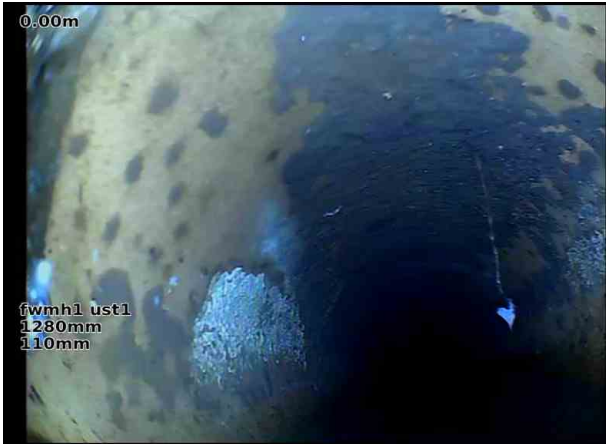
fwmh1
ust1X_050c8132-337f-40a8-9bdd-d4d7d3cf4e33_20240207_22
5913_935.jpg, 00:00:00, 0.00 m
Start node, manhole, reference: fwmh1 ust1

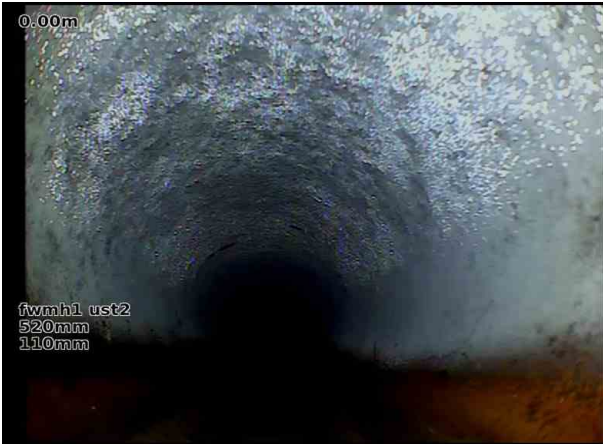
fwmh1
ust2X_127f8755-9e42-43df-b262-c778cd27fb33_20240207_230217_398.jpg, 00:00:00, 0.00 m
Start node, manhole, reference: fwmh1 ust2
