**Preliminary Roost Assessment
Update Report
Former Hampton Police Station
68 Station Road**

**Hampton
London
TW12 2BT**

Report no. HE 2230624.
Date of publication: 3rd July 2024

Updated Preliminary Roost Assessment to consider potential impacts to bats and protected species in relation to development proposal

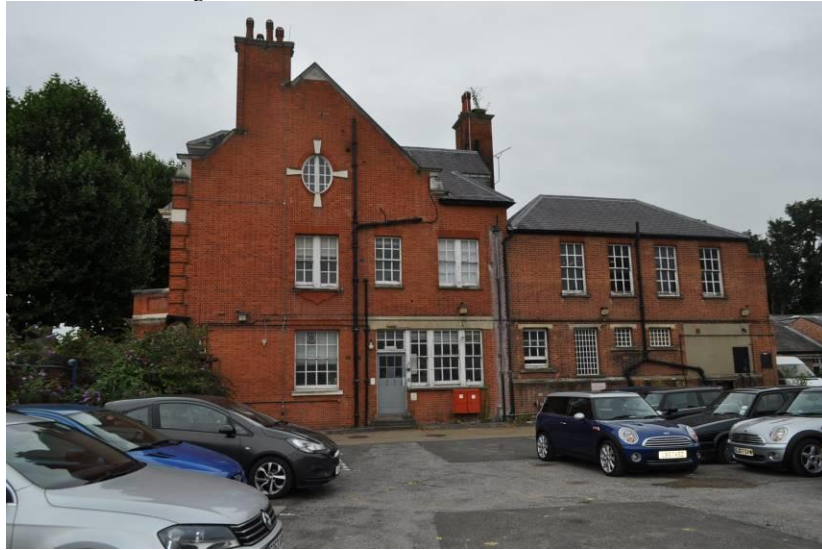
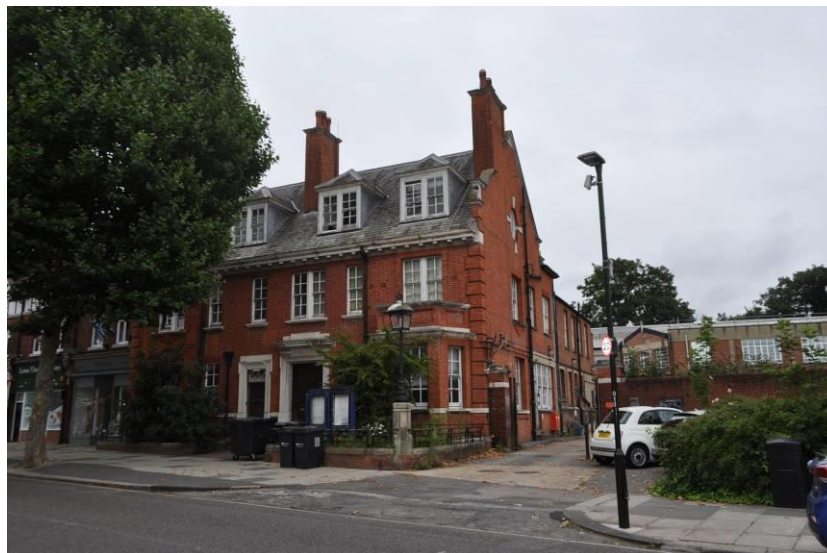
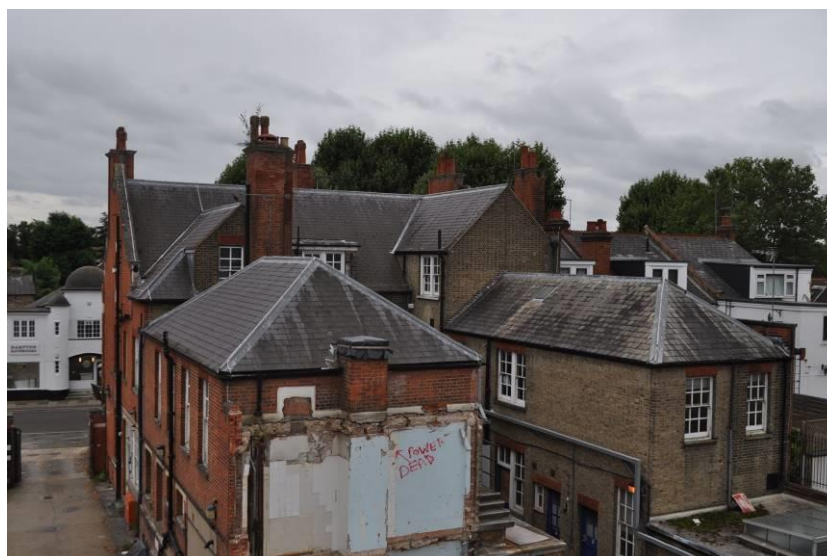
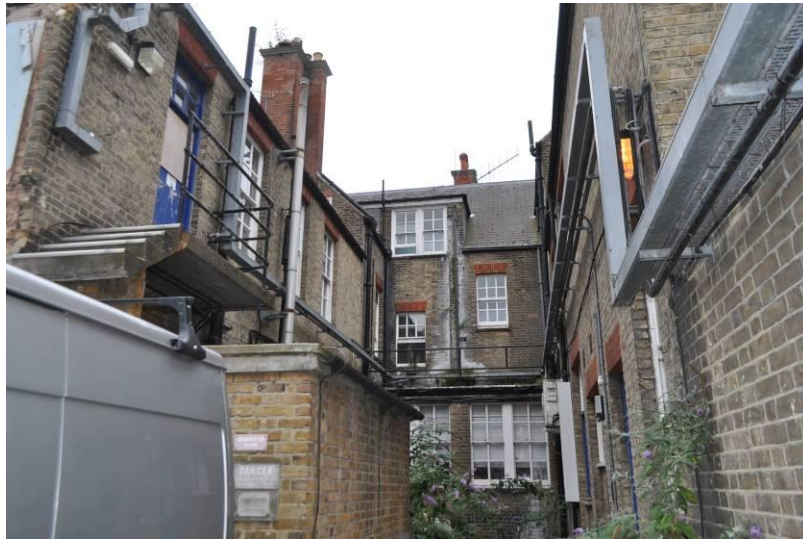
Plate B.1 Main Building - External

Preliminary Roost Assessment – Main Building (See Photographs: Appendix B).
<p>Description: A former Victorian Police Station with additional extensions built during the 20th Century. The main building is a 3-storey brick built with multi-pitched slate roofs. The building extends northwards along the western boundary wall and reduces in height to 2-storeys and then a line of continuous single storey rooms which conjoin the garage/workshop building along the northern boundary.</p> <p>The exterior brick work, roofs (including flashings along valleys, chimneys and dormer windows), doors and windows are tight fitting and in good condition with no major gaps suitable for bat access.</p> <p>The internal loft space is dry and in good condition with the roof boarded and presumably lined beneath the tiles.</p>
<p>Potential Access Points: None</p>
<p>Potential Bat Roost Features: None</p>
<p>Evidence of bats found: None</p>

<p>Evidence of birds found: None</p>
<p>Potential for roosting bats: No potential due to lack of suitable features.</p>

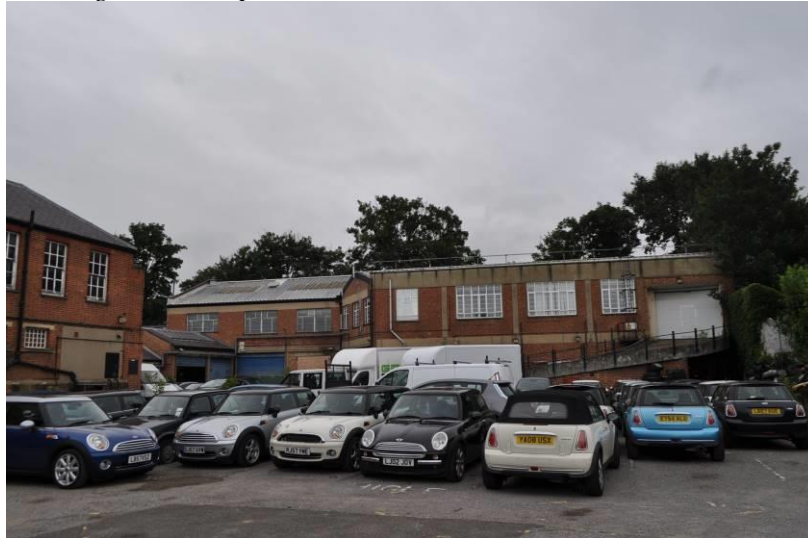
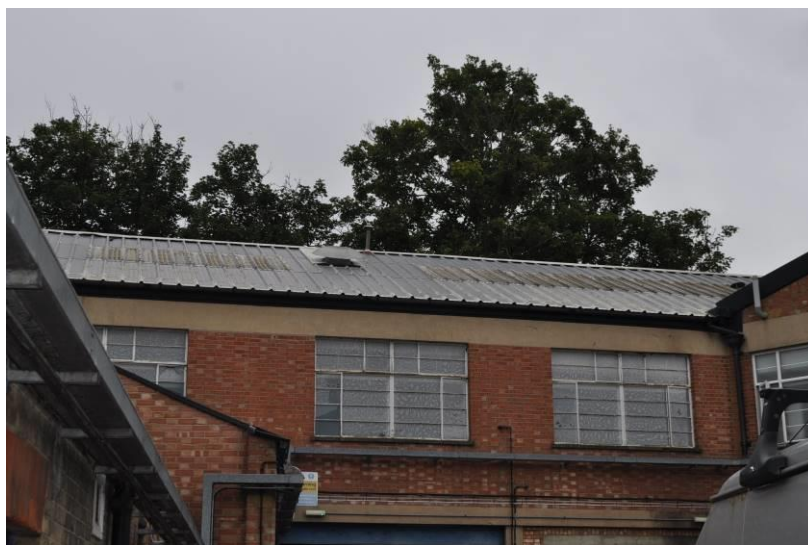
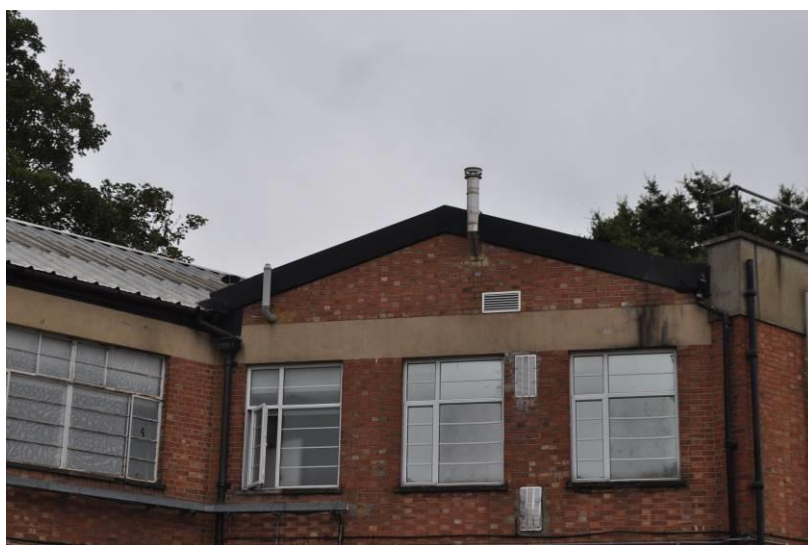
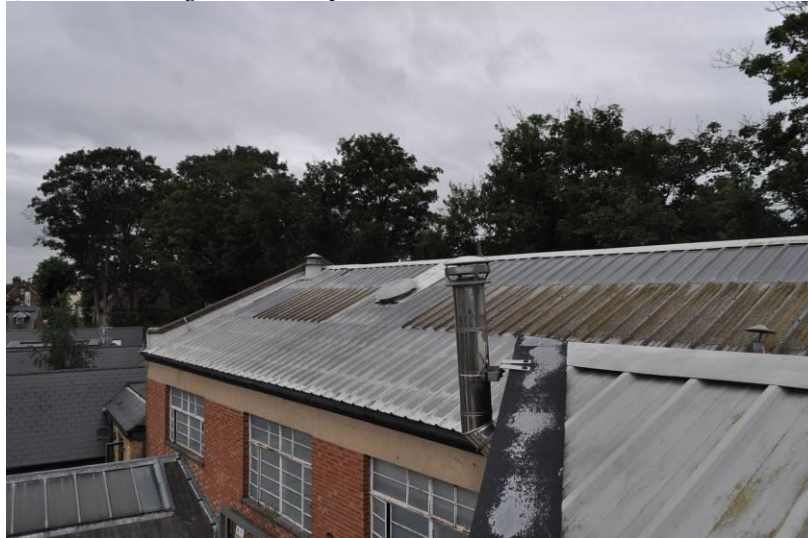
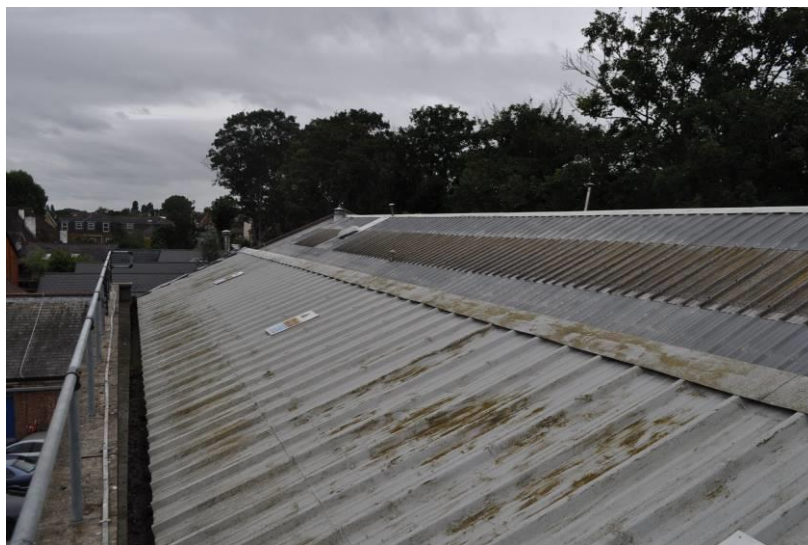
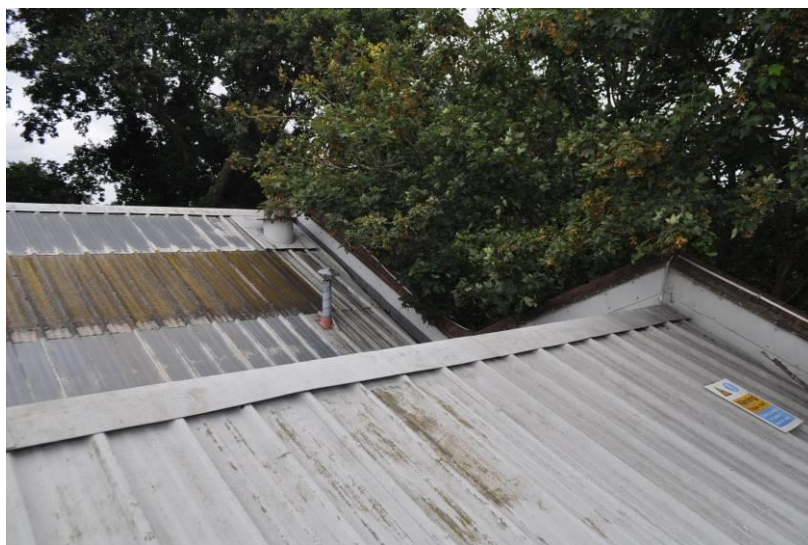
Plate B.3

Preliminary Roost Assessment – Garage/Workshop (See Photographs: Appendix B).
<p>Description: A mid to late 20th Century brick-built 2-storey building with a double pitched roof constructed from corrugated metal and fibre sheeting, occupying the northern boundary of the site. The windows are metal framed and tight fitting with no gaps. Access to the upper floor is through a roller door off a concrete ramp. The shutter door is tight fitting with minor gaps under the canopy over the door.</p>
<p>Potential Access Points: Minor gap under canopy of roller door.</p>
<p>Potential Bat Roost Features: Within canopy of roller door.</p>
<p>Evidence of bats found: None.</p>
<p>Evidence of birds found: None.</p>
<p>Potential for roosting bats: Low potential.</p>

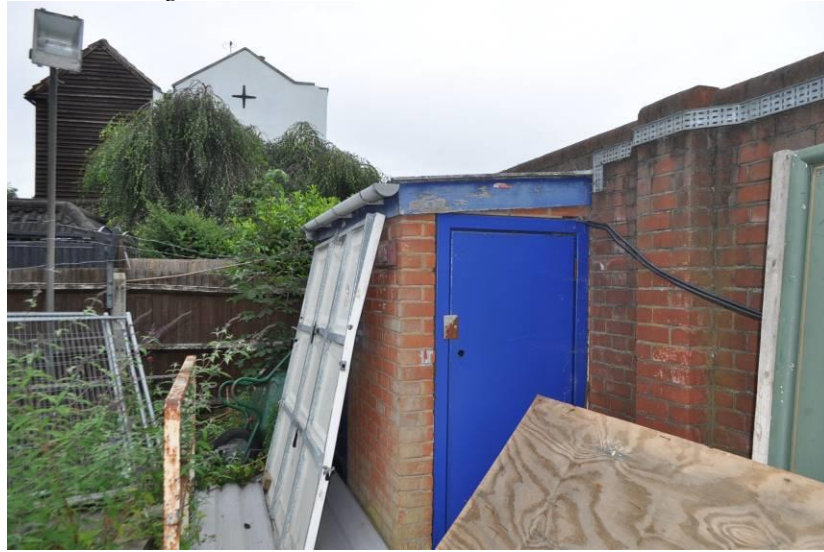
Plate B.4 Outbuilding

Preliminary Roost Assessment – Outbuilding (See Photographs: Appendix B).
<p>Description: A small modern brick-built lean-to with a flat fibre sheeted roof. The building forms part of the front wall with no gaps in the brickwork or where the roof joins. The access door is tight fitting with no gaps.</p>
<p>Potential Access Points: None</p>
<p>Potential Bat Roost Features: None</p>
<p>Evidence of bats found: None.</p>
<p>Evidence of birds found: None.</p>
<p>Potential for roosting bats: No potential due to lack of suitable features.</p>

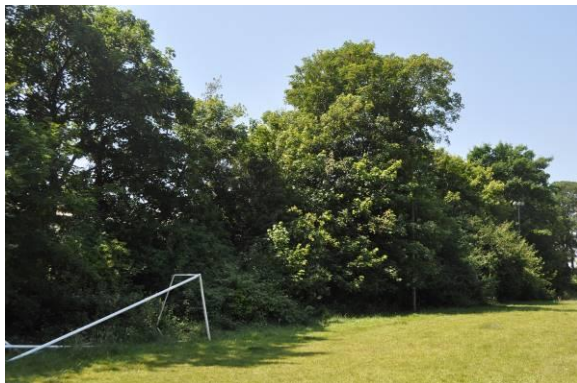
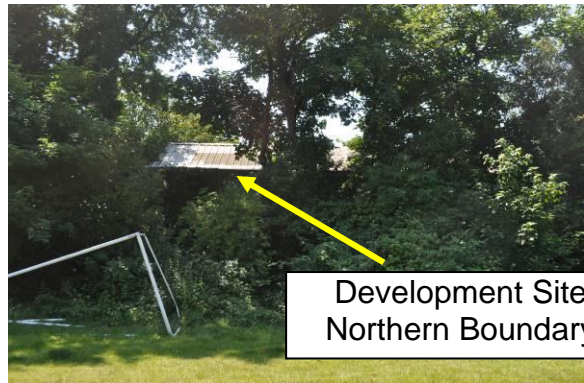
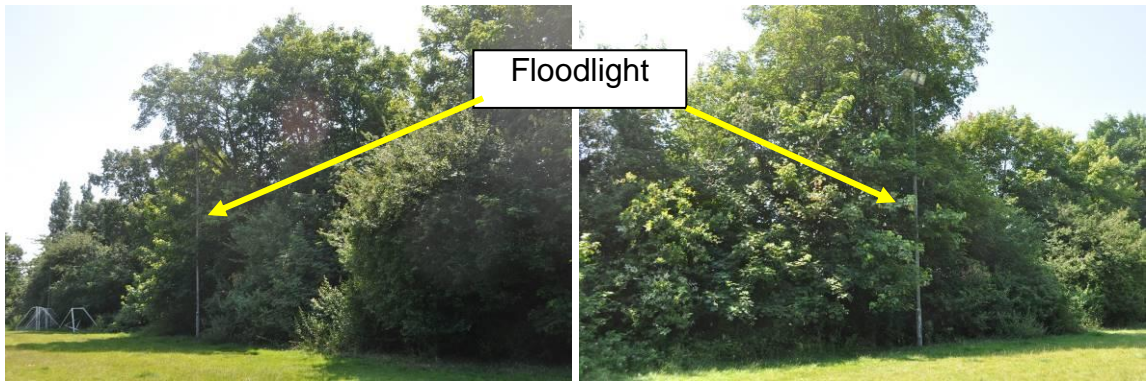
Plate B.6

The trees within the plantation do not contain features that would support roosting bats (flaking bark, rot holes, cracked limbs). The ivy covering is predominately restricted to the lower sections of the canopy trees, mixed with the ground flora and partially covering the boundary wall to the development site. The ivy covering is not dense enough (brickwork and tree bark visible under the ivy) to provide roosting areas for bats.

Adjacent Habitats	No encroachment onto the adjacent land by scaffolding or demolition equipment. No lighting to be directed on to the plantation from the development.
Nesting Birds	Demolition/site clearance of areas that could be potentially used as nesting sites should be timed to avoid impact on nesting birds. The nesting season generally runs from March to August; but is species dependent. Autumn through to very early spring clearance is a well-established means of preventing this impact. If this is not possible, further advice from an ecologist should be sought.

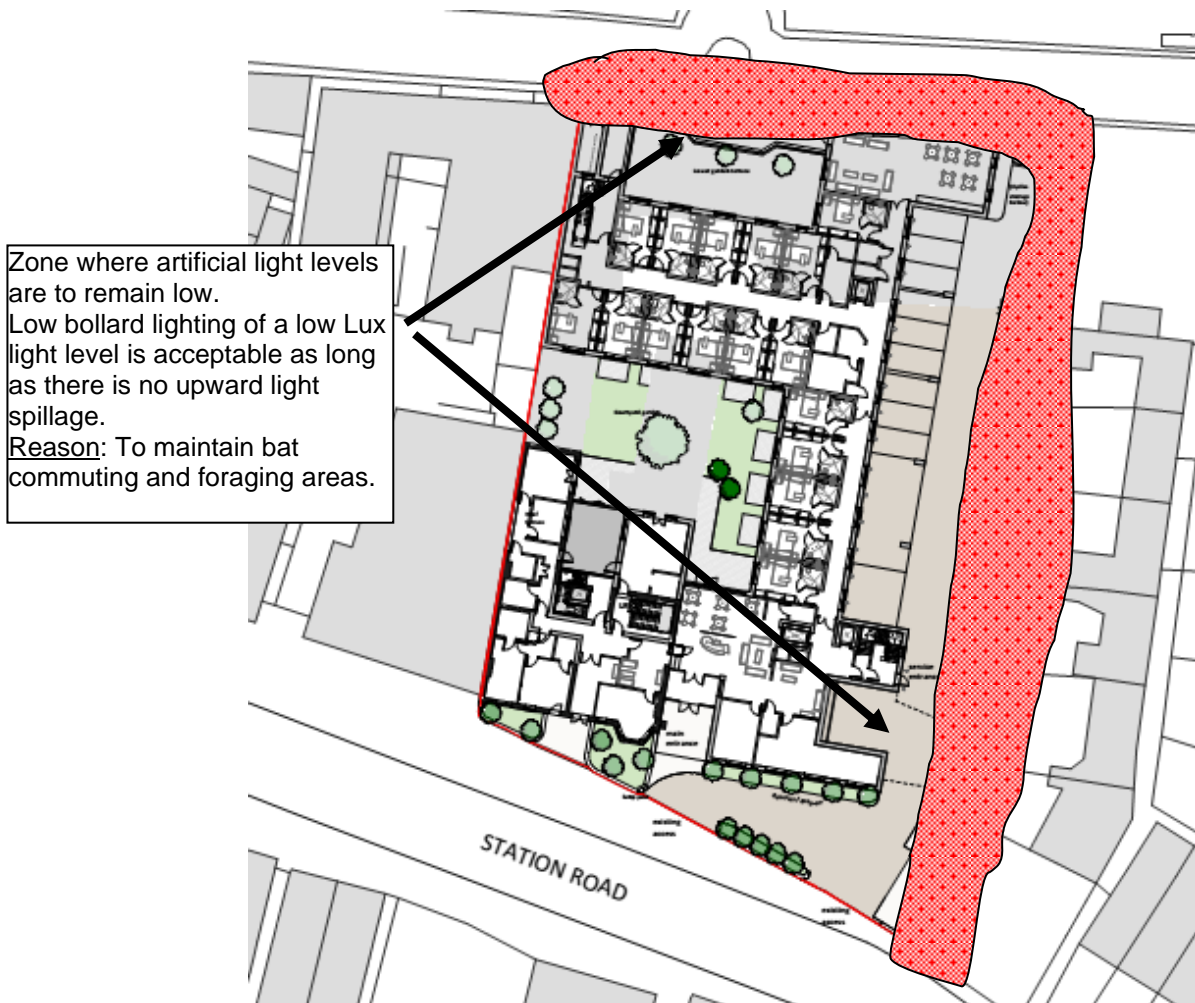
Figure C.1 Ecological Restraints Plan

General: Landscaping scheme should include plants that will attract invertebrates and enhance bat foraging opportunities. A list of suitable plants can be found below.

Avoidance (A), Mitigation (M), Compensation (C) & Enhancement	
General	
All staff and workers on site, including sub-contractors, should be made aware of species and habitat protection issues at site induction talks. Work must stop immediately bats are found onsite. Haslam Ecology can be contacted on 07729 186361 for further advice.	
Protected & NERC Species	
Bats (A)	Although bats are likely absent from the buildings, the main consideration is to avoid light spillage onto the northern and eastern boundary commuting routes during demolition, construction and final operating phases of the development. Ideally, demolition works should take place between October and March when bat activity is low, but demolition works outside this period will not have a significant impact on the local bat populations.
Bats (M)	When planning the locations and directions for lighting , avoid an increase in lighting levels or focusing lighting on the canal corridor. This can be achieved through use of cowls, hoods, etc. to direct the light, avoiding tall lighting columns, using motion-sensor security lighting, and timing the lighting to avoid the 1hr after dusk and 1hr before dawn when bats are most active
