BS5837 Arboricultural Impact Assessment & Method Statement

534 Hanworth Road, Whitton, Hounslow, TW4 5LH

Job Reference: 05169R

August 2024

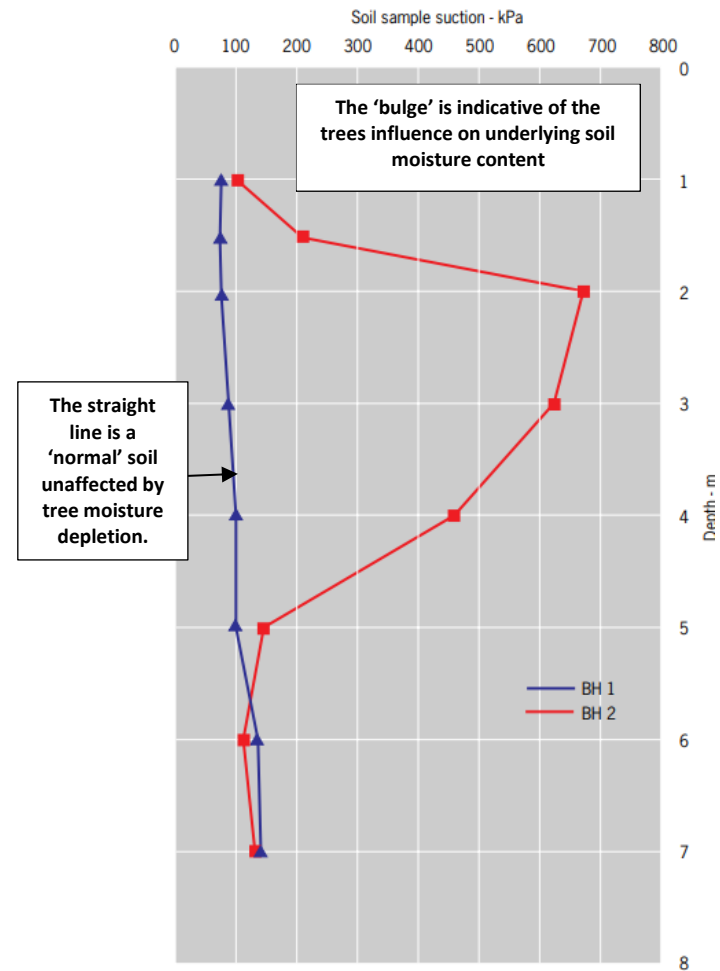
Fig 3 – Borehole log 10m from mature Oak tree on clay soil detailing fine roots to depths of 2.5m indicated with arrows (Source: Tamla Trees project) and annotated soil moisture depletion by trees showing a peak influence at 2m and extending to 5m (above right)

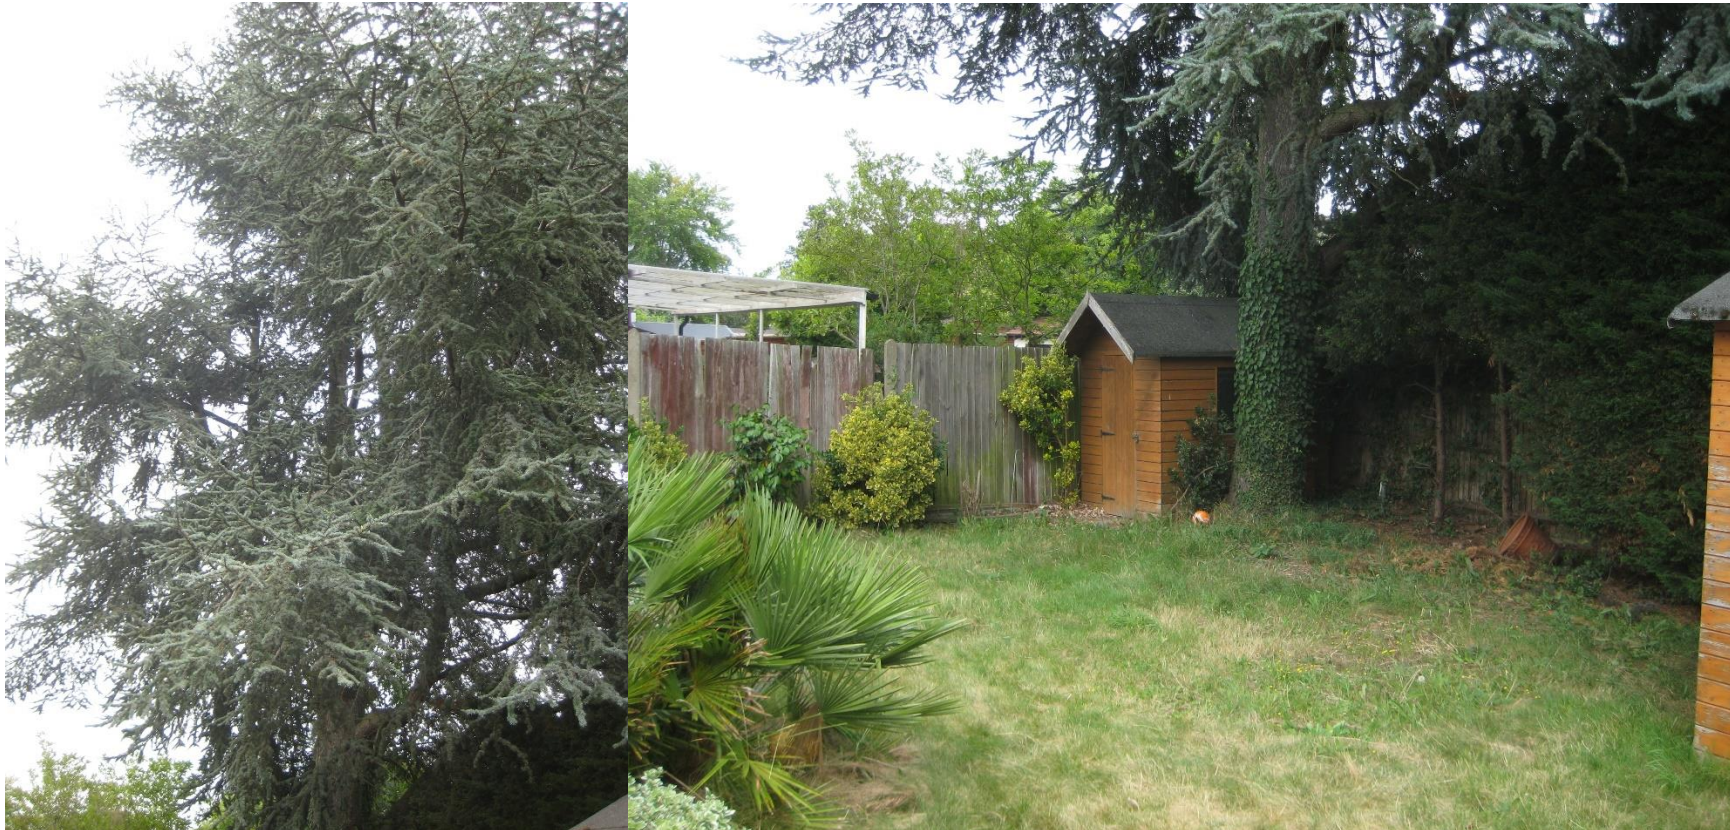
Fig 6 – T1 canopy (left) and lower branches relative to existing garden shed (right).

5.3.1 No trees are proposed for pruning/ removal to facilitate the proposal. The client wishes to remove some branches in low proximity to the garden shed. They also wish to establish a repeat canopy pruning regime to manage the tree at its existing dimensions given the species and garden size.

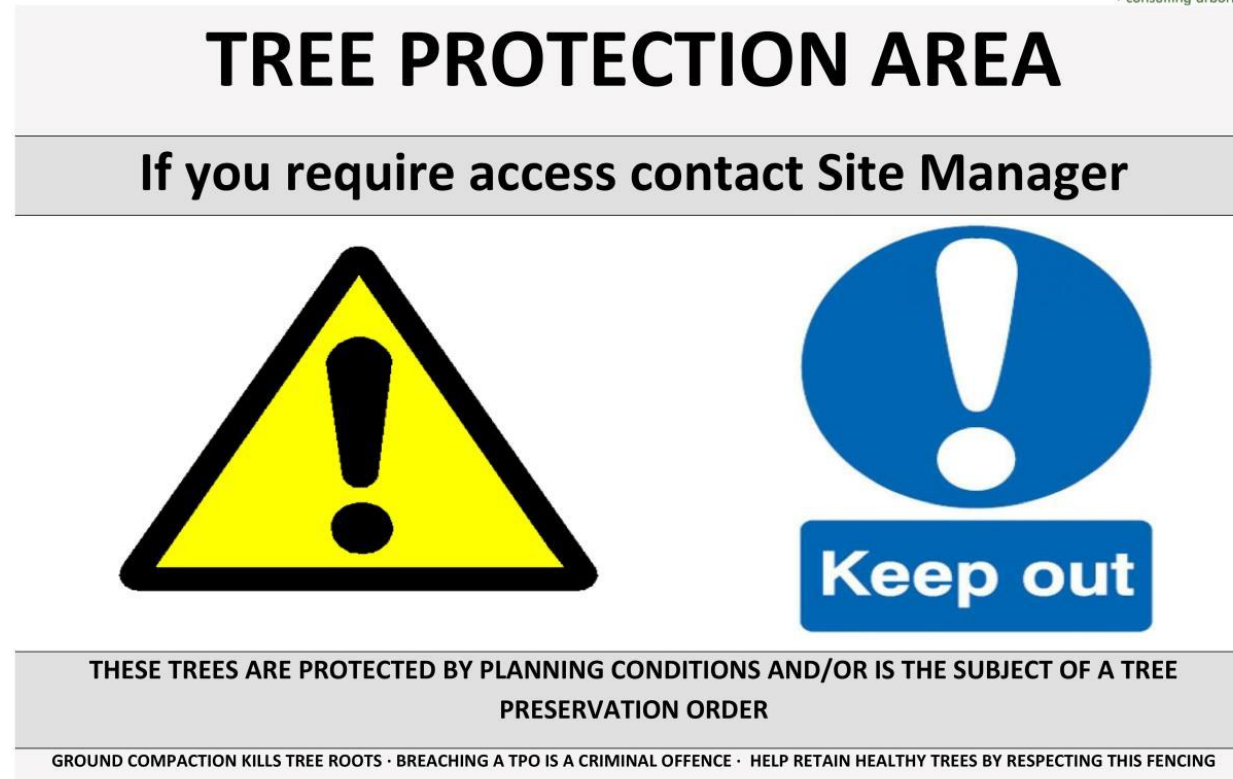
Fig 7 – Professional grade weatherproof tree protection signs no smaller than 297 x 420 mm (A3) should be installed.

5.4.3 All internal tree protection must be appropriately signed to ensure that all site operatives know its purpose.

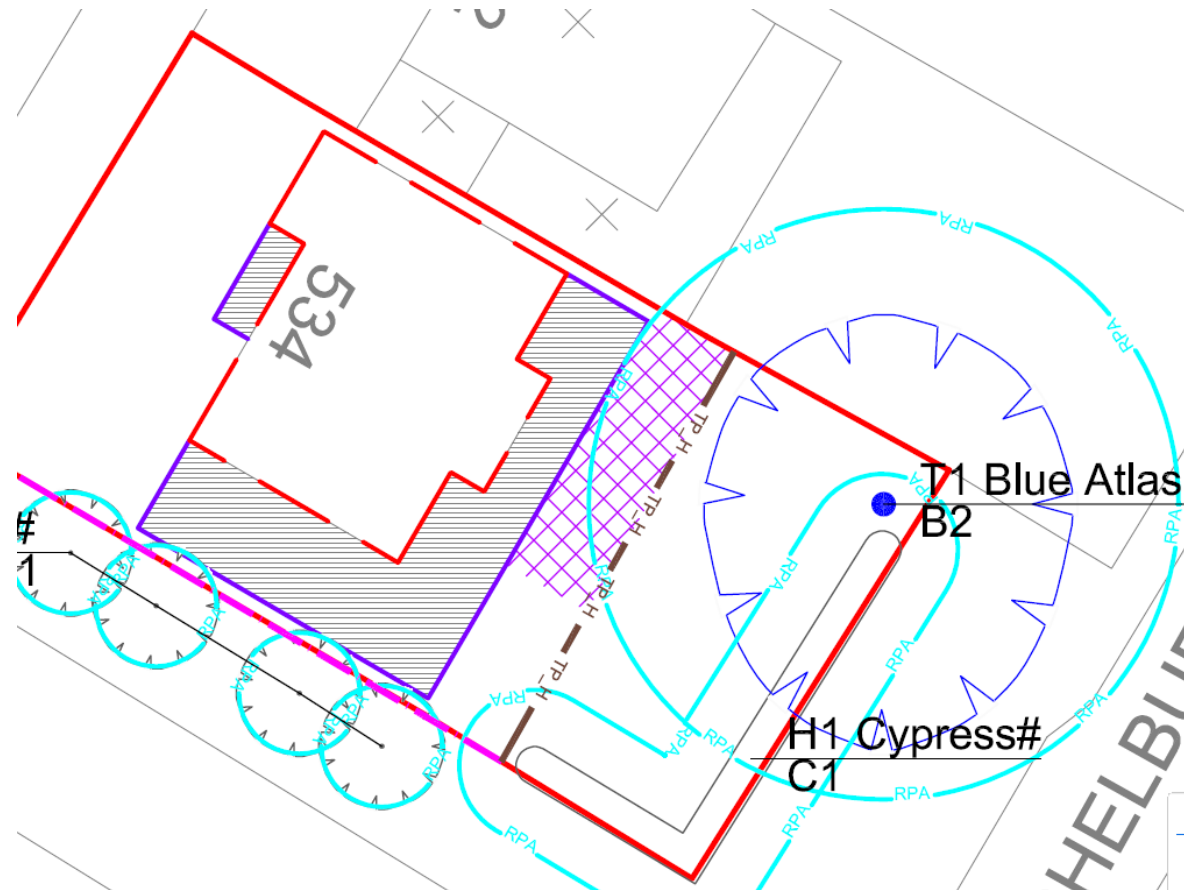
Fig 8 – Temporary ground protection will be used to be realistic to construction movements on site (hatch).

5.4.4 Temporary ground protection is required to allow safe movement around the proposal. It should be installed prior to any site activity and maintained for the duration of the works.

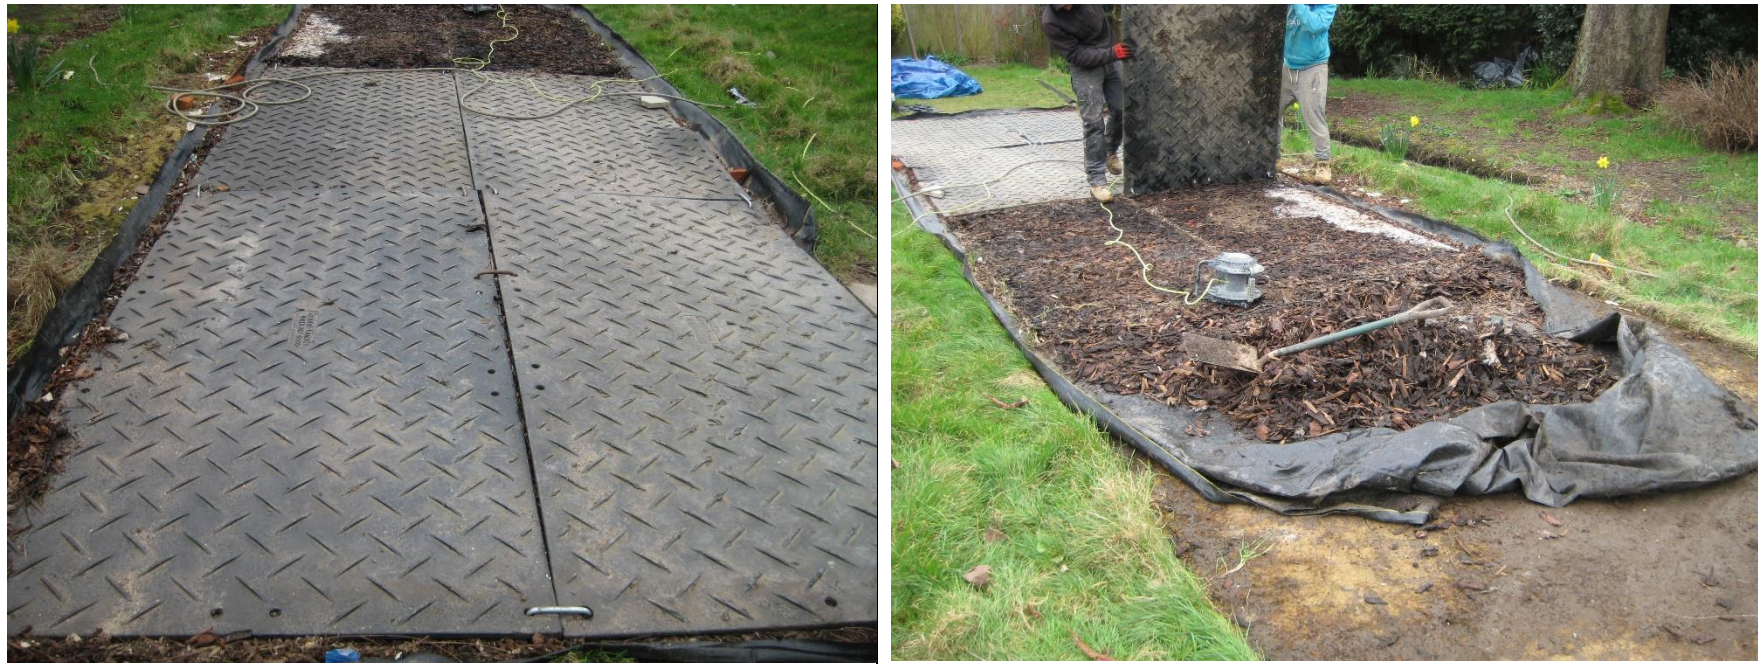
Fig 10 – Temporary ground protection is an effective way of allowing access through the RPA of retained trees. It must be installed prior to any on site activity and maintained for the duration of all works to be effective. Above left Tamla Trees project ground protection in place and above right being removed following the completion of site works. (Note: depending on the length of time it is in place it will adversely affect underlying grass ground cover which will need reseeded/ turfed accordingly)

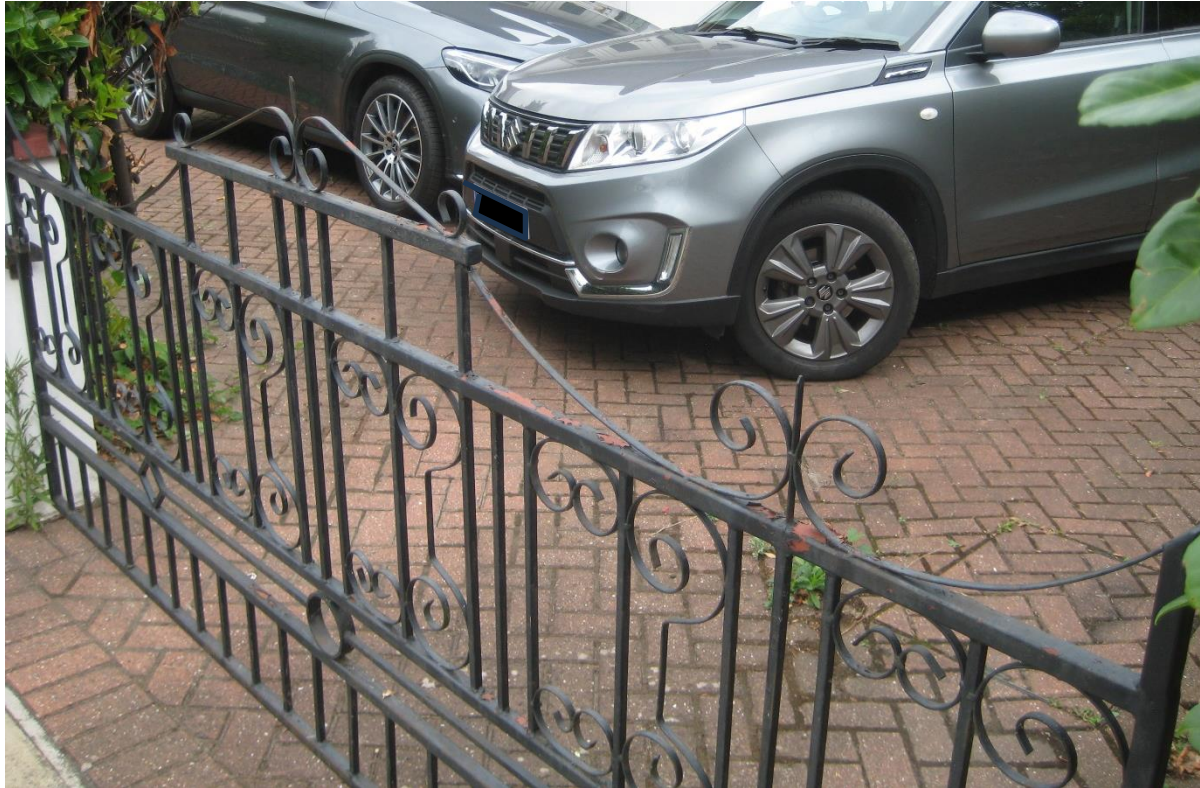
Fig 11 – Existing surface to the front driveway for material storage.

- 5.5.1 No new surfaces within the RPA of retained trees are proposed. There is existing hard surfacing to the front of the site which is suitable for material storage.

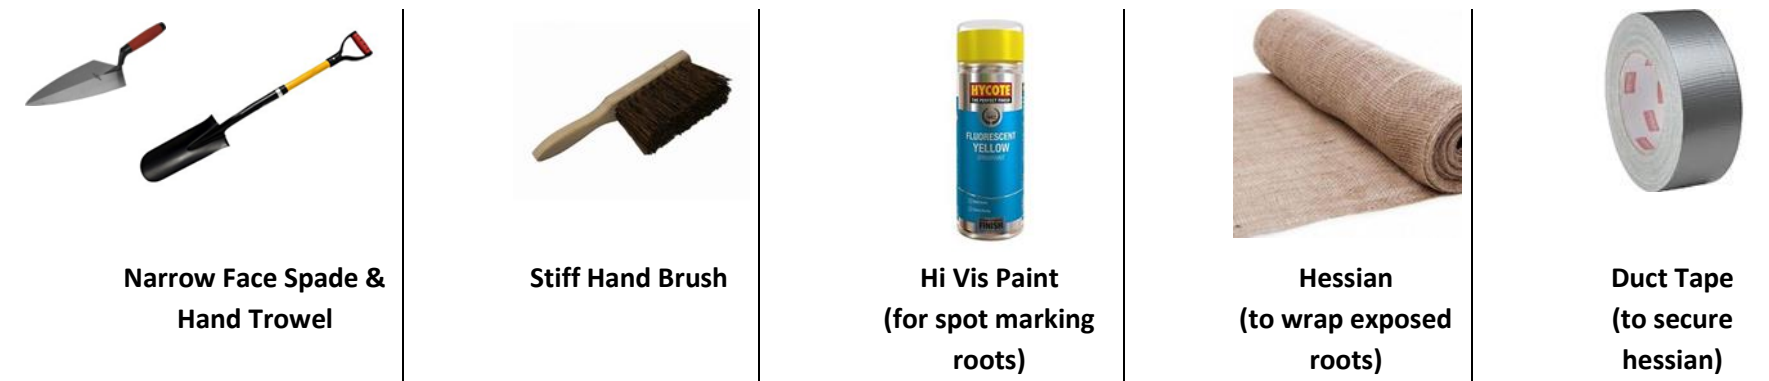
Fig 14 – Advised tools/ materials which should be available for all excavation works within RPA

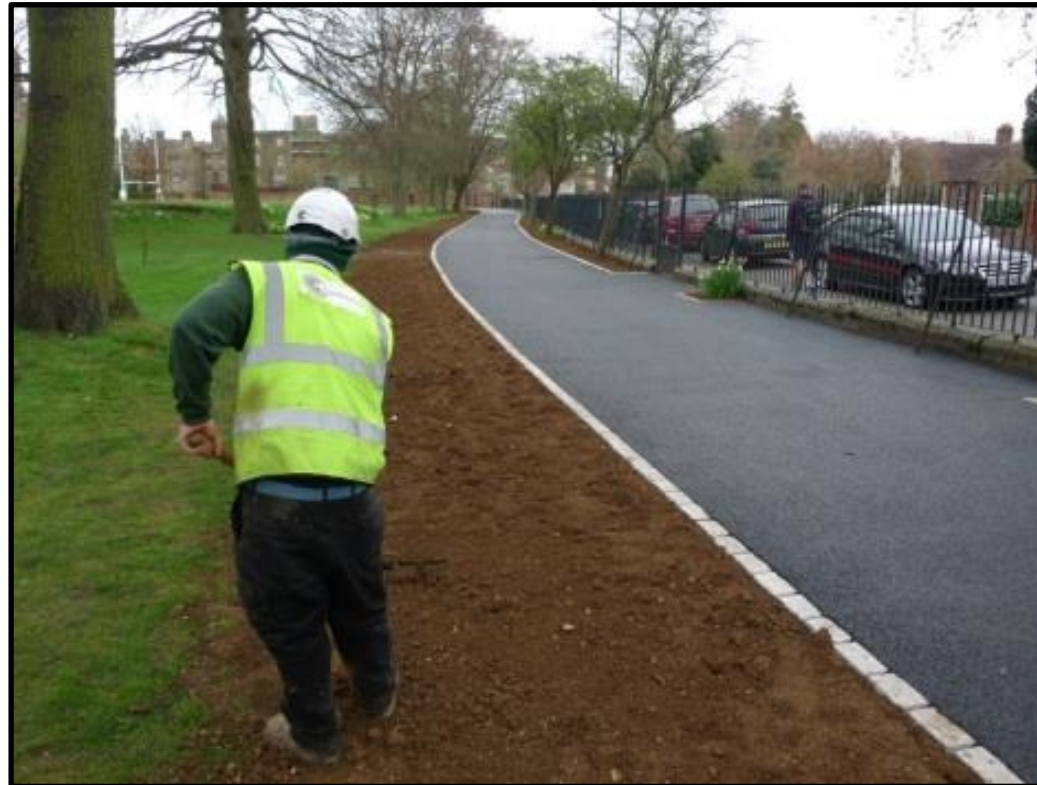
Fig 15 – All 'making good' topsoil will be BS3882 compliant and raked out by hand to no greater depth than 100mm.

- 5.7.1 All 'making good' will be with BS3882 compliant topsoil raked out by hand (to no more than 100mm depth within any tree RPA) and then seeded/planted as appropriate. Further comment on full landscaping details is outside the scope of this report.

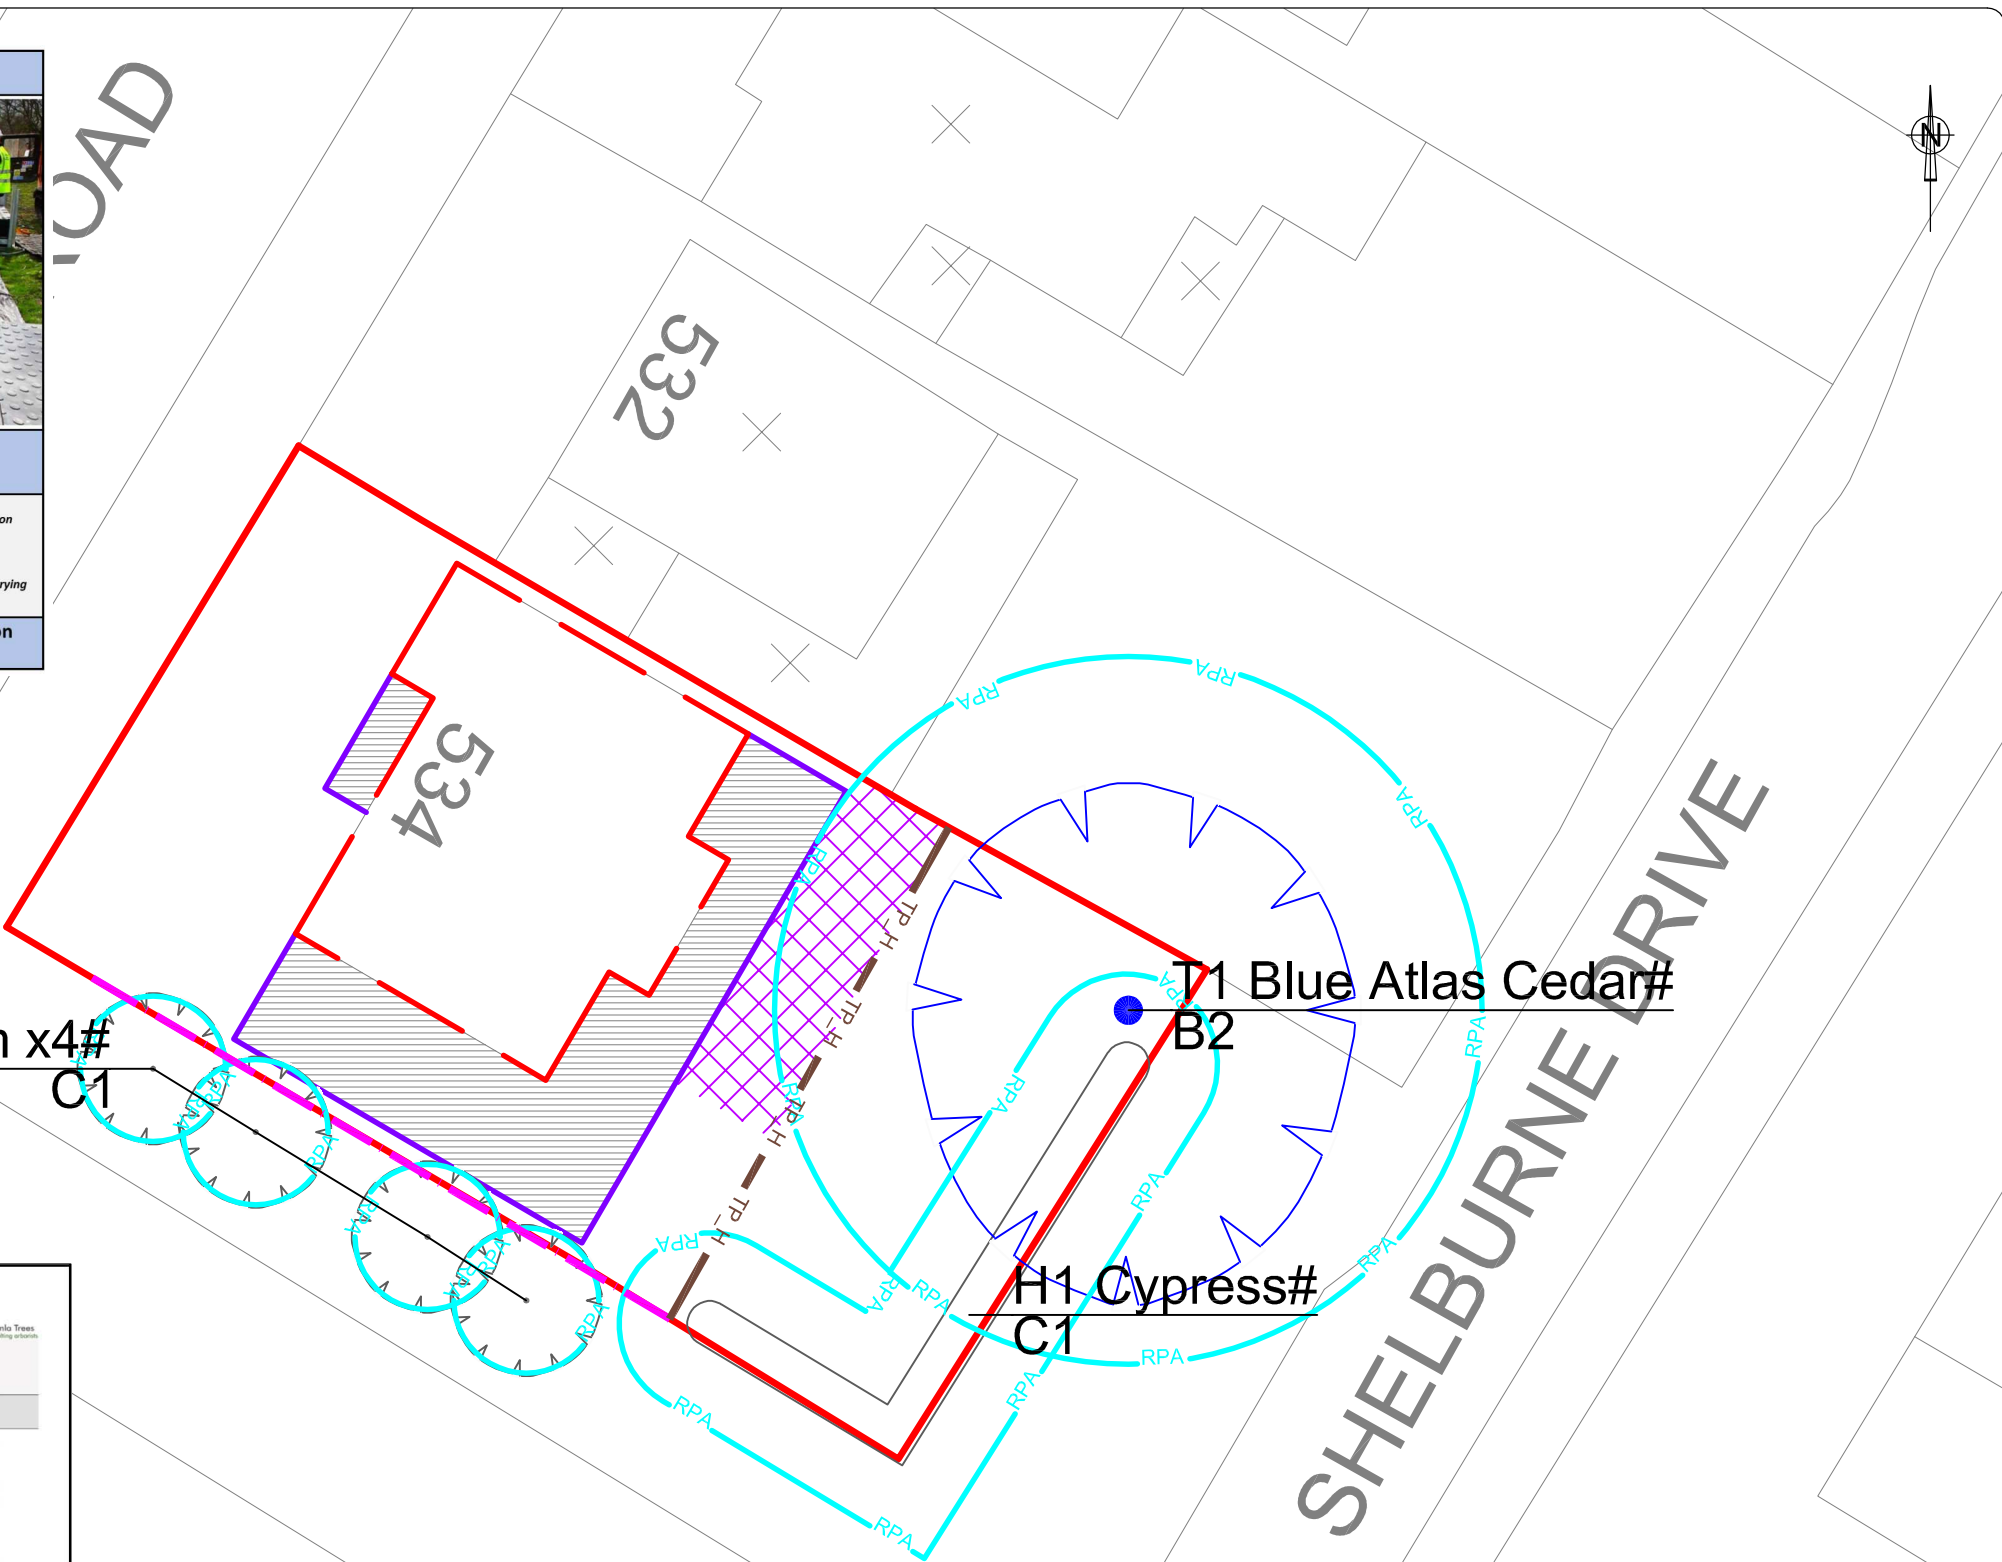
TG1 Whitebeam x4#

T1 Blue Atlas Cedar# B2

H1 Cypress# C1

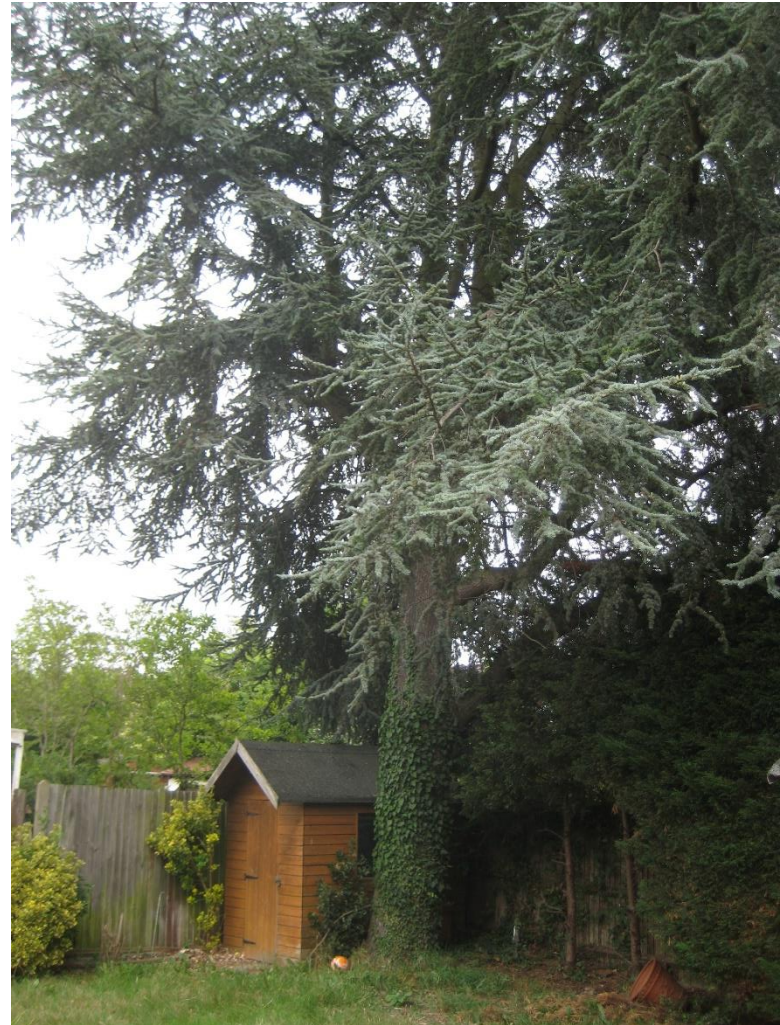
Image 3 –T1 Cedar.

Tree No.	Species	DBH (m)	No of Stems	Ht (m)	Crown Spread				BS Cat	Age Class	Life Expect	Cr Ht (m)	Observation	Recommendations	RPR (m)
					N	E	S	W							
T1	Cedar (Blue Atlas)	0.78	1	16	6	6	7.8	5.7	B2	Mature	20 to 40	2	Ivy on lower stem. Previously topped. Some storm damage. Some tight canopy V unions.	Crown lift to provide 2m clearance from existing shed. Undertake sensitive (hand tool) canopy reduction by 1-2m to suitable side growth points to establish long term pruning points. Sever Ivy. All works to be undertaken in accordance with BS3998 Tree Works.	9.4
TG1	Whitebeam x 4	0.16	1	4	2	2	2	2	C1	Early mature	20 to 40	1	Varying sizes, no access (Private Road).	No works	1.9
