PHASE 2 ENVIRONMENTAL INVESTIGATION
of a site at
LONDON HOUSE 243 - 253 LOWER MORTLAKE
ROAD
for
AVZ GEOENG LTD

Project No 2684
Report ref: 2684-P2E-1-A
Issued: 22 August 2024
Revision: A

2684-P2E-1-A: London House 243- 253 Lower Mortlake Road
AVZ GeoEng Ltd

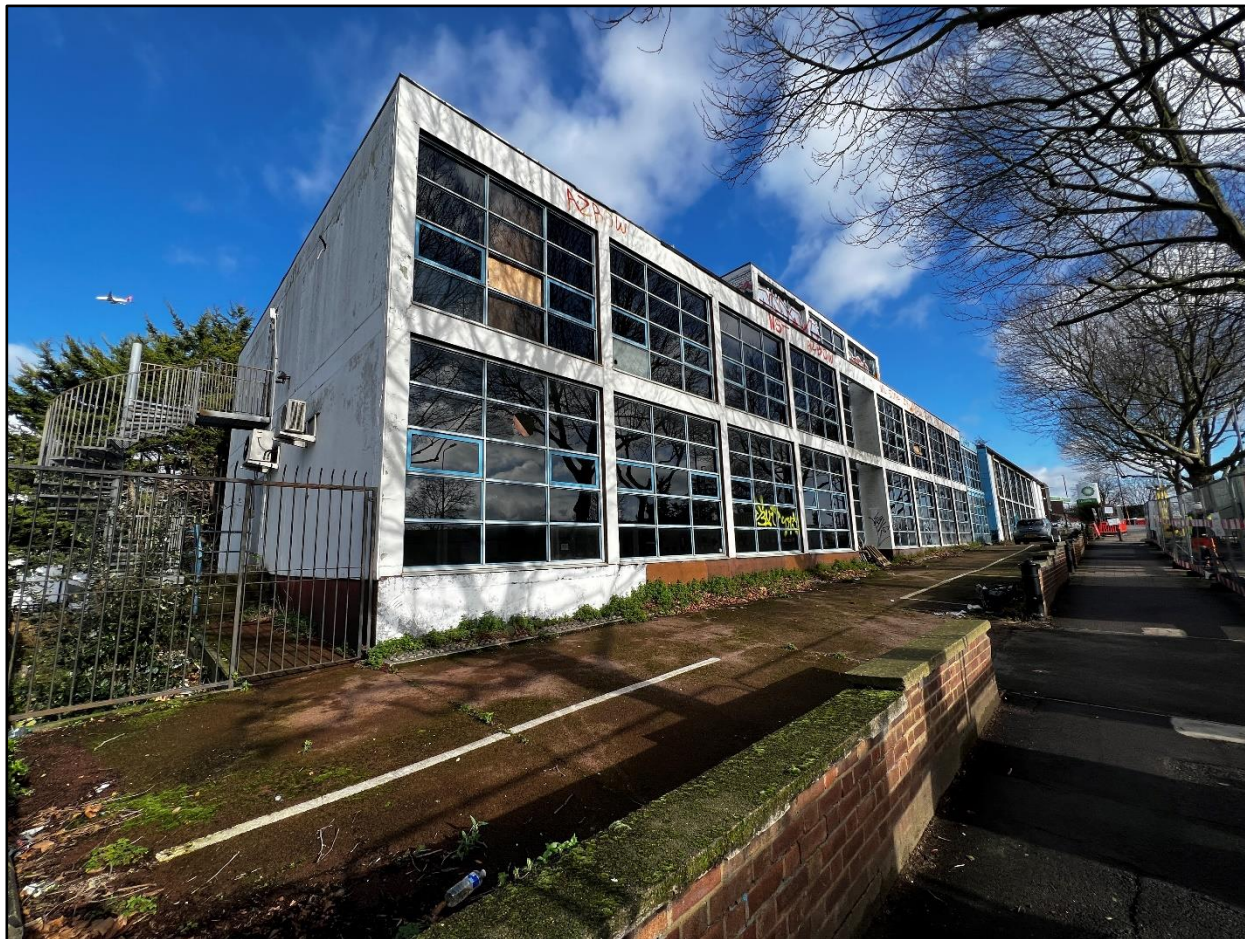
Photograph 1: View of the site frontage from the footpath of Lower Mortlake Road

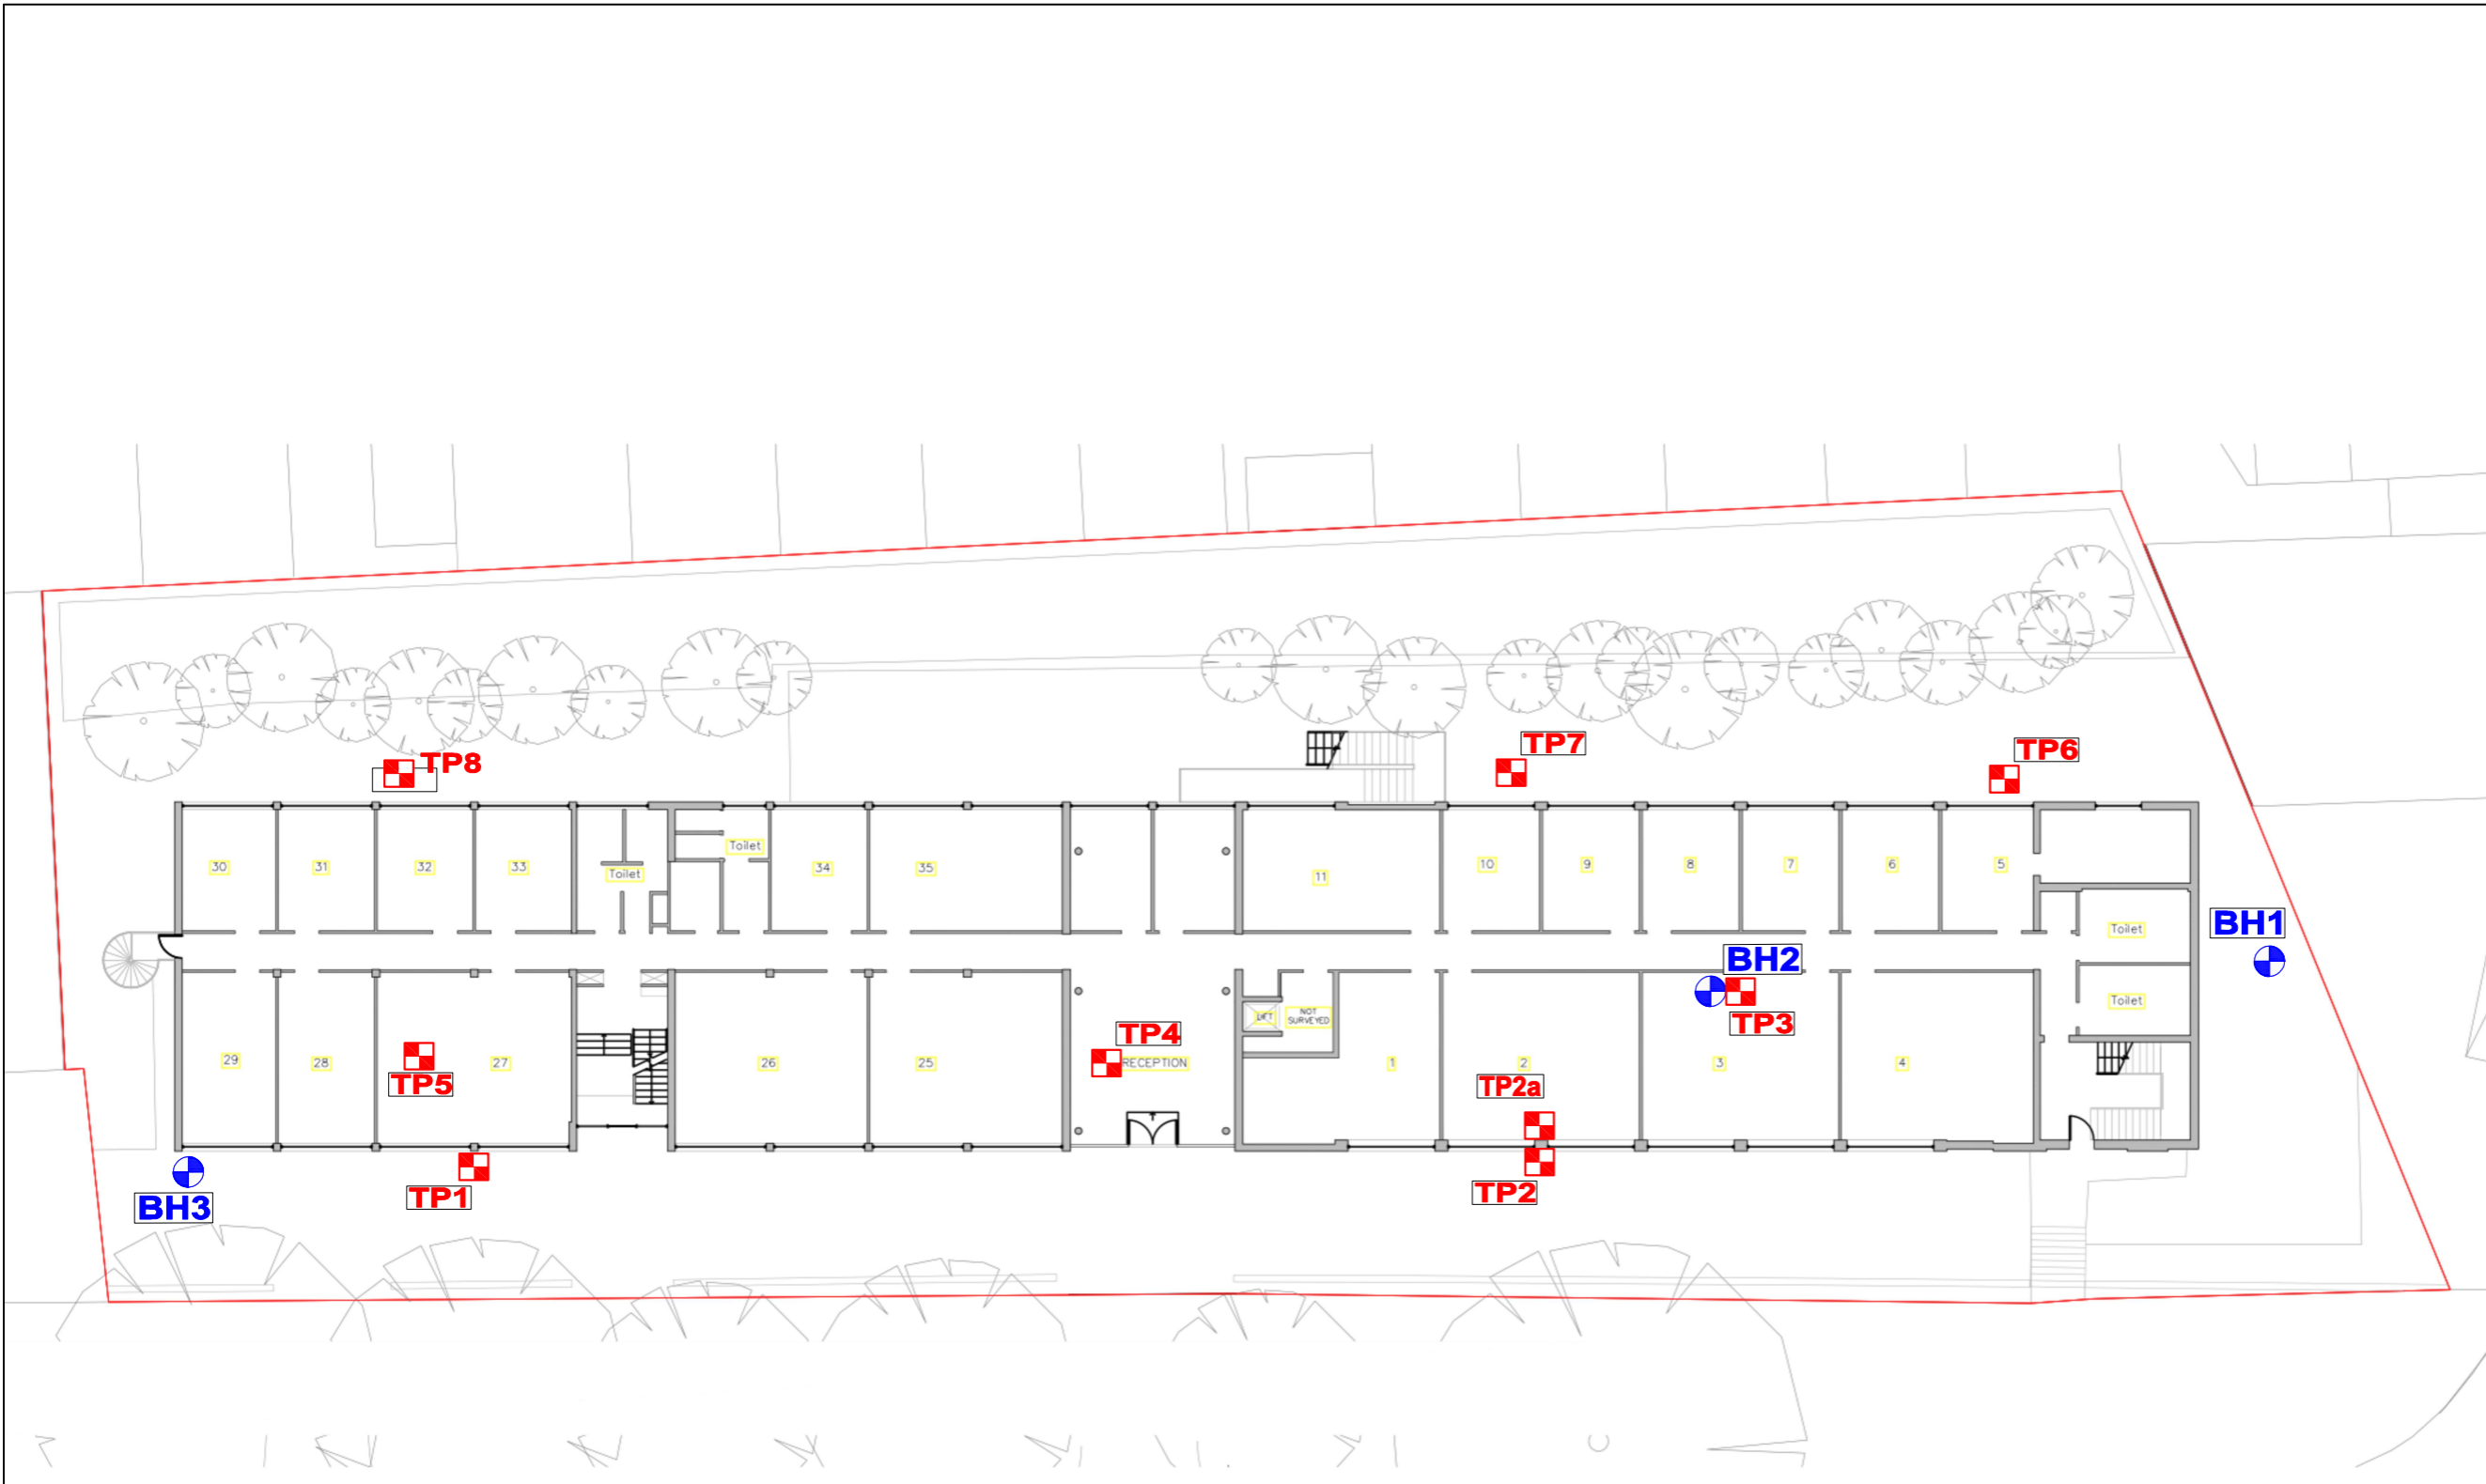
Appendix B – Site Works Plan

LEGEND:
 ● BH - Borehole
 ■ TP - Trial pit

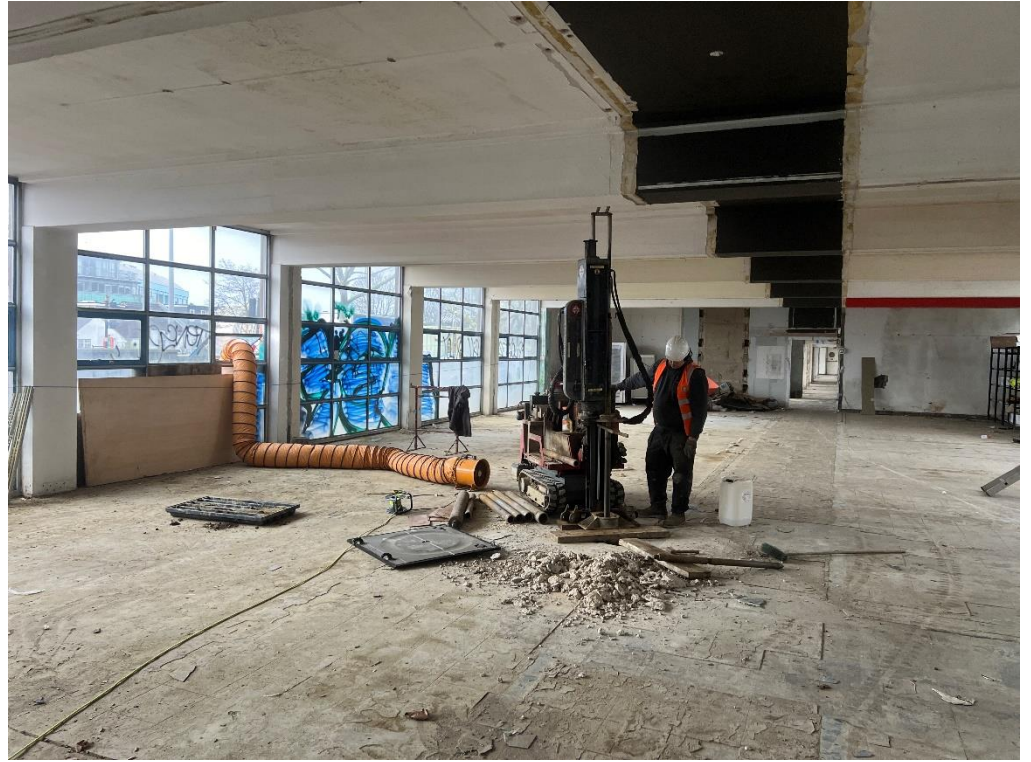
**Description:
Performing Drilling at
the location**

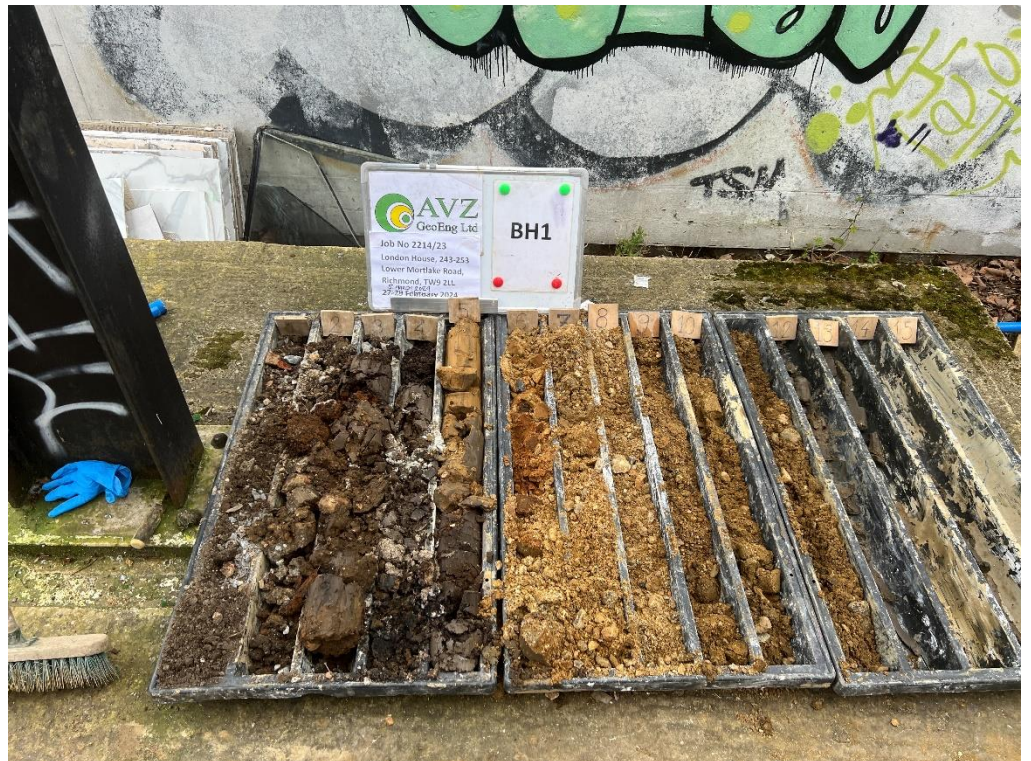
**Photo
No.2**

**Description:
Core Recovered
From BH1**

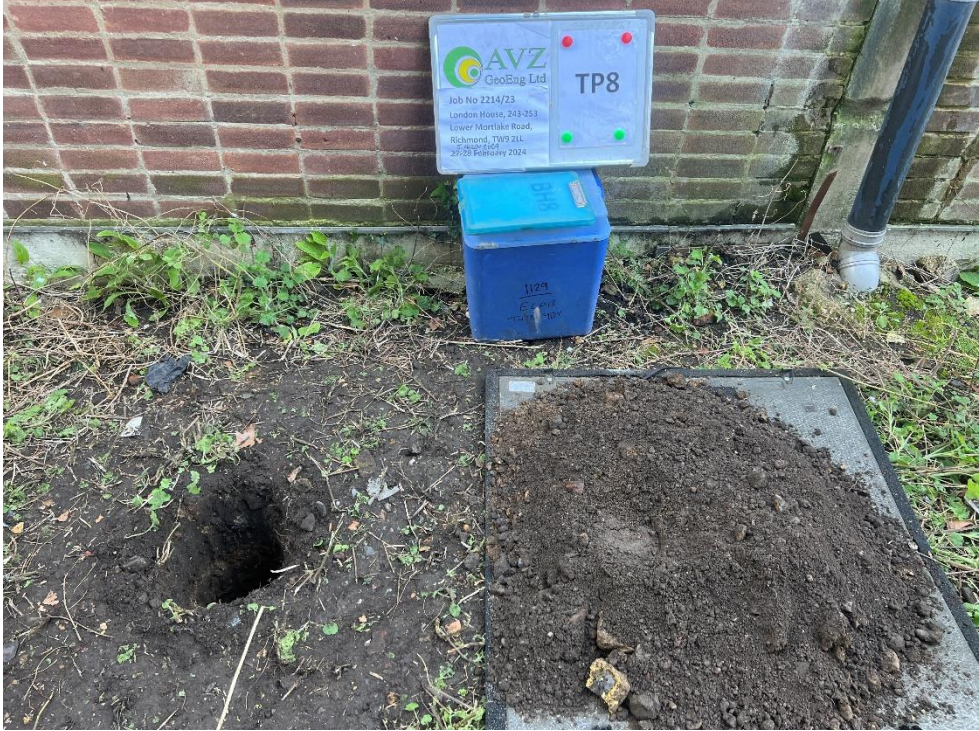
Photo No.13	Figure 6

Description: Trial Pit TP8
