Arboricultural Method Statement

In Relation to Development of Land at 40
Twickenham Rd, Teddington. TW11 8AW

Produced by Rob Fear, Arboricultural Consultant for
Helyg Tree Surveys

Date	August 2024
Report Ver.	2218_Fv1

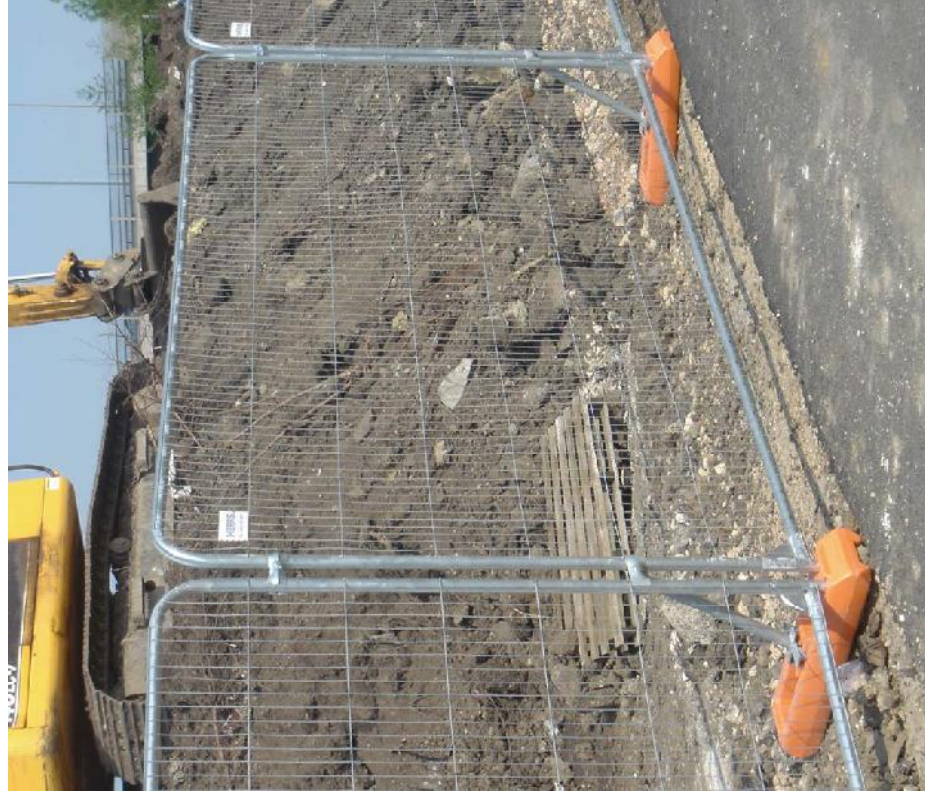
ROUND TOP PANELS WITH ANTI-CLIMB MESH

- The unique design of this clever strut dramatically increases the stability of the fence.
- The strut fits neatly within the high visibility block allowing a neat and compact solution, and acts as an integrated anti-lift device.
- 3 additional fixing holes incorporated into the design allow for soil pins and thunderbolts, dependent on ground conditions.

1. Front stabiliser.
2. High visibility footblocks.
3. Round top panel.
4. Steadfast strut.
5. Anti-tamper coupler.
6. Optional steadfast safety strips.
7. Anti-climb round top panel with steadfast struts to increase stability.

- 3.10. The tree protection fencing should consist of a series of heras panels secured together and set on concrete or plastic feet which have been fixed in position using 500mm long steel rebar J pins². The ground pins should be driven in each corner of the foot at angles to prevent movement or be braced in position with 750mm long survey pegs driven at each side and a cross brace screwed over the foot in an inverted U formation. Supporting struts should also be fixed to the backside of the fence to add additional support accounting for any slope. Signs should then be fixed to every third panel informing operatives of the need to respect and not move fencing. A fence specification and example of signage is shown at *Appendix E*.

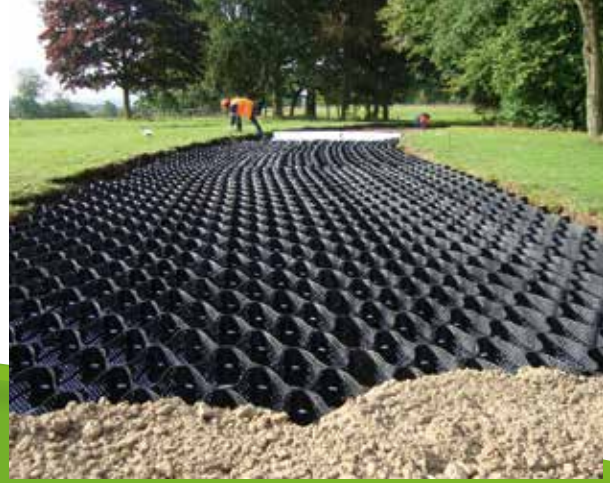
TREE ROOT PROTECTION (TRP) SYSTEM

Used extensively in civil engineering construction for over 30 years, the GEOWEB® system is a three-dimensional structure that:

- provides strength to confined soils
- distributes loads laterally, not vertically
- reduces point loads
- reduces compaction of the subsoil

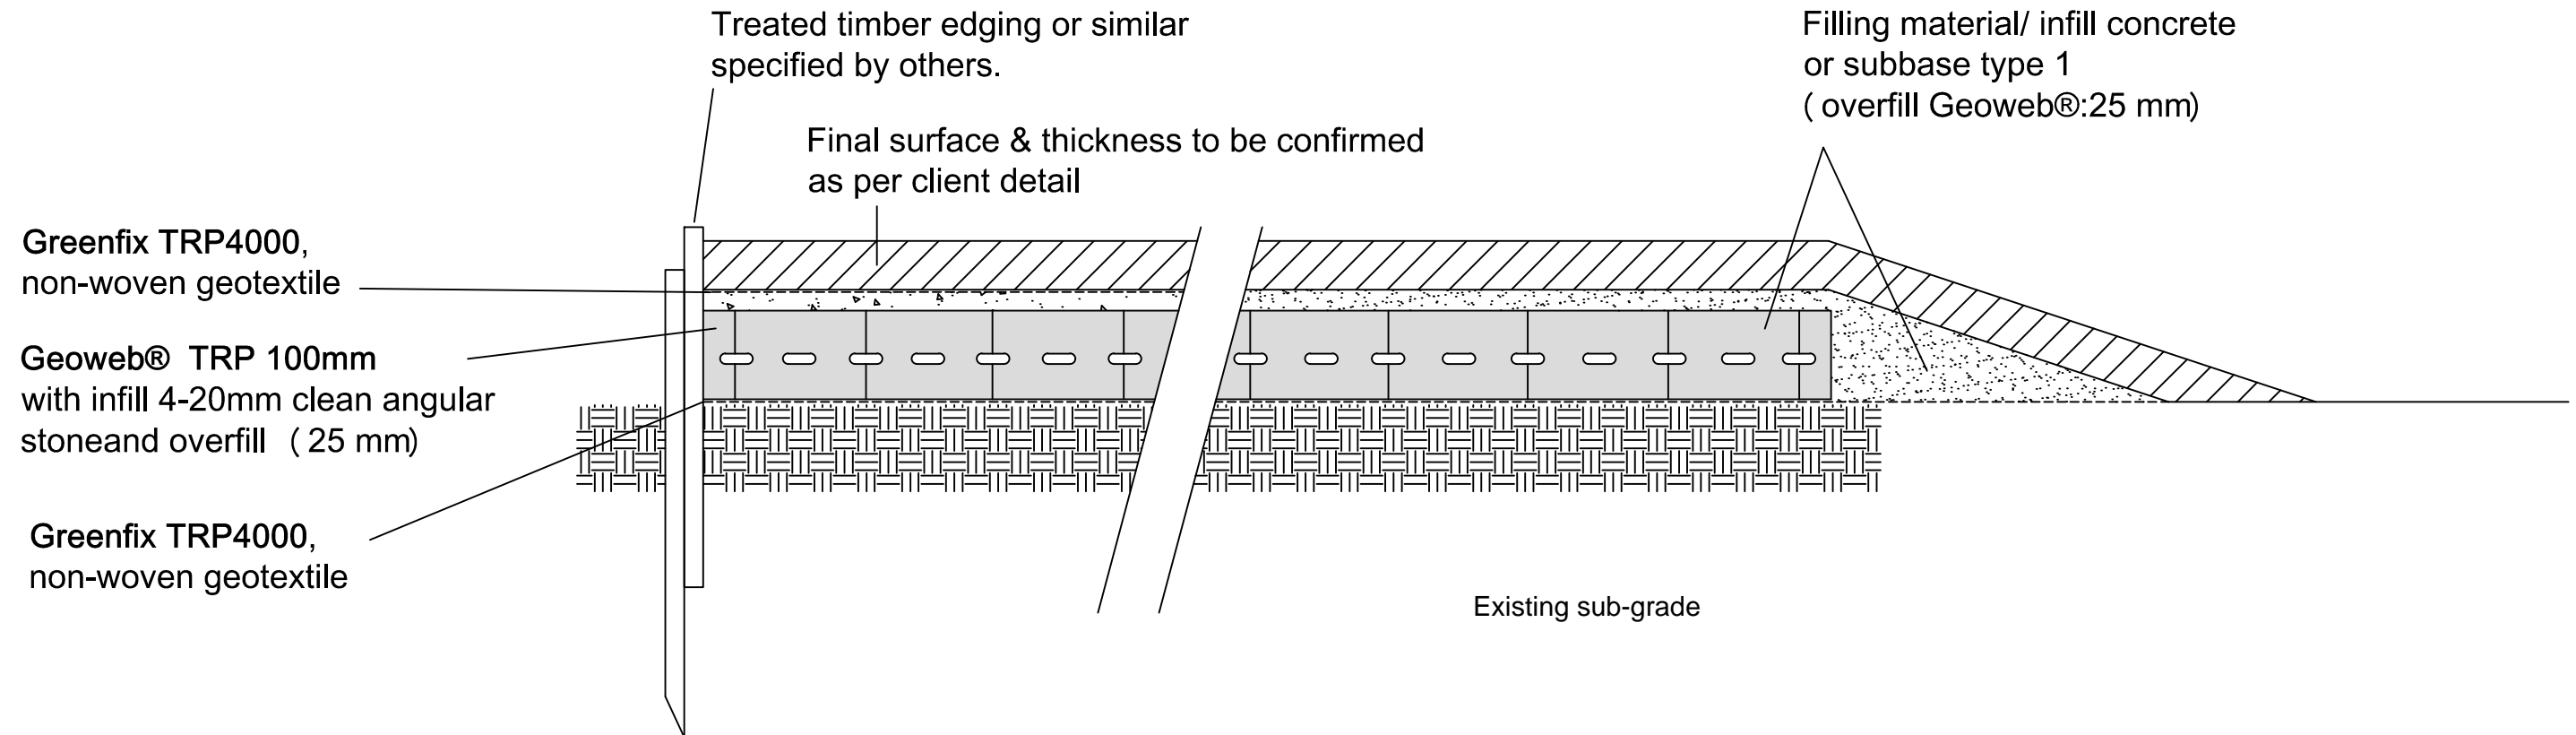
**Standard/ Generic detail
transition ramp from existing levels**

Note: 3 or 4 cells filled with concrete or subbase type 1

Adjacent Geoweb units to be joined with Atra-keys.
