# Heritage Statement

## 64 The Green, Twickenham TW2 5AG

**Written by:** Ignus Froneman B Arch Stud ACIfA IHBC      **Date:** 02 Sept 2024  
**On behalf of:** Elstree Land Ltd      **Ref:** 0458

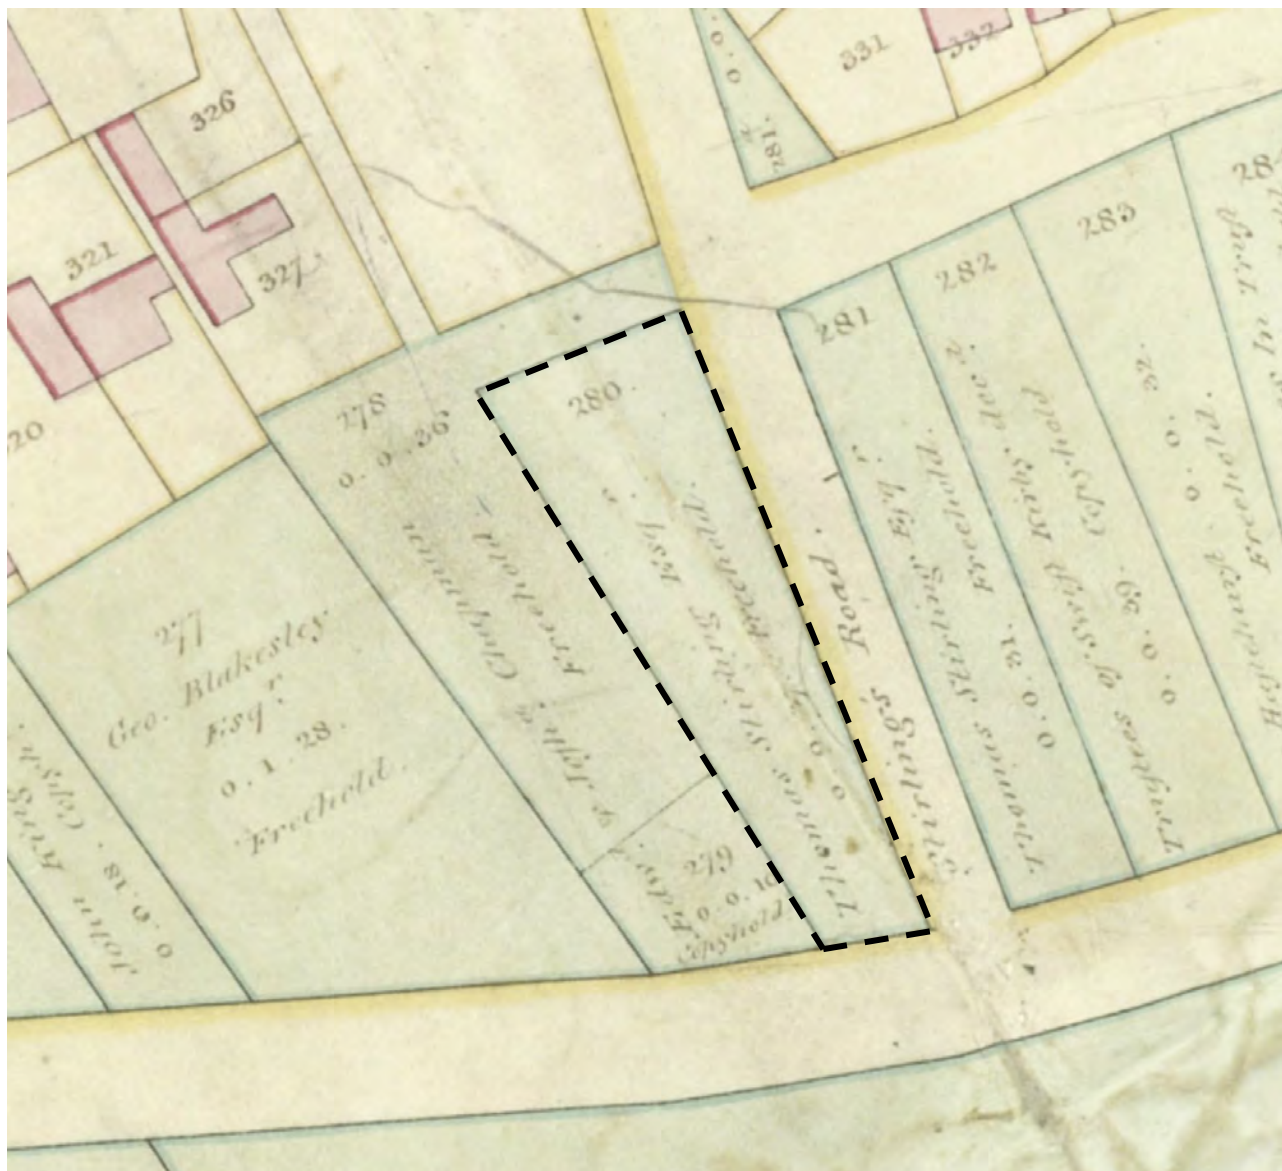
Fig 1: An extract of the Enclosure Map of 1818. The parcel of land numbered 280, owned by Thomas Stirling, is outlined in a dotted black line. © Richmond Local Studies Library

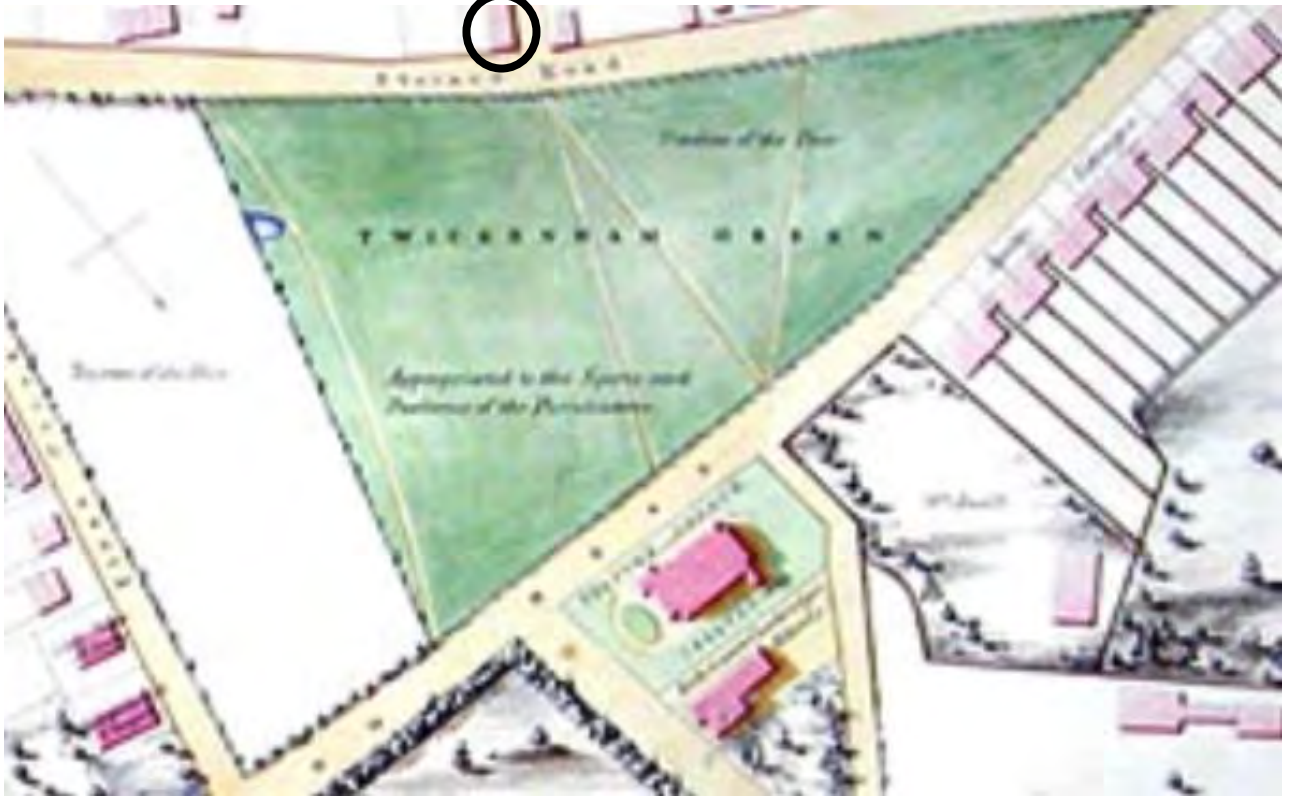
Fig 3: An extract of the 1849 map of the 'Locality of Trinity Church Twickenham' with the corner building on the application site encircled in black. © Richmond Local Studies Library

2.6 The 1849 map showing the 'Locality of Trinity Church Twickenham' (Fig 3, it is also included in the Twickenham Green Conservation Area Appraisal), shows the corner building on the application site, although the top of the map is cut off and it is not possible to tell whether there were buildings to the north. When comparing the 1849 map with the tithe map, it can be seen that the buildings on the 1849 map are not very accurately depicted, with the buildings footprints apparently more generally representative of built form, than accurate depictions of the outlines of the actual buildings.

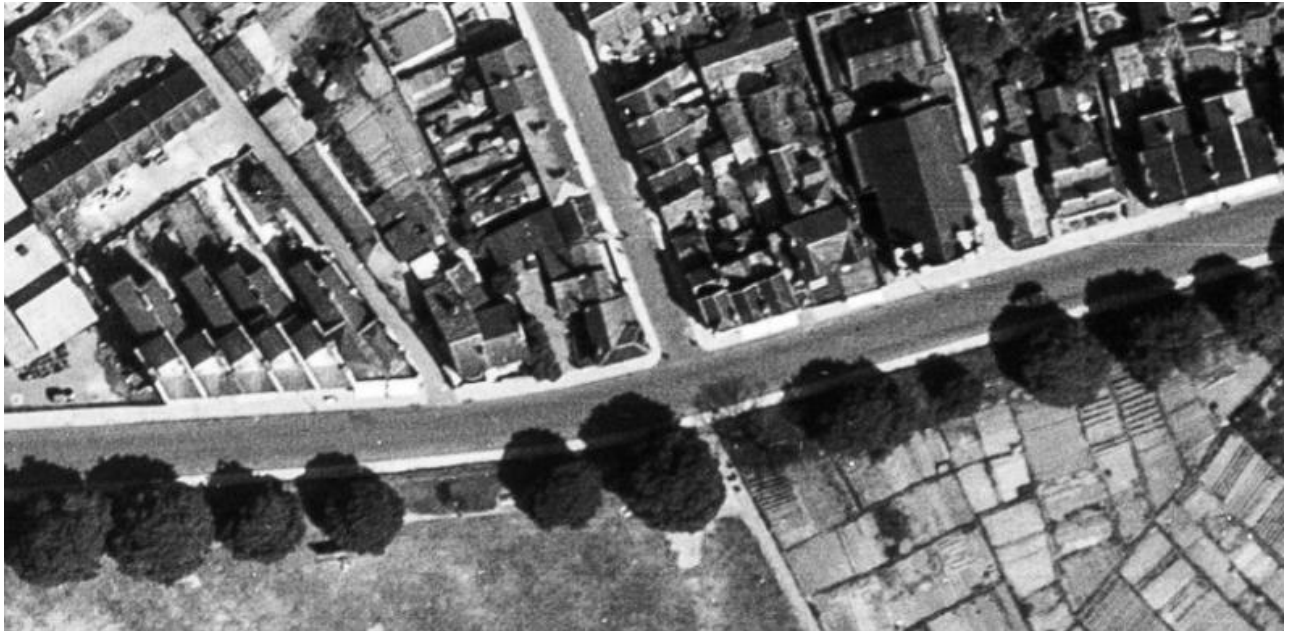
Fig 7: An extract of a 1947 aerial photo. © Historic England raf\_cpe\_uk\_2112\_v\_5339

2.10 Various early C20 photos and postcards of The Green, and the development along the edges of The Green, have been sourced. However, none of these show the application site and they have not been reproduced (many also appear in the Twickenham Green Conservation Area Appraisal). The 1934 Ordnance Survey map (not reproduced) shows a structure behind the northernmost building, and this can be seen on an aerial photo of (Fig 7).

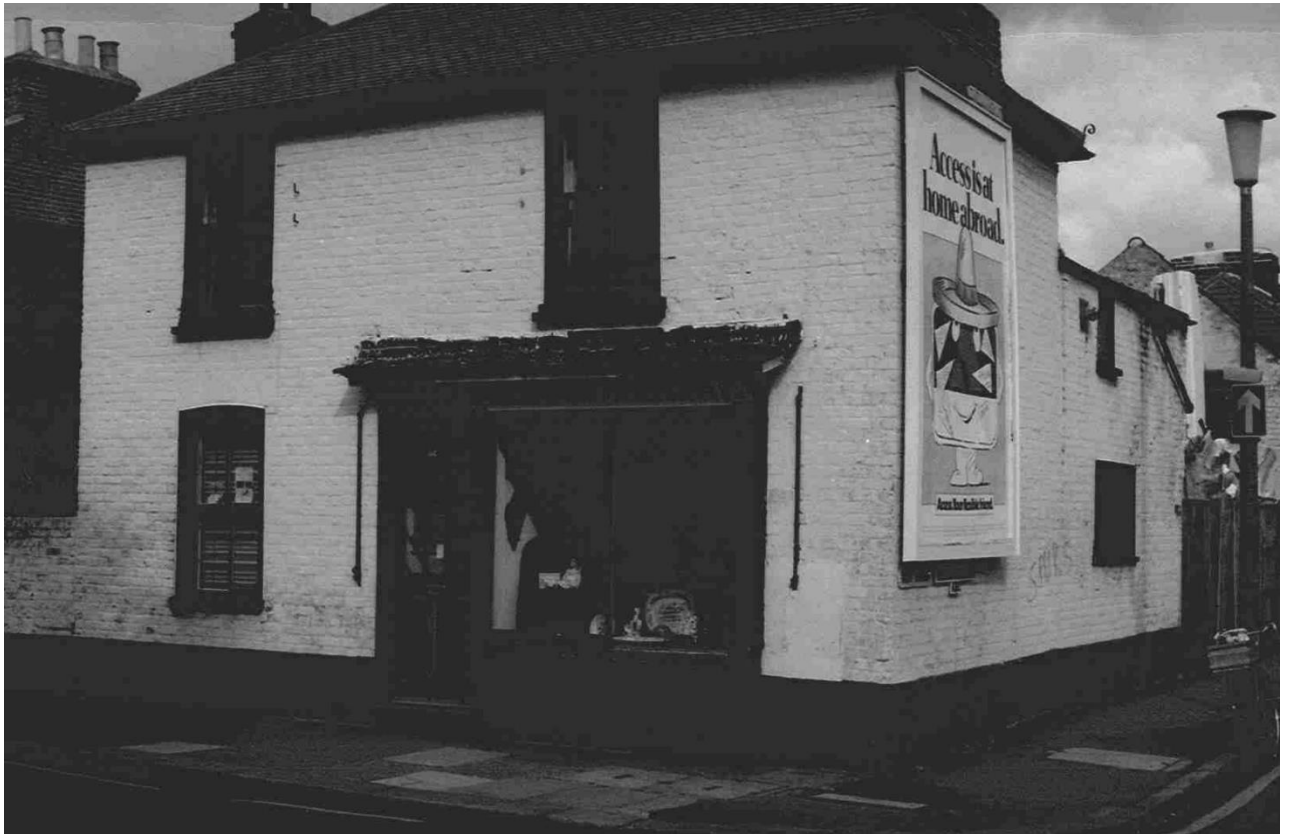
Fig 10: An extract of a photo of 64 The Green, taken in 1982. © Richmond Local Studies Library

2.13 In the late C20 the buildings were used for artistic/stage set production by the company J G Pemberton Ltd. Richmond Local Studies Library has a poor quality photo of 64 The Green, taken in 1982 (Fig 10). The setback area of the application site on May Road was fenced at that time, and the eastern elevation of the corner building was fitted with a large billboard.

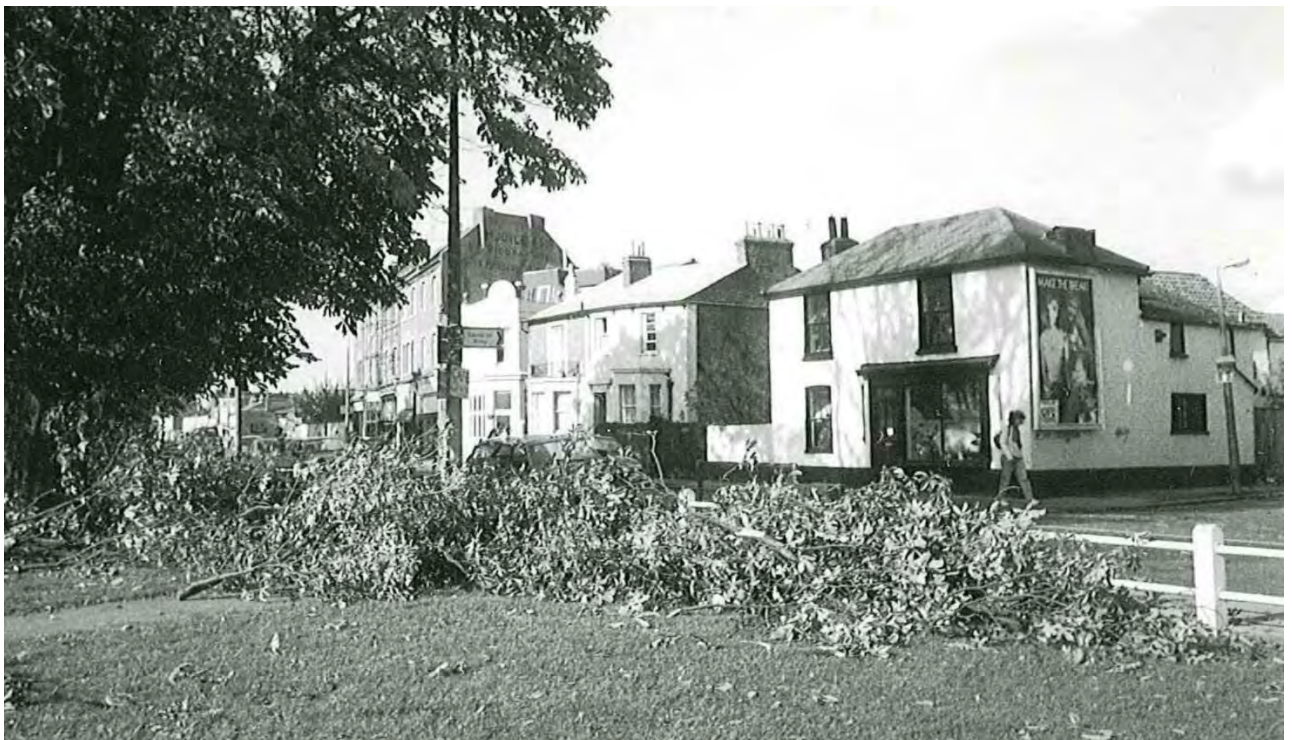
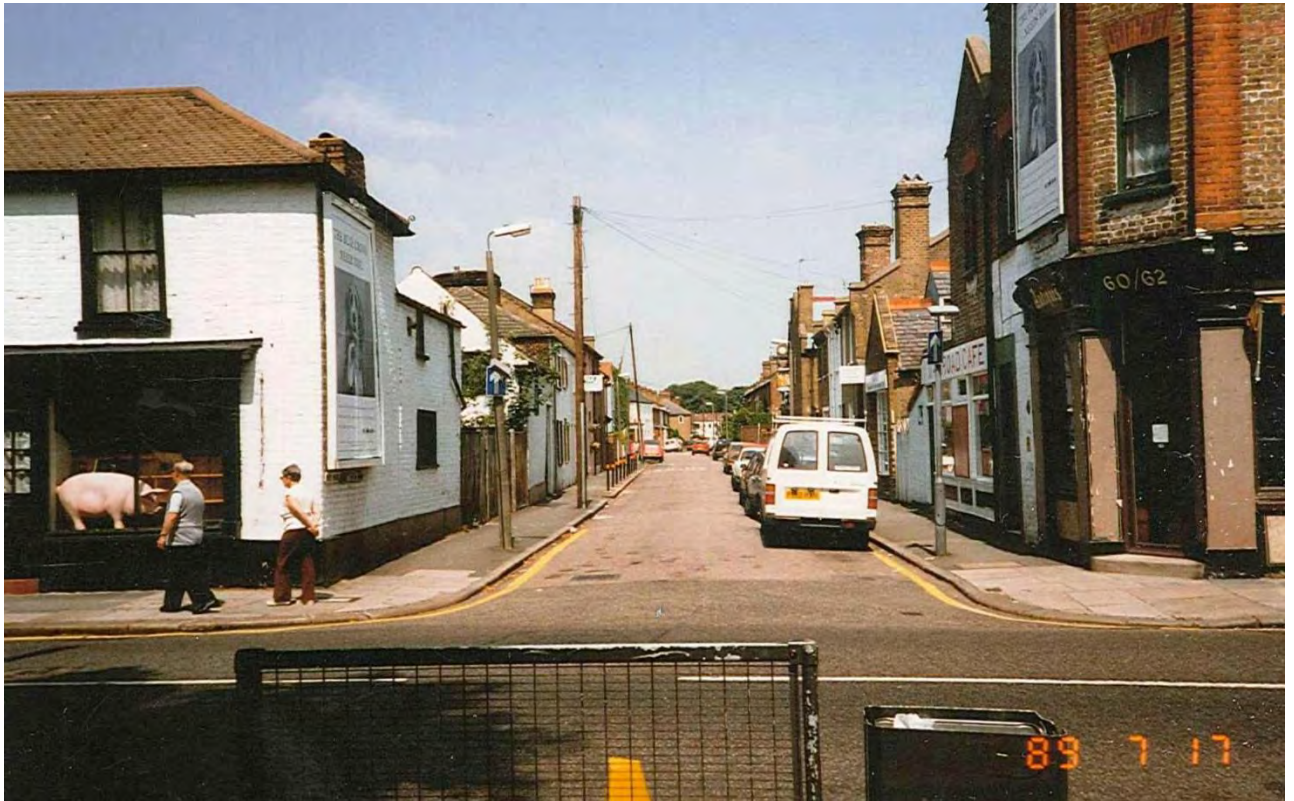
Fig 11: An extract of a photo of 64 The Green, taken in 1987. © Richmond Local Studies Library

Fig 12: An extract of a photo looking up May Road, with 64 The Green on the left, taken in 1989. © Richmond Local Studies Library

2.14 The building is similarly recorded on photos of 1987 and 1989, held at the Richmond Local Studies Library (Figs 11 & 12). At that time the corner building still had the stub of a chimneystack on the east, which explains the absence of windows on the elevation.

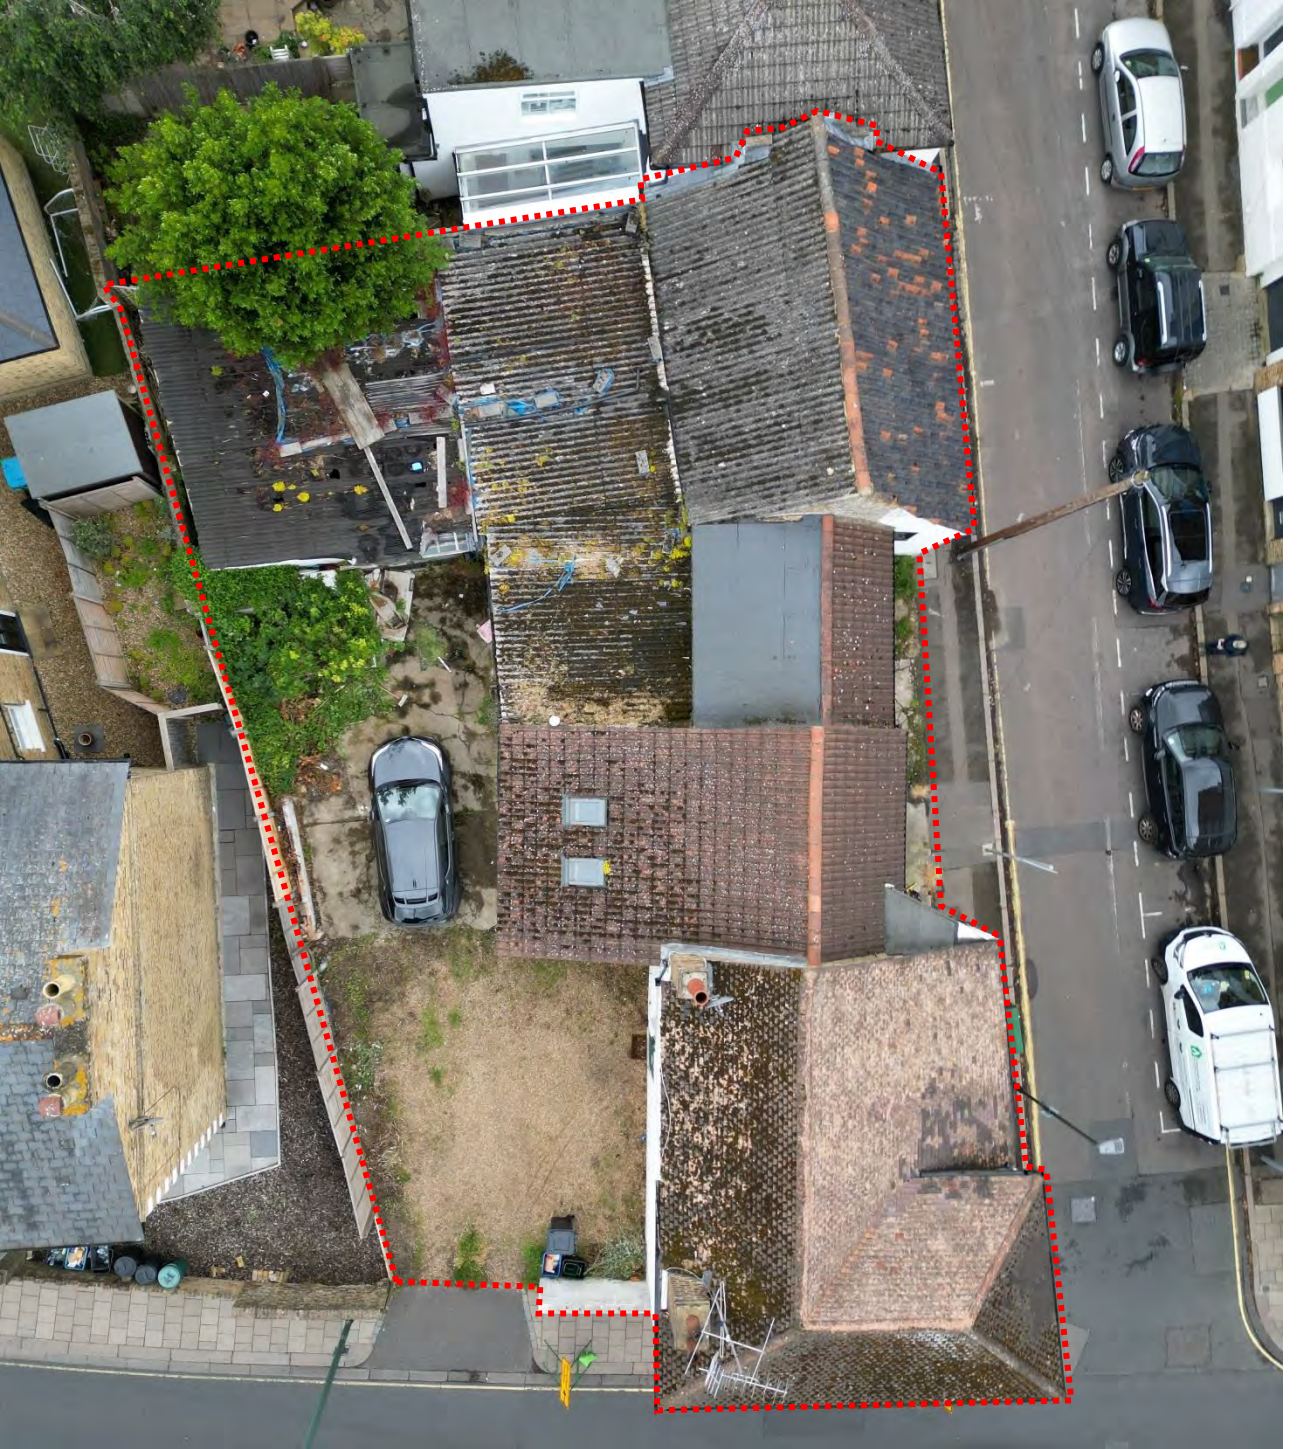
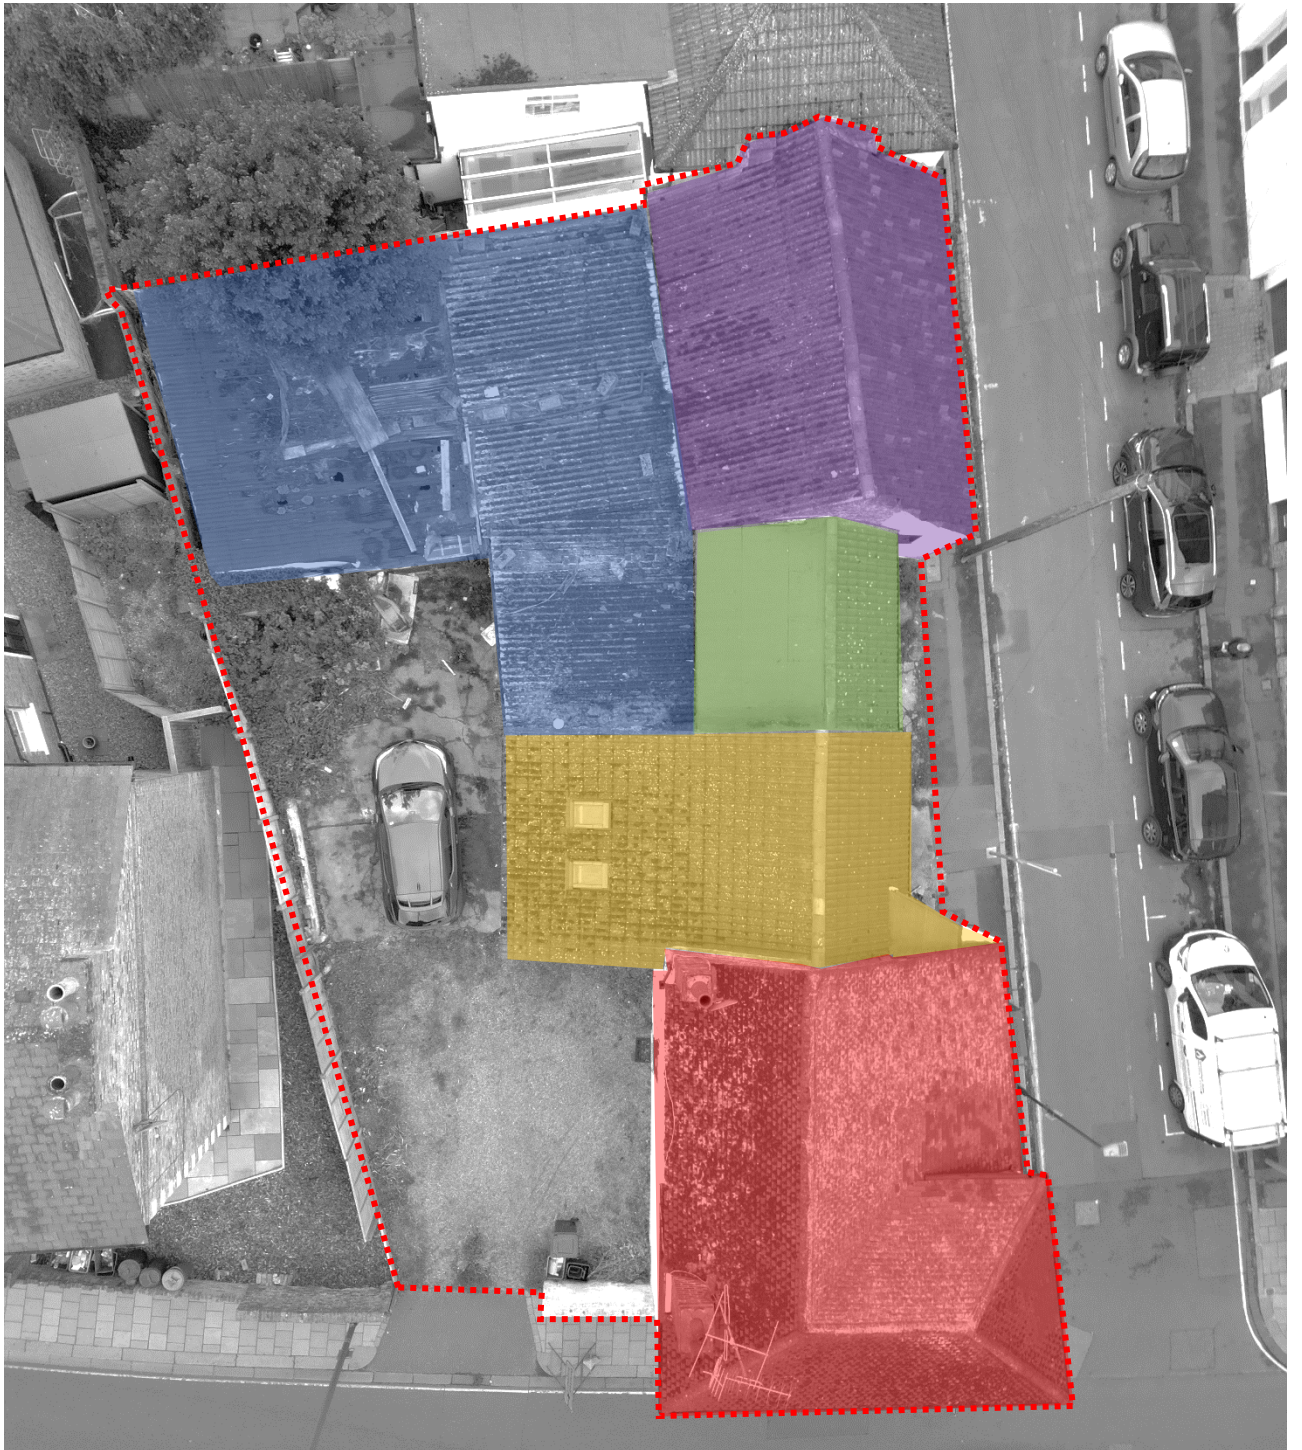
Photo 1: A vertical aerial photo of the application site (the site and buildings outlined in a dotted red line).

Photo 2: An annotated version of the vertical aerial photo of the application site (the site and buildings outlined in a dotted red line):

1. In red, at the bottom (south), is the early C19 corner house, originally probably L-shaped and with a later two storey catslide infill on the east, to May Road.
2. To the north of it, in orange, a heavily altered/rebuilt mid-late C19 two storey extension with a rear catslide roof to the west.
3. To the north of it, in green, a small, heavily altered and partially rebuilt mid-late C19 single storey extension with the rear roof reconfigured to create additional space for the internally inserted mezzanine.
4. To the north of it, in purple, a partially rebuilt mid-late C19 two storey extension with a the rear roofslope in a corrugated sheet cladding.
5. In blue, to the NW of the application site, modern poor quality concrete 'breeze' block and corrugated sheet roof lean-to structures or 'workshops'.

- 2.31 The buildings on the application site are first shown on the un-annotated aerial photos (Photos 1, 3 & 5), and then individual components are identified in different colours on the second series of aerial photos (Photos 2, 4 & 6). This is how the buildings are referred to henceforth.

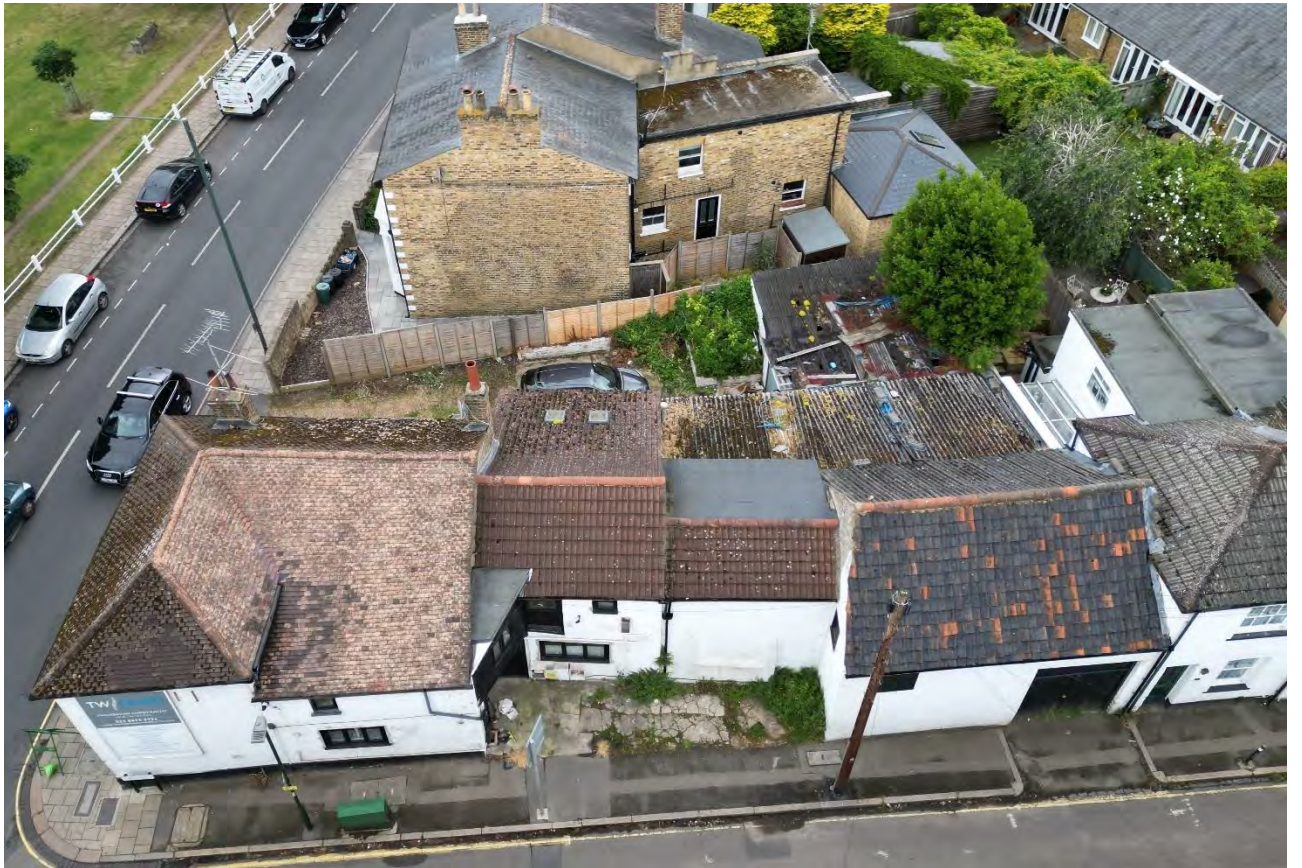
Photo 3: An oblique aerial photo of the application site from the east.

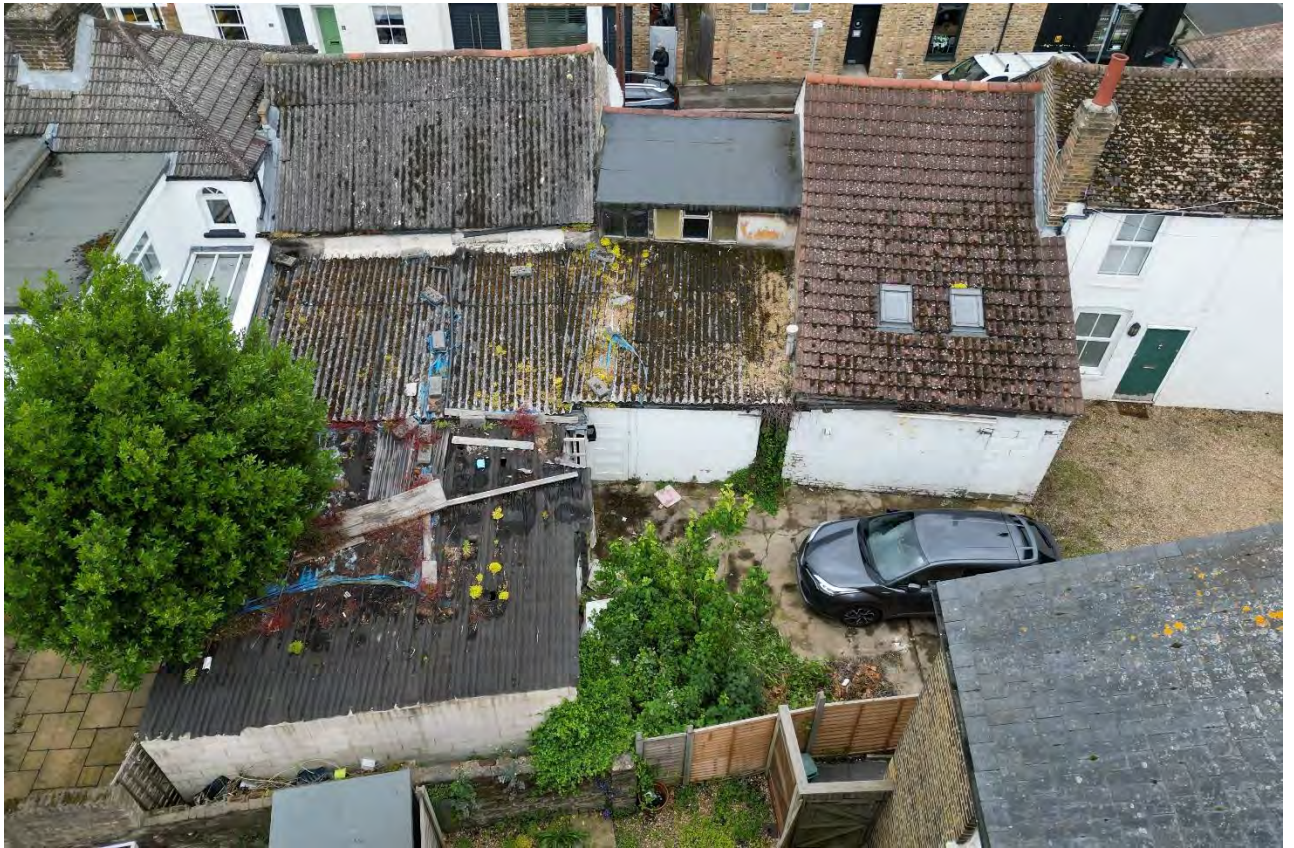
Photo 5: An oblique aerial photo of the application site from the west.

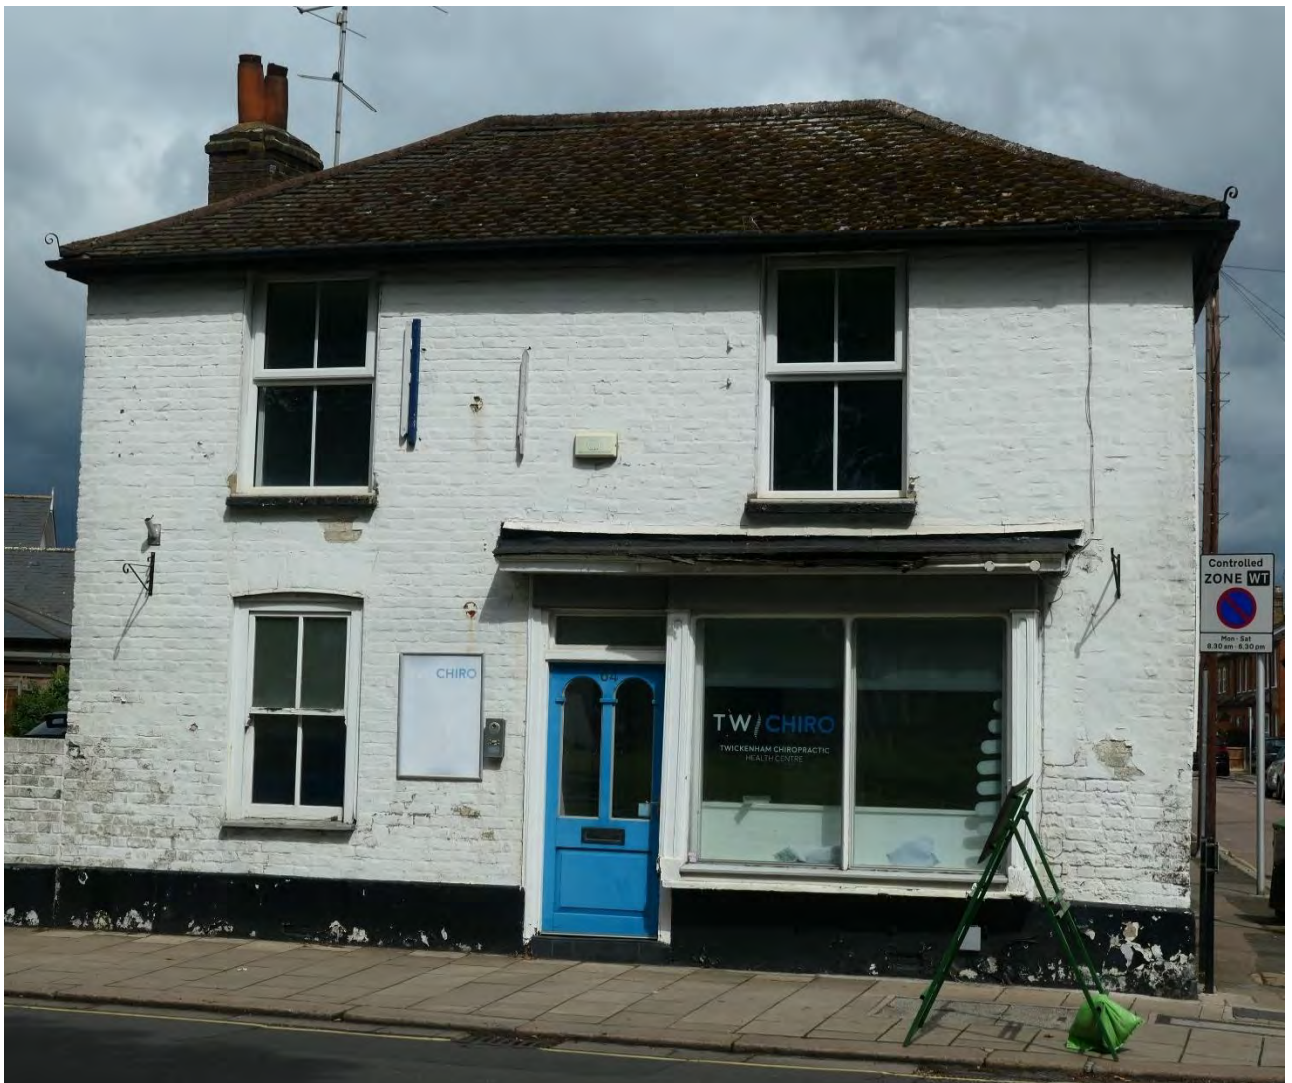
Photo 6: A frontal view of the early C19 corner house.

2.32 The frontage of the early C19 corner house has two window bays to The Green, either side of a central ground floor entrance (Photo 6). The east ground floor window has been converted to a rudimentary shopfront, under a shallow projecting canopy. The shopfront appears to have been altered/reconstructed in recent times and is of no great age or interest. The windows are poor quality UPVC replacements. The roof is hipped with end stacks to the west (the stack to the east has been removed), indicating a likely original plan form of two rooms either side of a central stairs core, and a rear outshot to the west, making the L-shaped footprint, that was later infilled to the east with the catslide addition.

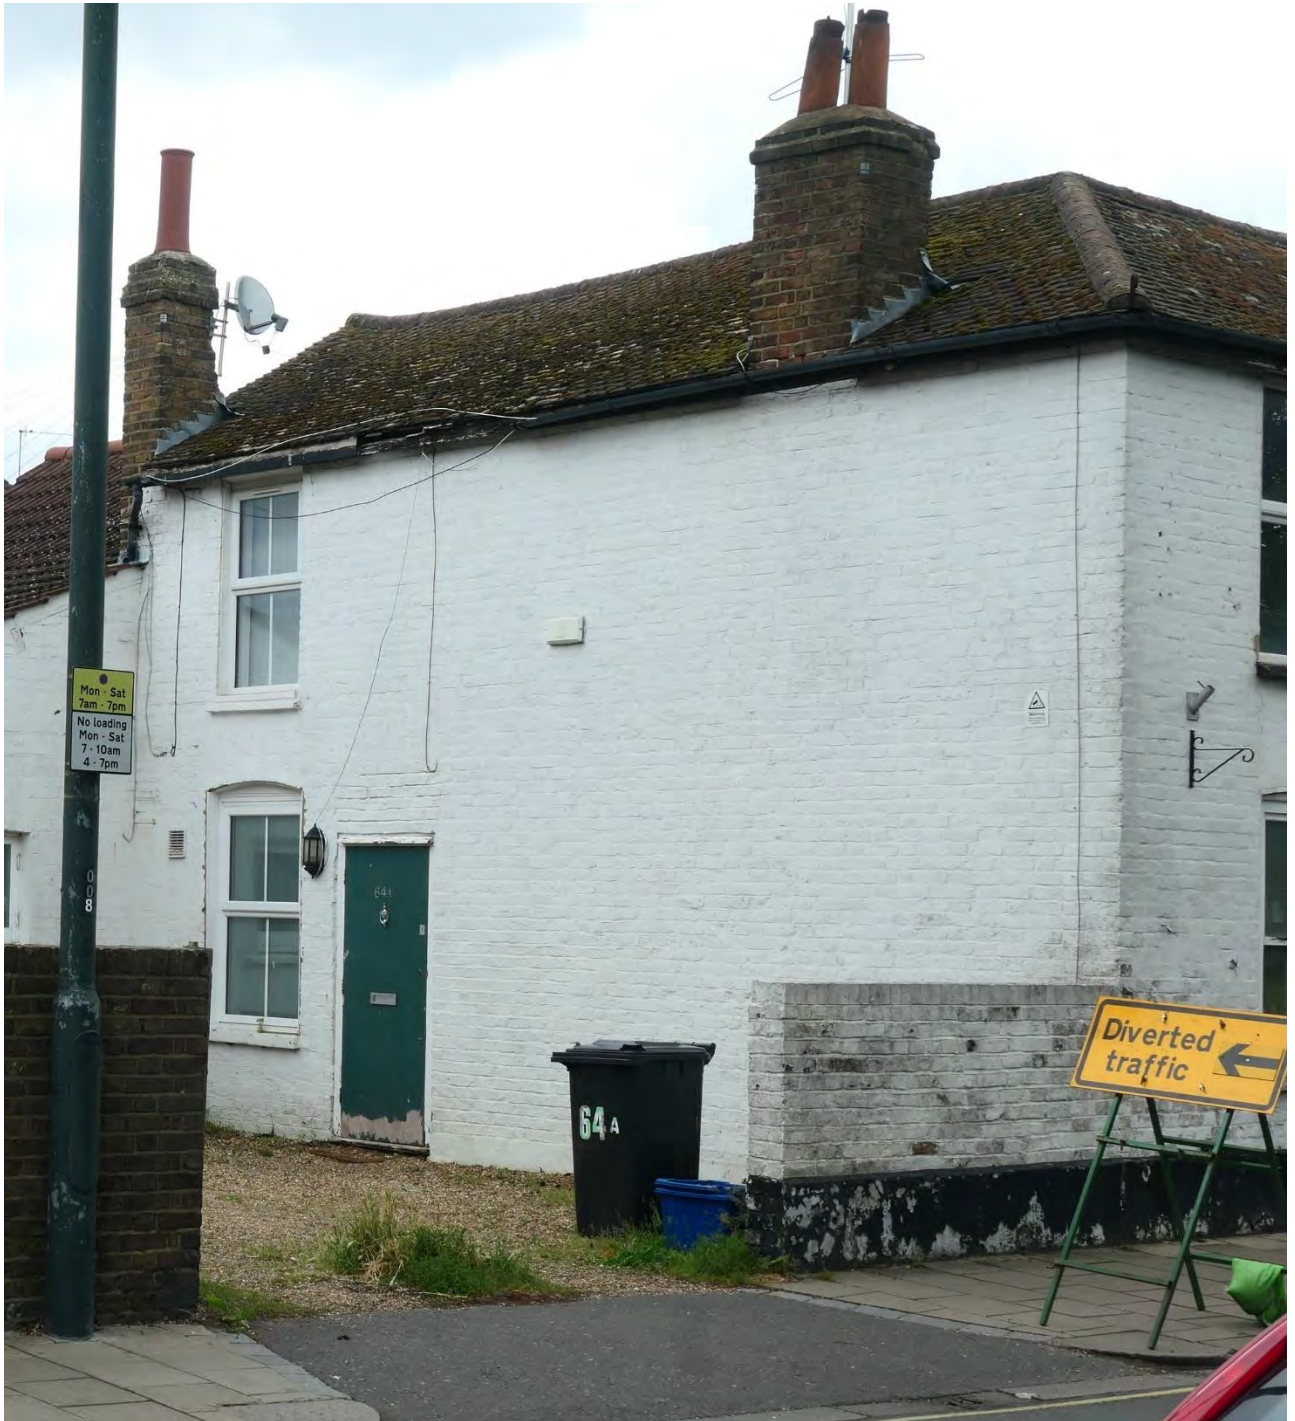
Photo 7: The west return elevation (Photo 7) is largely blank, aside from an inserted modern door and a set of windows at the northern end. It is not an especially notably part of the building for any reason.

2.33 The west return elevation (Photo 7) is largely blank, aside from an inserted modern door and a set of windows at the northern end of the rear range. It is not an especially notable part of the building for any reason, and it is unremarkable in its own right.

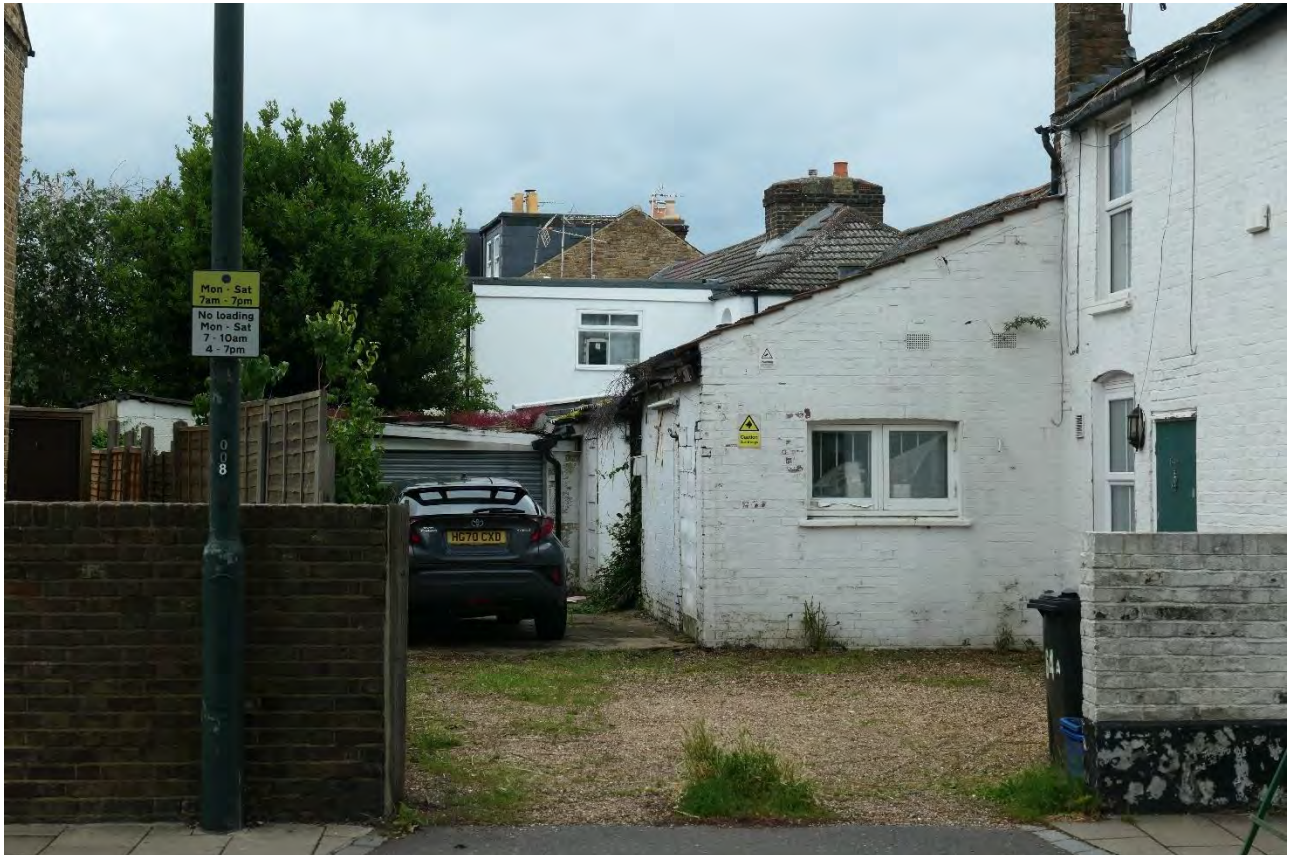
Photo 8: To the west is a short section of boundary wall, with a vehicular entrance that allows parking space for two cars side-by-side on the gravel surfaced area; beyond this, the largely modern and very poor quality piecemeal and had hoc accretions to the rear 'workshops' can be seen.

- 2.34 To the west is a short section of boundary wall, with a vehicular entrance that allows parking space for two cars side-by-side on the gravel surfaced area to the west of the house (Photo 8). Beyond this, the largely modern and very poor quality piecemeal and had hoc rear 'workshops' can be seen. **Beyond the rear 'workshops' on the application site, the large rear extensions and the box dormers to the houses on May Road are seen.**

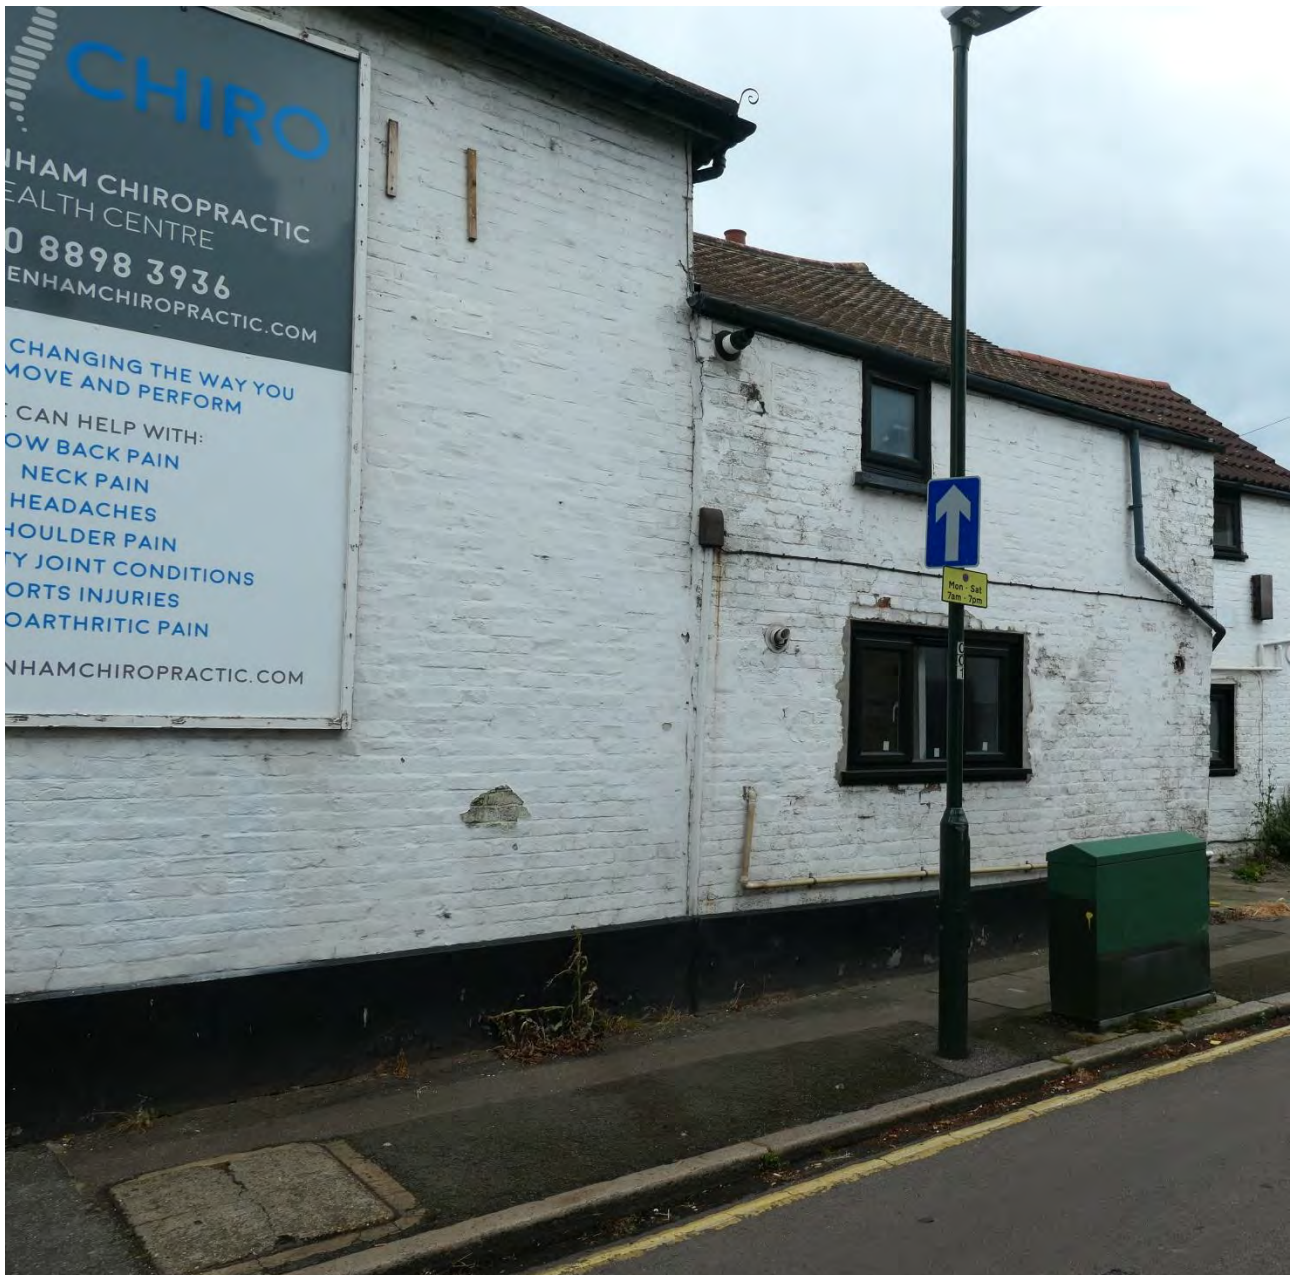
- 2.35 The corner house has a prominent advertisement on the eastern return elevation (Photo 9). There is a straight vertical joint on May Road where the catslide infill attaches to the original house, indicating it was added later. The May Road elevation of the catslide infill (Photo 10) is cluttered with vents and pipes and an inappropriate ground floor window has been cut into the elevation.

Photo 9: The east return elevation of the early C19 corner house and the catslide infill on May Road.

- 3.4 The modifications to the building are relatively minor, and largely positive. The removal of the advertisement on the eastern return elevation would be a notable and highly visible improvement, and there would be no harm in removing the non-original shopfront, given the generally domestic design and appearance of the building. The deeply setback side entrance door, which would be overlapped by the extension (considered below) would be replaced with a new side entrance. Together with the new front garden here, in place of the present car parking, this would be an enhancement.

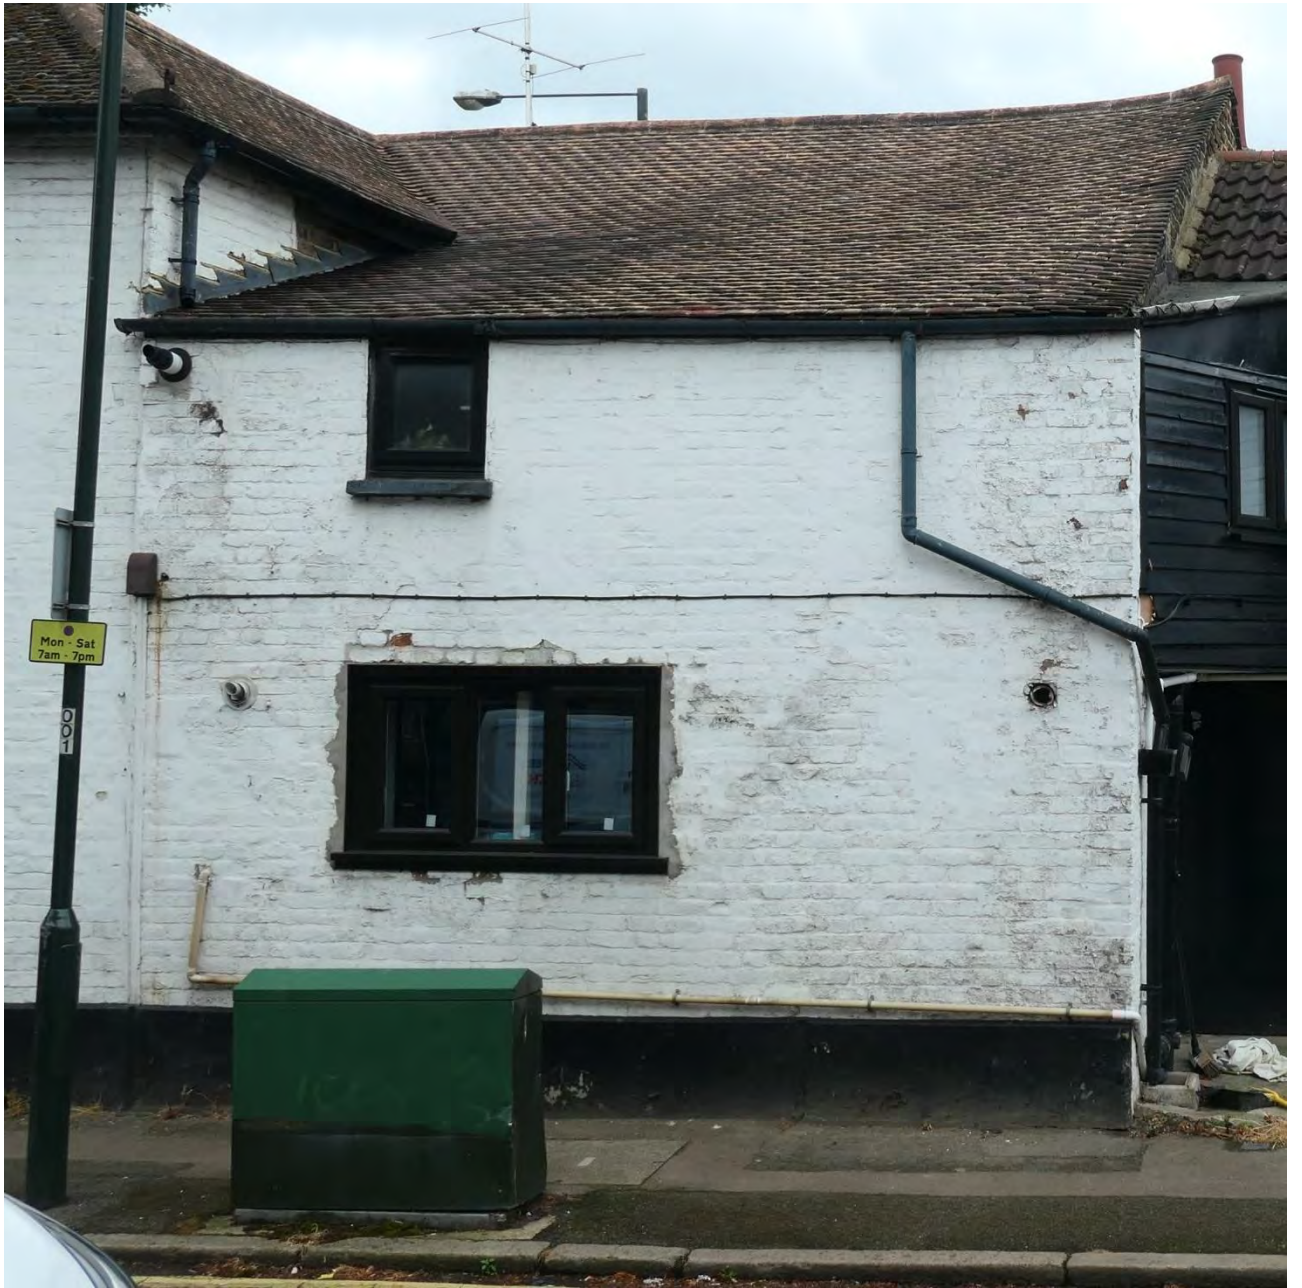
Photo 10: The east elevation of the catslide infill on May Road.
