# Heritage Statement

## 64 The Green, Twickenham TW2 5AG

**Written by:** Ignus Froneman B Arch Stud ACIfA IHBC      **Date:** 02 Sept 2024  
**On behalf of:** Elstree Land Ltd      **Ref:** 0458

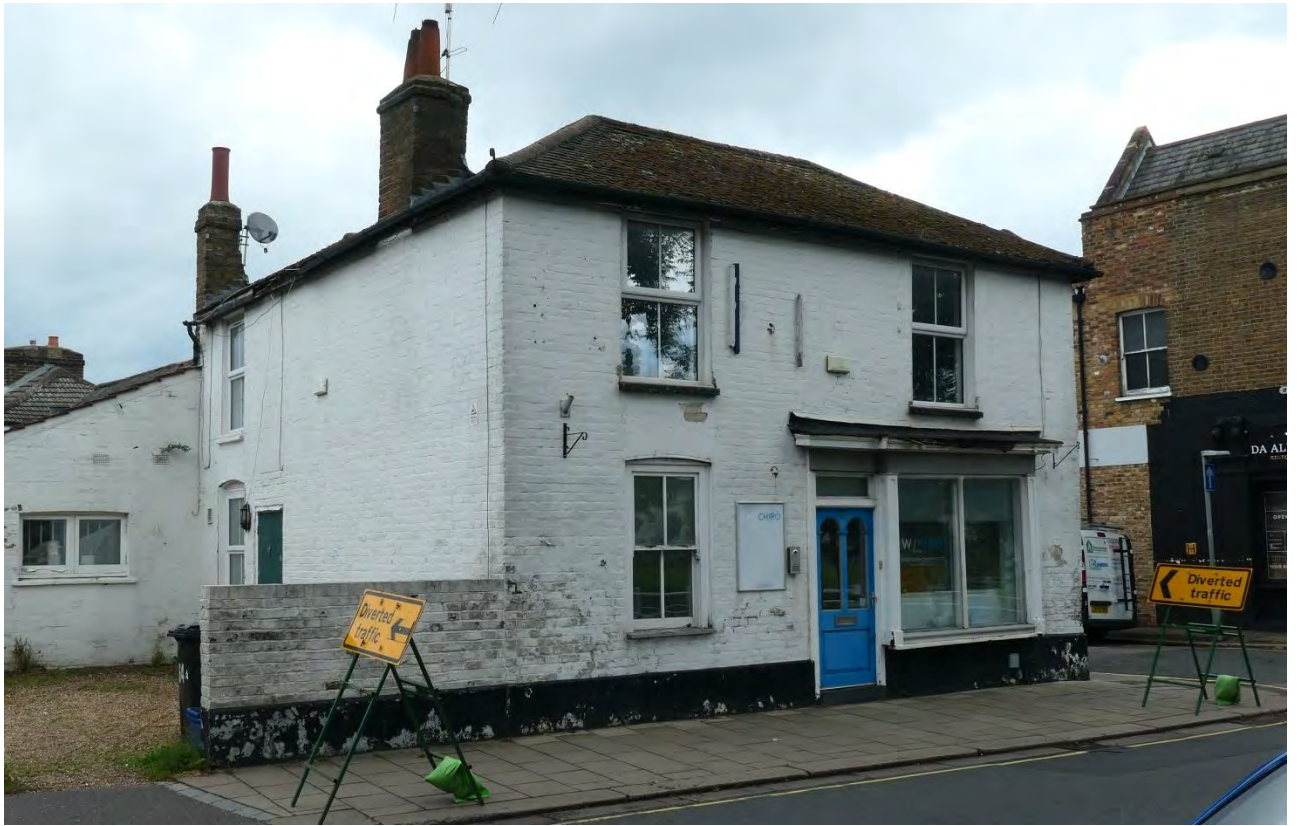
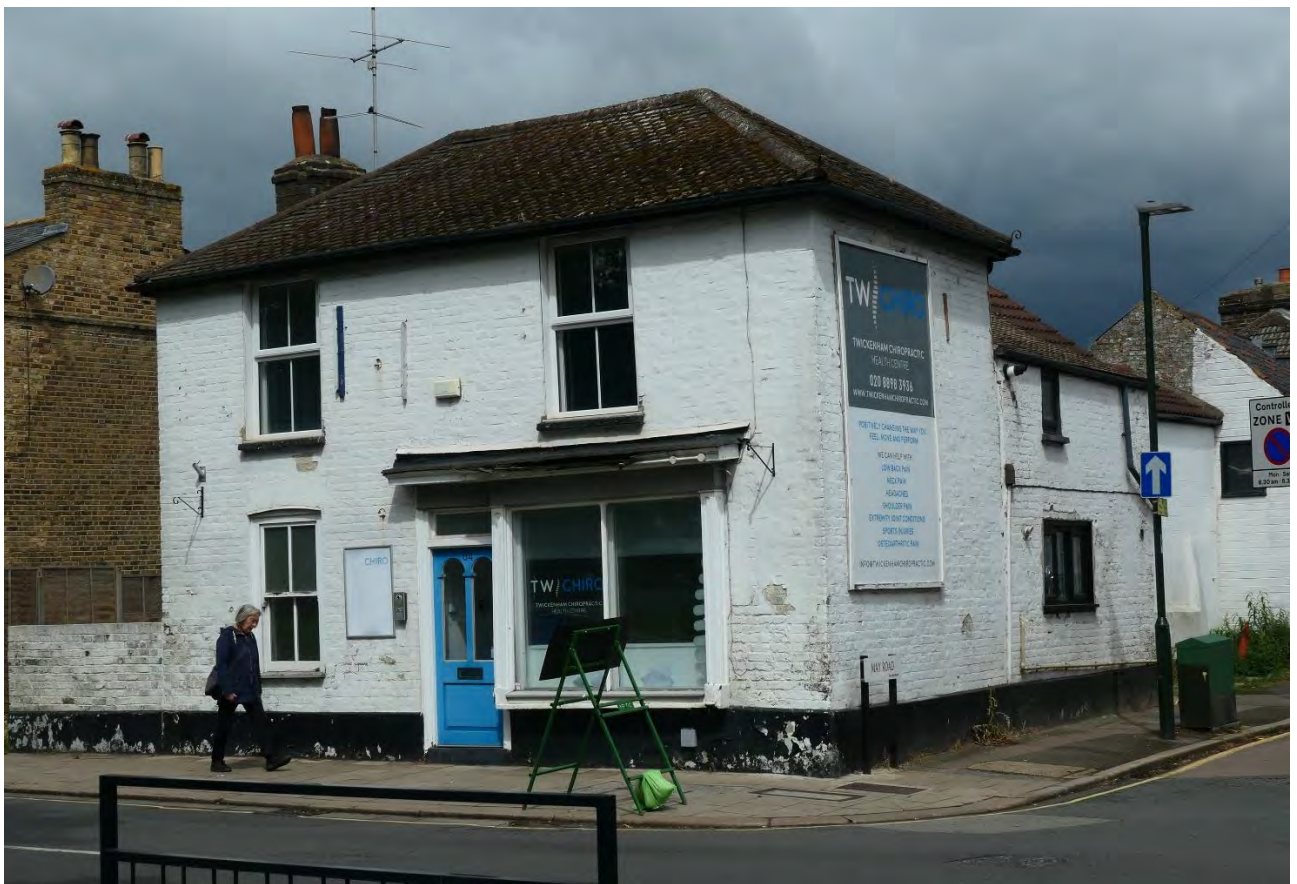
- 2.36 Altogether, the south façade has been compromised by unsympathetic insertions and alterations, but this part of building retains the essence of an early C19 house. The west return elevation is unremarkable, though obviously part of the building. The advertisement on the eastern return elevation of the early C19 corner house, and the poor quality, cluttered elevation of the catslide infill makes for a somewhat disappointing flank elevation to the BTM. Nevertheless, when seen in the round, the building retains a good deal of its character, despite the various unsympathetic alterations (Photos 11 & 12).

Photo 11: The early C19 corner house, from the SW.

Photo 12: The early C19 corner house, from the SE.

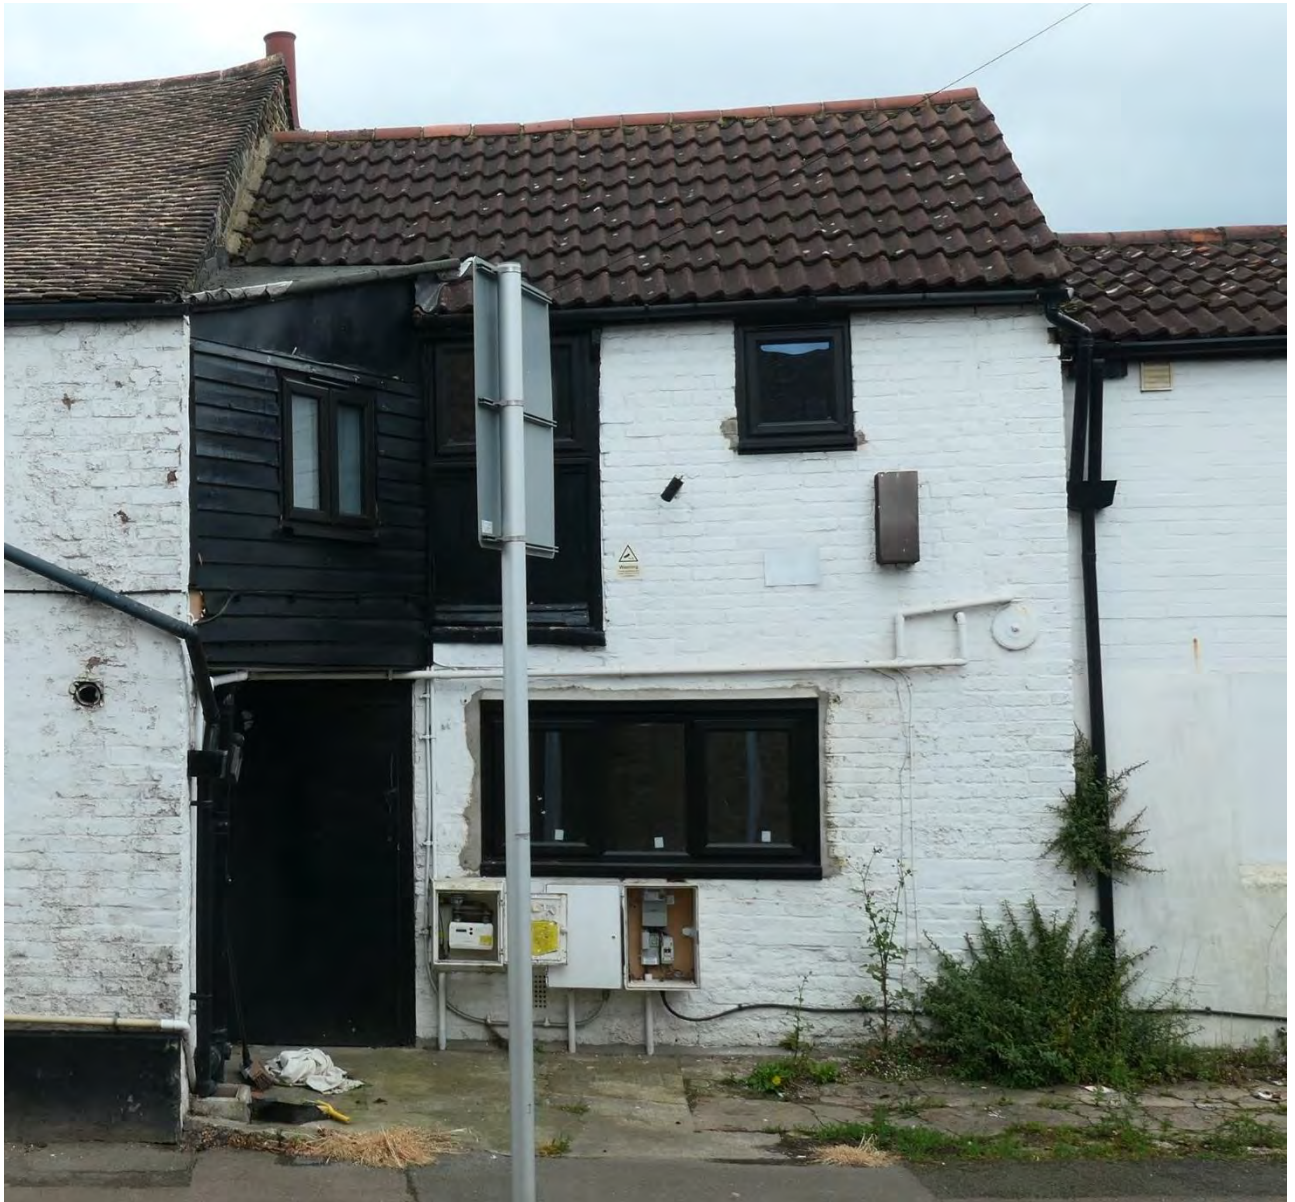
Photo 13: The east (May Road) elevation of the heavily altered/partially rebuilt mid-late C19 two storey extension with a rear catslide roof.

2.38 The east (May Road) elevation of the heavily altered/partially rebuilt mid-late C19 two storey extension (Photo 13) is again somewhat cluttered with utilities and pipes, and an inappropriate ground floor window has been cut into the elevation. This area was previously fenced from the street and that might explain the poor quality of the cluttered elevation. The ad hoc weatherboard first floor link, set at an angle under a corrugated roof, and the adjacent loft/loading door, together with the pantile roof, give the structure an organic 'old world' feel that imparts some character. On the other hand, on closer inspection, it is largely modern (Photo 14), and hardly a high quality or exceptional structure. It contributes to a sense of time depth in the conservation area and as a quirky, but heavily altered/partially rebuilt remnant of the piecemeal development to the north of the early C19 corner house.

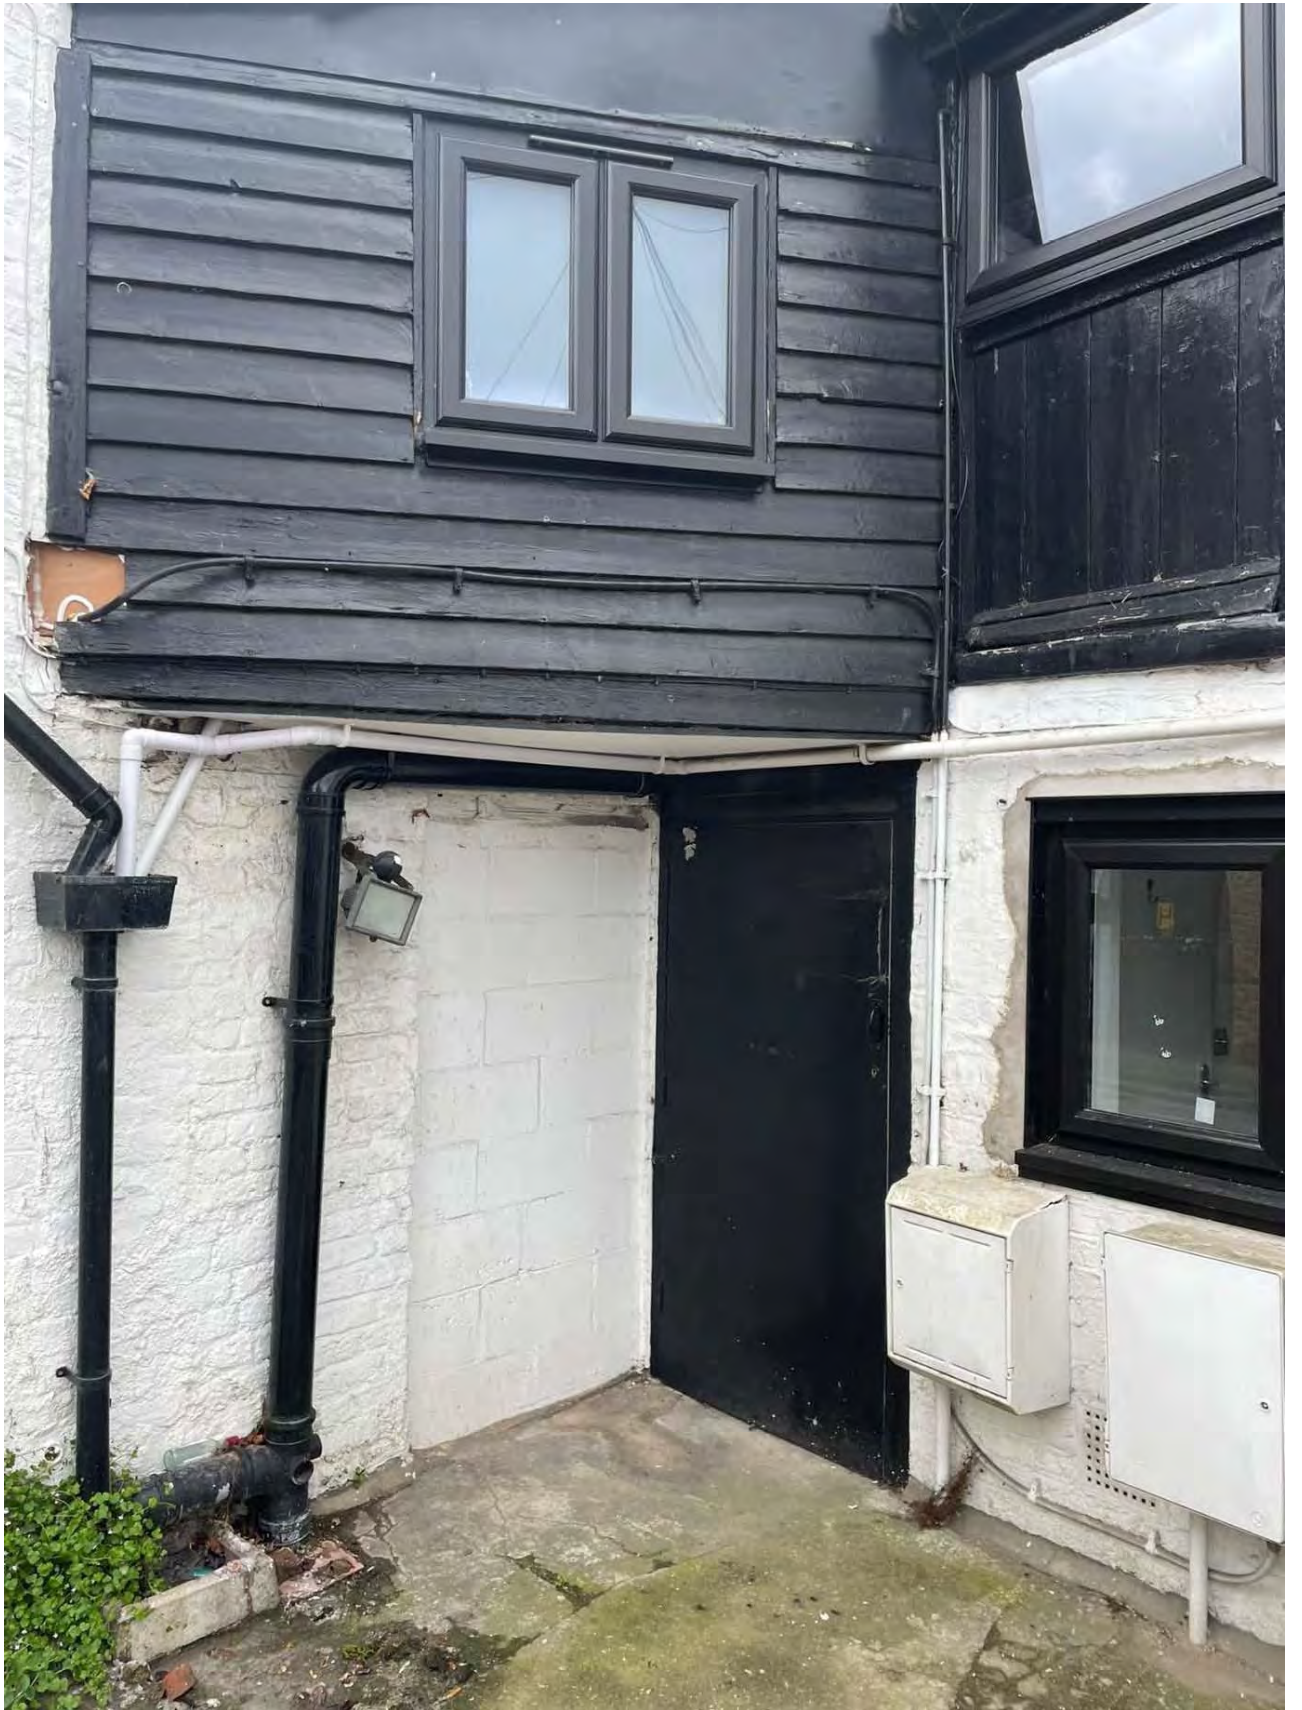
Photo 14: On closer inspection, it is largely modern.

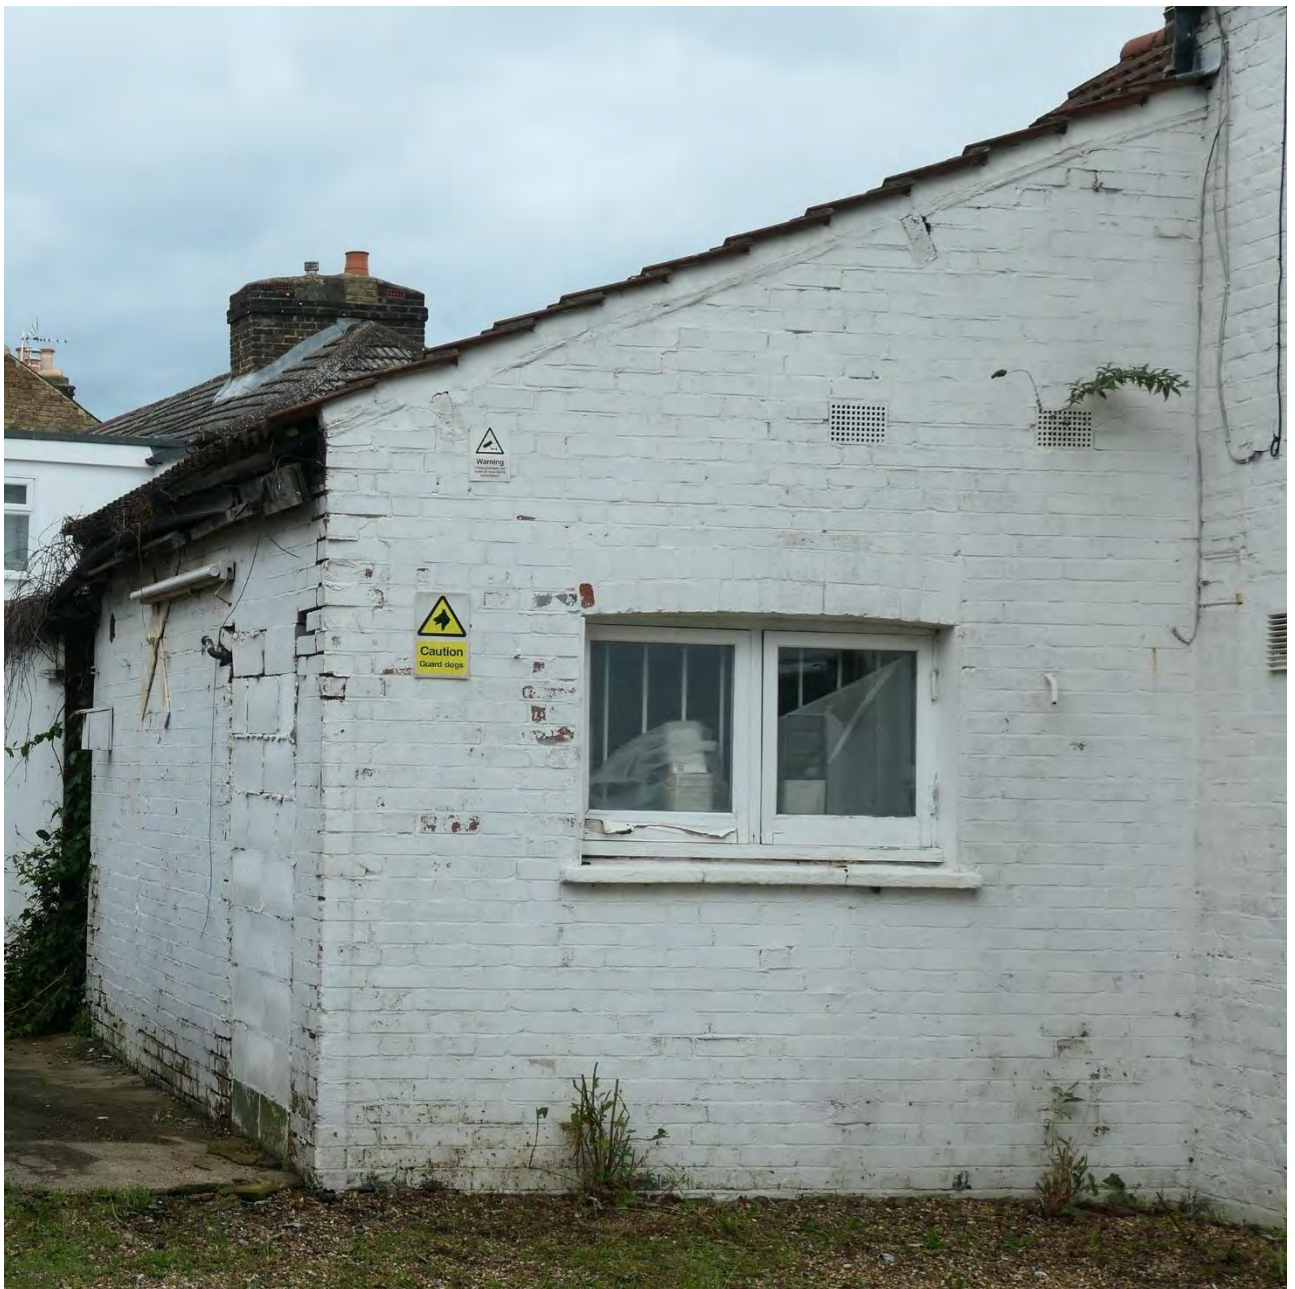
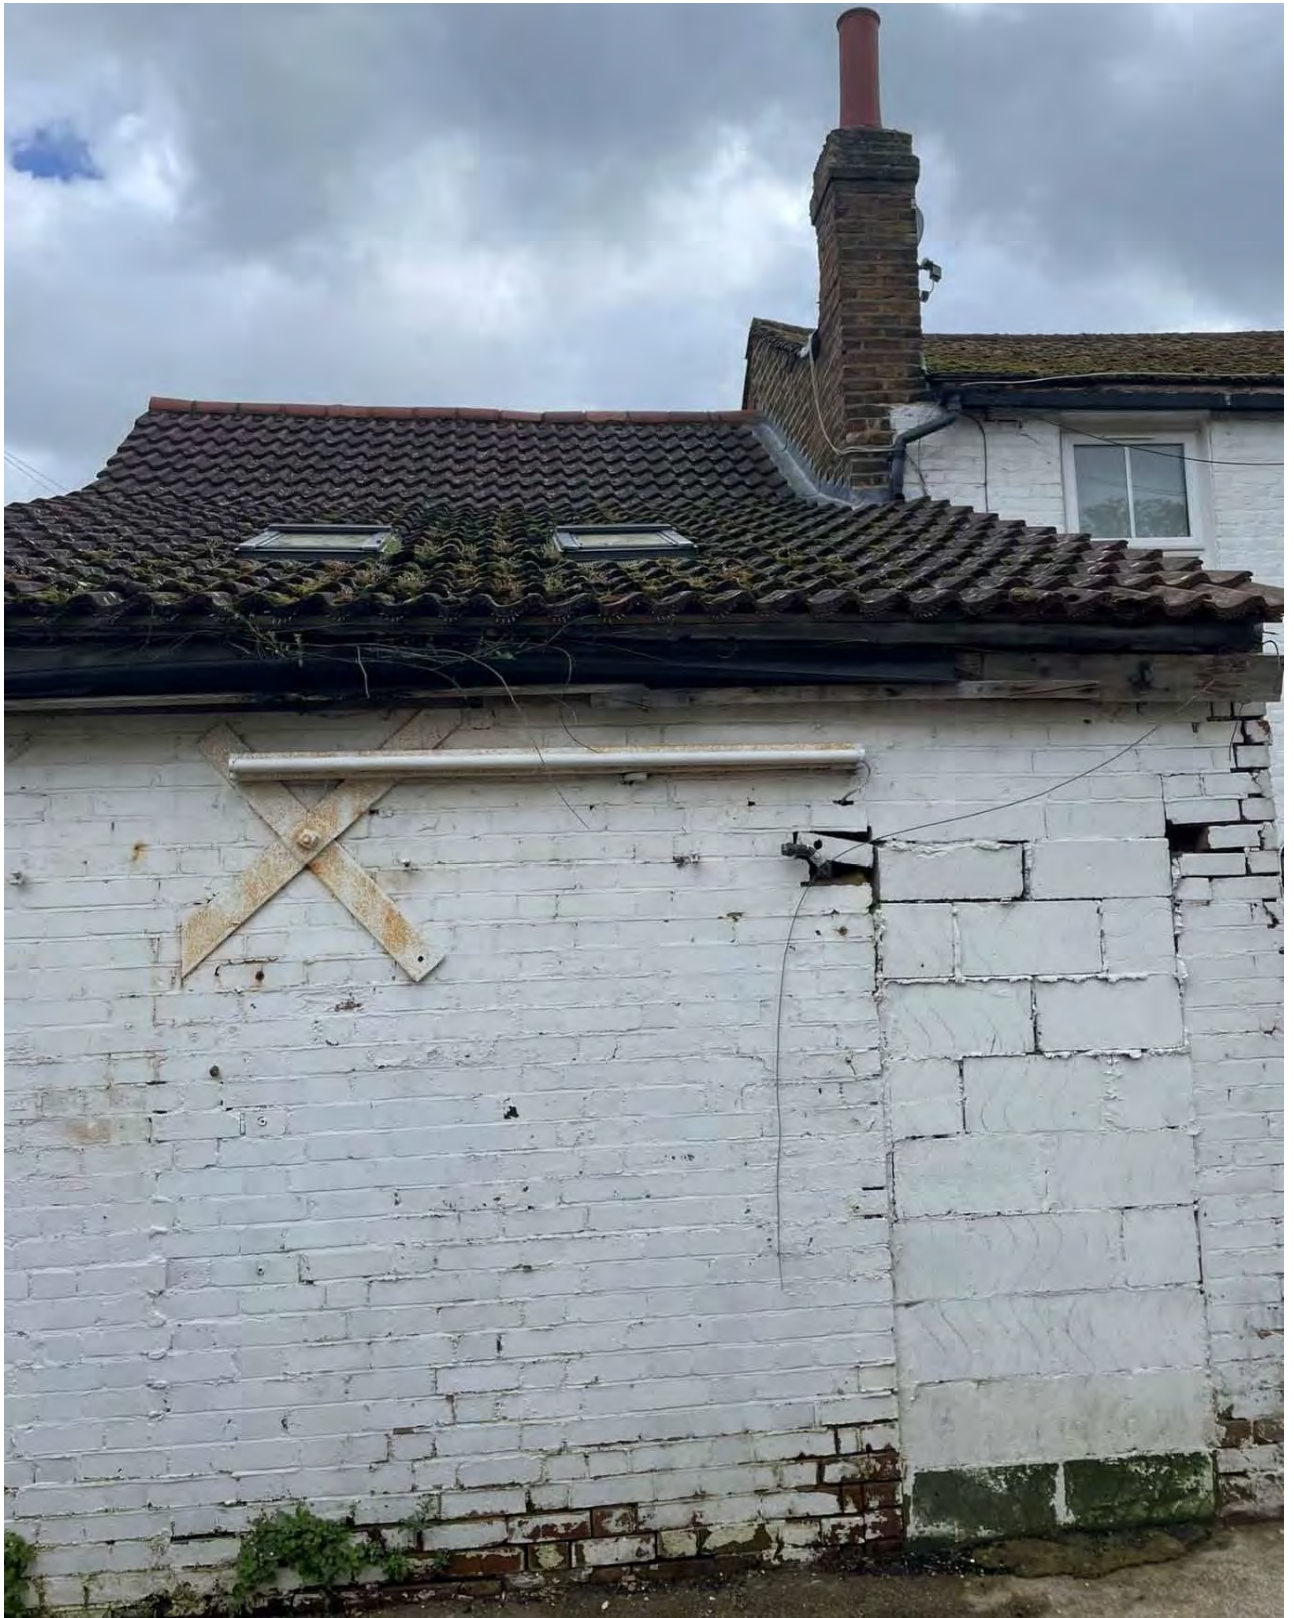
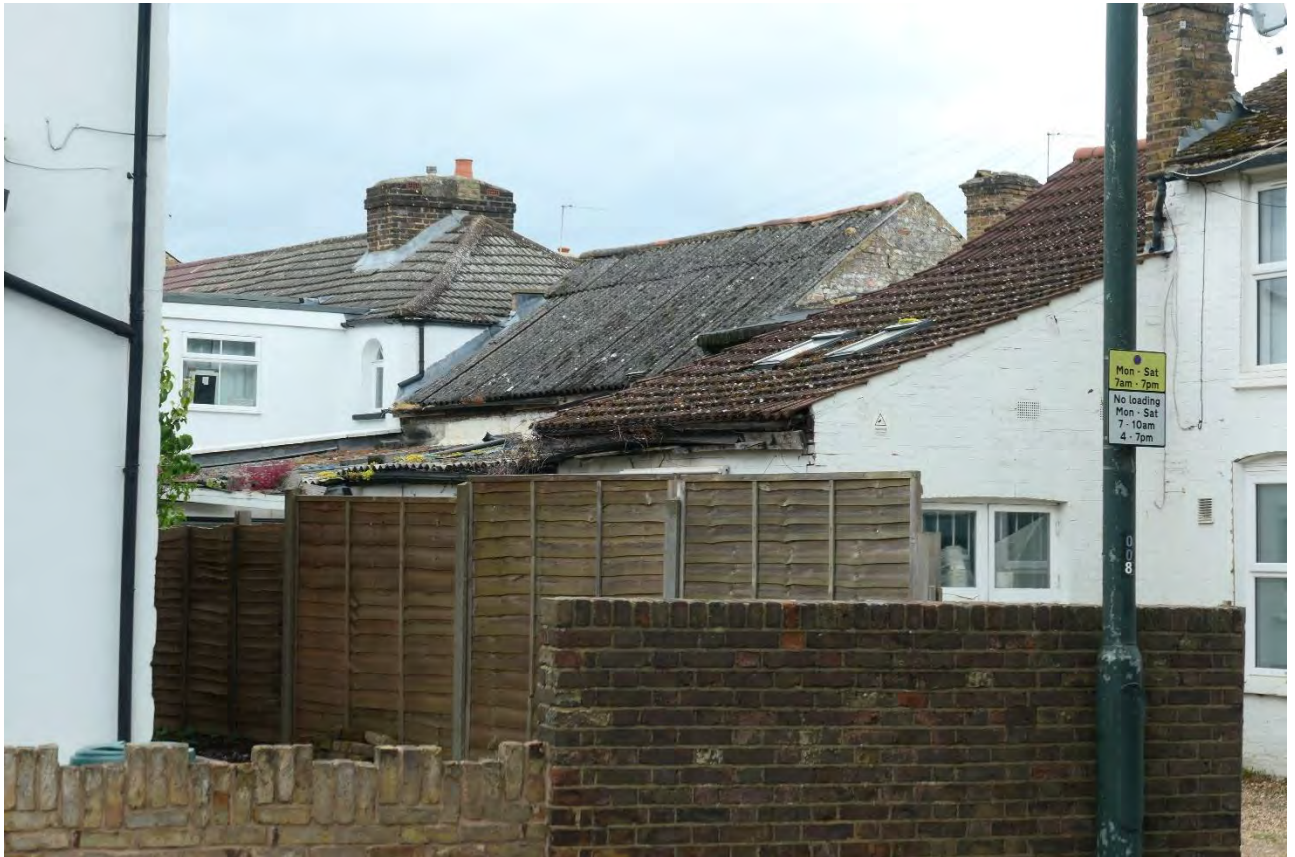
Photo 15: The heavily altered/partially rebuilt mid-late C19 two storey extension with a rear catslide roof, seen from the south.

Photo 16: The back of the heavily altered/partially rebuilt mid-late C19 two storey extension with a rear catslide roof, seen from the south.

Photo 17: The catslide roof, seen from the SW.

2.39 Turning to the rear (Photo 15), the 1885 Ordinance Survey map shows that the structure at that time projected slightly beyond the building line of the early C19 corner house. The present building has a deeper rear projection, and although the painted-over brickwork makes it hard to see the bricks properly, judging from what can be seen (Photos 15 & 16), it would appear that the rear projection is much more recent. The footprint of the current structure seems to have been added between the 1915 and 1934 Ordinance Survey maps, and that is reflected in the more uniform bricks. The west end elevation is heavily altered and in a poor state (Photo 16). There is nothing especially notable about this part of the building, which is for the most part obscured from public view; the rear catslide pantile roof can be seen at some angles (e.g. Photo 17) but again there is hardly anything notable about it.

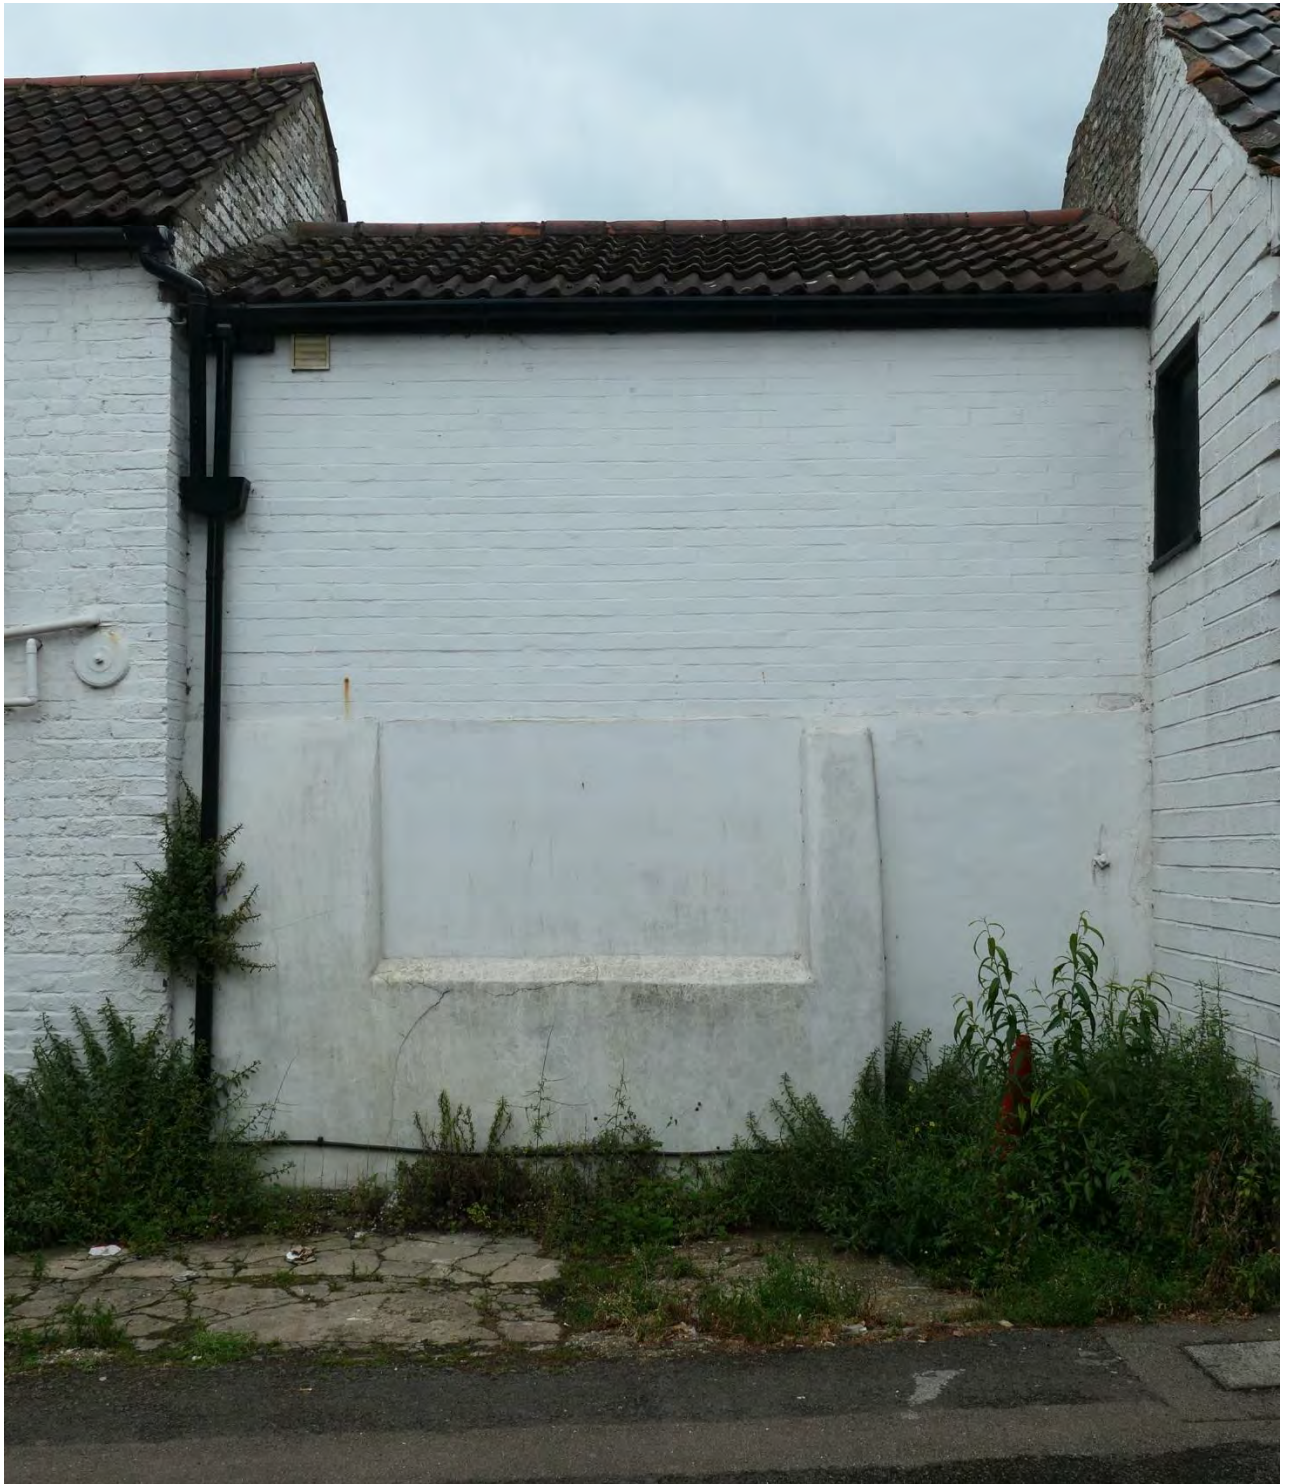
Photo 18: The plain blind east elevation of the partially rebuilt mid-late C19 single storey extension on May Road.

- 2.42 There is nothing notable about this structure, with its single pantile roofslope on May Road the only exposed component that is not obviously modern.

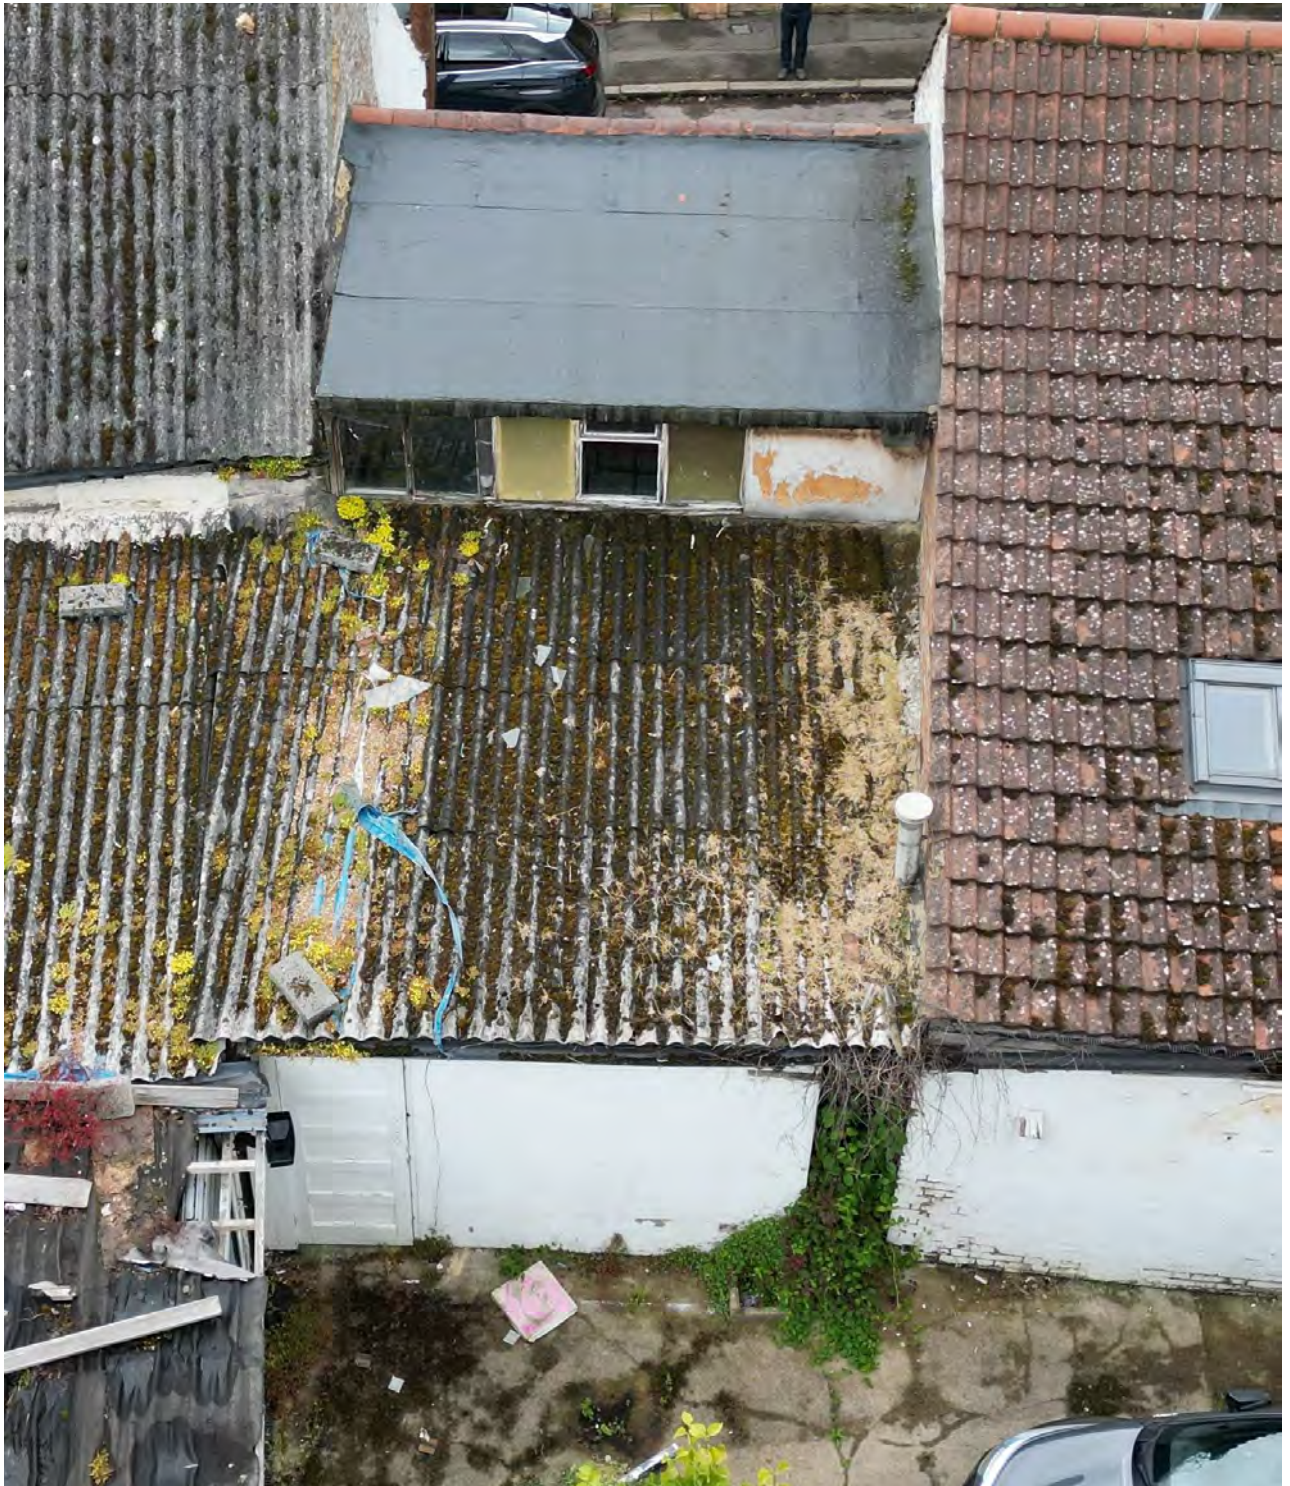
Photo 19: At the back, the roof has been lifted; it is a poor quality modification that is fortunately well-hidden from view.

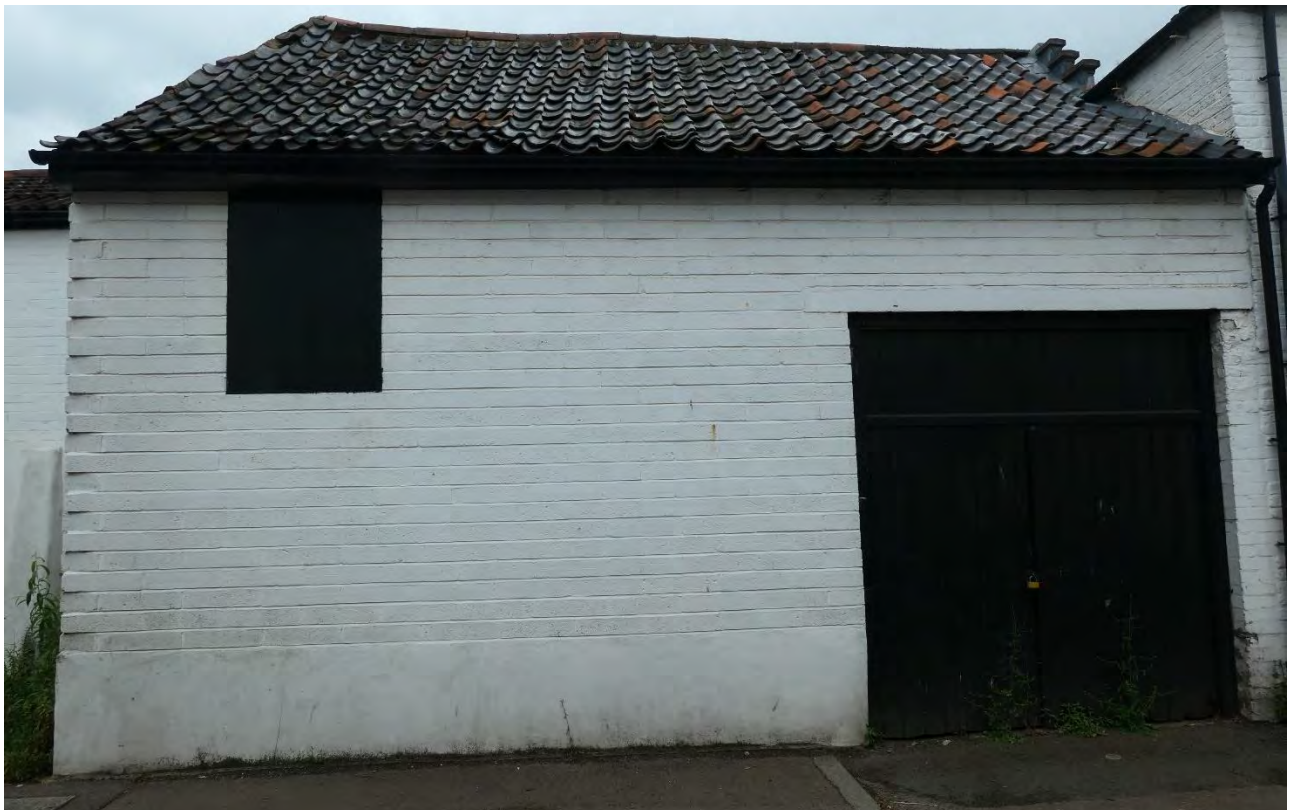
Photo 20: Almost all of what can be seen of the partially rebuilt mid-late C19 two storey extension from May Road is a modern reconstruction, executed to a rather poor standard, as evidenced in the brick 'toothing' at the southern corner.

2.44 As with the previous structure, the pantile roofs to the single east facing roofslope on May Road gives a veneer of age and texture, but what can be seen of this building is modern fabric of no great age or significance. The large garage doors again offers no meaningful interaction with the street.

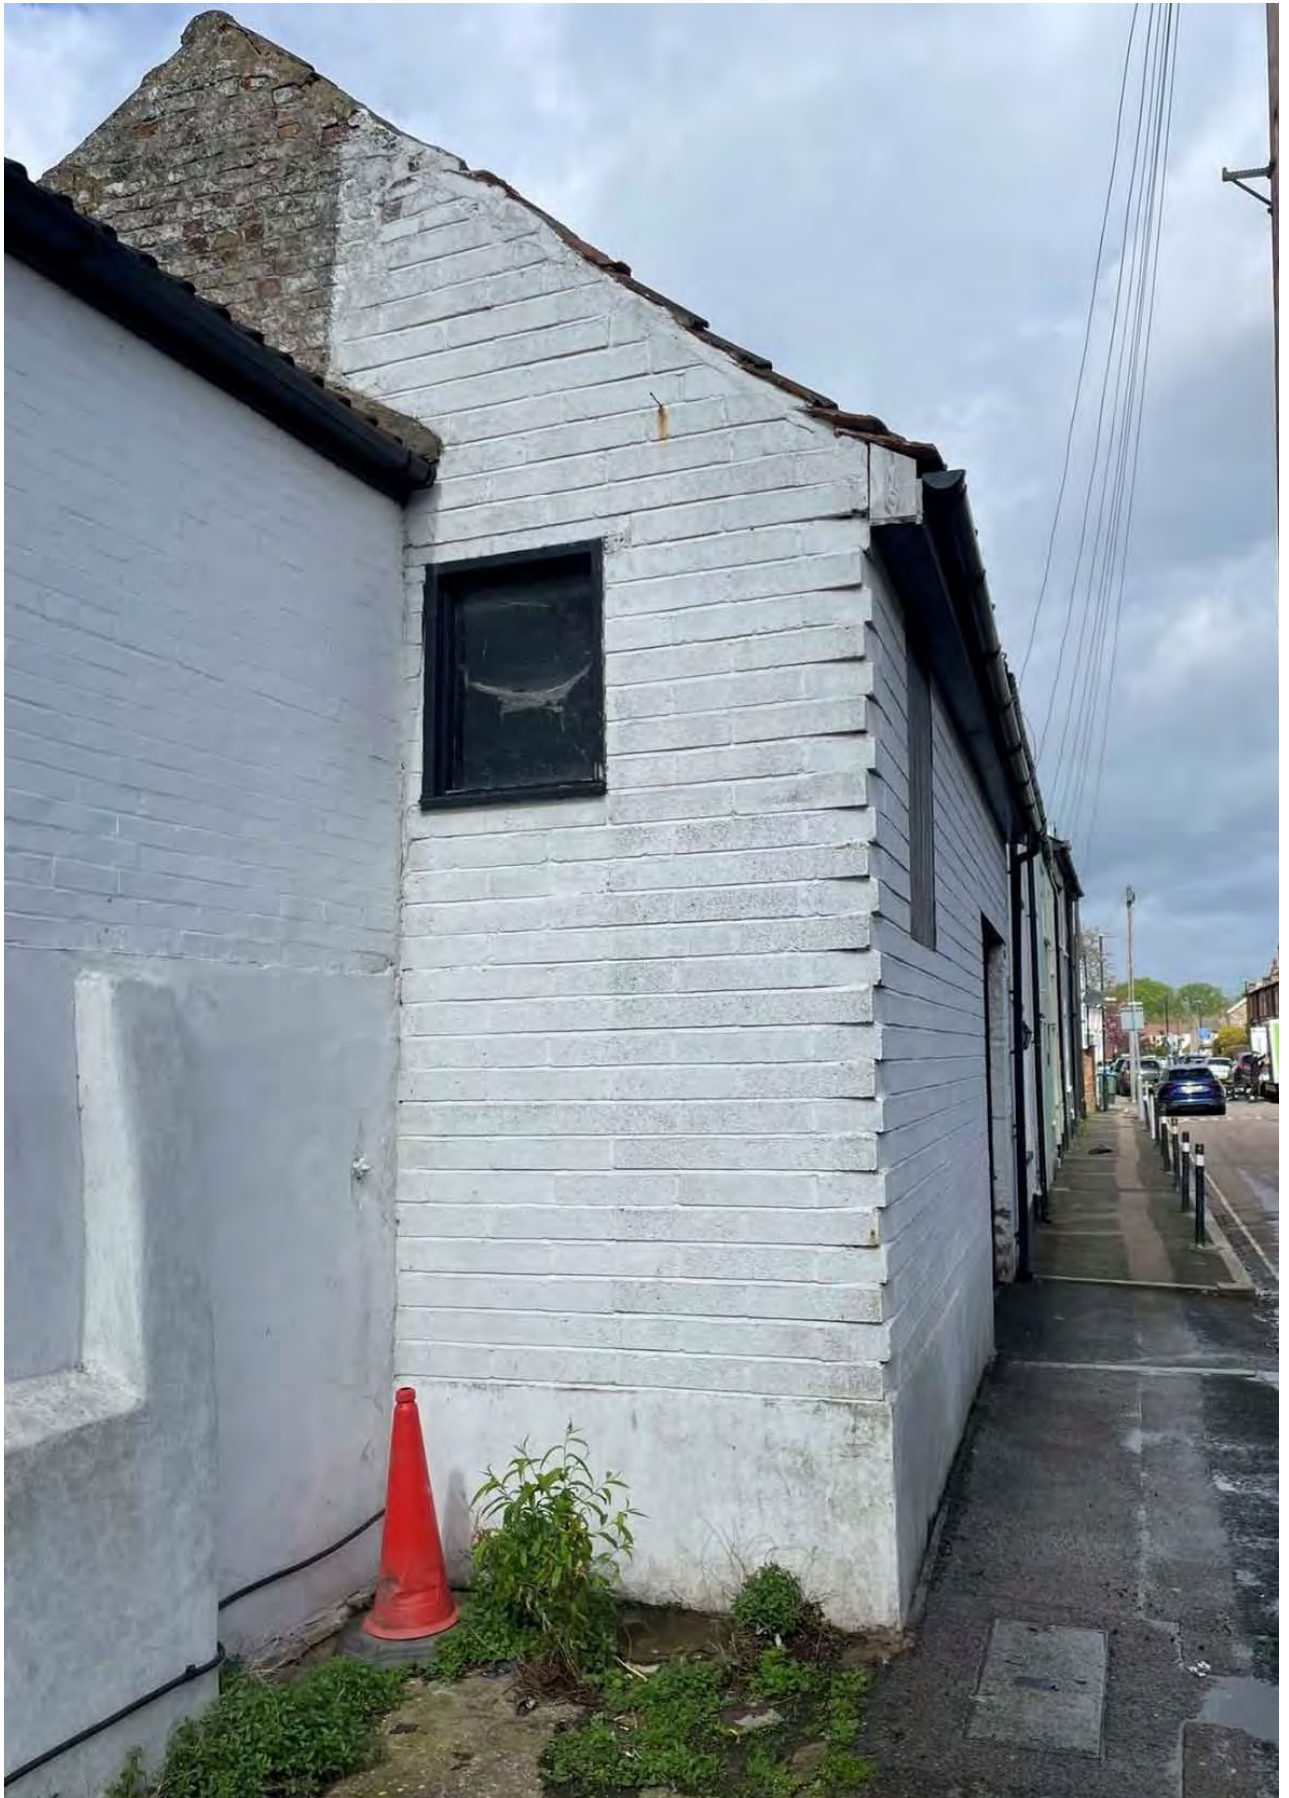
Photo 21: A small part of the southern gable that can be seen still contains the original brickwork.

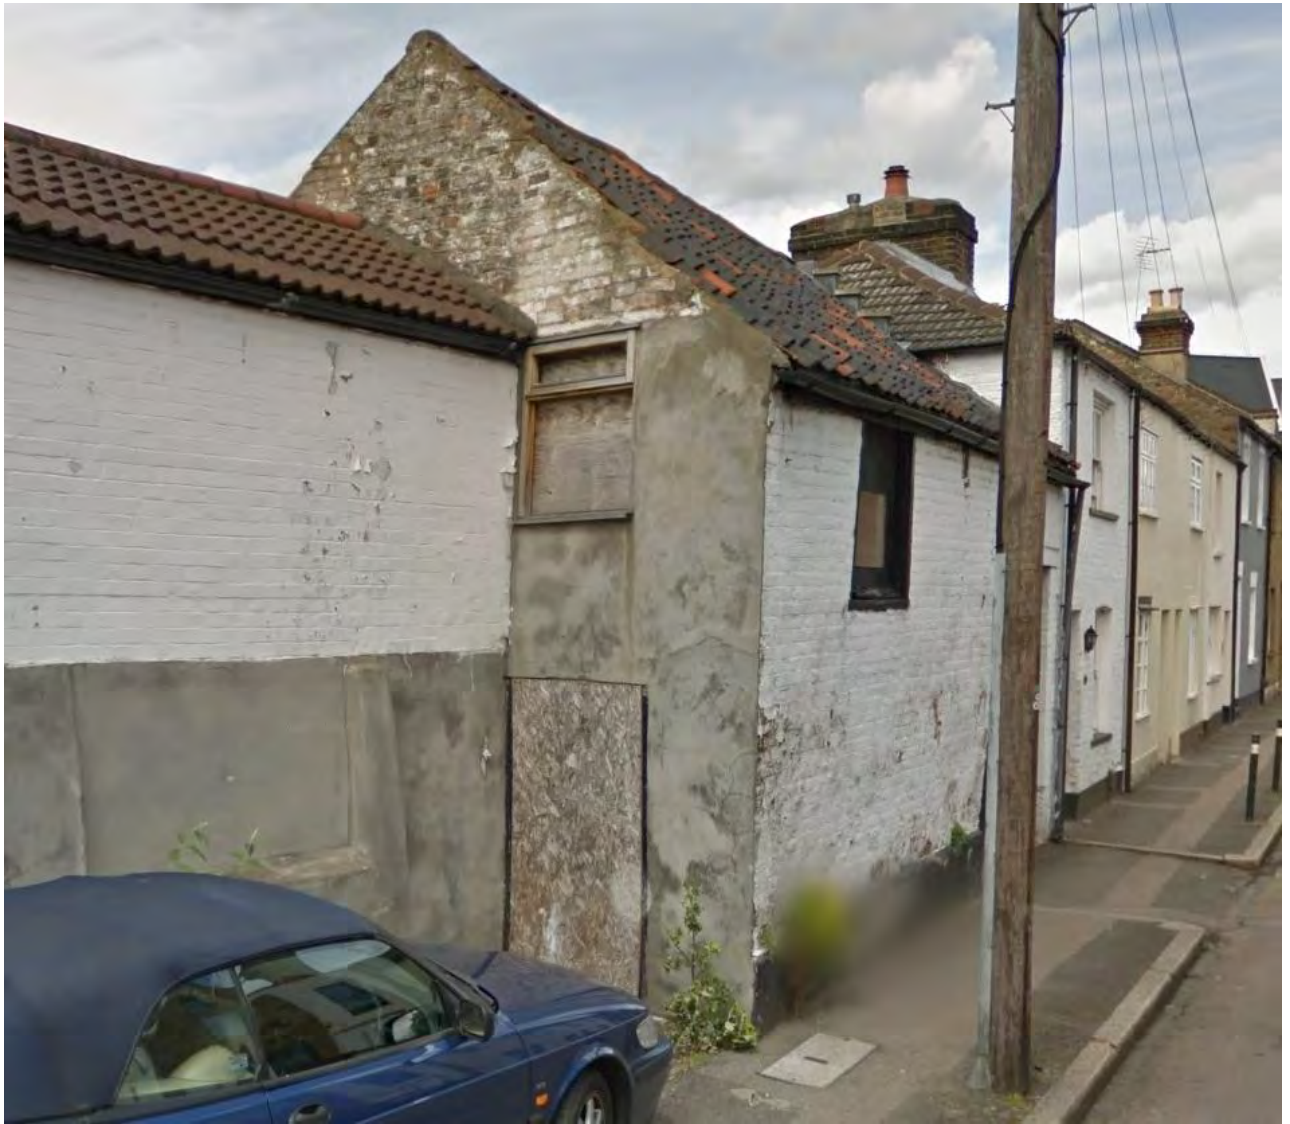
Fig 15: An extract of a Google 'streetview' image, taken in 2012 and showing the partially rebuilt mid-late C19 two storey extension before the May Road elevations were rebuilt. © Google maps

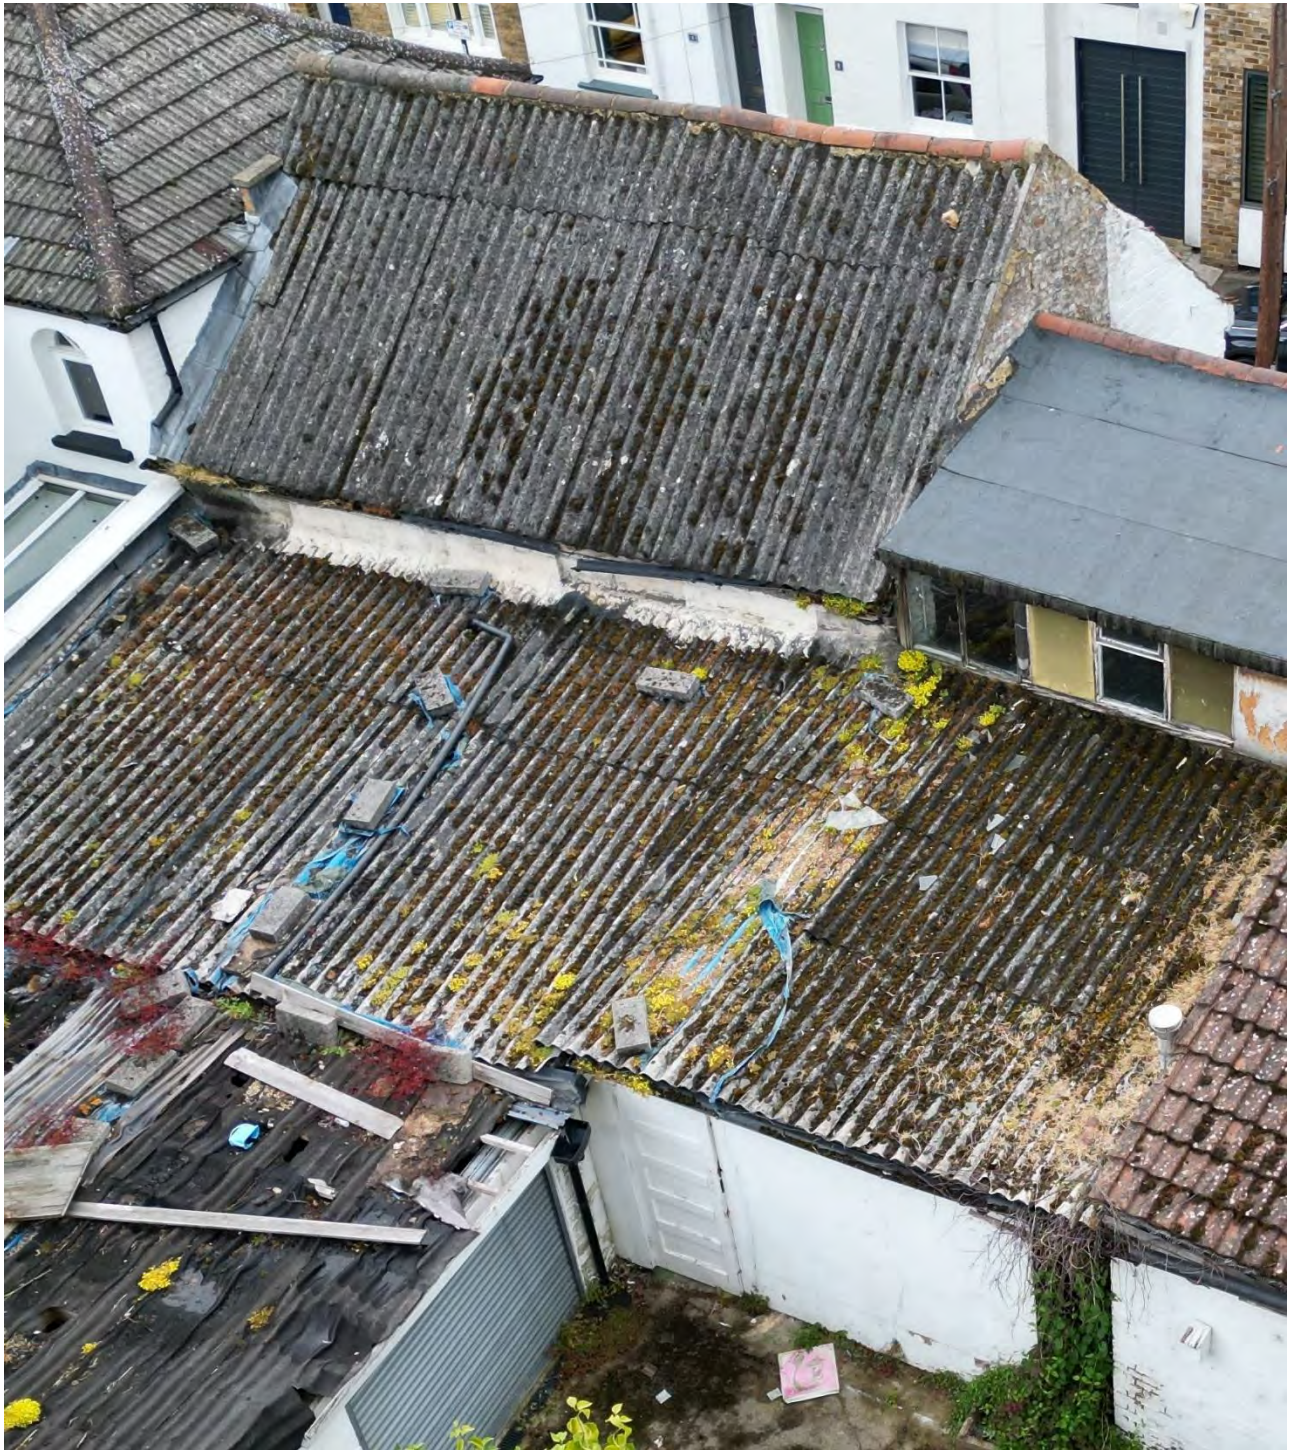
Photo 22: Almost all of what can be seen of the partially rebuilt mid-late C19 two storey extension from May Road is a modern reconstruction, executed to a rather poor standard, as evidenced in the brick 'toothing' at the southern corner.
