# Heritage Statement

## 64 The Green, Twickenham TW2 5AG

**Written by:** Ignus Froneman B Arch Stud ACIfA IHBC      **Date:** 02 Sept 2024  
**On behalf of:** Elstree Land Ltd      **Ref:** 0458

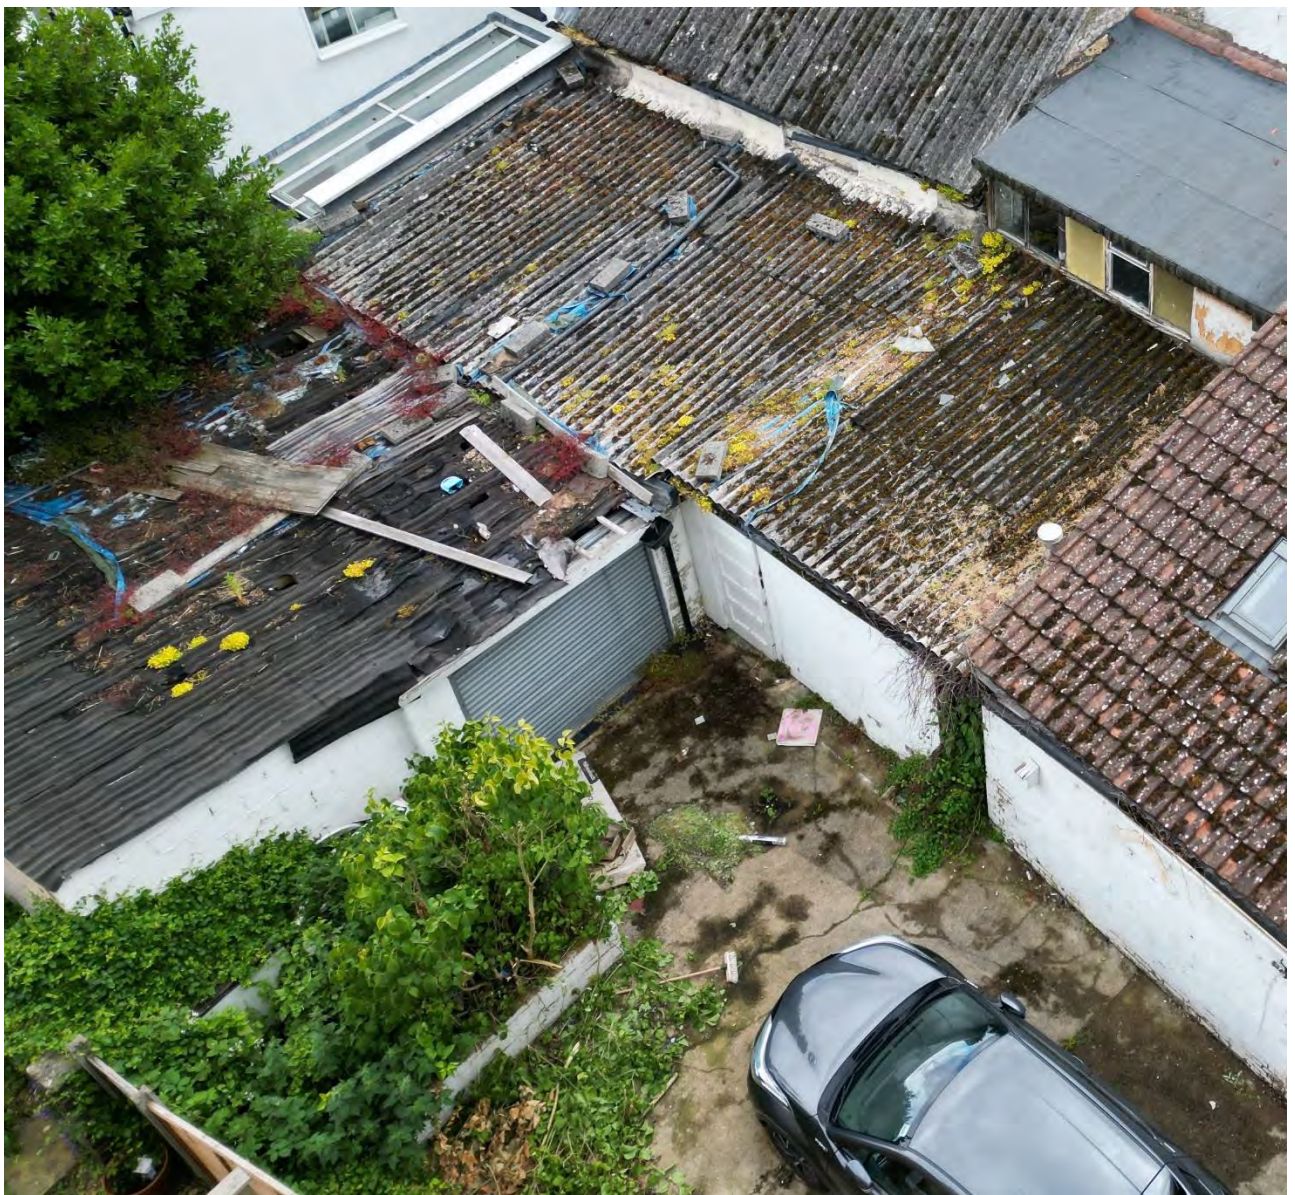
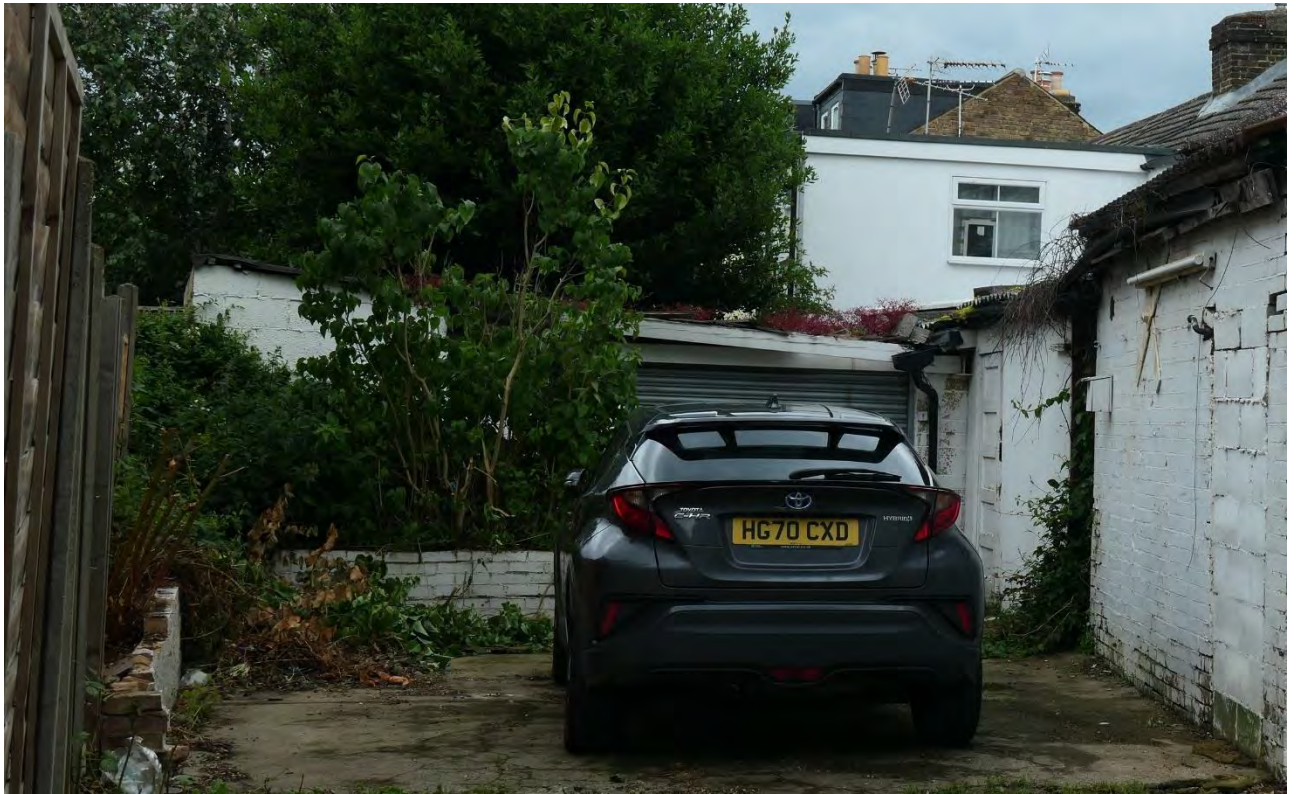
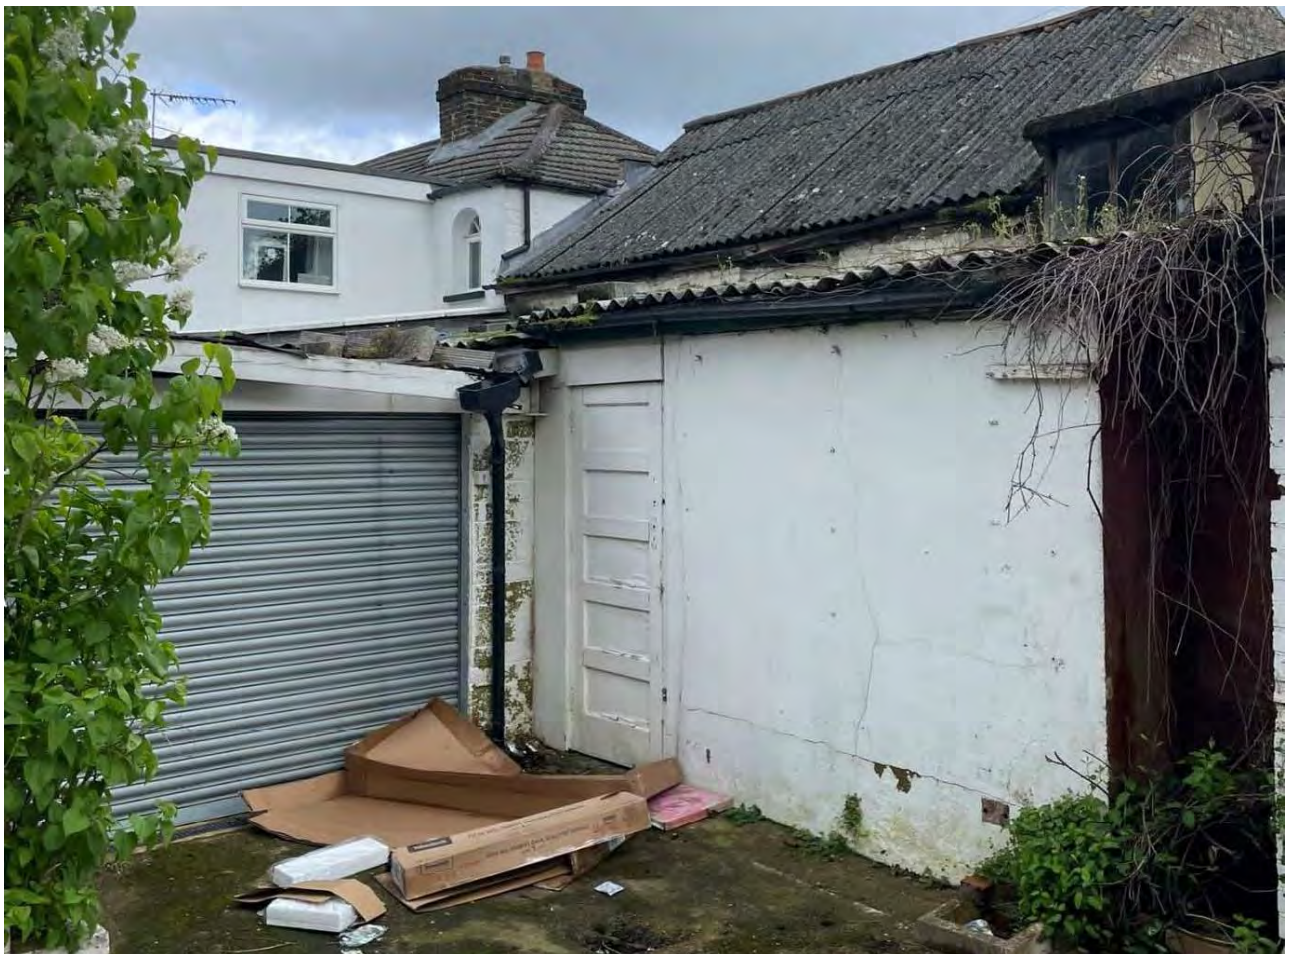
2.45 The Ordnance Survey maps show that by 1934 there were structures behind the May Road fronting buildings, but apparently in a different configuration. The present lean-to type structures appear to have been added after WWII, as can be seen from the **concrete 'breeze' block remnant walls internally**, and the steel channel roof members. The infill structure at the north is a much later, modern addition (in the past this structure encroached further south, but the southern part has since been removed).

2.46 These structures can be dealt with in short order. As can be seen from Photos 23-25 below, they are of a very poor quality and it would not be an overstatement to say that they make for something on an eyesore on the site, which markedly detracts from the character and appearance of the conservation area.

Photo 23: The modern 'workshops' behind the buildings on May Road and at the north of the application site.

Photo 24: The modern 'workshops' behind the buildings on May Road and at the north of the application site.

Photo 25: The modern 'workshops' behind the buildings on May Road and at the north of the application site.

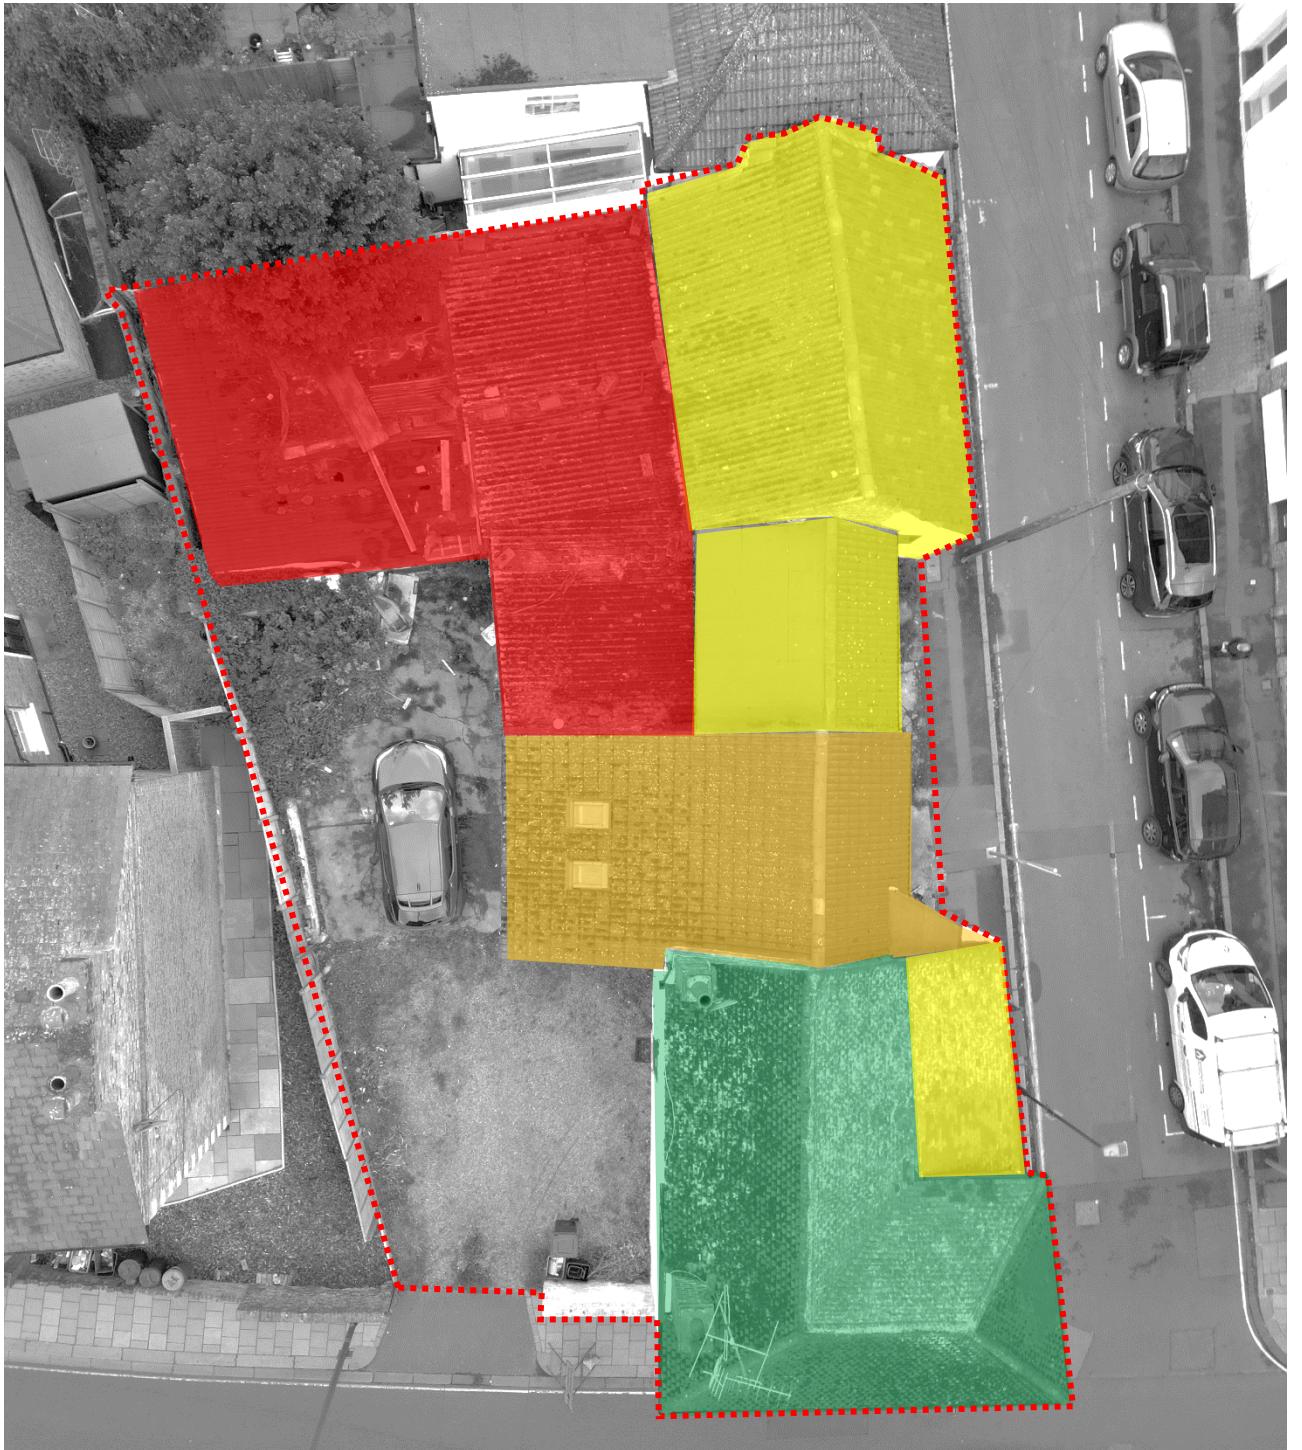
Photo 26: An annotated vertical aerial photo of the application site with the contribution of the various components on the site shown in different colours: green – positive contributor; orange – neutral contributor; yellow – neutral contributor with detracting elements; red – detractor.

2.47 In conclusion, the contribution of the various components on the site is visually summarised on Photo 26 below.

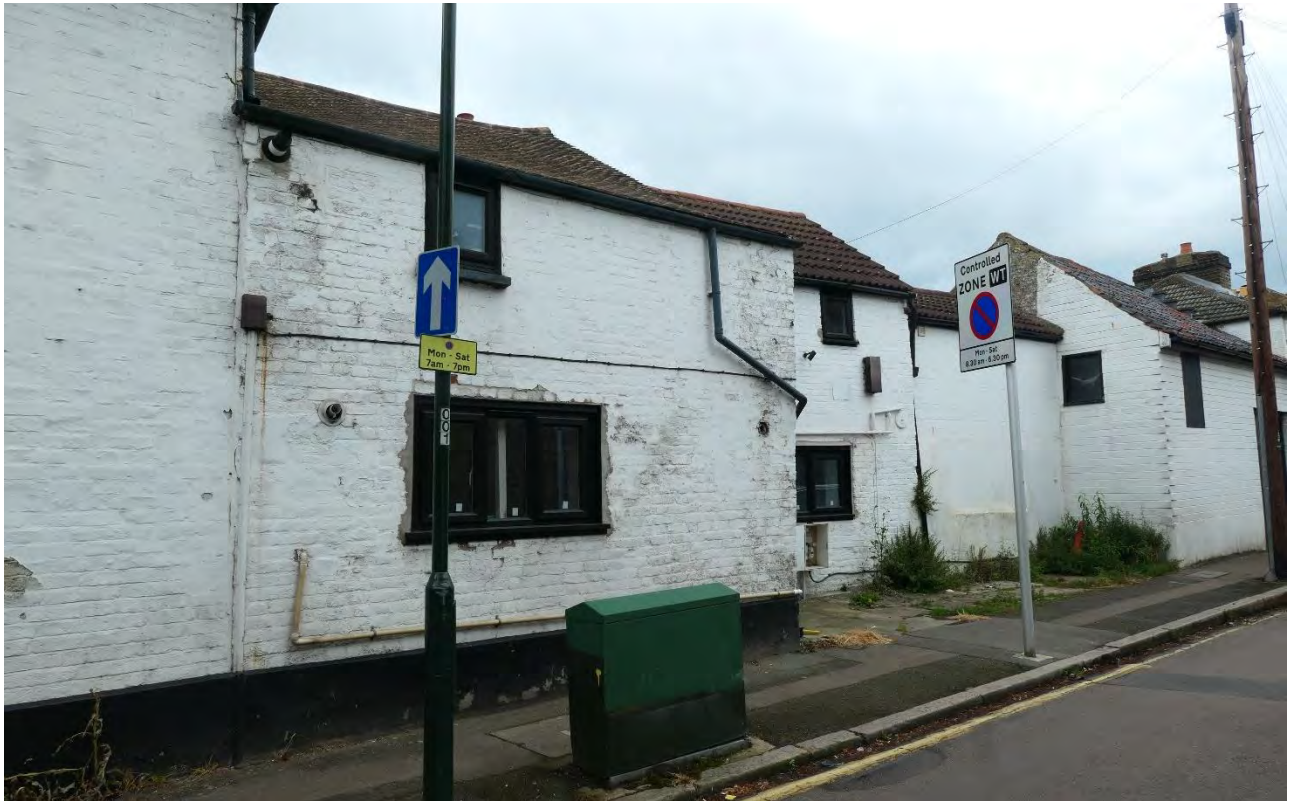
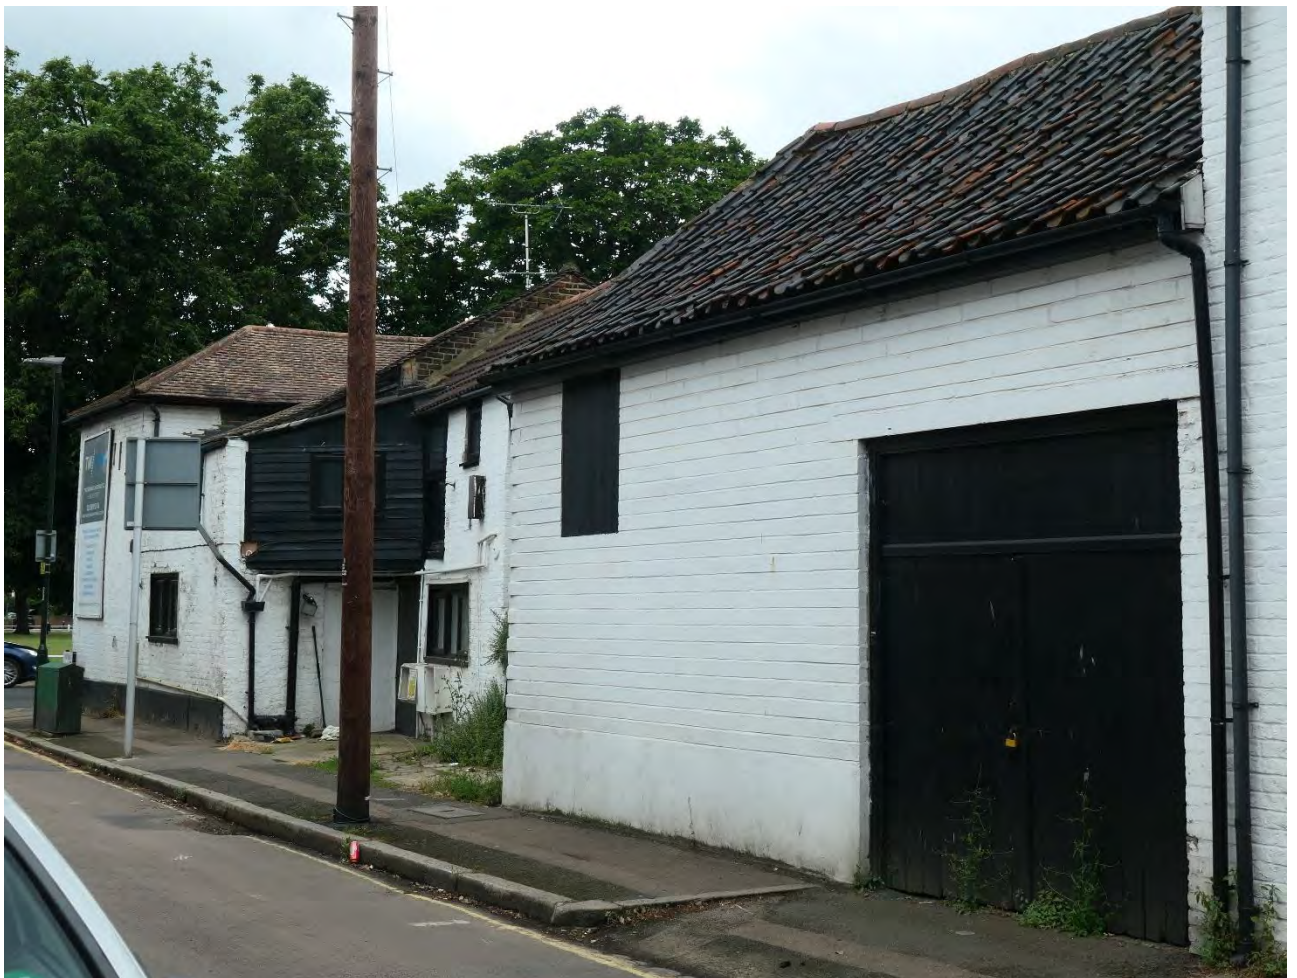
- 2.53 Nevertheless, in the area where there is an overlap between historic interest and townscape, it can be said that the northern buildings on May Road have some character in their fine grain and piecemeal/ad hoc appearance (Photos 27 & 28). The pantile roofs, the variations in height and width, and the stepped building line have much to do with this, along with the occasional glimpse of older fabric in a gable, and the little weatherboard link at the back of the corner building. That said, none of the buildings can lay claim to any notable quality or intactness. Their attraction lies in mainly in the visual interest that the juxtaposition of different forms and roofs provide.

Photo 27: The northern buildings on May Road have some character in their fine grain and piecemeal/ad hoc appearance.

Photo 28: The northern buildings on May Road have some character in their fine grain and piecemeal/ad hoc appearance.

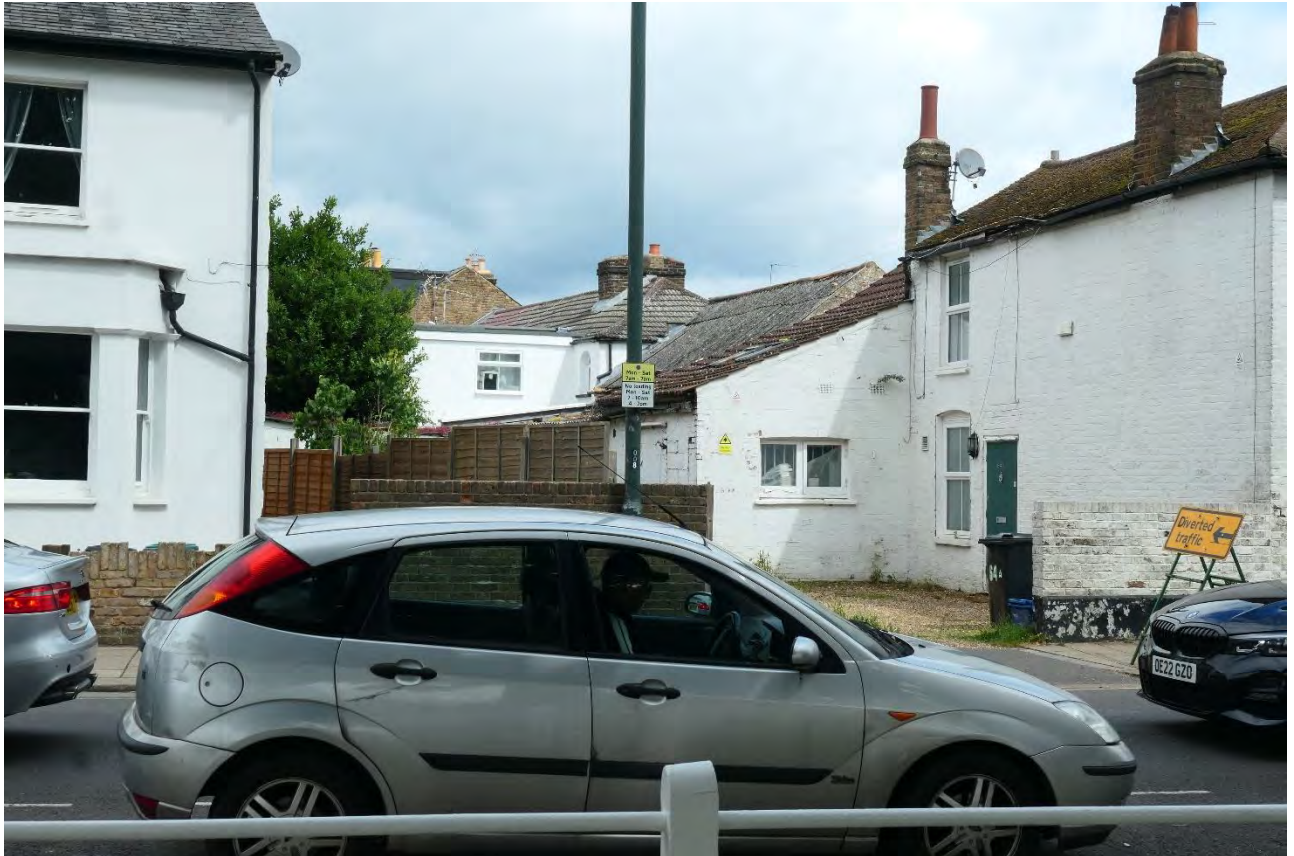
2.54 It is difficult to conclude that what can be seen of the rear of these buildings, collectively, makes any meaningful contribution to the conservation area (Photo 29). Aside from the pantile catslide roof, the corrugated asbestos roofslopes (and at some angles the section of modified felt covered rear roofslope) is the most visible manifestation of these buildings. There is nothing remarkable or notable about this, and it is not of importance, either from a historic interest, or townscape, perspective.

Photo 29: The rear of the northern buildings on May Road, seen from the SW.

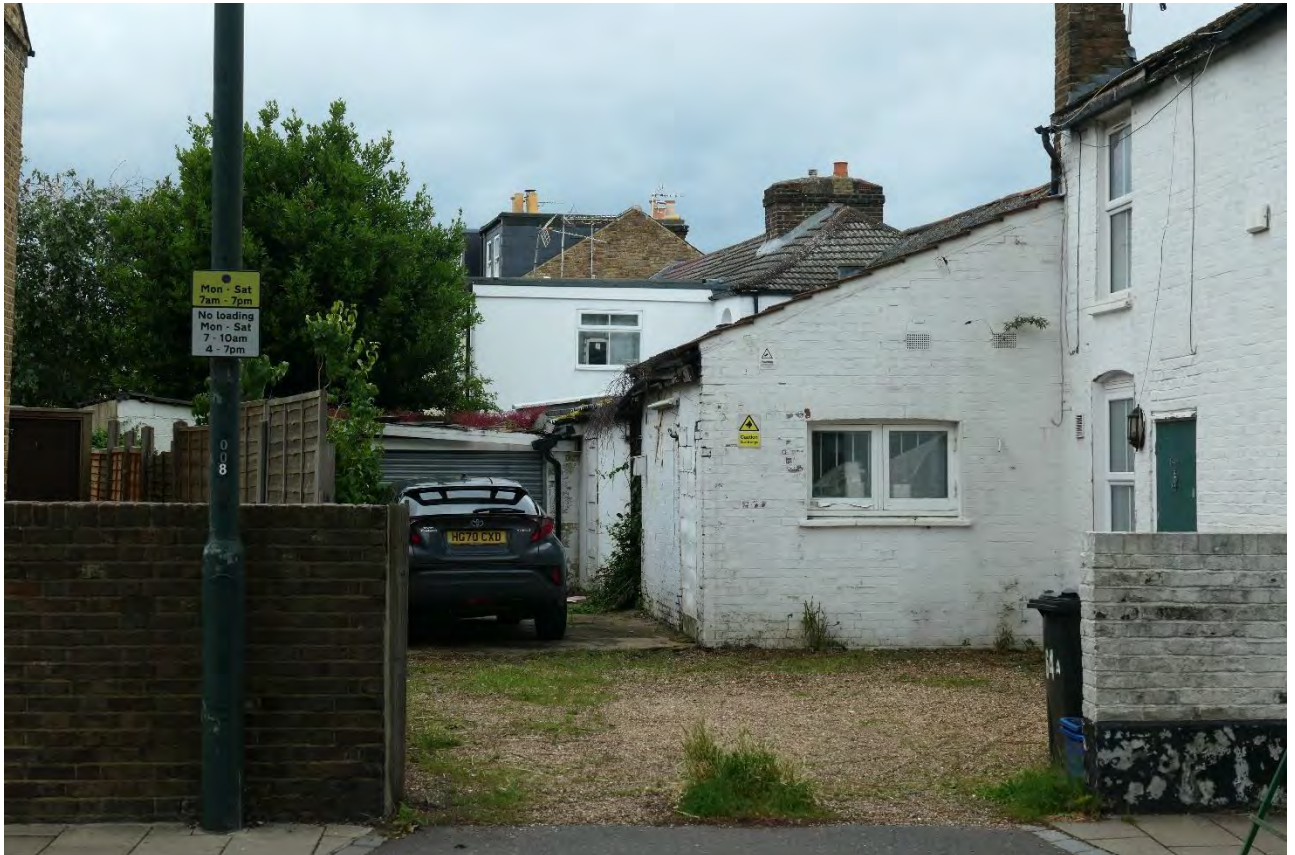
Photo 30: At the front of the application site on The Green, is a vehicular opening giving onto a gravel area where two cars can be parked side-by-side.

2.56 The car parking and lack of enclosure at the front of the application site on The Green obviously detracts from both the BTM and the conservation area; the gap here is uncharacteristic of the tightly packed development along the north of The Green and there is evidently scope for improvement here. It can also be noted that the views beyond is of the bulky rear extensions and dormers to the houses on May Road to the north, and it is not a view that can be said to reveal anything positive.

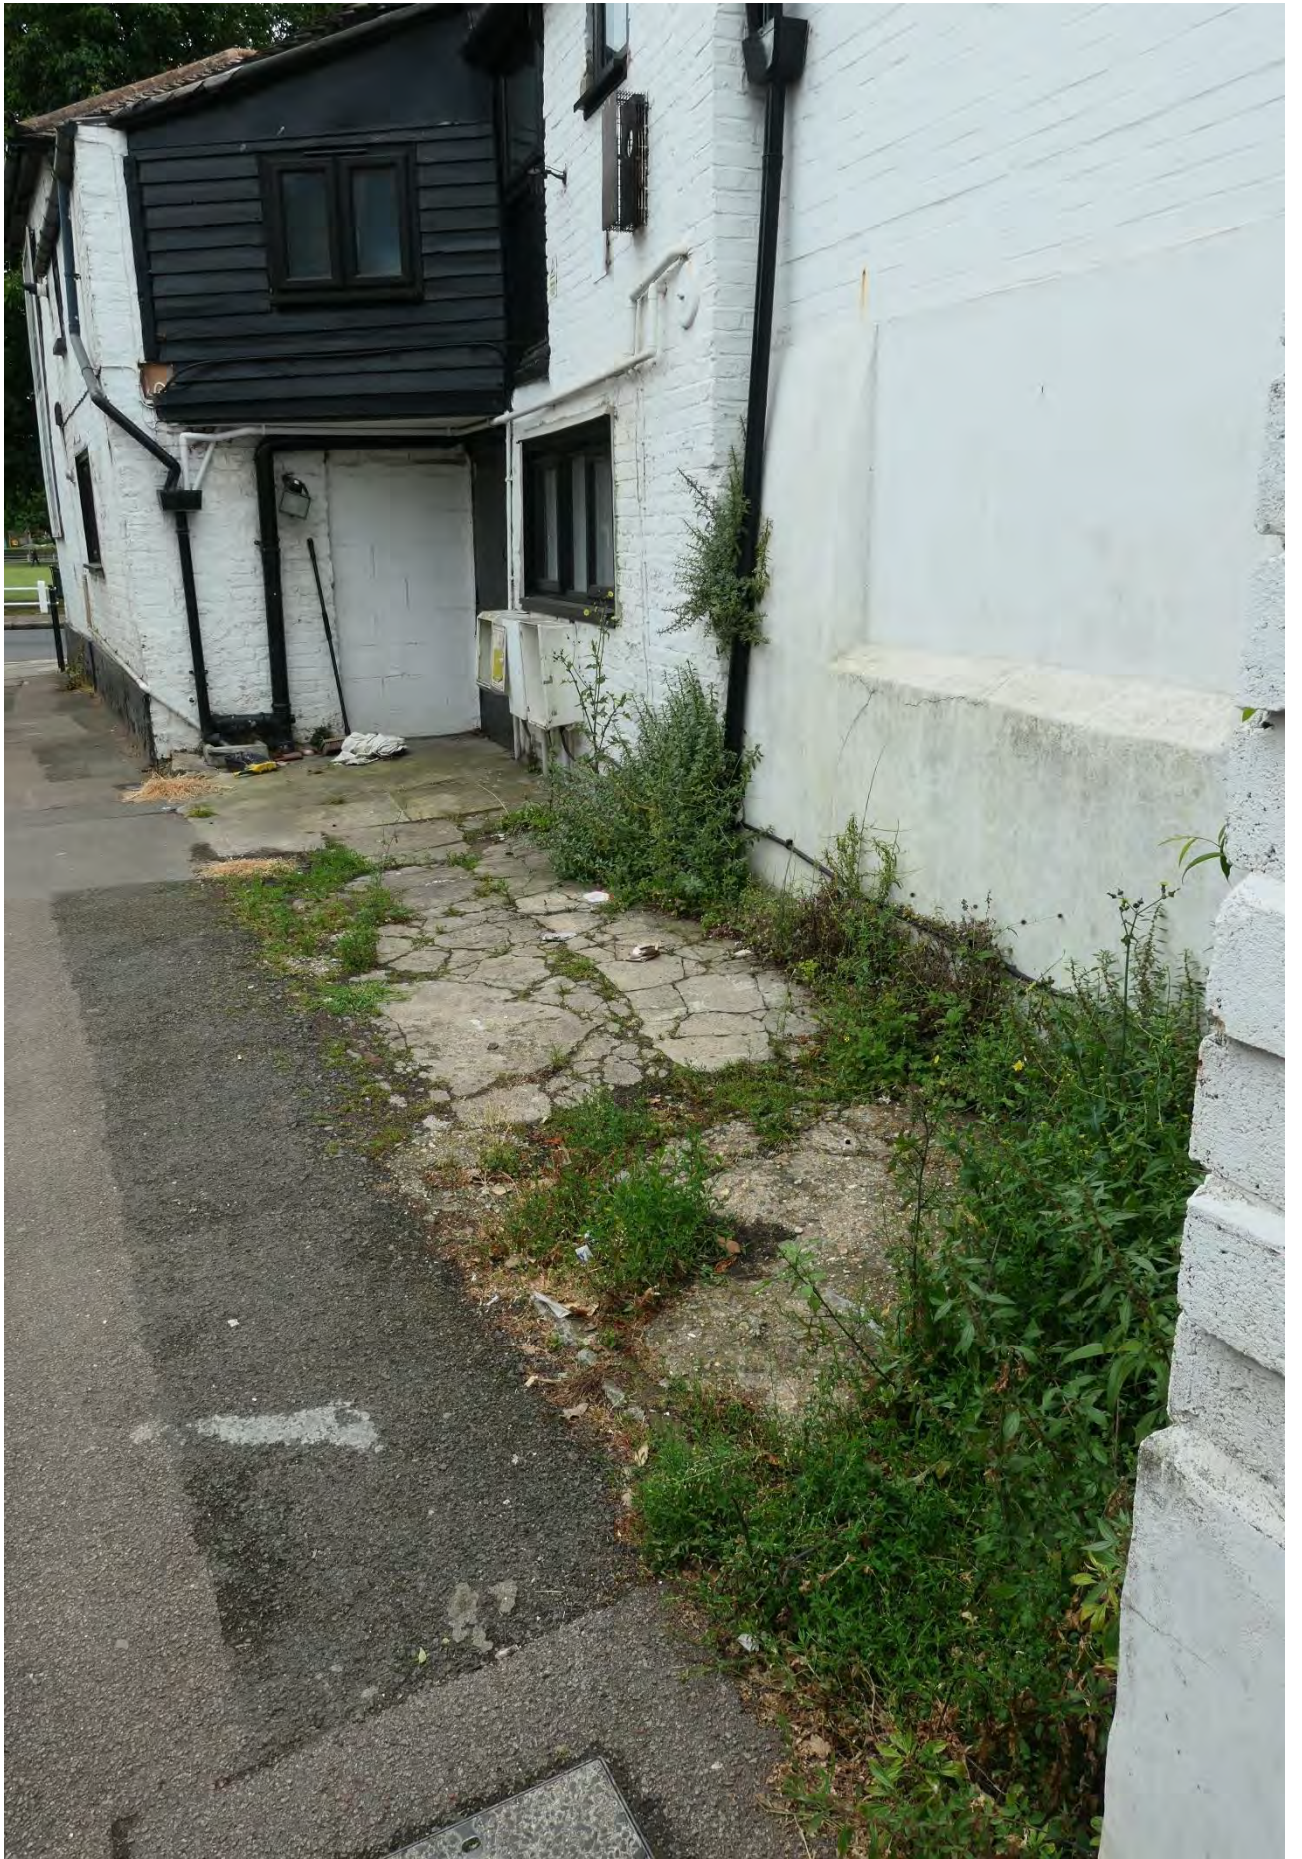
Photo 30: The little setback area on May Road is something of an eyesore.

- 3.13 The characterful elevation of this structure on May Road, including the weatherboarded first floor link, would not be altered.
- 3.14 The poor quality little inset area at ground level, with a cracked concrete surface that has for many years been used as a car parking space, would become a small garden, as it was in the past. This would enhance the conservation area.
- 3.15 The deep, pantile roof rear catslide of the building would be redeveloped, but this is a largely hidden part of the building and the rear elevation is of no quality or interest (the proposed side extension would obscure this area from view, in any event).

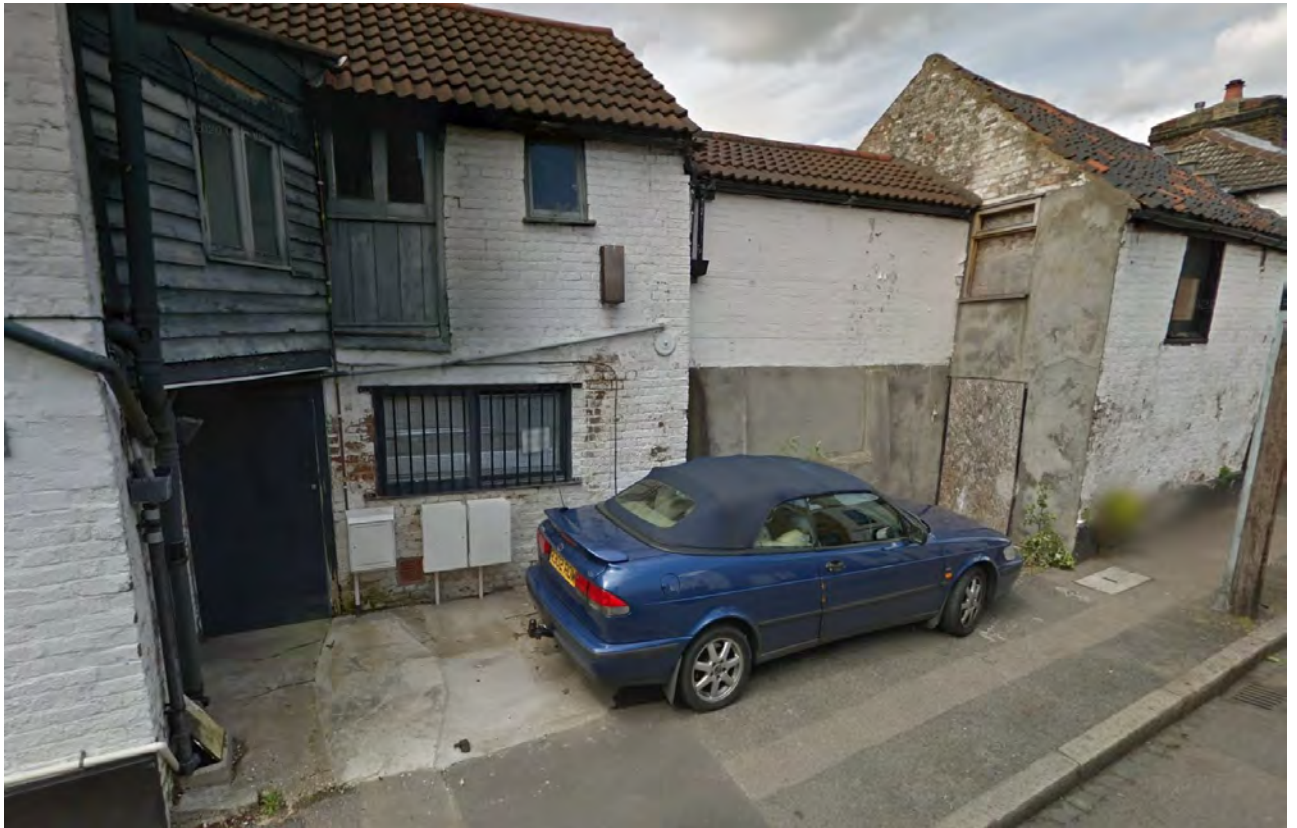
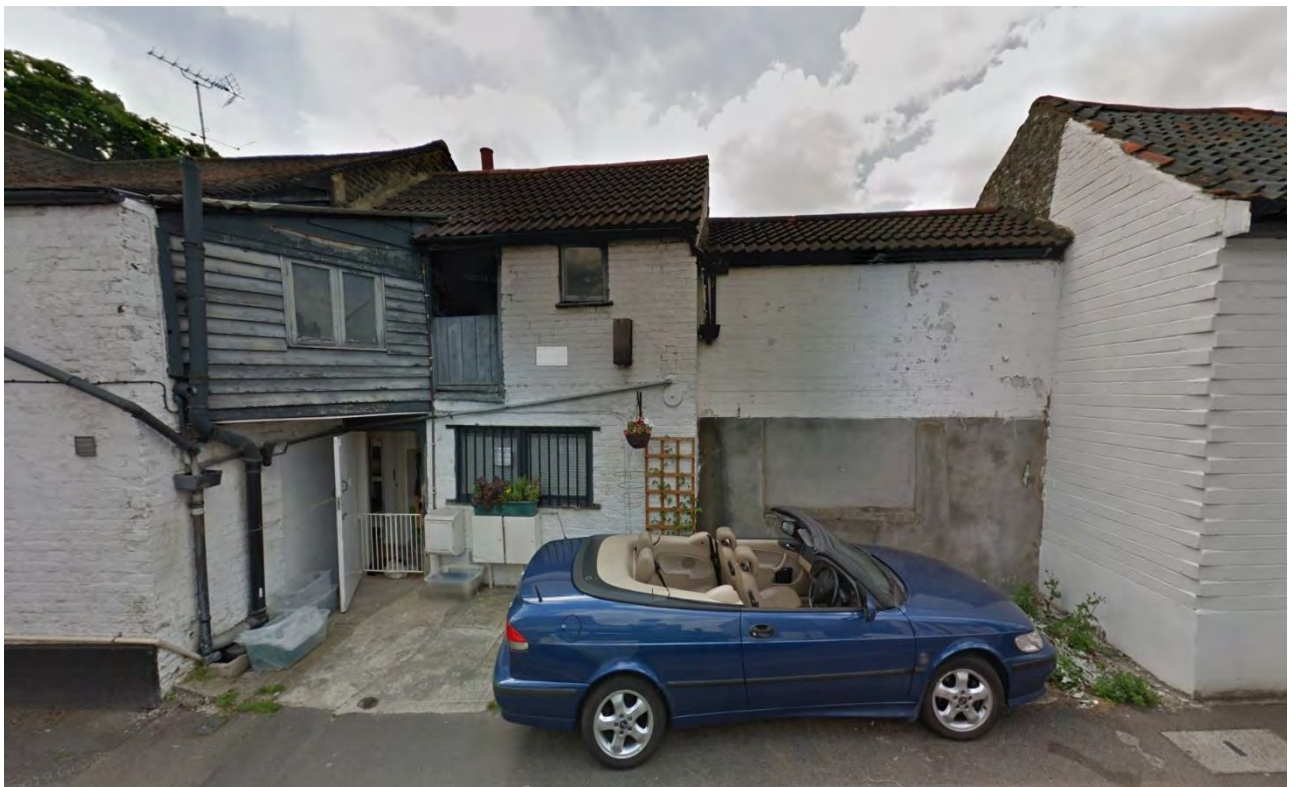
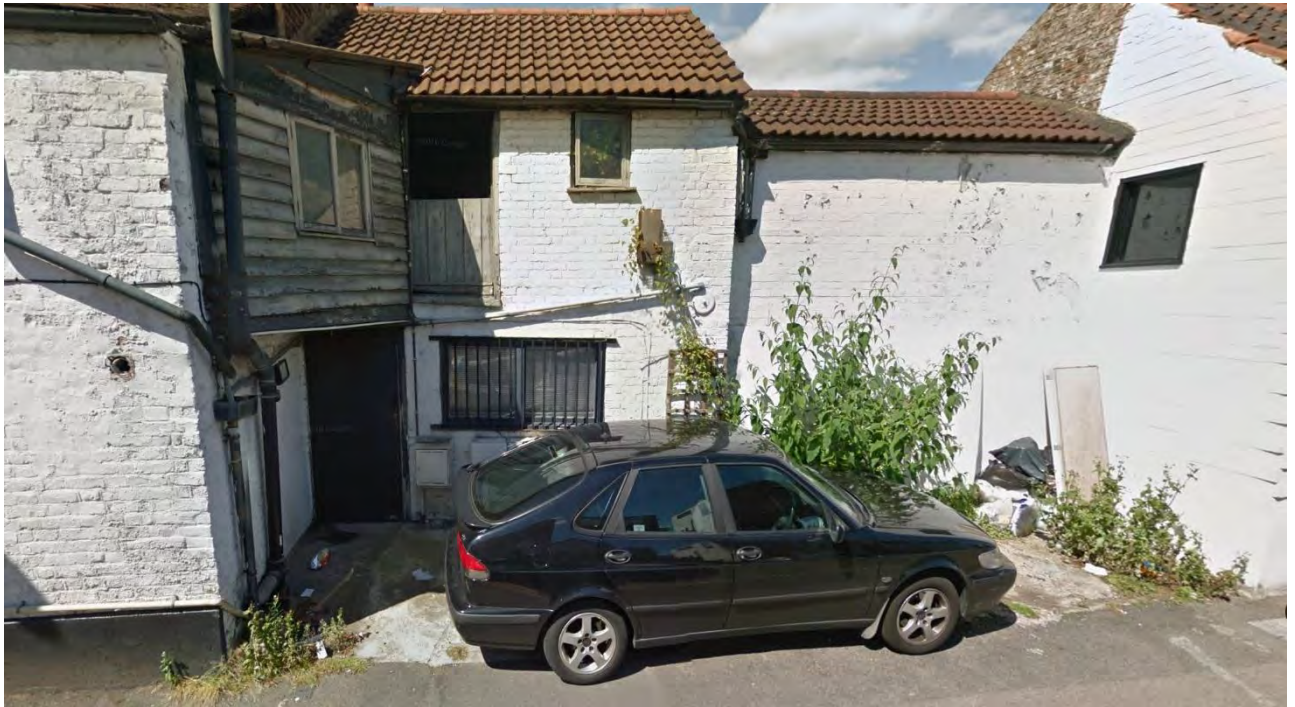
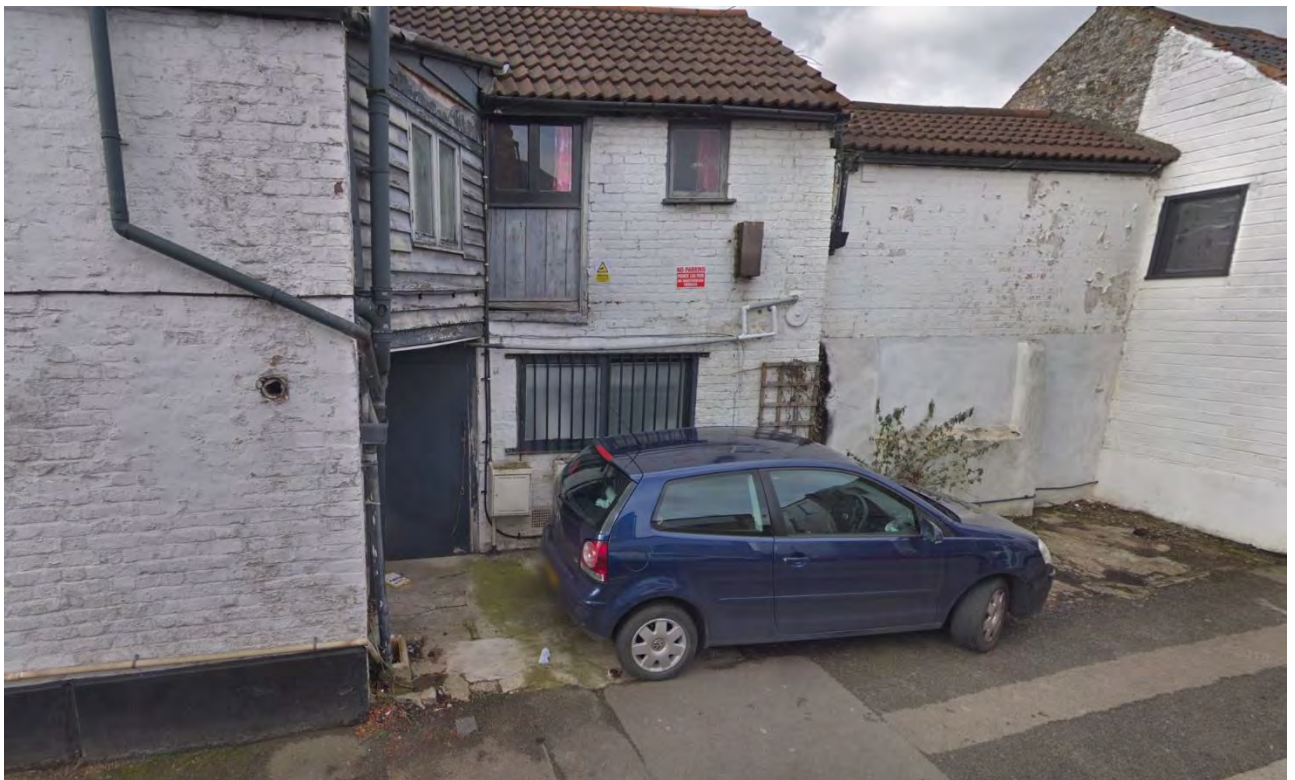
Fig 16: An extract of a Google 'streetview' image, taken in 2012 and showing a car parked on the setback area on May Road. © Google maps

Fig 17: An extract of a Google 'streetview' image, taken in 2014 and showing a car parked on the setback area on May Road. © Google maps

Fig 18: An extract of a Google 'streetview' image, taken in 2016 and showing a car parked on the setback area on May Road. © Google maps

Fig 19: An extract of a Google 'streetview' image, taken in 2018 and showing a car parked on the setback area on May Road. © Google maps

- 3.11 The unsightly car parking would be replaced with a front garden area, which would be an obvious improvement.
- 3.12 This part of the proposed development would enhance the character, appearance and significance of the conservation area and preserve the significance of the BTM.
