BS 5837:2012 Tree Survey, Arboricultural Impact Assessment, Method Statement & Tree Protection Plan

19 Church Road
Barnes
SW13 9RE

14th February 2024

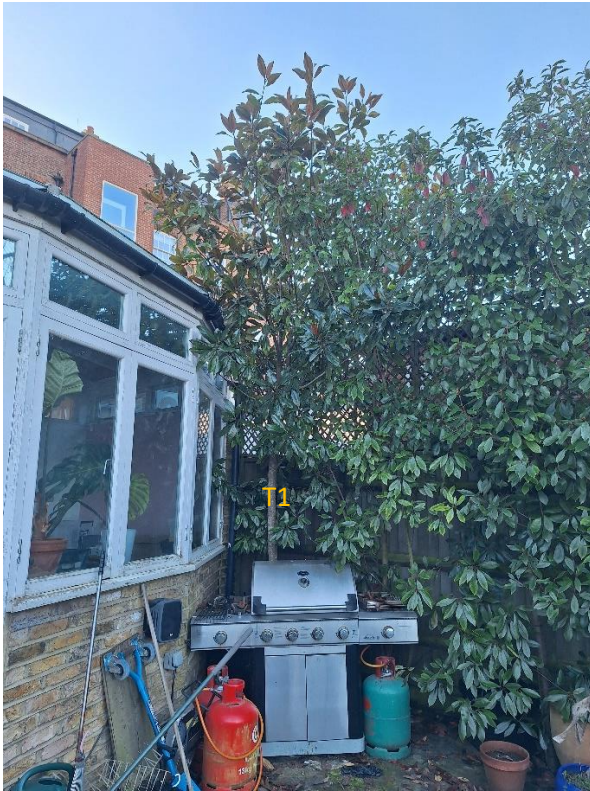
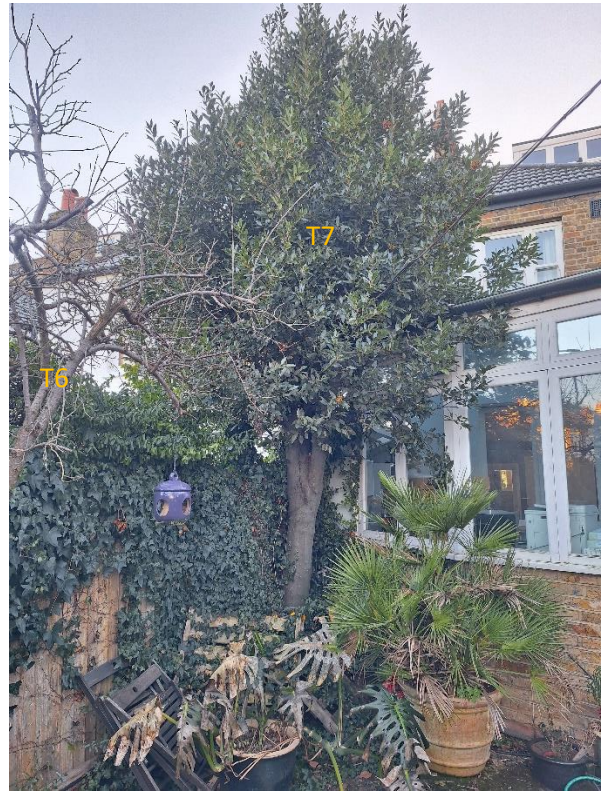
T1 Evergreen Magnolia & T7 Bay.

Photos above showing T1 category C Magnolia and T7 category C Bay tree, both growing directly next to the existing conservatory. The trees will need to be removed in order to facilitate the erection of the rear extension.

T1 Magnolia- Requires removal in order to demolish the existing and erect a new extension.

T7 Bay tree- Requires removal in order to demolish the existing and erect a new extension.

A further 2 small trees may be planted in the rear garden in order to mitigate the loss of **T1** and **T7**.

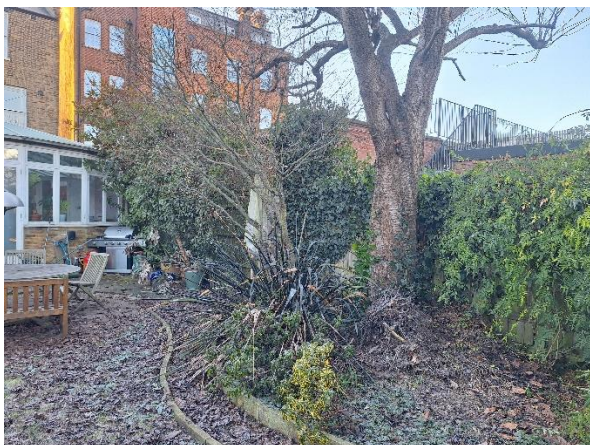
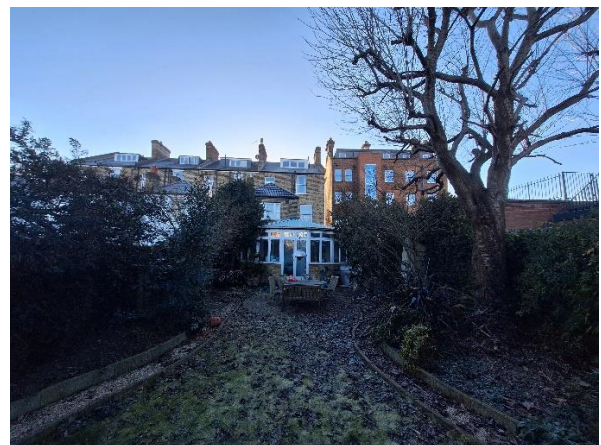
T6 Cherry

Photos above of T6, category B Cherry, subject to recent crown reduction. A small portion of the root protection area of T6 may be exposed during the removal of existing paving and installation of decking.

A combination of tree protective fencing and ground protection will ensure that the majority of the RPAs of **T3** and **T6** are adequately protected throughout all stages of demolition and construction.

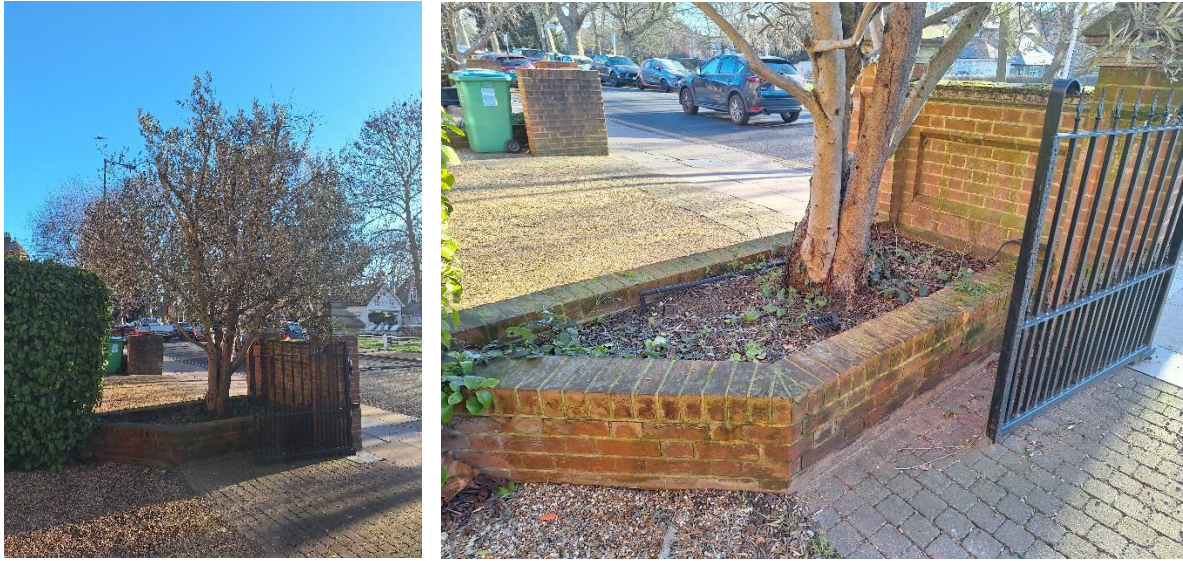
Photos above of T8, category C Olive growing within the confines of a raised planter. The tree makes an attractive contribution to the site's frontage and will be retained within the proposed development.

T8 Olive grows within a raised planter in the front garden. Below ground, the RPA of **T8** will be safely protected due to its containment within the existing and retained planter, however, the stem, branches and immediate soil area within the planter will be protected with carefully erected plywood hoarding to avoid inadvertent construction damage.

- Plywood hoarding will be erected to avoid inadvertent damage to **T8 Olive** as suggested below.

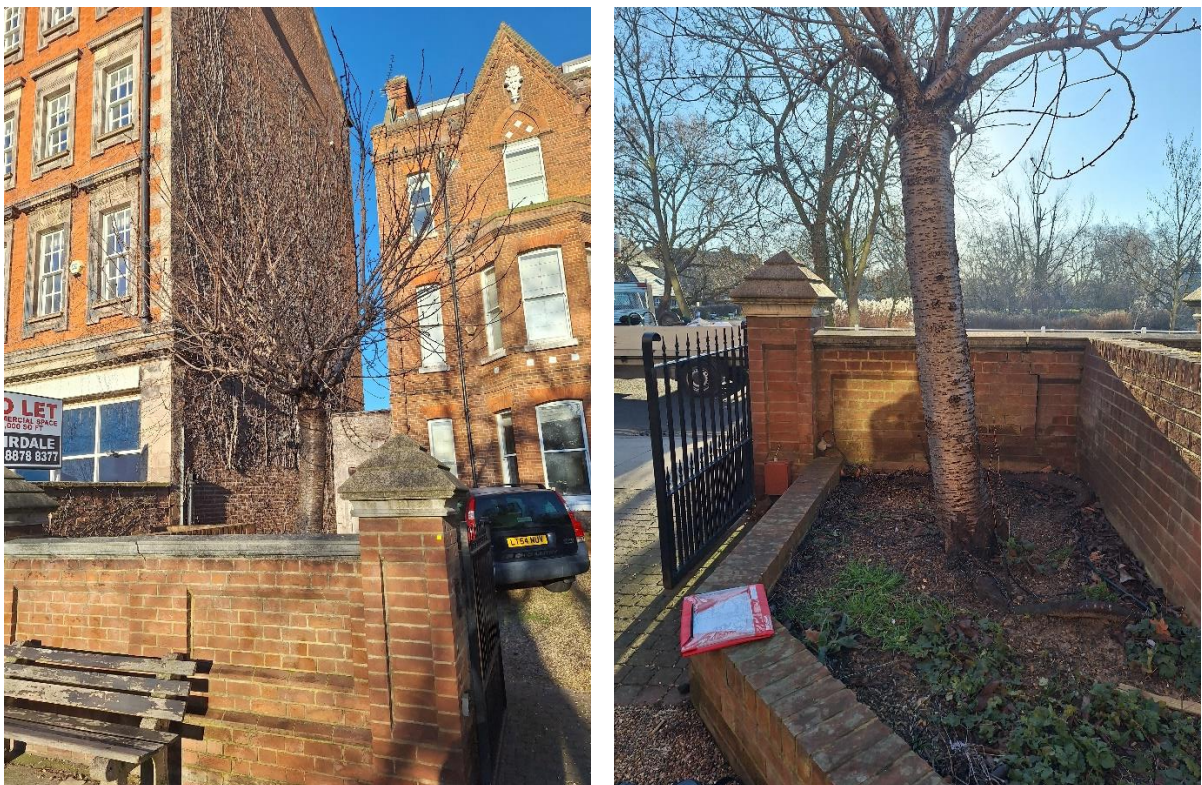
T9 Cherry

Photos above of T9, a category C top and bottom grafted Cherry, the remaining tree from a previously protected group of 3 Cherry trees. The proposal requires the removal and replacement of T9 in order to widen the driveway entrance.

T9 Cherry- Requires removal in order to remove the existing planter and widen driveway entrance. The planter will be reconstructed as part of the proposed works and a replacement tree planted with a minimum stem girth of 10-12cm, Select-standard size.

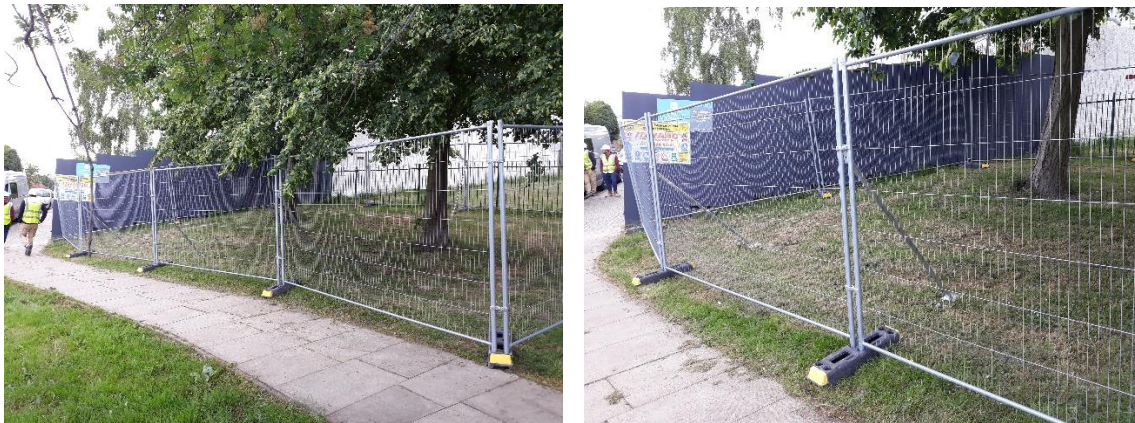
Images above show protective fencing installed as per BS5837:Fig 3A with rubber feet and stabilizer struts.

- Erect protective barrier fencing in locations shown on the tree protection plan at **appendix 4**. Tree protection positions will have already been marked out by the project arboriculturalist during phase 1. A protective fencing diagram can be found at **appendix 5**. Barriers will consist of a heras type panel inserted into rubber 'elephants feet' and reinforced with a stabiliser strut. Two clamps either end of each section will ensure the area within the fence (CEZ) remains out of bounds during demolition activities. Tree protective fencing will be partially relocated prior to construction.

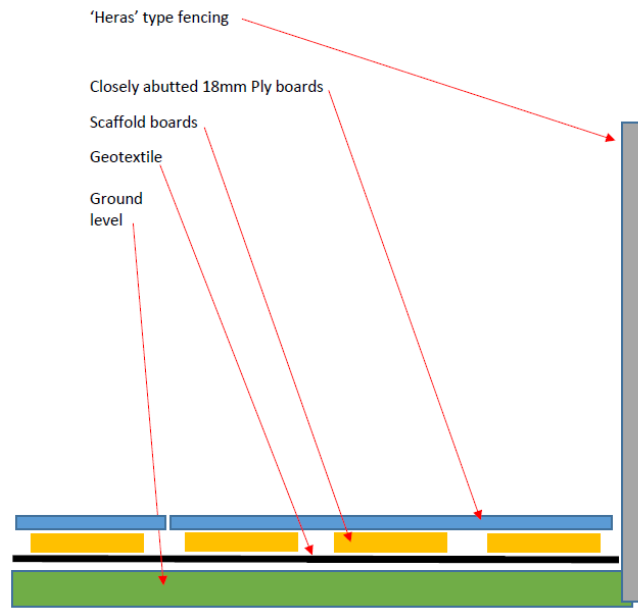
Diagram showing Ply boards set upon scaffold boards to reduce compaction

Figure 1 above showing an alternative method for ground protection where construction is less intense.

- The above system will be installed following demolition of the existing rear extension. The ground protection will replace the existing patio until construction is complete.

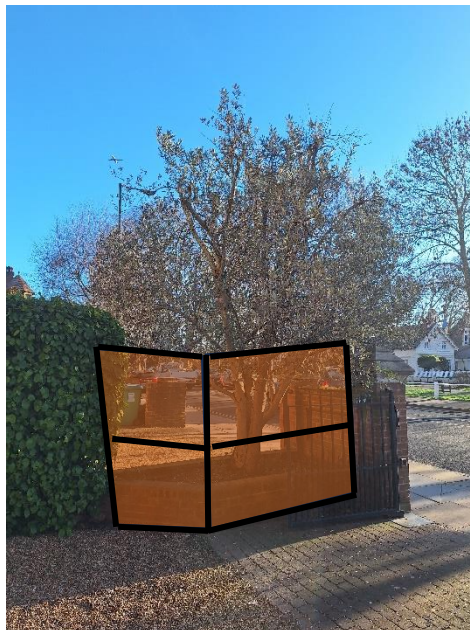
Image above showing braced plywood hoarding around T8 and associated planter.
