Phase I and II Geo-Environmental Site Investigation Report RBG Kew Learning Centre Royal Botanical Gardens Kew

Issue Number 01 7th April 2022

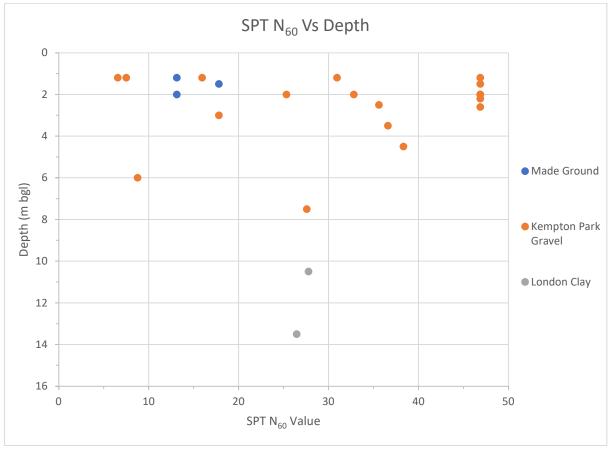
Figure 2 – SPT N₆₀ against Depth (m bgl)

Uncorrected N values and corrected N60 values within sub-surface strata were recorded between 7 and >50 blows, whilst corrected values ranged from 7 to 47. Corrected values are summarised in the graph below:

The results of the SPTs indicate locally loose but generally medium dense to very dense sands and gravels, over stiff clays.

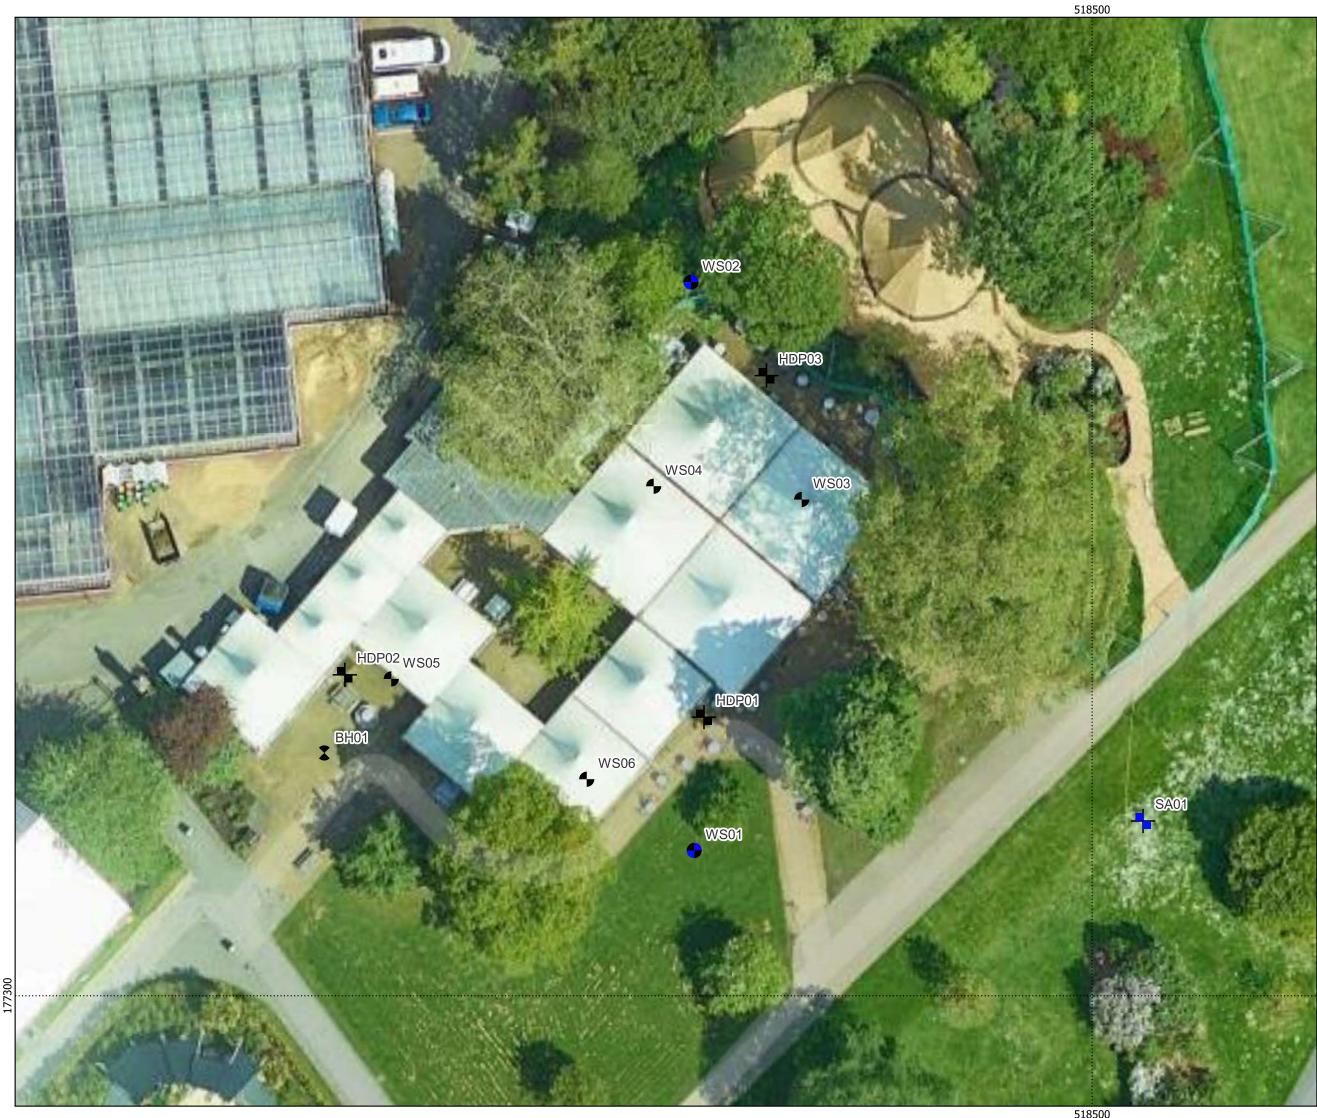
PEV-SK-C-0002 – Exploratory Hole Location Plan

- Hand Dug Trial Pit
- Soakaway Test
- Window Sample Location (with Falling Head Test)
- Window Sample Location
- Cable Percussion Borehole
