Bat Survey Report

Avenue Lodge

**51 Ham Common
Ham
Richmond
TW10 7JG**

**23-234
July 2024**

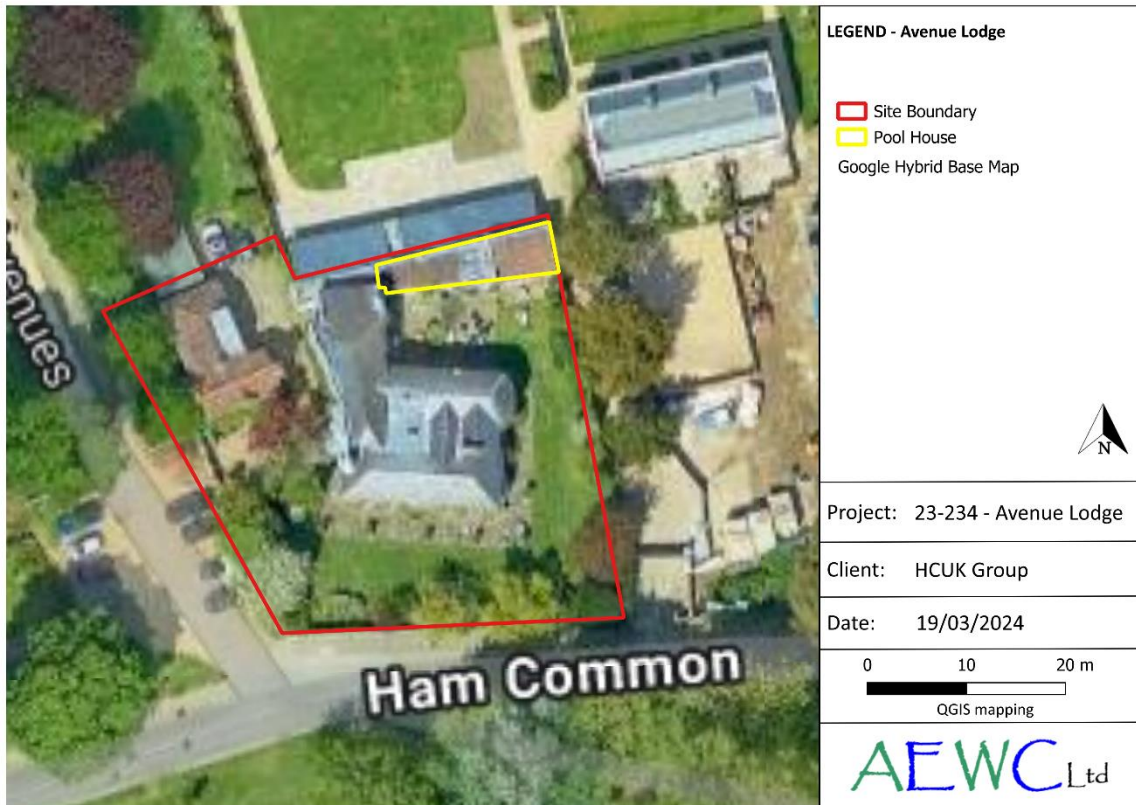
1.9 There are three buildings present on site: a large, detached house, a small pool house adjoining to the north and a detached cottage. Only the pool house is subject to proposals under this planning application and is the only building covered within this report. See Figure 2.

FIGURE 2: SHOWING THE BUILDING SUBJECT TO SURVEY.

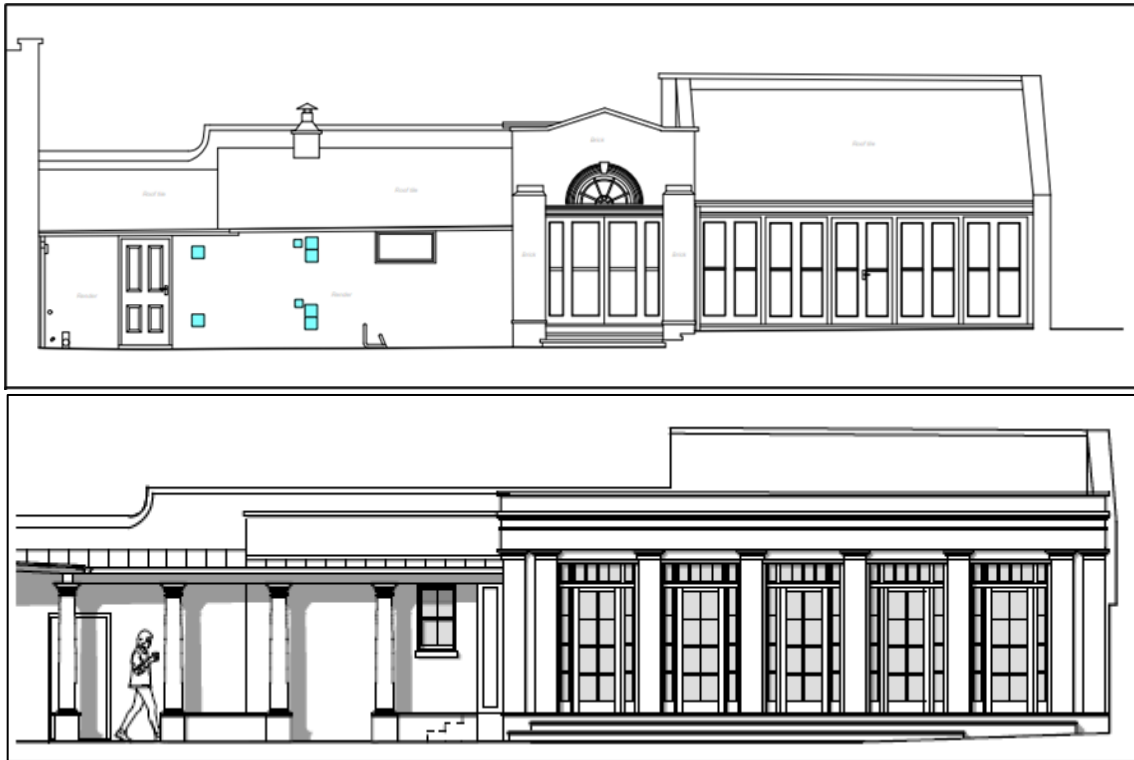
- 1.14 Proposals are for removal of the existing pool house roof and remodelling of the building with a new flat roof.

FIGURE 3: SHOWING THE EXISTING (TOP) AND PROPOSED (BOTTOM) PLANS.

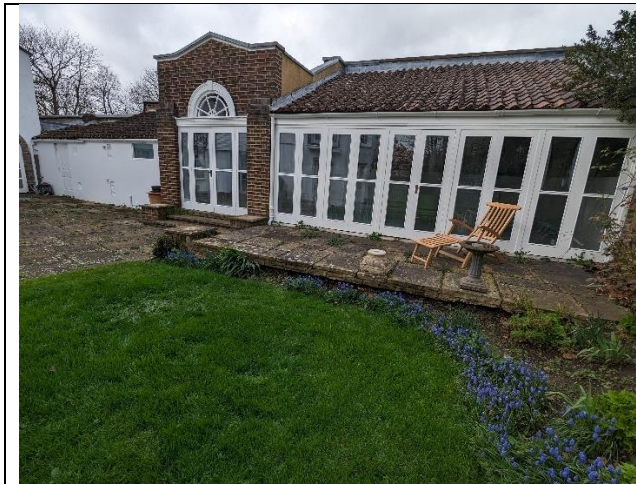
- 4.5 The pool house was a single-storey, brick-built building that adjoined to the north of the main house. It had a sloping roof with a southerly aspect off a rear parapet wall, supporting clay interlocking roof tiles. The building contained a swimming pool, central changing room, and plant room at the western end.

Photograph 1: *The pool house viewed from the south.*

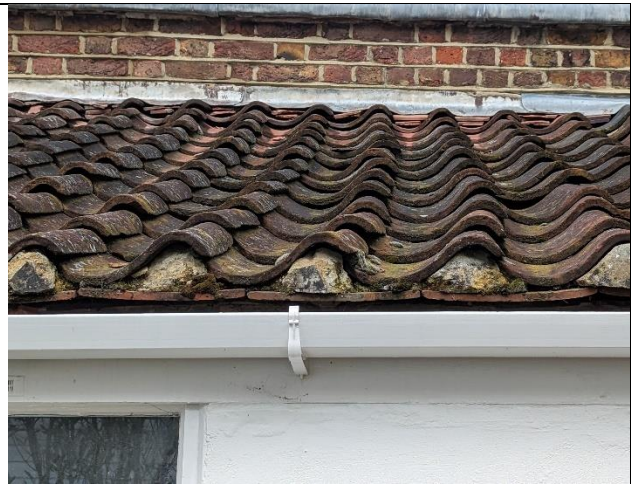
- 4.7 Many of the roof tiles were lifted, especially in the western portion of the building, creating gaps into the batten spaces that may be utilised by bats.

Photograph 2: *Lifted roof tiles.*

- 5.2 From the daytime assessment it was considered that the pool house had moderate potential to support roosting bats. No bats or evidence of bats was found, but there were potential roosting features including gaps under roof tiles and mortar gaps in brickwork. Features were not optimal for void-dwelling bat species, due to a single central roof void which was very small and offered minimal flight space, and the building was more suitable for crevice-dwellers.

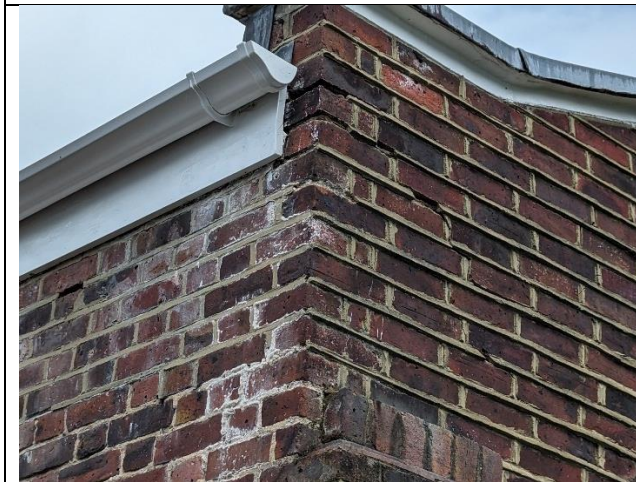
- 4.6 The building walls were predominantly in good condition, however some mortar gaps in the brickwork were seen on the central part of the southern elevation, creating crevice opportunities.

Photograph 3: *Mortar gaps in the brickwork.*

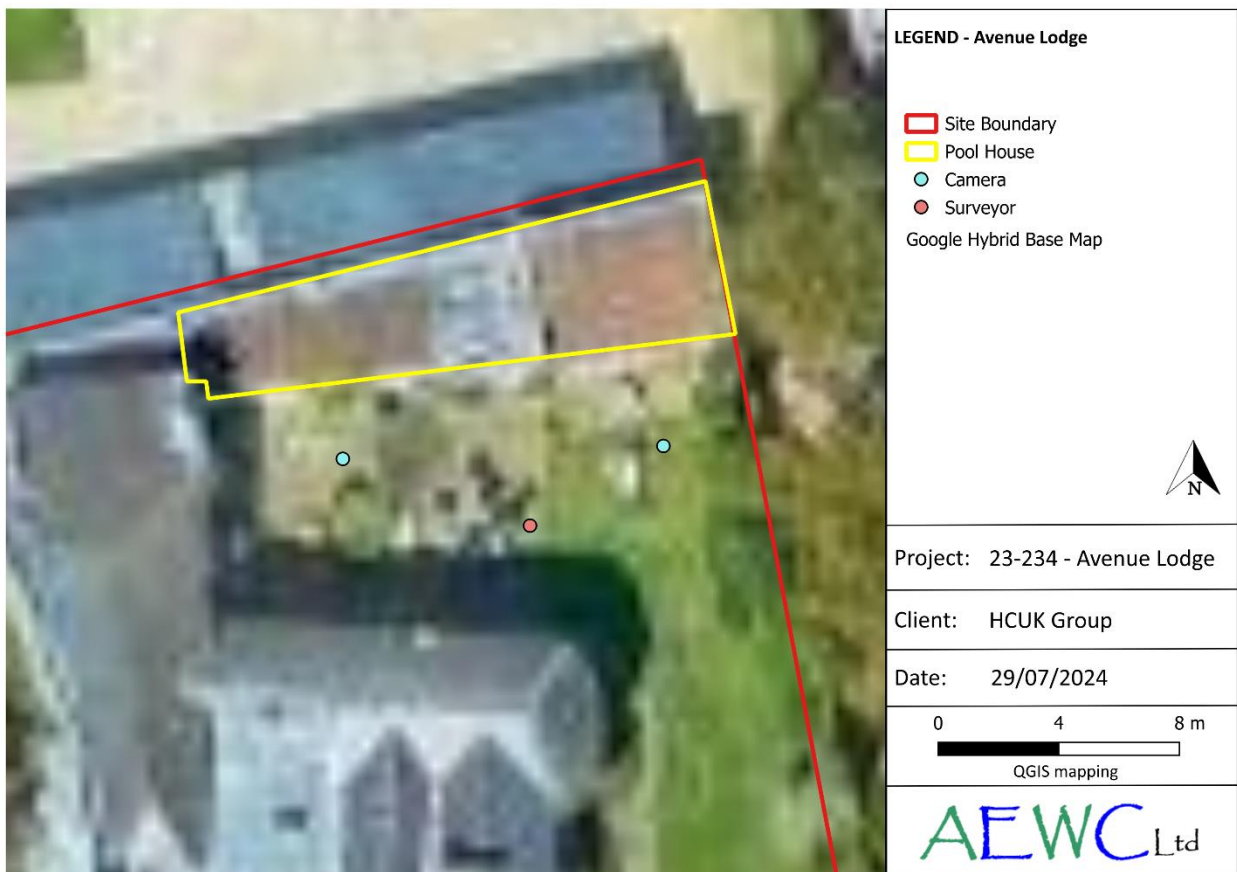
- 2.12 One surveyor and two professional night vision cameras were used for the emergence surveys (Figure 6). The surveyor and cameras were positioned to get a good all-round view of the building with a particular focus on the areas of impact and where potential roost features were identified present. Given the structure of the pool house, with a parapet wall forming the northern, eastern and western edges, all identified potential roost features and access points had a southerly aspect and the building was therefore surveyed along the southern elevation only.

- 4.11 A diagram showing the locations of the surveyor and night vision cameras during the evening surveys can be seen in Figure 6 below.

FIGURE 6: SHOWING POSITIONS OF SURVEYOR AND NIGHT VISION CAMERAS DURING THE 2024 EMERGENCE SURVEYS.
