INTERIM VERIFICATION REPORT

45-49 STATION ROAD,
HAMPTON VILLAGE,
TW12 2BU

Job No: P9086J703b/JWT

Date: 23/08/2023

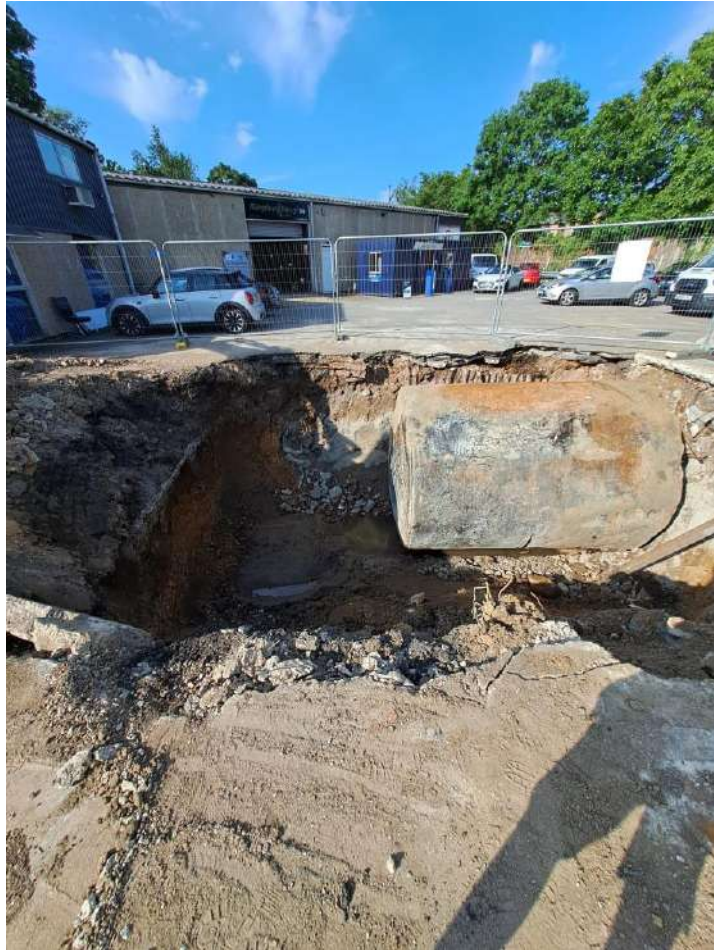
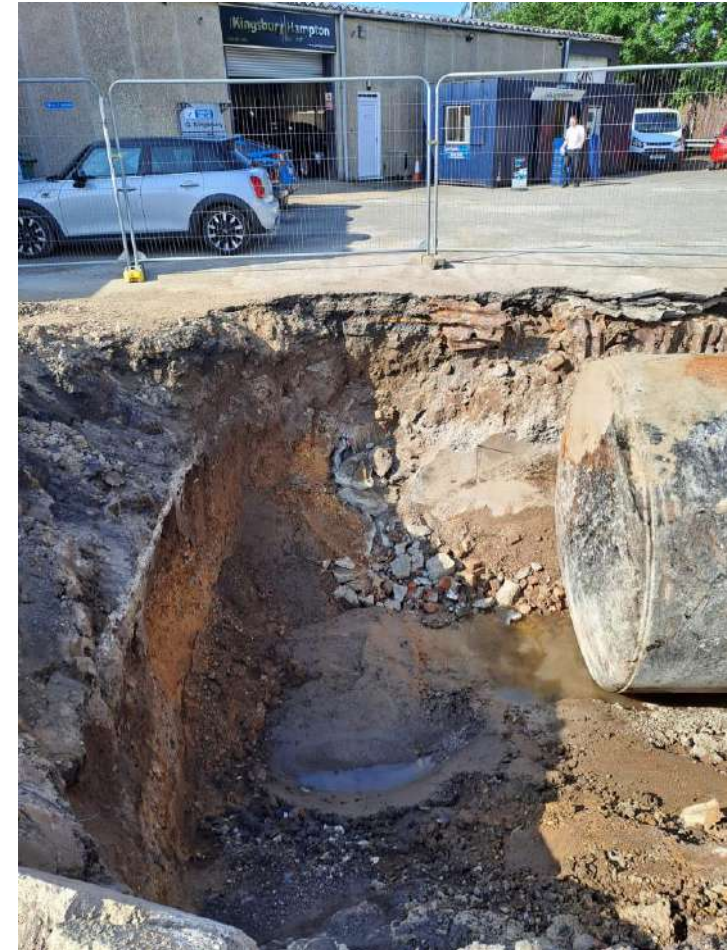
PROJECT NAME	45-49 Station Road, Hampton Village, TW12 2BU	CLIENT	Preston Park Development LTD
TITLE	Tank Excavation 1 Photographs	FIGURE	5b
Photo 1: Tank Excavation 1 as observed on arrival, viewed southeast.		Photo 2: Close up of eastern end of Tank Excavation 1, viewed southeast.

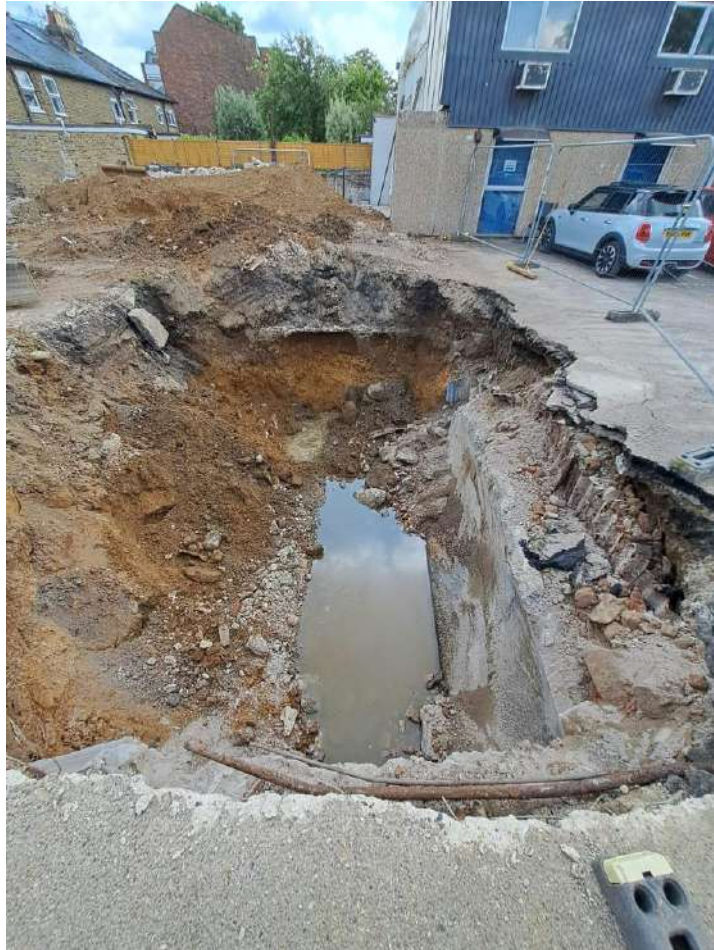
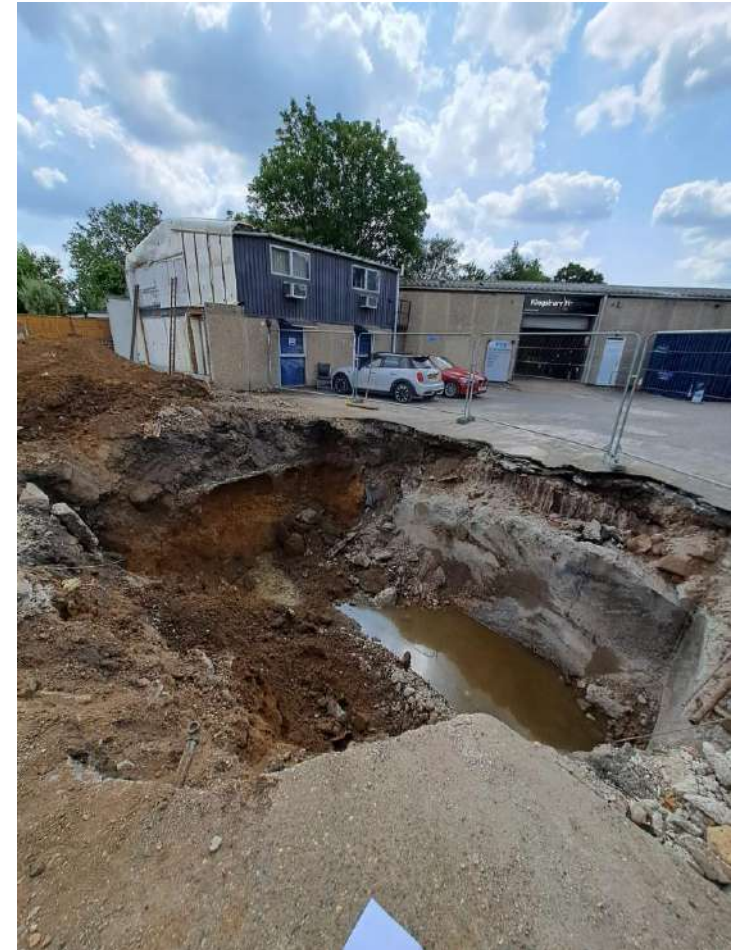
PROJECT NAME	45-49 Station Road, Hampton Village, TW12 2BU	CLIENT	Preston Park Development LTD
TITLE	Tank Excavation 1 Photographs	FIGURE	5b
Photo 3: Tank Excavation 1 following removal of the tank, viewed northeast.		Photo 4: Tank Excavation 1 following removal of the tank, viewed east.

2.4.5 During the removal of the remaining tank segments there was a slight hydrocarbon odour noted, and a black staining along the concrete base and north-west corner of the excavation was observed.

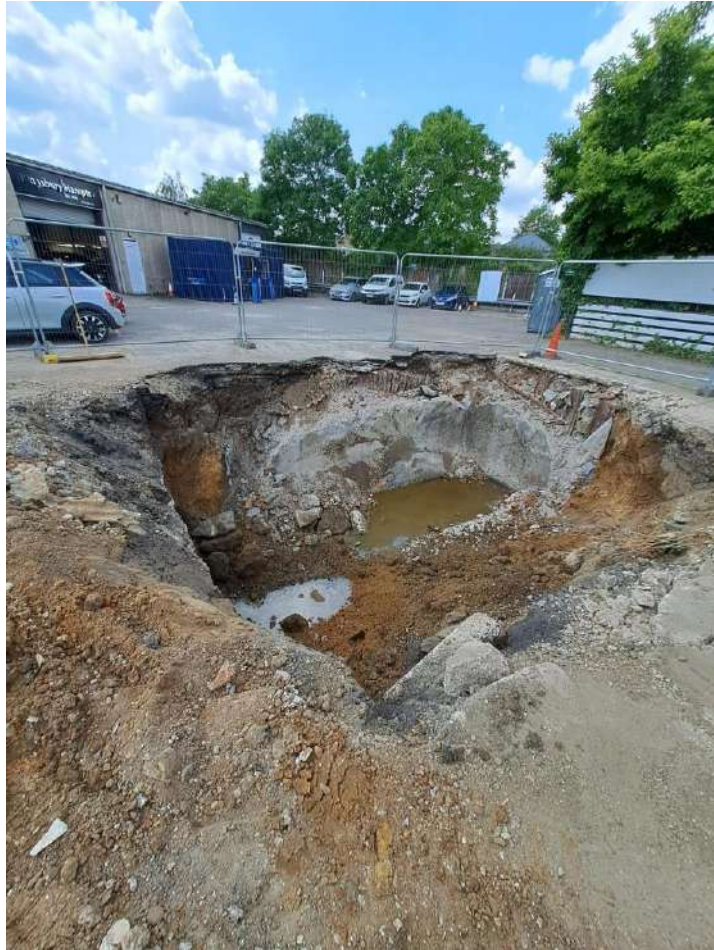
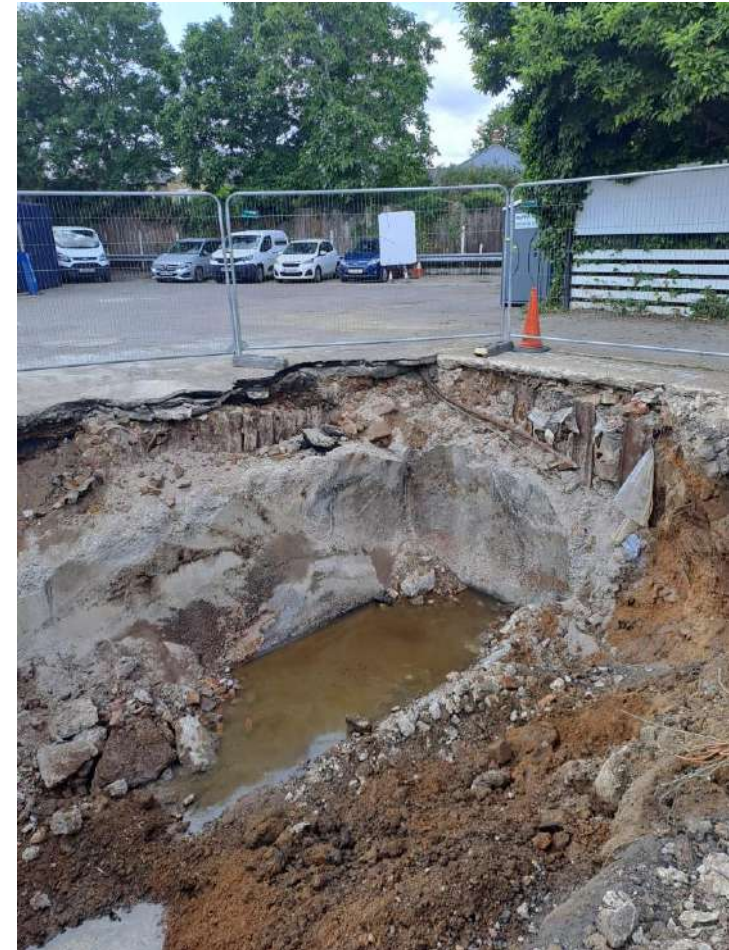
PROJECT NAME	45-49 Station Road, Hampton Village, TW12 2BU	CLIENT	Preston Park Development LTD
TITLE	Tank Excavation 1 Photographs	FIGURE	5b
Photo 5: Tank Excavation 1 following removal of the tank, viewed south.		Photo 6: Southeastern and southwestern walls of tank cradle left in to support the adjacent access road to the MoT garage.

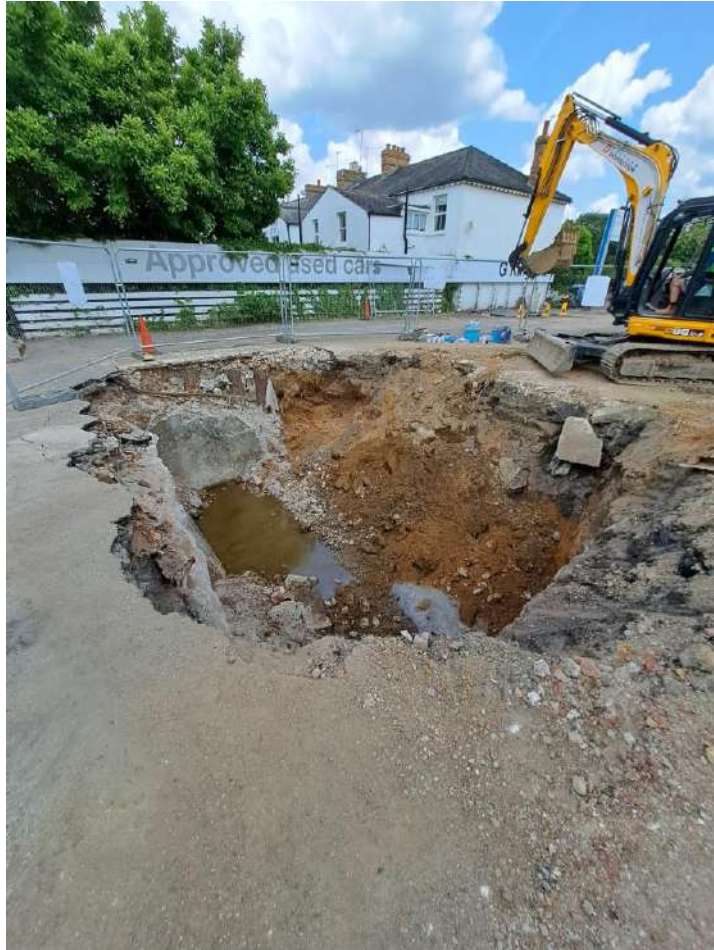
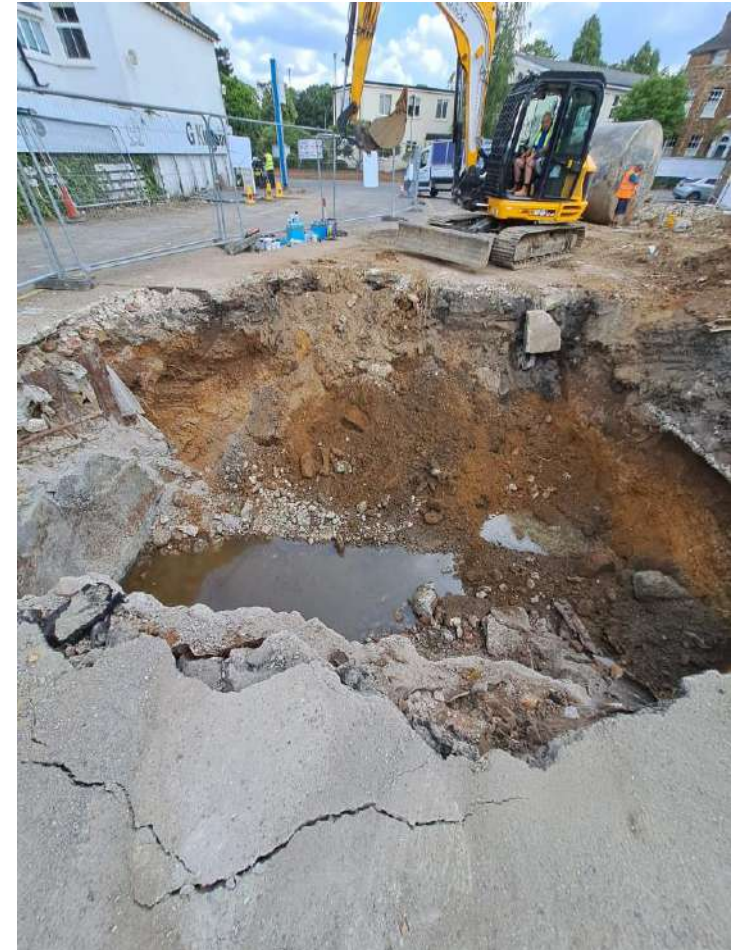
PROJECT NAME	45-49 Station Road, Hampton Village, TW12 2BU	CLIENT	Preston Park Development LTD
TITLE	Tank Excavation 1 Photographs	FIGURE	5b
Photo 7: Tank Excavation 1 following removal of the tank, viewed west.		Photo 8: Tank Excavation 1 following removal of the tank, viewed northwest.

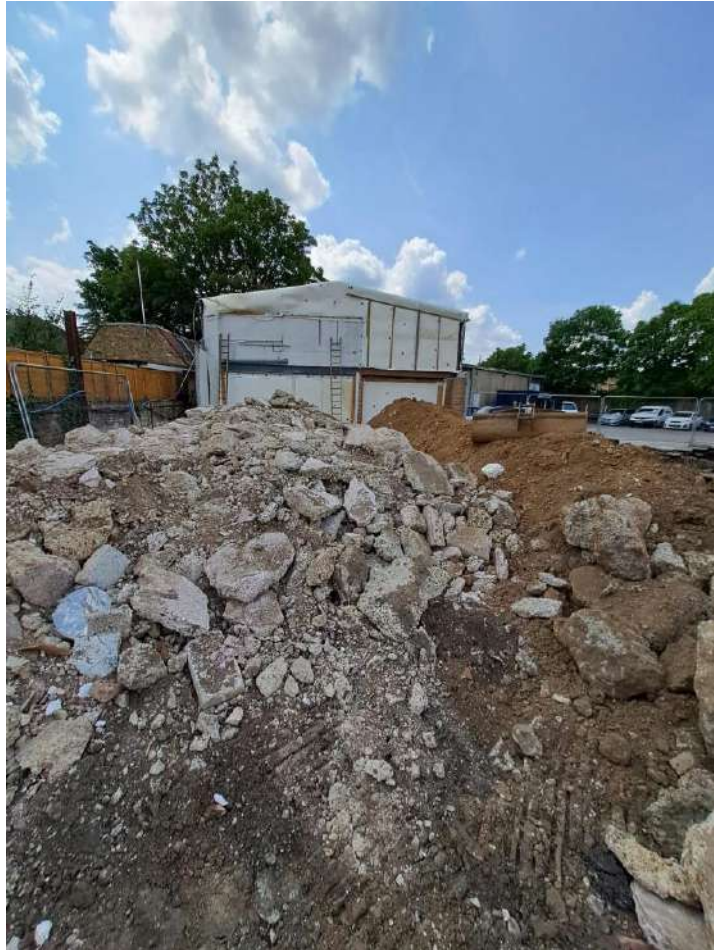
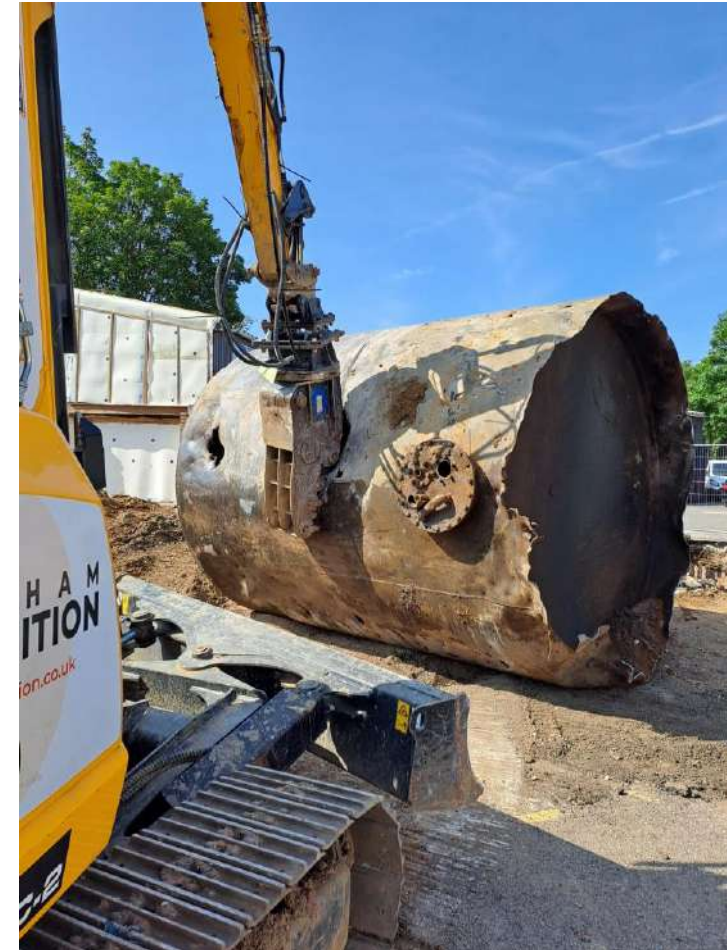
PROJECT NAME	45-49 Station Road, Hampton Village, TW12 2BU	CLIENT	Preston Park Development LTD
TITLE	Tank Excavation 1 Photographs	FIGURE	5b
Photo 9: Demolition material used in addition to visually clean soil arisings to backfill excavation after upon completion of the validation sampling.		Photo 10: Tank segment after removal from the excavation.

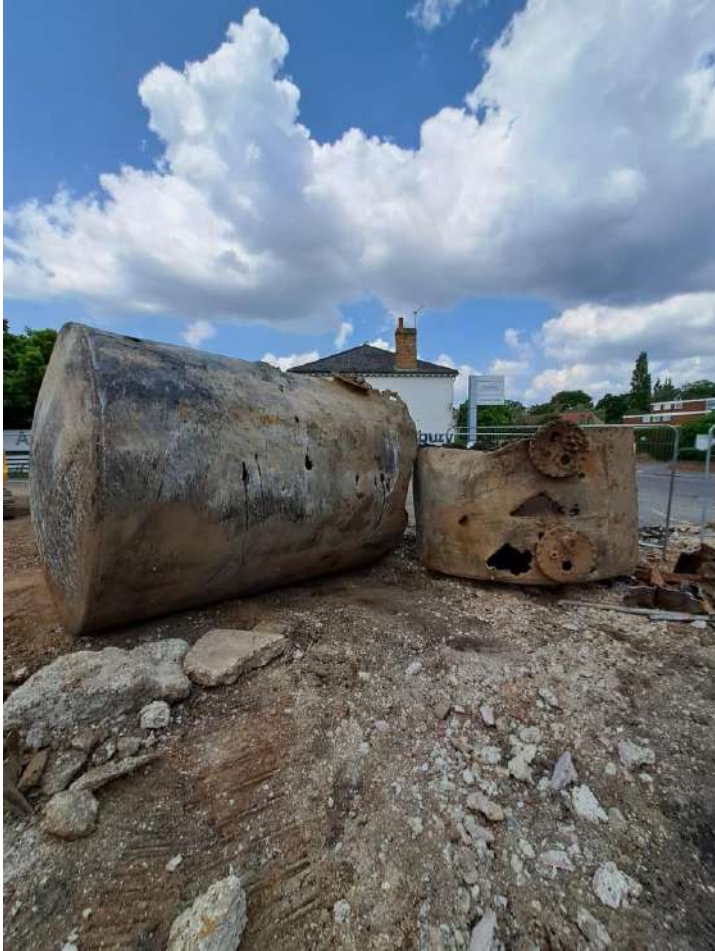
PROJECT NAME	45-49 Station Road, Hampton Village, TW12 2BU	CLIENT	Preston Park Development LTD
TITLE	Tank Excavation 1 Photographs	FIGURE	5b
Photo 11: Both tank segments after removal from the excavation.

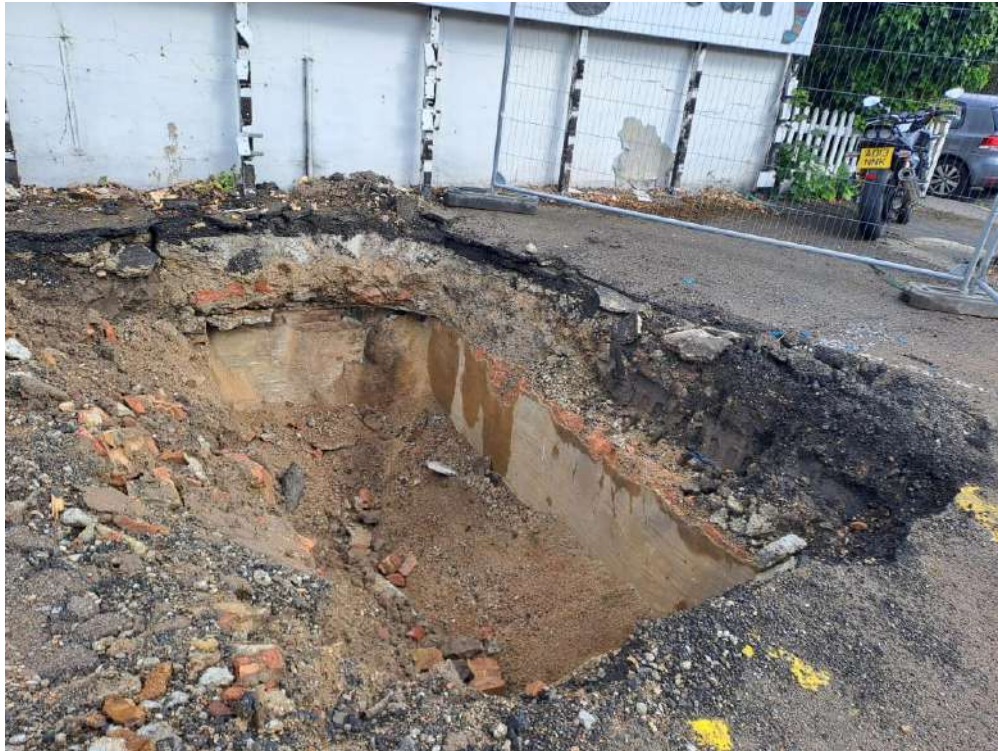
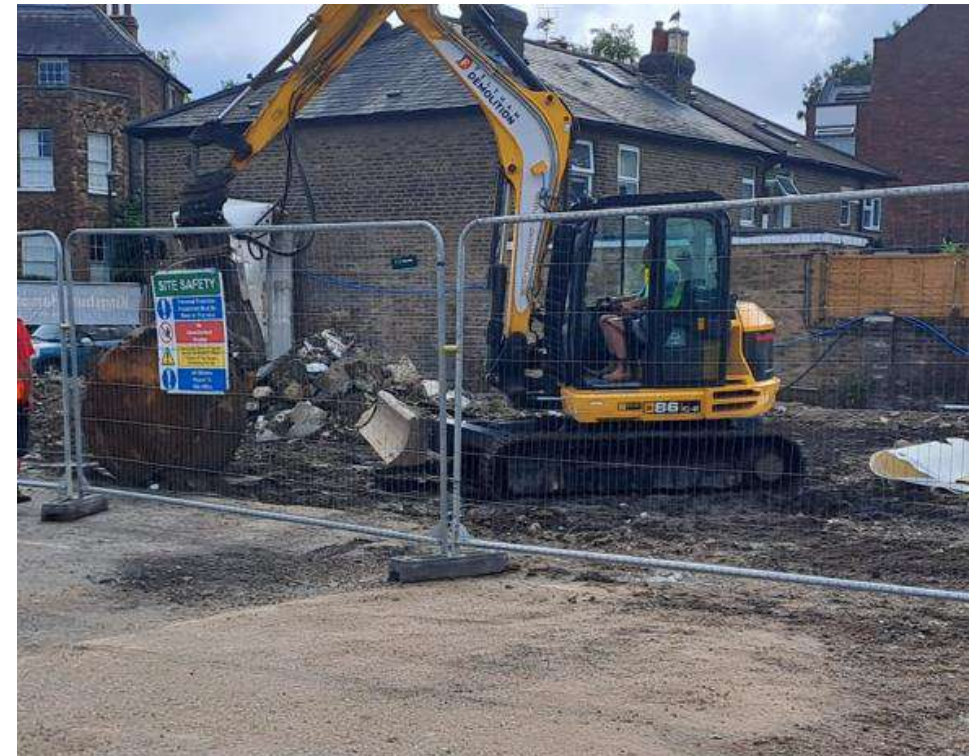
PROJECT NAME	45-49 Station Road, Hampton Village, TW12 2BU	CLIENT	Preston Park Development LTD
TITLE	Tank Excavation 2 Photographs	FIGURE	6b
Photo 1: Tank Excavation 2 as observed on arrival, viewed west.		Photo 2: Tank removed from Tank Excavation 2.

2.5.2 Initial observations made by the Jomas engineer on 05 July showed the asphalt ground surfacing had been broken out, and the tank successfully excavated and crushed in preparation for off-site disposal.

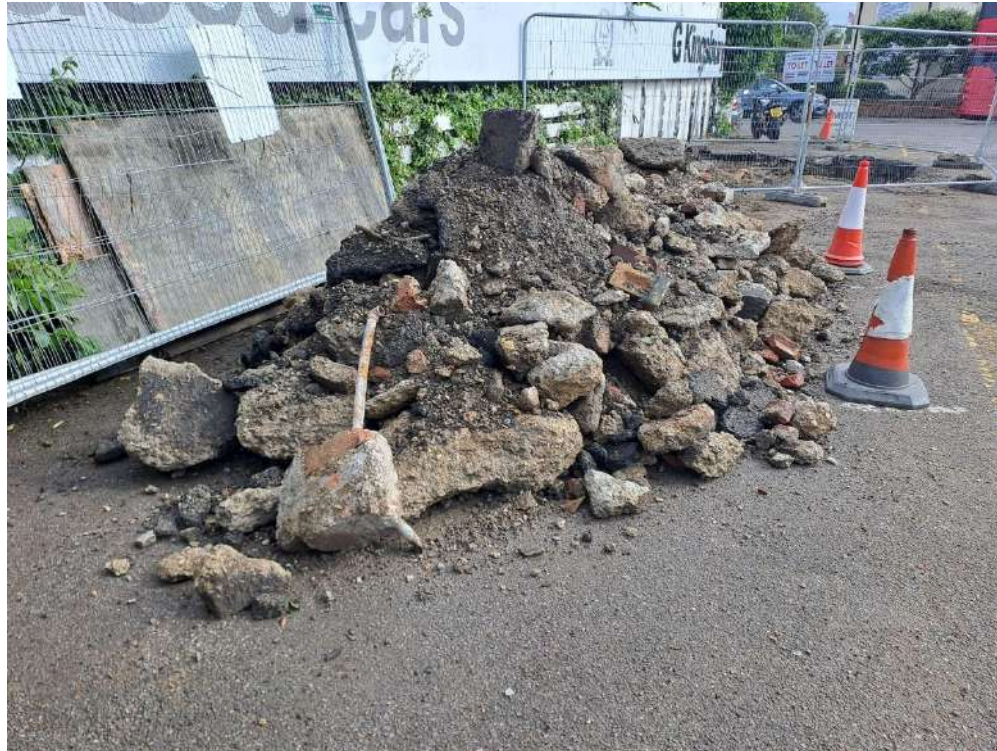
Photo 3: Material excavated from the top and side of the tank.

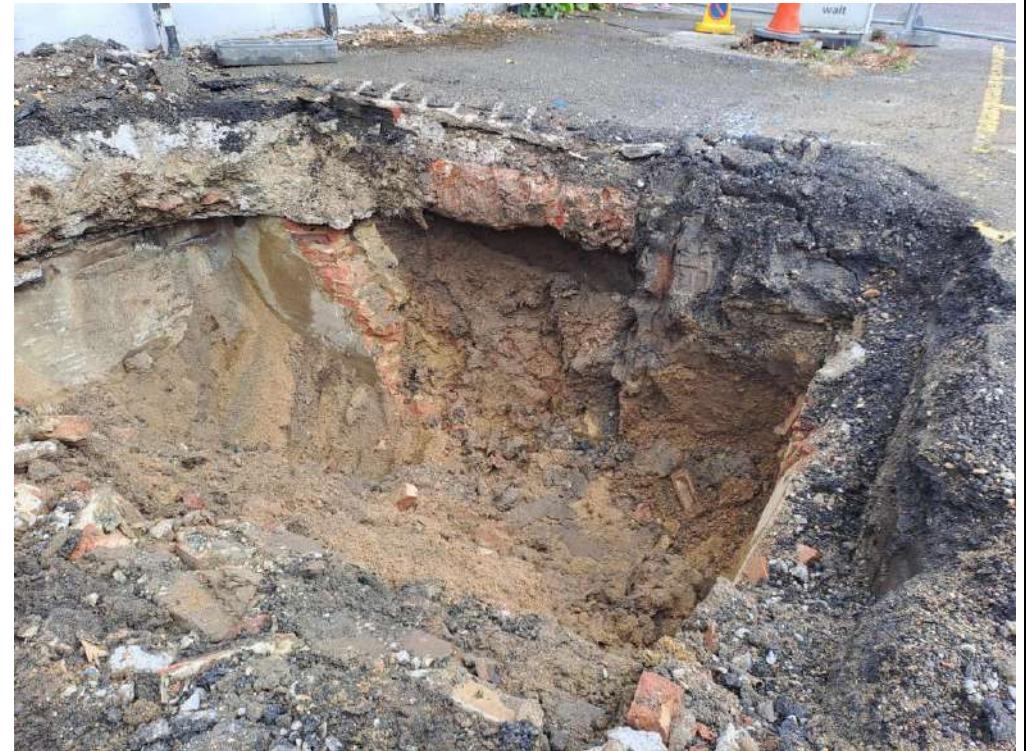
Photo 4: Northwestern face of Tank Excavation 2 during removal of the brick tank cradle.

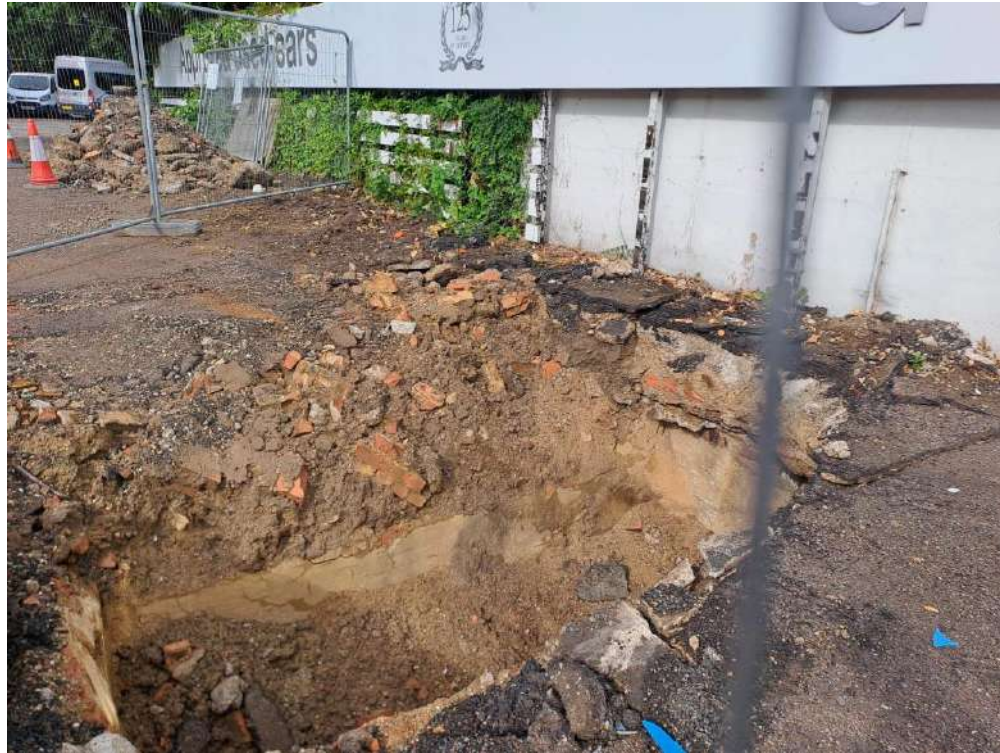
Photo 5: Southeastern face of Tank Excavation 2 during removal of the brick tank cradle.

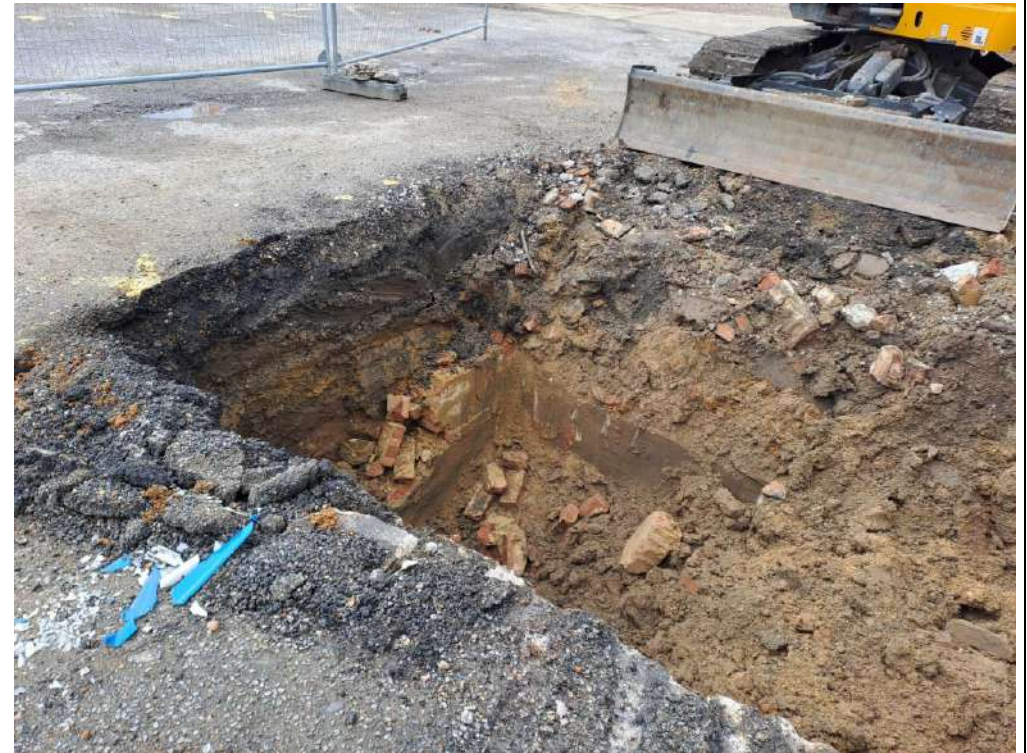
Photo 6: Northeastern face of Tank Excavation 2 during removal of the brick tank cradle.

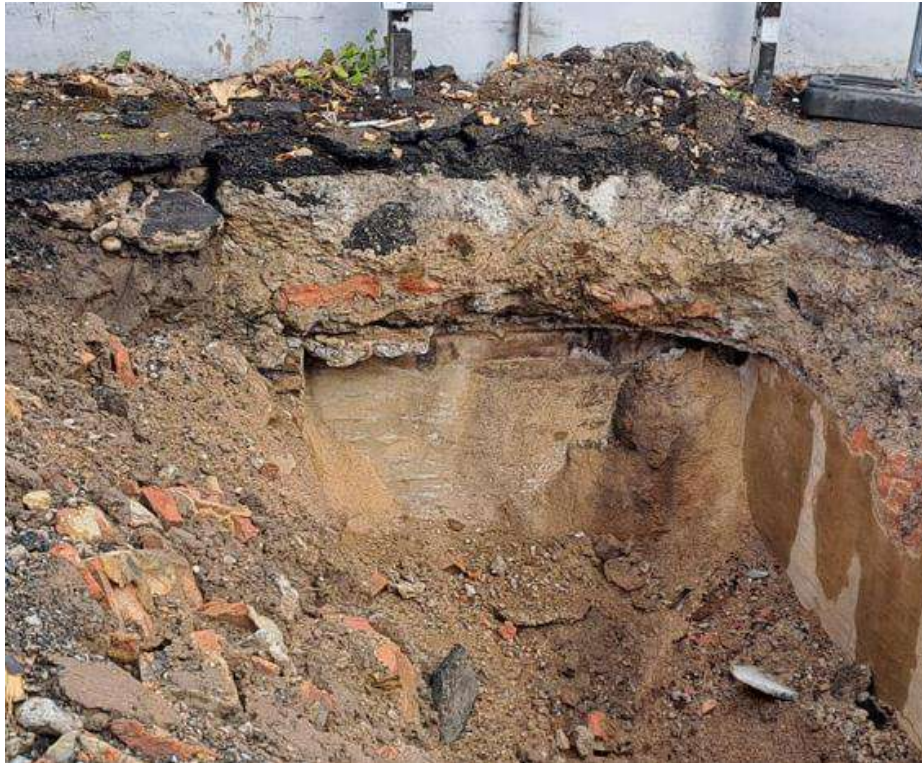
PROJECT NAME	45-49 Station Road, Hampton Village, TW12 2BU	CLIENT	Preston Park Development LTD
TITLE	Tank Excavation 2 Photographs	FIGURE	6b
Photo 7: Southwestern section of tank cradle left in-situ for stability due to proximity of the adjacent offsite building.		Photo 8: Resultant rubble following removal of brick cradle from Tank Excavation 2.
