EXTENDED PHASE 1 ECOLOGICAL AND BAT
ROOST ASSESSMENT

SEVENOAKS, 101A HIGH STREET, HAMPTON, TW12 2SX

FINAL REPORT

September 2024

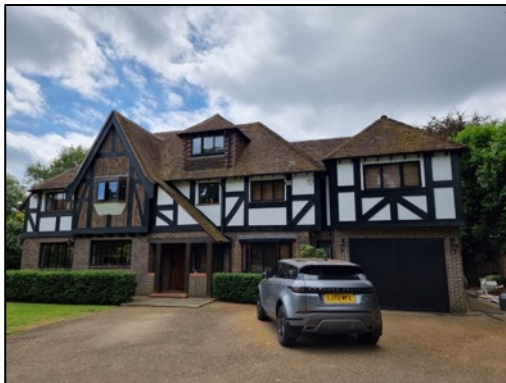
The building comprises a two-storey brick-built structure which rises to a multi-pitched, hipped and gable end roof design clad with clay roof, ridge and hip tiles. The house is oriented north to south. A two-storey hipped extension protrudes from the western elevation of the main house with a second gable end extension adjoining the western elevation. The eaves extend beyond their wall plates and remain exposed with wooden underboards infilling the gaps between them. A hipped dormer window is situated on the northern roof face and a flat roofed dormer protrudes from the southern roof face; both are clad with clay hanging tiles on their respective elevations. A wooden framed conservatory set on a brick plinth adjoins the rear of the house. The windows and doors are set in wooden frames which are tight fitting to the surrounding brickwork.

Figure 8 – northern elevation of the house

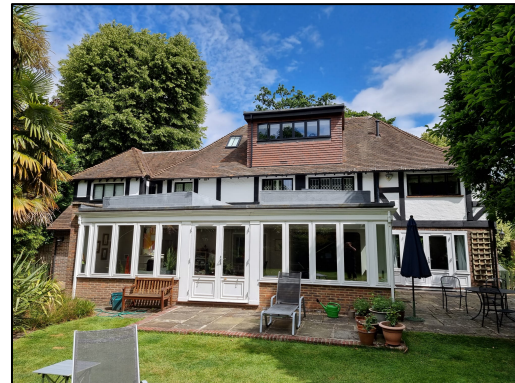
Figure 9 – southern elevation of the house with dormer window and conservatory

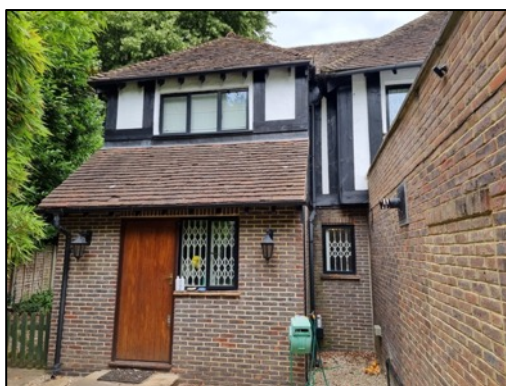
Figure 10 – western hipped extension

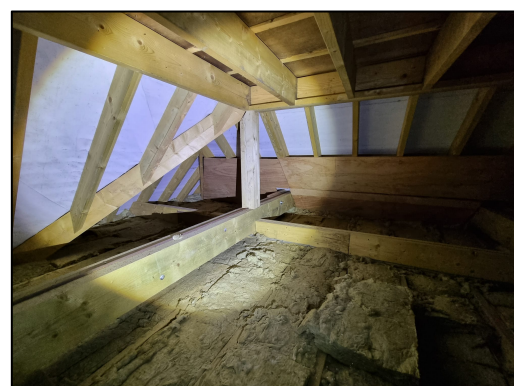
Internally, the roof of the main house is vaulted. A single half-height roof void is present in the western hipped extension. The space is lined with breathable lining on the roof and fibreglass insulation on the floor. Minimal cobwebbing is present with the extension being a recent addition to the main house constructed in 2008.

Figure 11 – half-height roof void inside the hipped extension

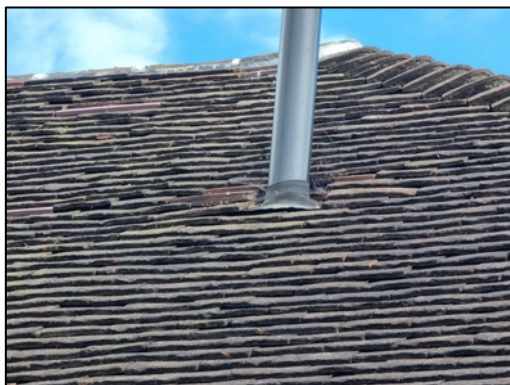
Figure 12 – lifted roof tiles on the southern roof face

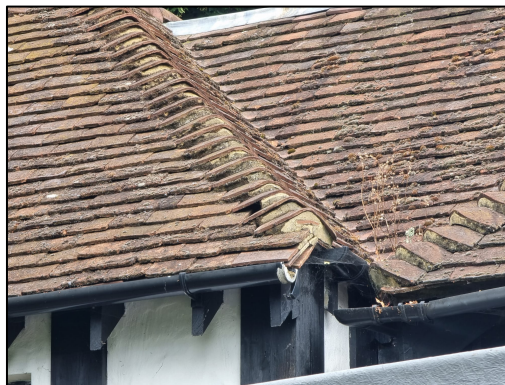
Figure 13 – missing mortar under the hip tiles on the western extension

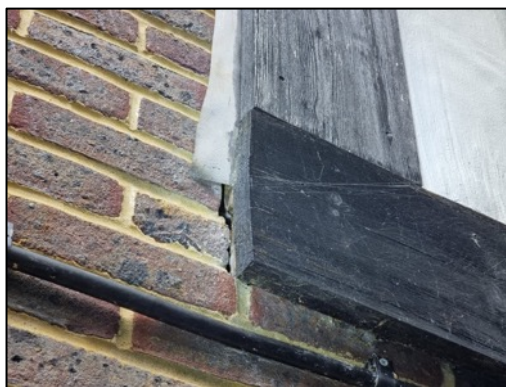
Figure 14 – gaps between the timber work and wall plate

- Prior to works commencing, crevice roost features on the timber wall features will be inspected with an endoscope. If a feature can be inspected exhaustively and it can be certain that no roosting bats are within, the feature will be temporarily blocked with sponge which will remain in place until the demolition takes place. If a feature cannot be inspected exhaustively or a roosting bat is found, a one way-exclusion device will be installed.

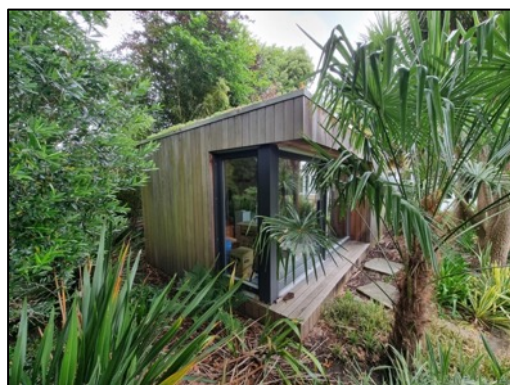
The outbuilding comprises a single-storey wooden built structure with a flat roof covered in a thin layer of moss and vegetation (Figures 15 and 16). The structure is oriented east to west. The elevations are formed with wooden boarding and metal encloses the eaves.

Figure 15 – south-eastern corner of the outbuilding

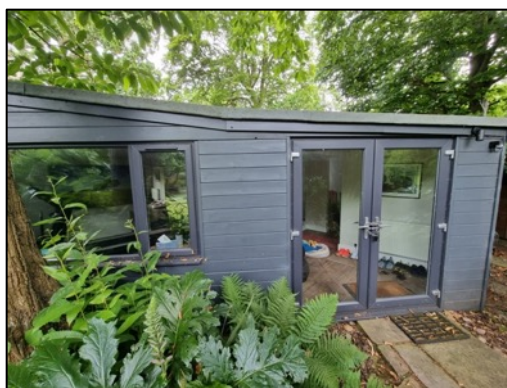
The southern outbuilding comprises a single-storey block-built structure with a mono-pitched roof covered with roofing felt (Figure 17). The structure is oriented north to south. The elevations are clad with wooden shiplap boarding. The eaves are enclosed with wooden fascia boards and closely adjoining uPVC guttering.

Figure 17 – northern elevation of the outbuilding

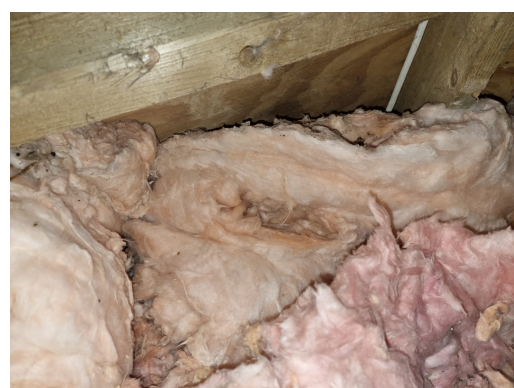
Internally, there is a small roof void (Figure 18). The space is unlined with the undersides of the wooden roof panelling exposed and is mostly filled with fibreglass insulation. Where the void is not filled with insulation the areas are heavily cobwebbed.

Figure 18 – fibreglass insulation infilling the void space
