Planning, Design, Access and Heritage Statement – Kneller Hall, Kneller Road, Twickenham, TW2 7DN

“Works to Band Practice Hall comprising repair works to cracking to external walls; underpinning works; localised repair works to slate roof; and internally removal of the internal back wall, introduction of new structural truss and structural tie, and raising the existing ties by 800mm.”

Condition Report
STRUCTURAL / CIVIL ENGINEERING

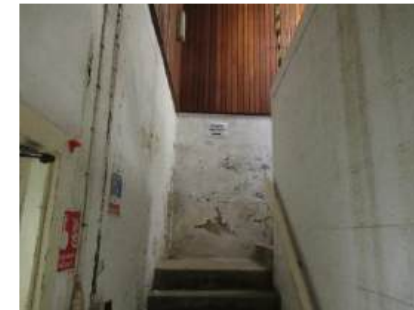
In the basement deterioration to render indicative of water ingress is evident (Jones Lang LaSalle IP, Condition Survey Report - Kneller Hall, 2020).

Photo 1 Water damage to right side basement stair in the main Kneller Hall west wing building (Photo taken from Jones Lang LaSalle IP, Condition Survey Report - Kneller Hall Guard House, 2020)

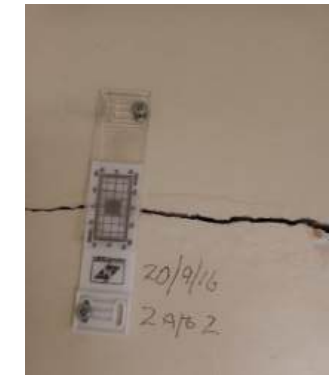
Cracking to masonry walls has been observed to the upper floors of the west wing. These walls do not continue down through the building and appear to be blockwork partitions constructed off the timber floors. In some locations, movement gauges have been installed across cracks. Based on the dates noted on the walls adjacent to these, they appear to have been installed approximately 5 years ago and show between 0 and 3mm of movement.

Photo 2 Movement gauge showing minimal further movement to one of the solid walls at level 3 Kneller Hall main house (west wing)

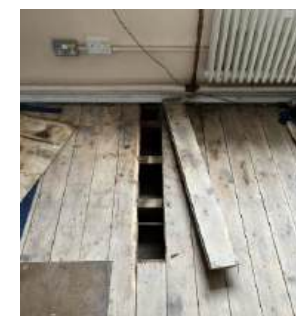
Photo 3 Opening up works showing existing floor joists at the first floor in the Guards House

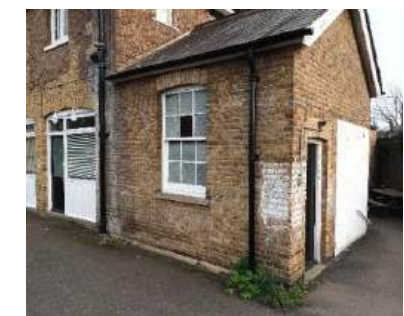
A brick arch above one of the windows at the rear single storey room has failed and cracking can be seen extending from the bottom corner of the window below. There are signs that the adjacent drainage pipe may not have been functioning adequately in staining on the brickwork.

Photo 4 Failed Brick Arch above sash window at the rear storage room in the Guards House

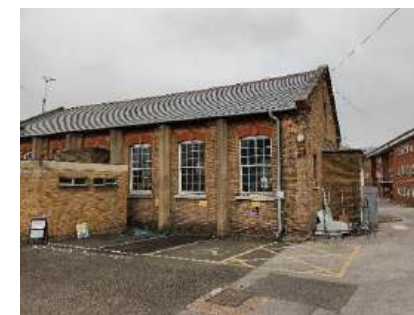
Past remedial work is visible in the form of external piers on the truss lines to both sides of the building. A record drawing from the 1970 shows that the piers are concrete encased steels (back-to-back channels) which anchor remedial ties to the trusses. The concrete encasement to the piers is showing signs of spalling in some locations. Concrete to the top of one of the piers was removed in order to inspect the steel which, in this location, were not significantly corroded.

Photo 5 Remedial piers formed of encased steels (back-to-back channels) which anchor remedial ties to the trusses in the Bank Practice Hall

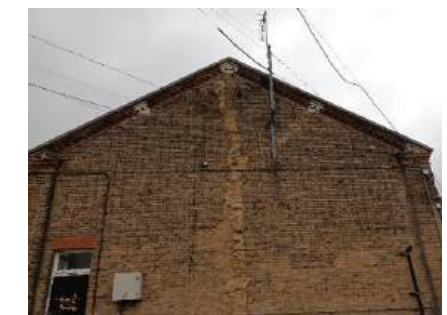
The structure shows evidence of significant movement as there is a large vertical crack to the rear elevation and a large diagonal crack to the internal dividing wall. These cracks appear to emanate from the interface with the basement wall. Evidence of multiple attempts to repair the crack in the rear elevation can be observed, however, none of these have been successful.

The sit investigation report states that the foundations to this structure do not appear to be functioning adequately and appear to be founded on relatively weak soils.

Photo 6 Significant vertical crack to the external gable wall at the rear of the Band Practice Hall

- Underpinning to be carried out to building to prevent further settlement of the foundations. Either traditional mass concrete underpinning to sound, natural ground; or a piled underpinning system (mini-piles/screw piles) adequately fixed to the existing foundations to support the structure.
- Once foundations have been stabilised, the cracking to the masonry should be repaired.
- Spalling concrete encasement to the remedial piers to be removed and the steel inspected for corrosion. Any corrosion to be removed by mechanical means and concrete encasement reinstated with a corrosion inhibited cementitious repair mortar. Alternatively, concrete encasement can be removed entirely and an alternative form of corrosion protection suitable for external steel applied.

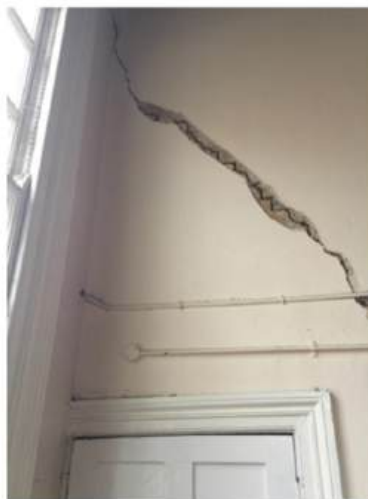
Diagonal cracking is visible on the internal wall within the existing building (see photo below). Again, this is indicative of differential settlement with the wall partially founded on the deeper basement at the west end. Note, this wall is proposed to be demolished as part of the refurbishment works.

Figure 1: Cracking to Internal Masonry Wall

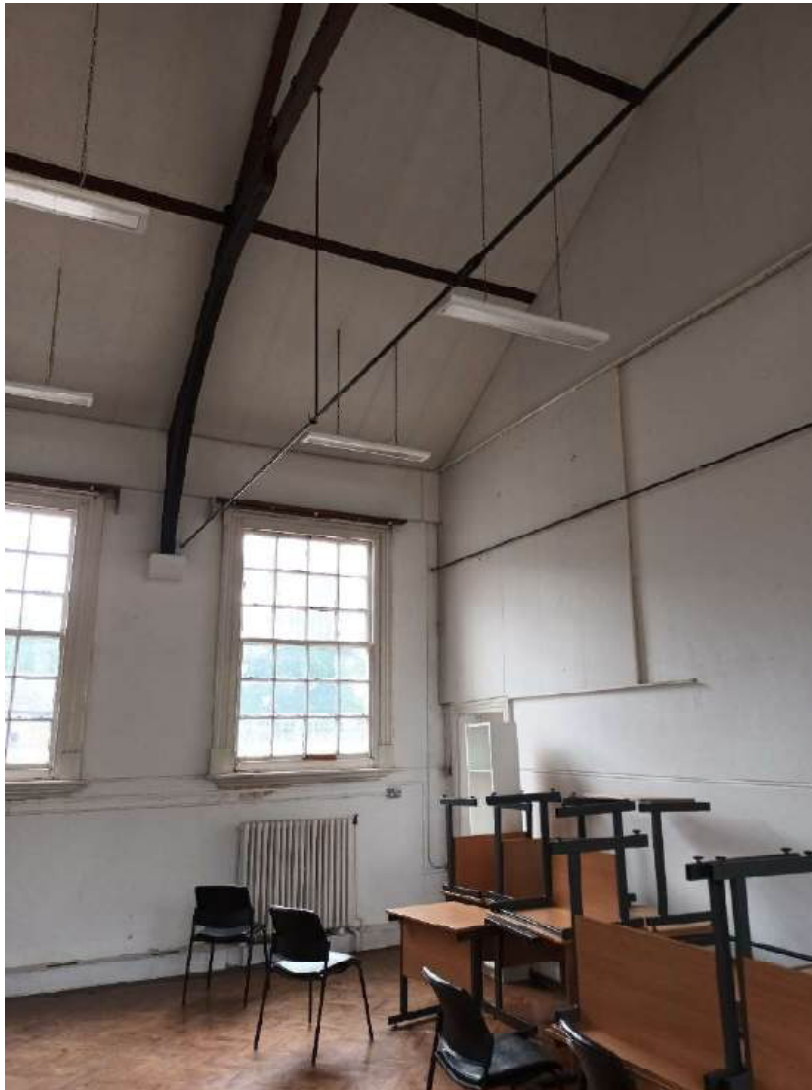
Photograph taken inside the Band Practice Hall, looking towards the internal wall to be removed

The photograph above shows the internal wall that is being removed. A tie, which is not original nor part of the original building design, is visible. No truss is visible. Discussions with Icen Heritage Consultants and ADP suggest that it may be appropriate to assume that there is no longer a truss in this location. If one was present in this location, it may have been removed when the internal wall was installed. However, with the wall in situ this cannot be confirmed.

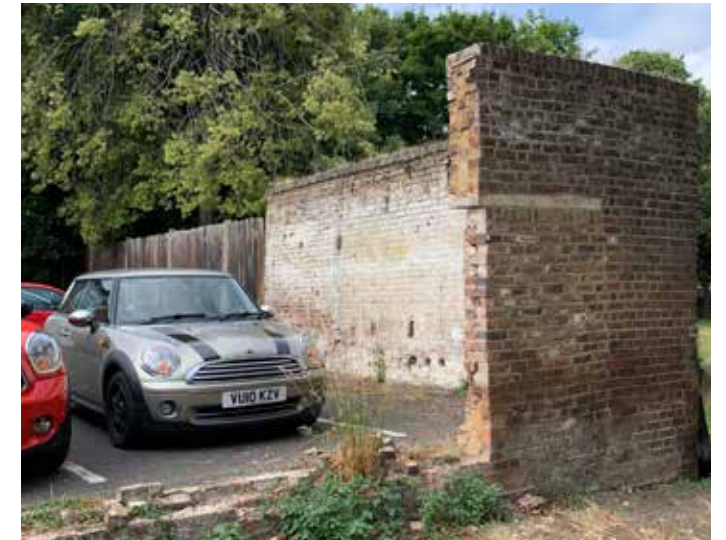
3.111 At present, the garden wall comprises a highly degraded wall which presents evidence of significant deterioration and structural instability. It has been buttressed at its west end using modern bricks of different tone from its historic fabric. Its northern end has collapsed and its brickwork lost, with only pieces of foundation brickwork partially visible. The present condition of the wall, alongside its dissociation with the Site's landscape, does not facilitate an appreciation of this structure as part of an historic walled garden.

Figure 3.46 Photograph of the surviving section of garden wall. The wall is in a state of disrepair and is structurally unstable.

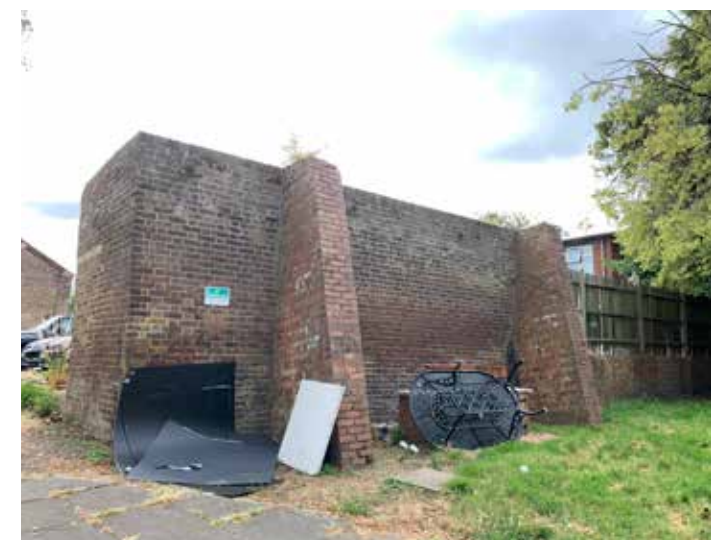
Figure 3.48 The rear elevation of the surviving section of garden wall, showing the modern buttressing. The south returning end of the wall (right) has been rebuilt using modern brick and fencing.

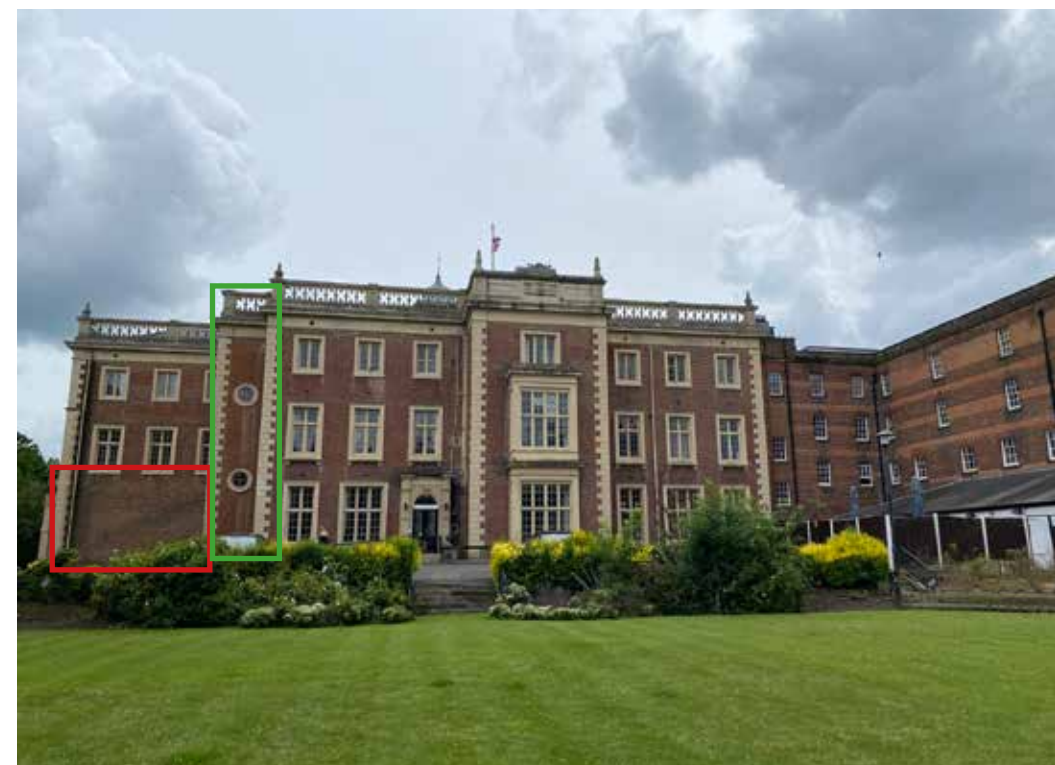
Figure 4.2 Rear north elevation of the hall. Red = exposed brickwork belonging to Hardwick's nineteenth-century wing. Discolouration in the brickwork indicates the location of a former staircase and terrace in this location. Green = a 1970s staircase tower which responds well to the architectural treatment of the hall's exterior.

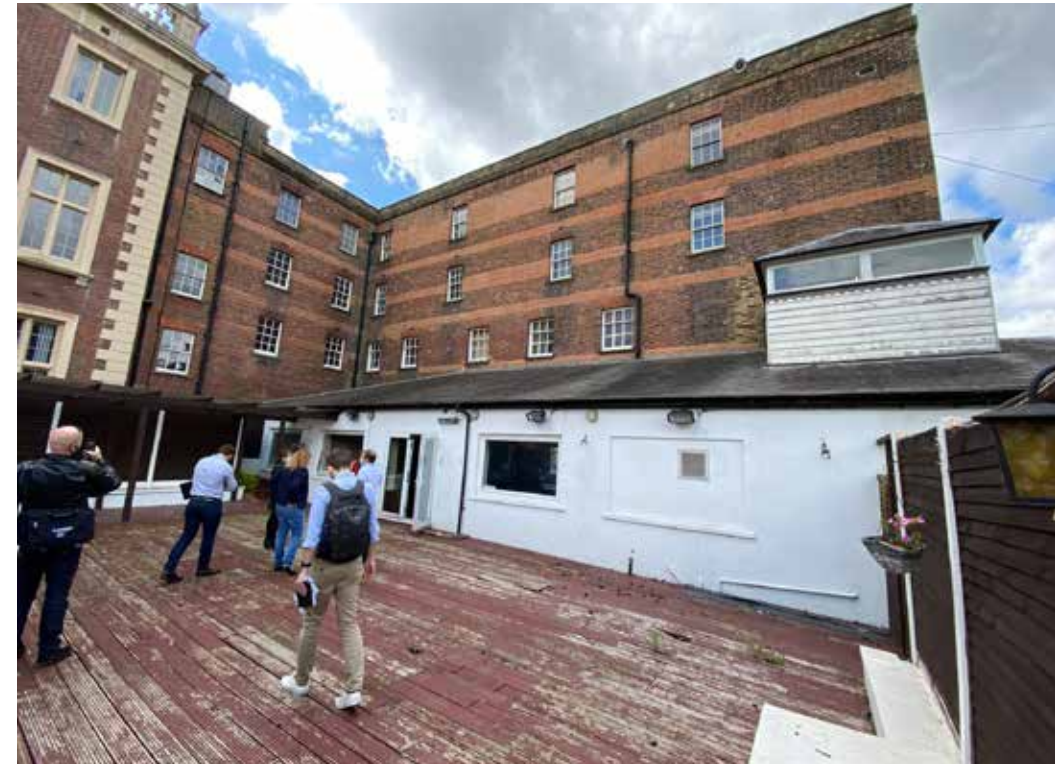
Figure 4.3 Rear north elevation of the hall, showing the new central range designed by George Mair (left) and the early-nineteenth century service wing (right). The rebuilt 'covered way' is shown in the foreground and the twentieth-century staircase tower is also visible.

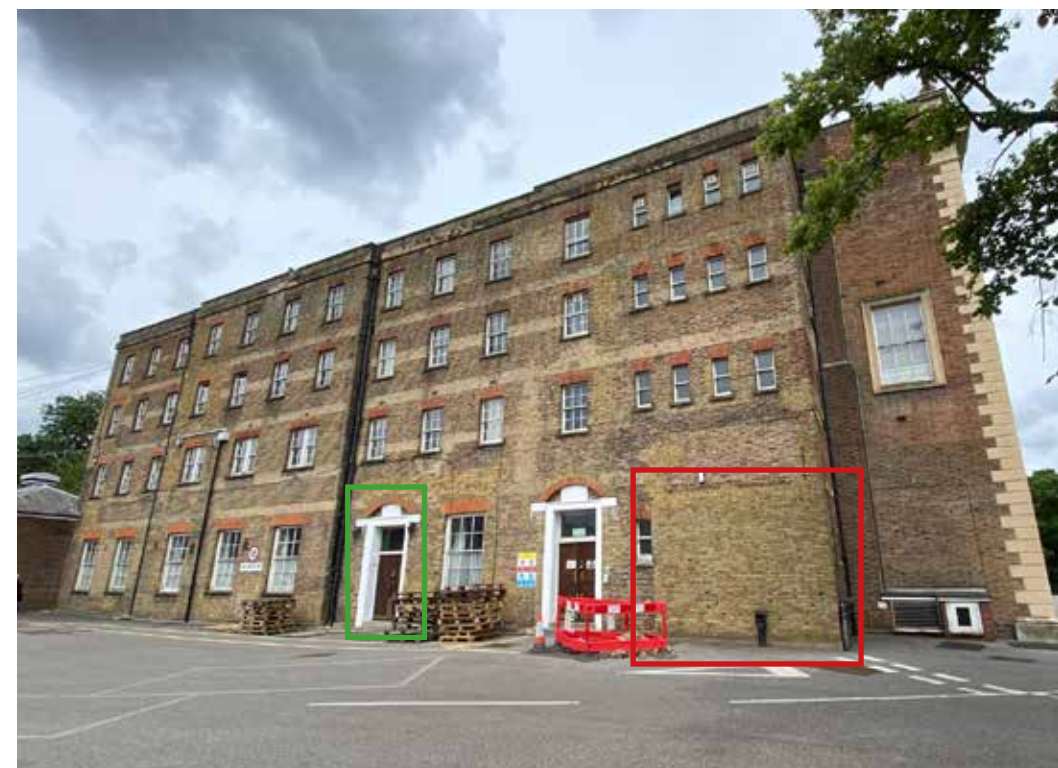
Figure 4.4 The west service wing of the building has experienced extensive alteration to its fenestration and general facade. Red = evidence for a former extension to the elevation. Green = an existing, non-historic entrance has been created through the adaption of an original window.

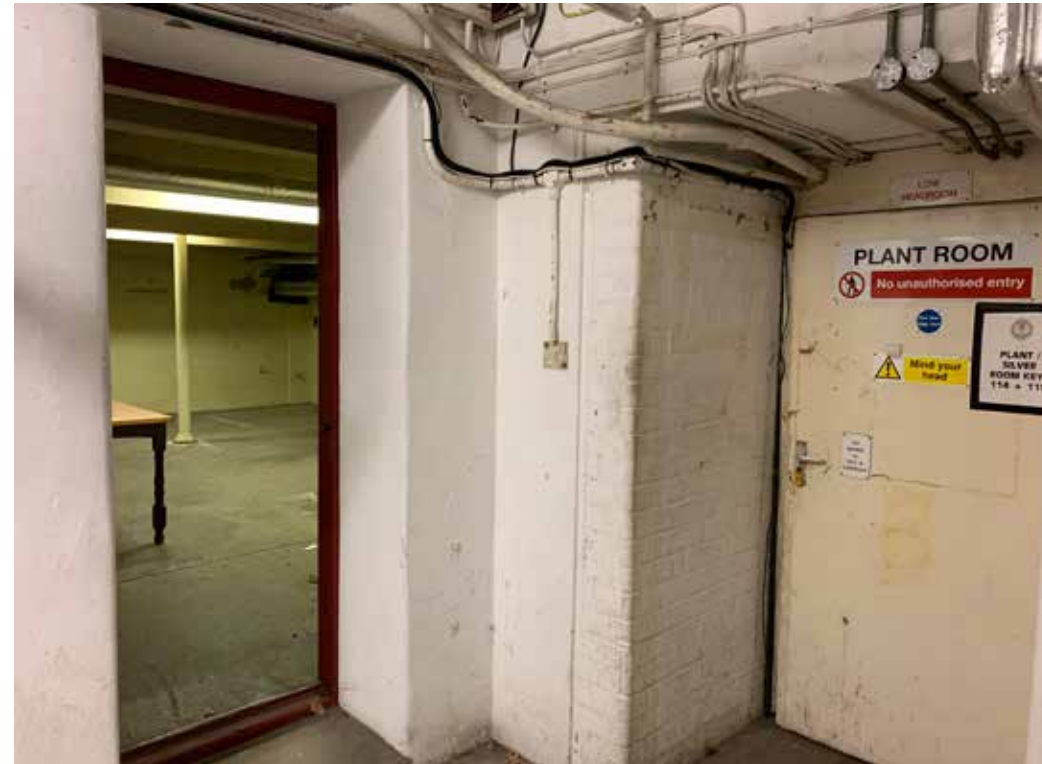
Figure 4.5 A typical corridor within the basement of the hall comprising early nineteenth-century walls which have been inappropriately fitted with exposed MEP equipment. Modern doors have also been introduced here.

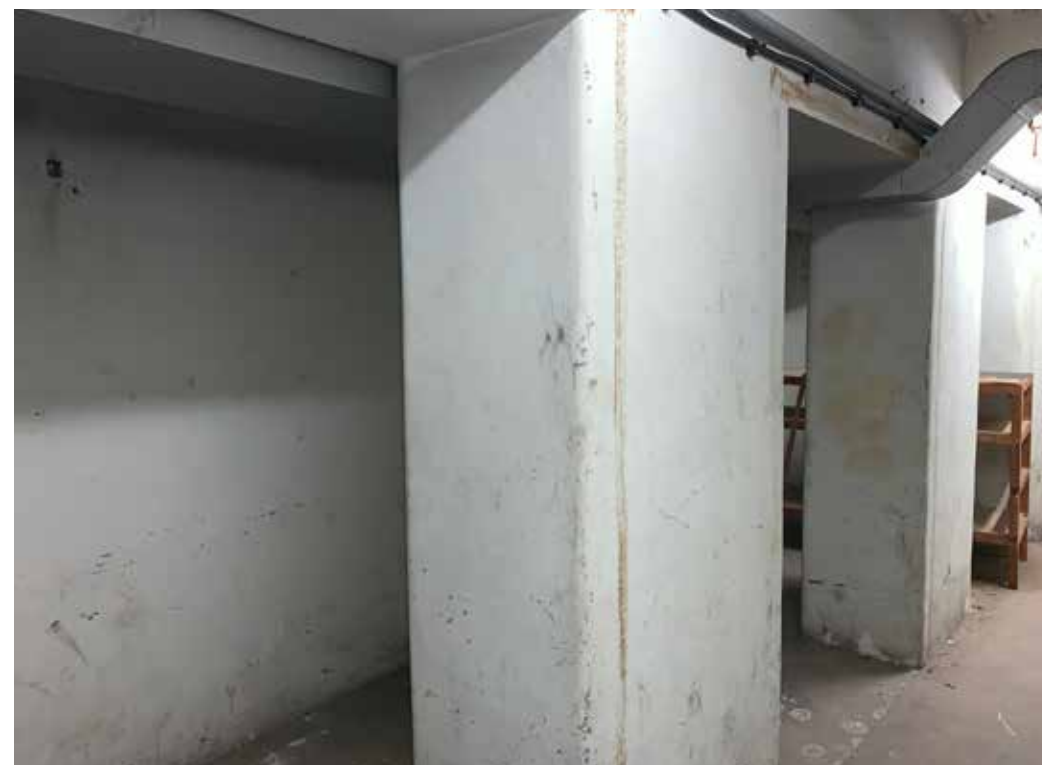
Figure 4.6 Early nineteenth-century supportive columns in the basement. Modern MEP equipment has been inappropriately fitted here.

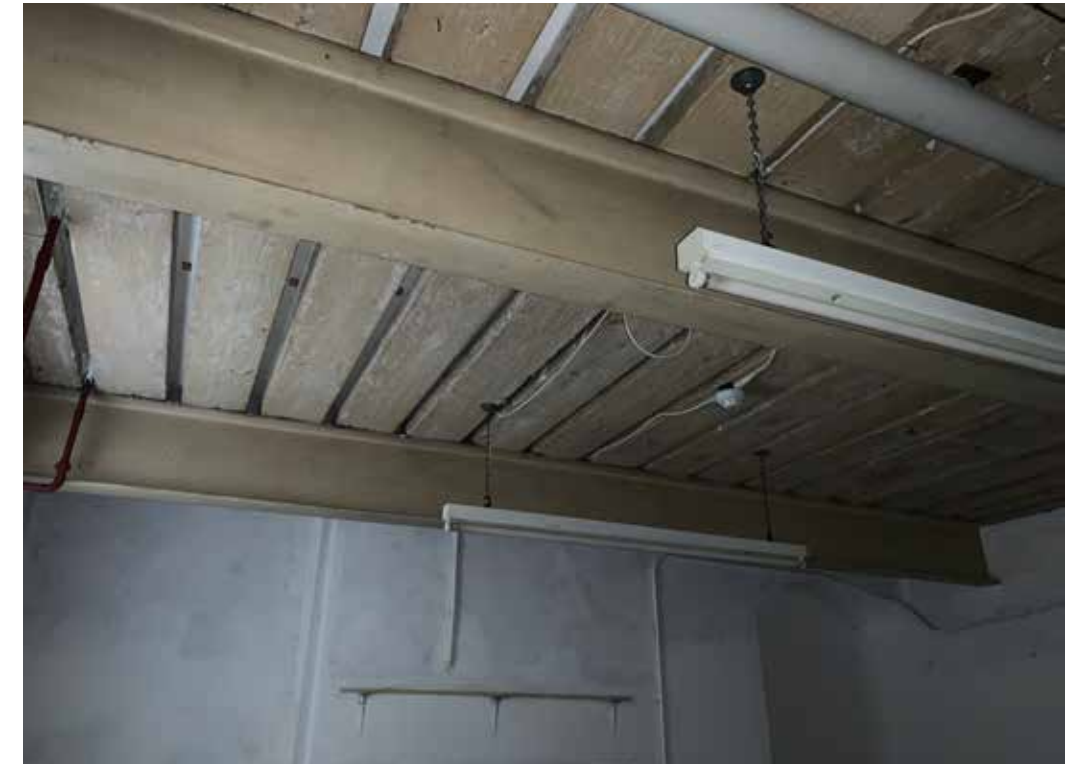
Figure 4.7 Modern ceiling beams and joists have been introduced in many rooms within the basement and replace historic features

- 4.17 While the nineteenth-century plan form of the basement has been maintained, the ancillary function and lower ground floor location limits their historic and architectural interest. The poor quality condition of the existing fabric further detracts from this interest, as does the insensitive presence of modern electrical and servicing equipment which has been fitted to walls throughout this space. There exist no features of artistic or aesthetic value at this level.

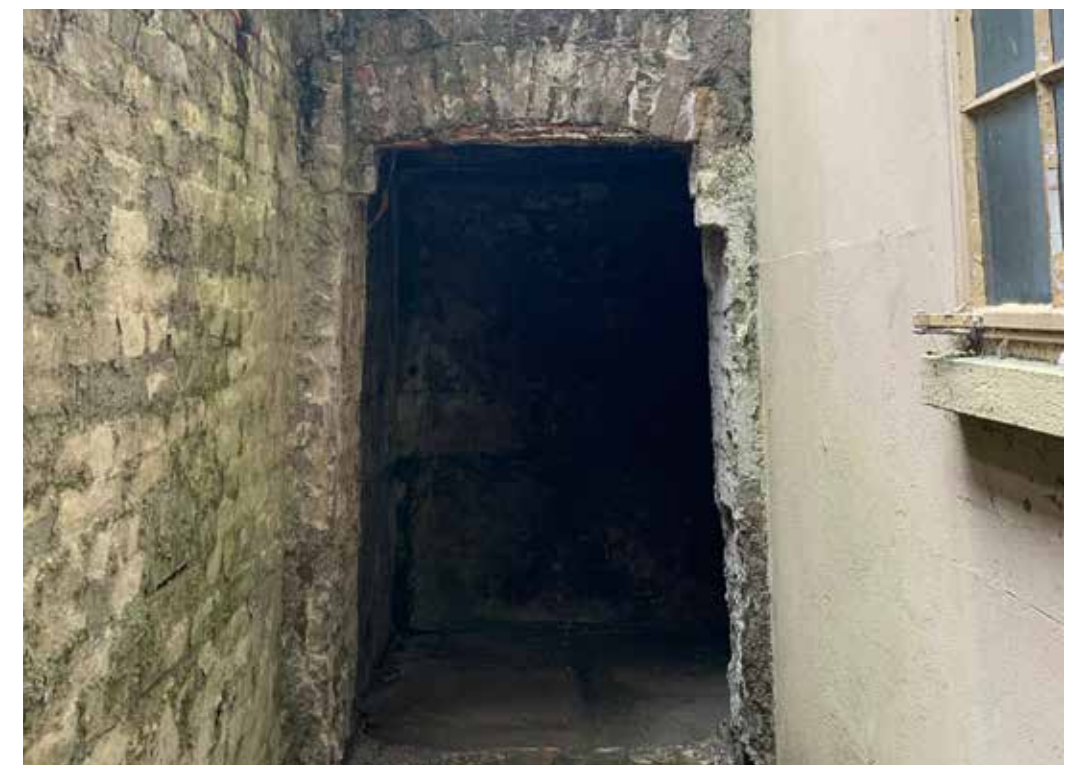
Figure 4.8 An historic external entrance survives at the rear of the basement but is in a state of disrepair

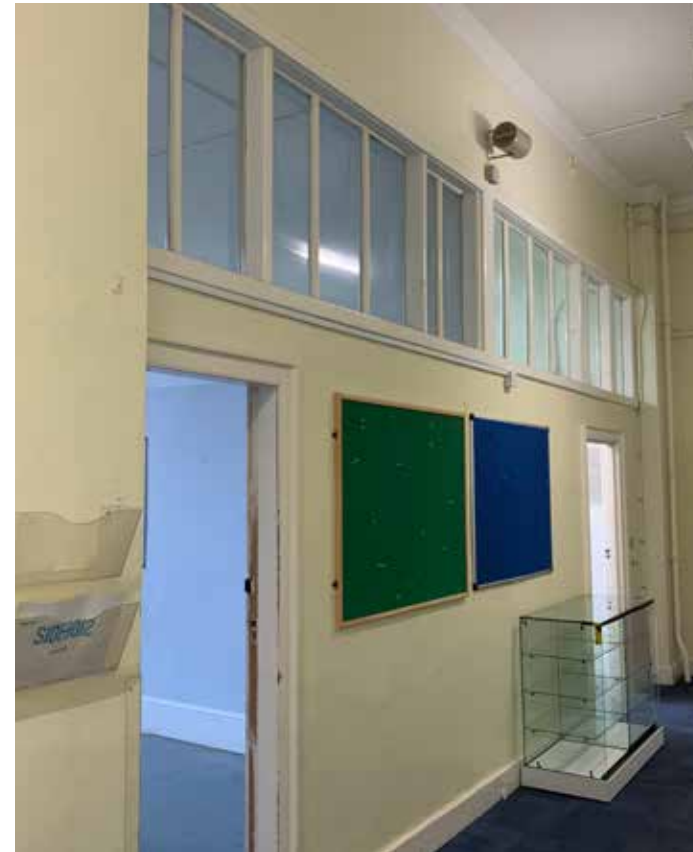
Figure 4.9 Detractive modern partition walls have been installed west of the main entrance hall. They comprise a plain design and have subdivided an historic classroom to create multiple rooms and a corridor

- 4.23 Where non-historic partitions remain in-situ within spaces such as historic classrooms located either side of the main entrance hall, they have limit any legibility of the rooms' historic functions. These features are thereby detractive from the historic value of the spaces and their removal presents an opportunity to better reveal their original plan form. This assessment is supported by findings presented within the 2020 Alan Baxter Report.

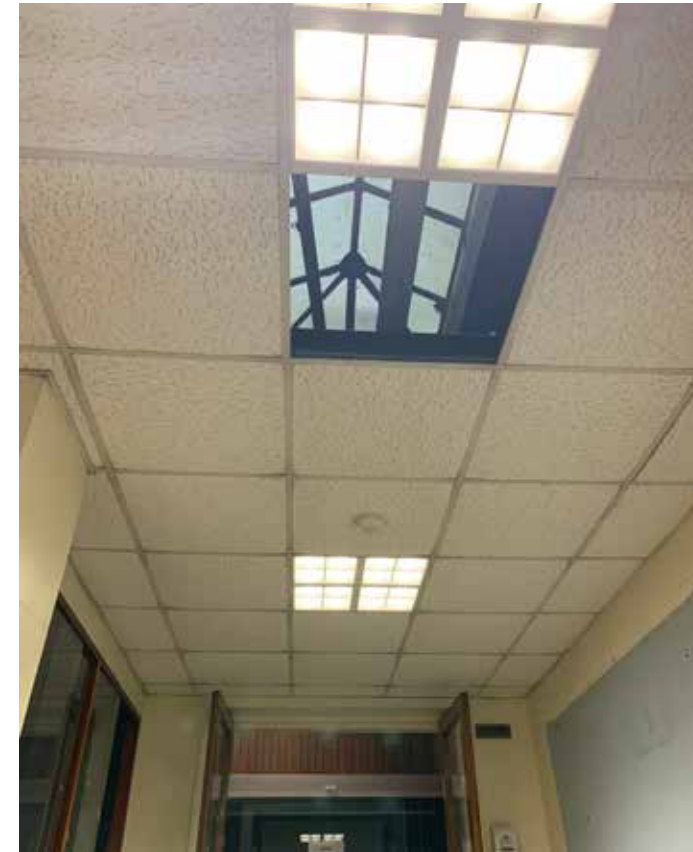
Figure 4.10 A modern dropped ceiling has been installed in the west-entrance corridor. It conceals the nineteenth-century skylight feature

- 4.22 An historic skylight, likely dating to the hall's alteration in c.1840s, is located within the western entrance corridor. It has partially been concealed by a detractive suspended ceiling. This feature is in poor condition and its rubber seals are compromised by weathering and asbestos. There is an opportunity to improve the contribution of this feature to the hall's significance by enhancing its current poor condition.

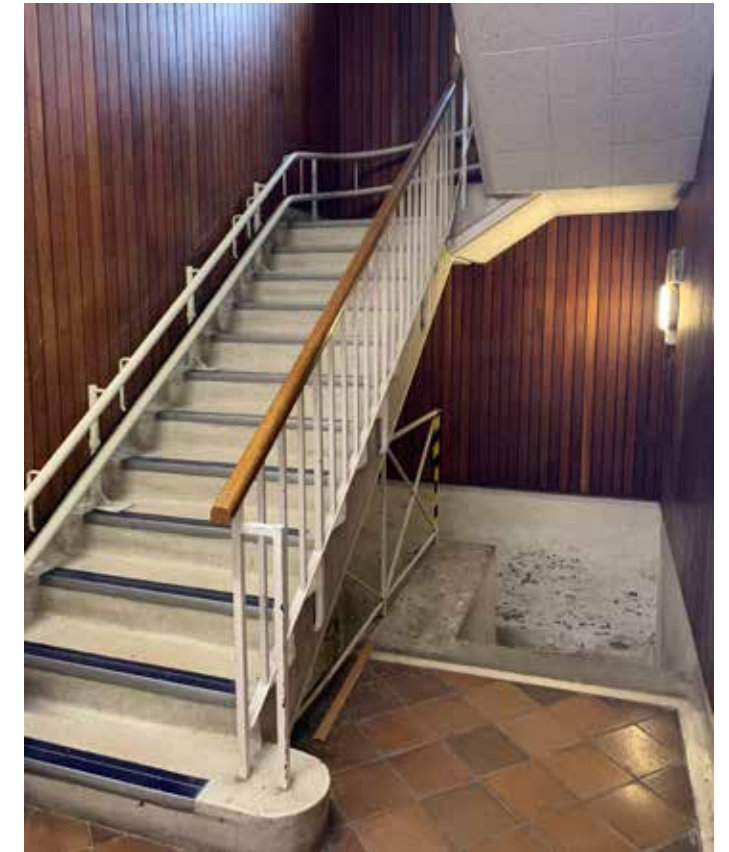
Figure 4.11 A staircase hall located on the east side of the building. Its staircase comprises modern fabric with a plain design and its walls have been covered by timber panelling

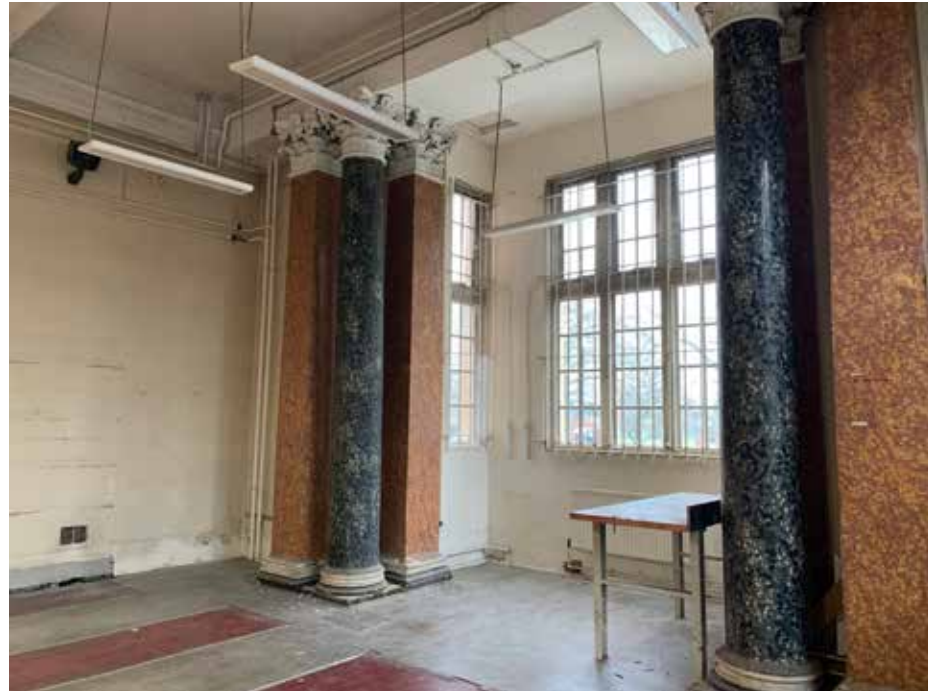
Figure 4.12 Columns, believed to be the 'scagliola columns' identified by the 1841 survey, survive in their early-eighteenth century situation in the east wing. Alterations to the room have resulted in their awkward interaction with the alternating ceiling level.

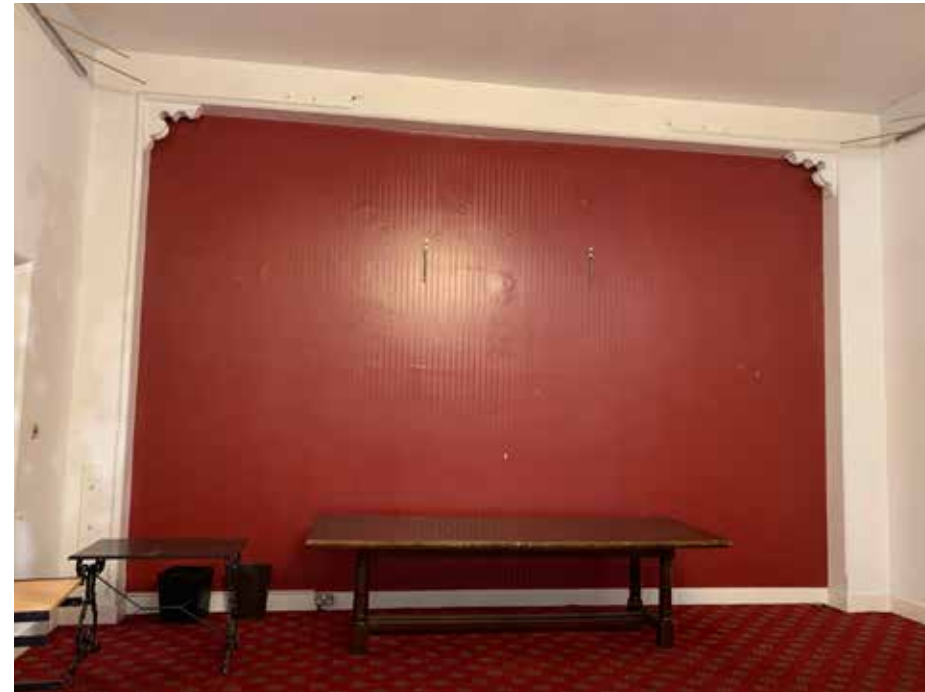
Figure 4.14 The north wall to the main entrance hall is possibly an original feature which has likely been altered by the construction of frame that supports the Chapel located above

- 4.29 It is theorised that the chapel located at this level was a later addition to the building, following soon after alterations carried out by Mair. 1844 plans of the upper levels of the building appear to show an empty, vaulted space with no entrance, suggesting that at this time, no proposals for a chapel had been produced. Existing wall and ceiling braces located in the main entrance hall directly below the chapel further suggest that a first floor was installed retrospectively.

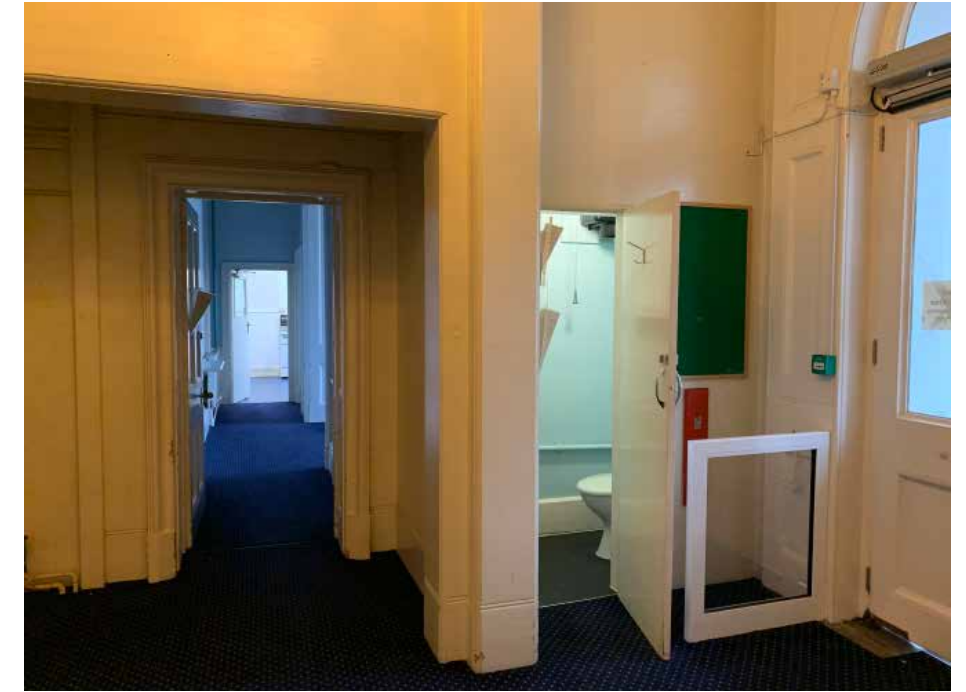
Figure 4.16 The plan of the rear entrance hall has been much altered by the blocking up and creation of new openings.

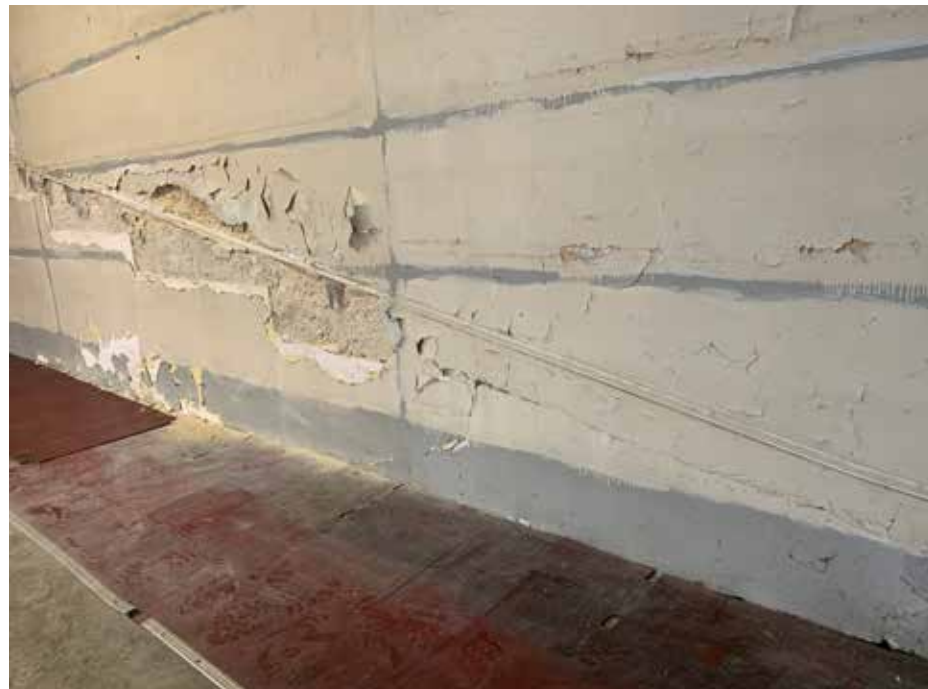
Figure 4.13 Elements of chasing within plastered walls of the front, eastern classroom reveal the position of historic tiered seating

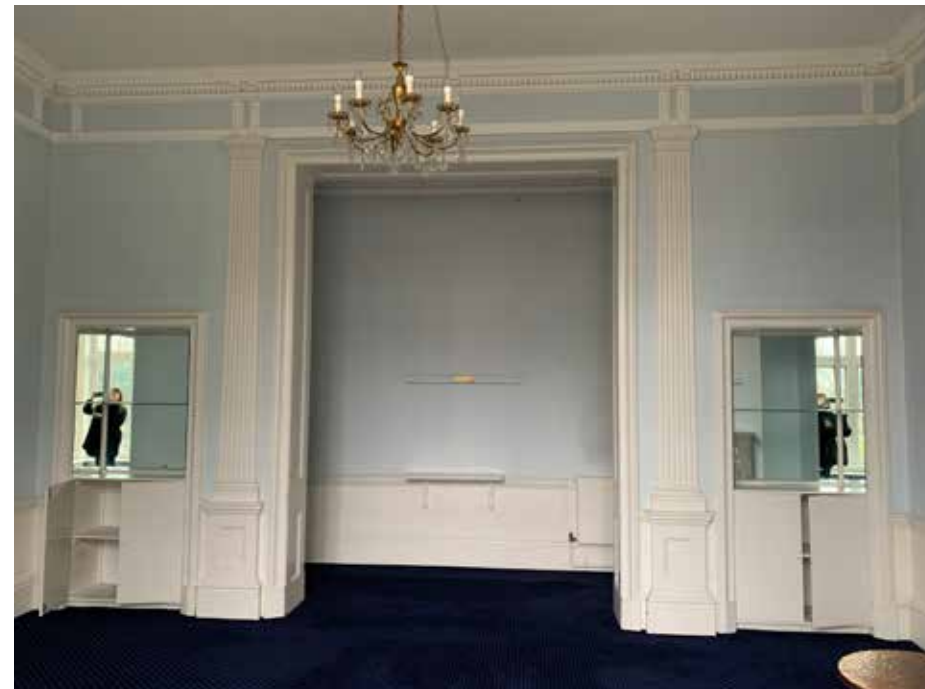
Figure 4.15 Openings in this wall, located behind the rear wall of the main entrance hall, have been infilled with modern cupboards. These features are considered to detract from the interest of the room

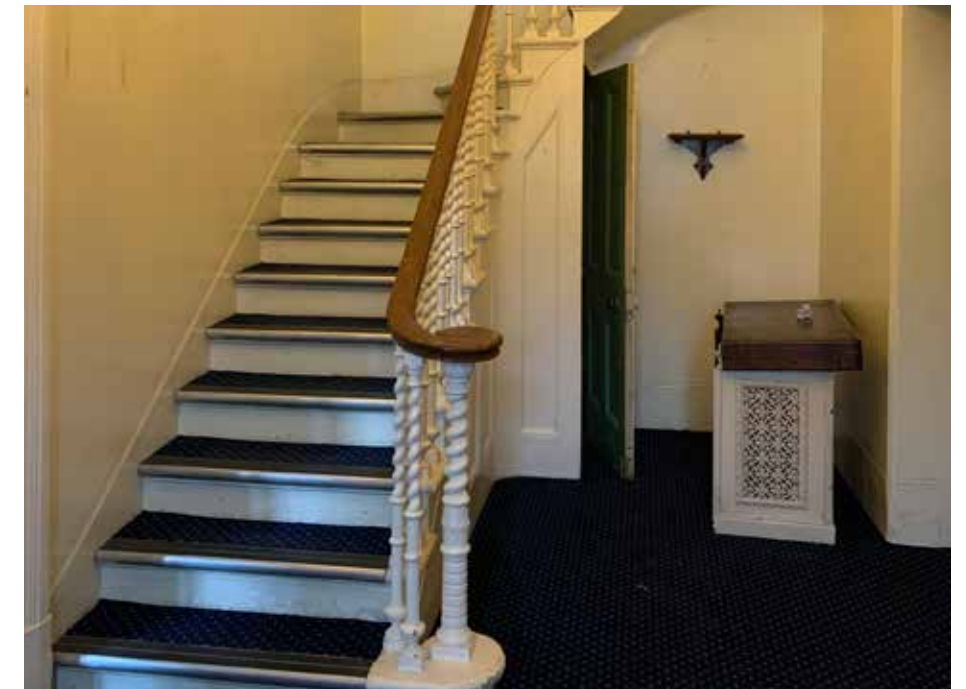
Figure 4.17 A historic staircase survives in the rear entrance hall. Modern carpet and nosings have been fitted to its treads and detract from its interest. Chasing in the plastered wall to the right indicates the historic location of an additional flight of stairs

- 4.19 In many cases, these rooms also retain historic decorative features such as window architraves, fireplaces, ornamental ceiling or wall plasterwork, cornicing and skirting. Where these features survive, they provide a source of interest within their respective spaces. Evidence of lost features or historic alterations to the fabric of interior spaces is also sporadically present. For example, chasing within the plastered walls of the rear entrance hall at ground floor level indicates the former extent of the basement staircase within the space [Figure 4.17].

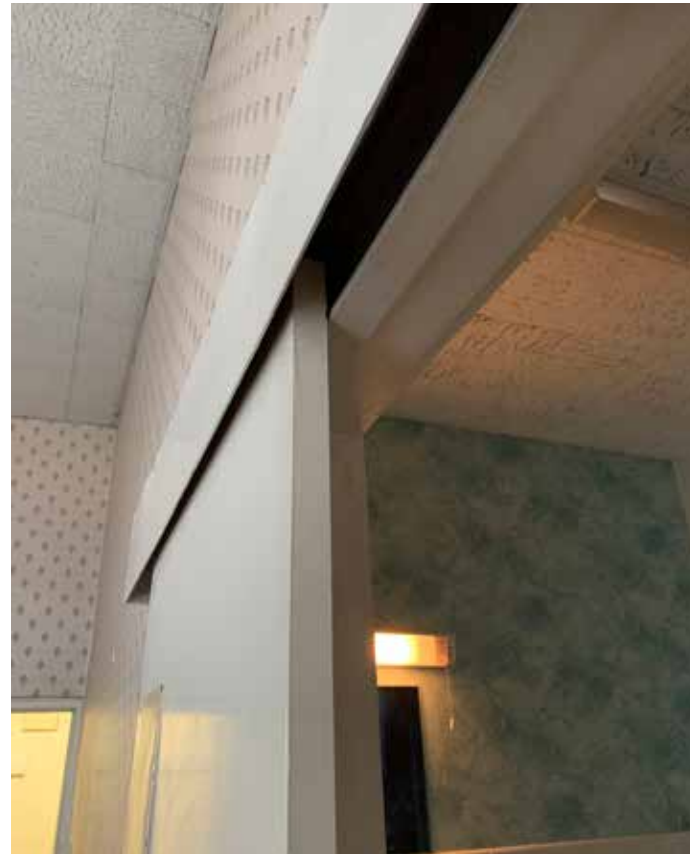
Figure 4.18 An example of the many modern partition walls introduced to subdivide historic spaces in the building. Modern dropped ceilings have also commonly been installed. The room in the photograph has been created through the subdivision of the former Vice Principal's bedroom and sitting room

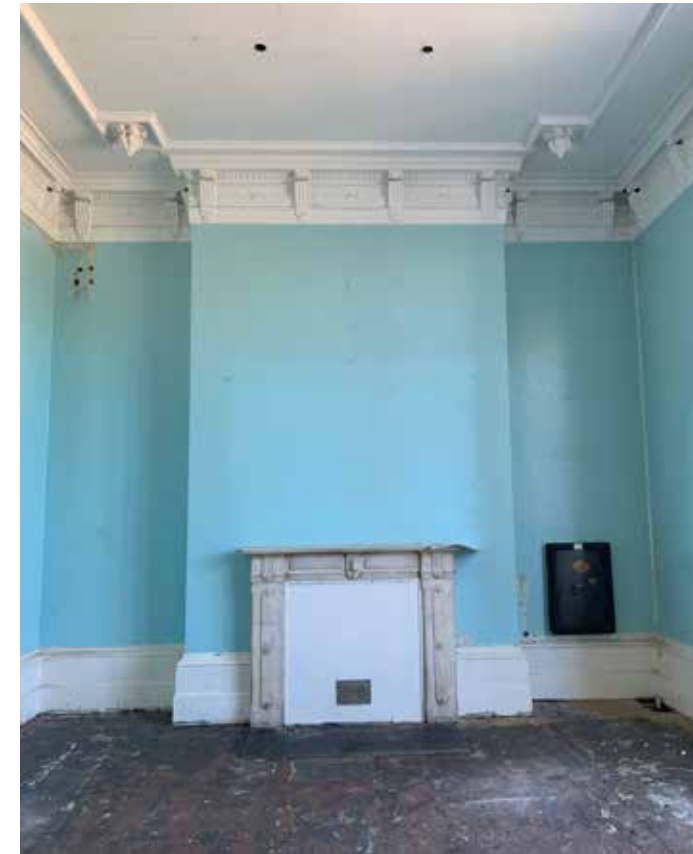
Figure 4.19 Where historic decorative features survive in situ, such as this fireplace, cornicing and ceiling moulding, they provide a principal source of interest

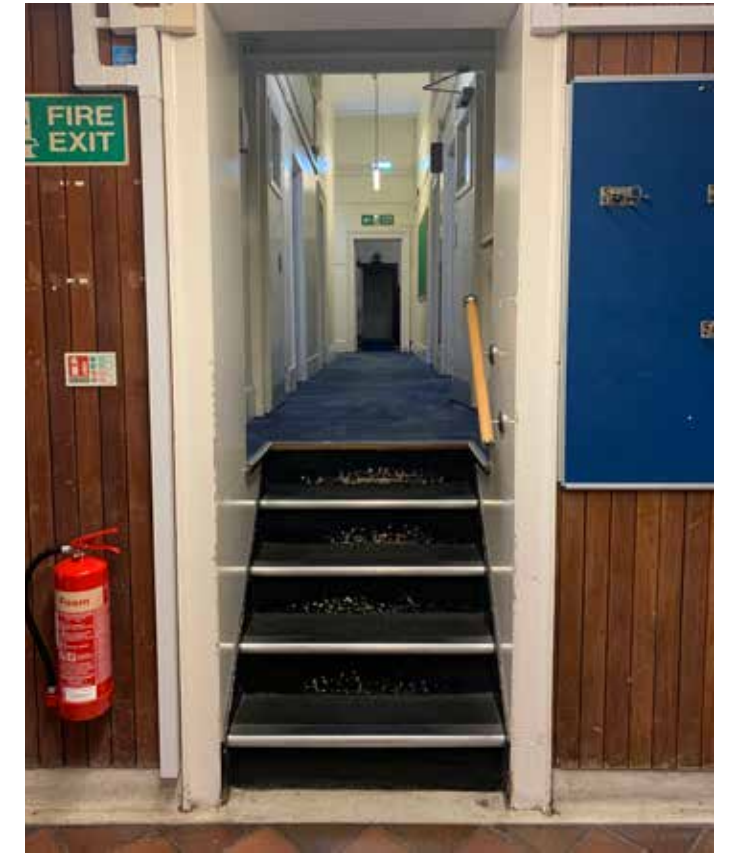
Figure 4.20 A set of steps connecting the 1970s staircase and adjacent corridor is considered to detract from the significance of the building

4.33 The 1970s stairwells located to the east and west of the building are considered to hold neutral significance due to their relatively sensitive integration into the much-altered layout of the building and their plain decorative finish. Nevertheless, there is an opportunity to improve the quality and role of these staircases within the circulation of the hall. For example, the western staircase is believed to have been created through the adaption of an historic stairwell and derives some interest through this quality. However, the resulting alteration in floor levels here - negatively perpetuated by a set of steps - is considered to detract from the interest of the space [Figure 4.20].

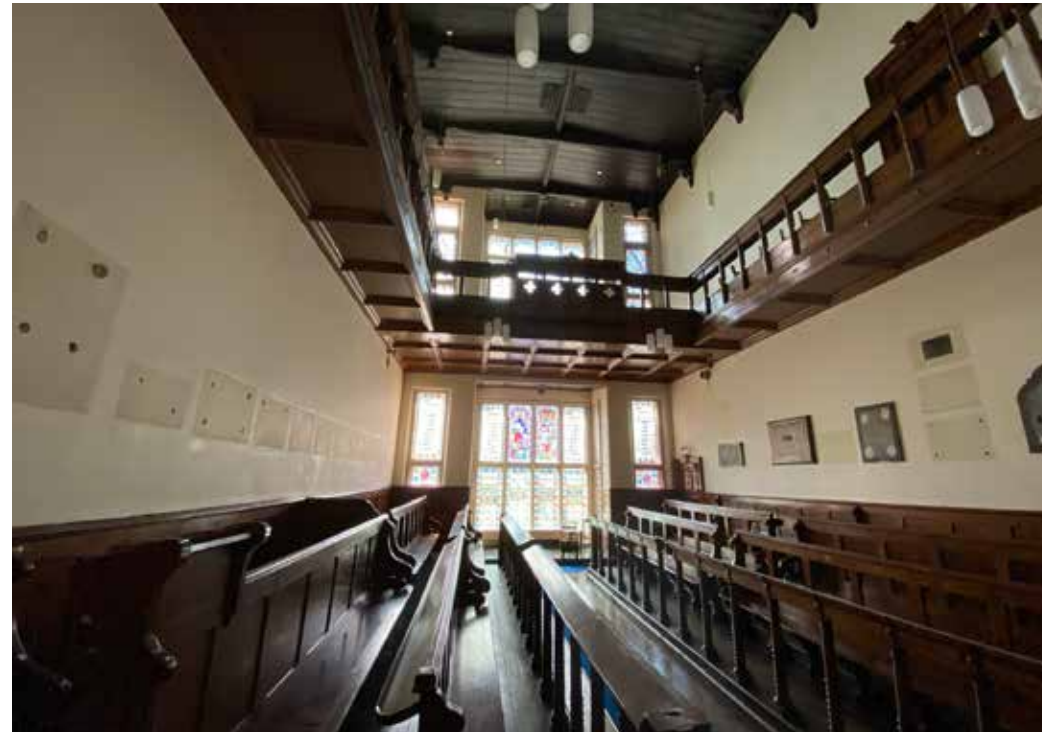
Figure 4.21 The chapel of the hall retains its historic pews and timbered ceiling. These features provide a source of interest to the building

4.31 Features such as the full-height bay window, decorated with stained glass, the carved timber pews, gallery, doors, ceiling and screen are a source of high architectural and historic interest in this space. Very few modern features have been fitted within the room, thereby maintaining its high significance.

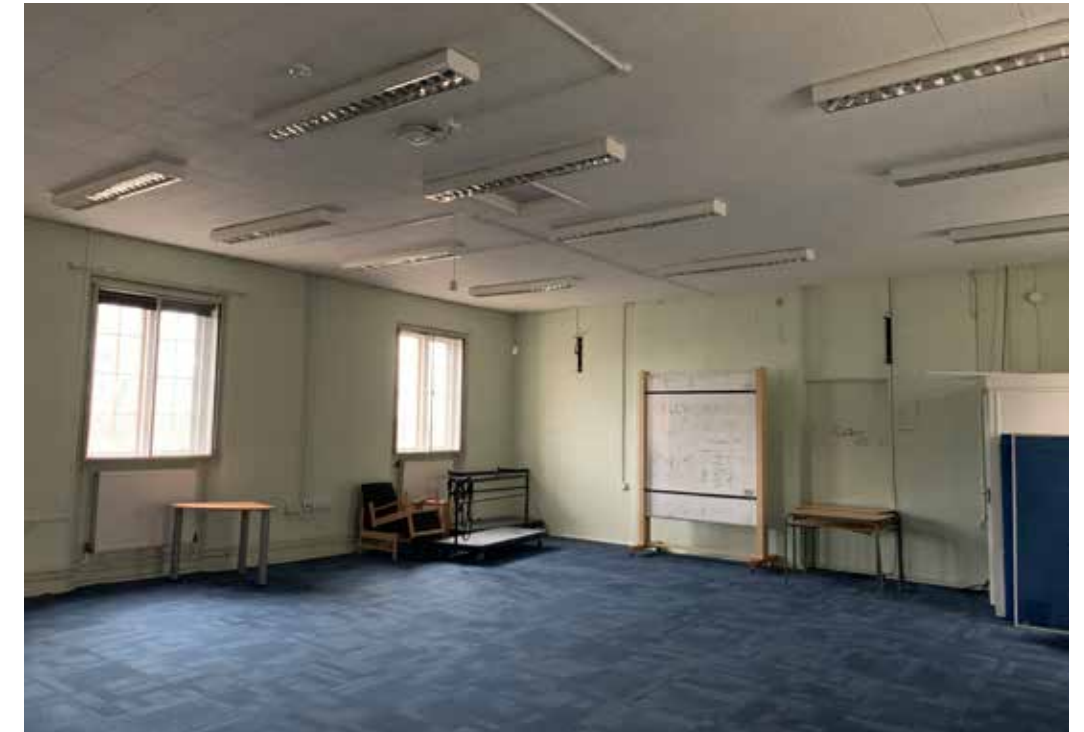
Figure 4.23 A modern dropped ceiling, window grilles, carpet and electrical fixtures have been installed in a front classroom at second-floor level

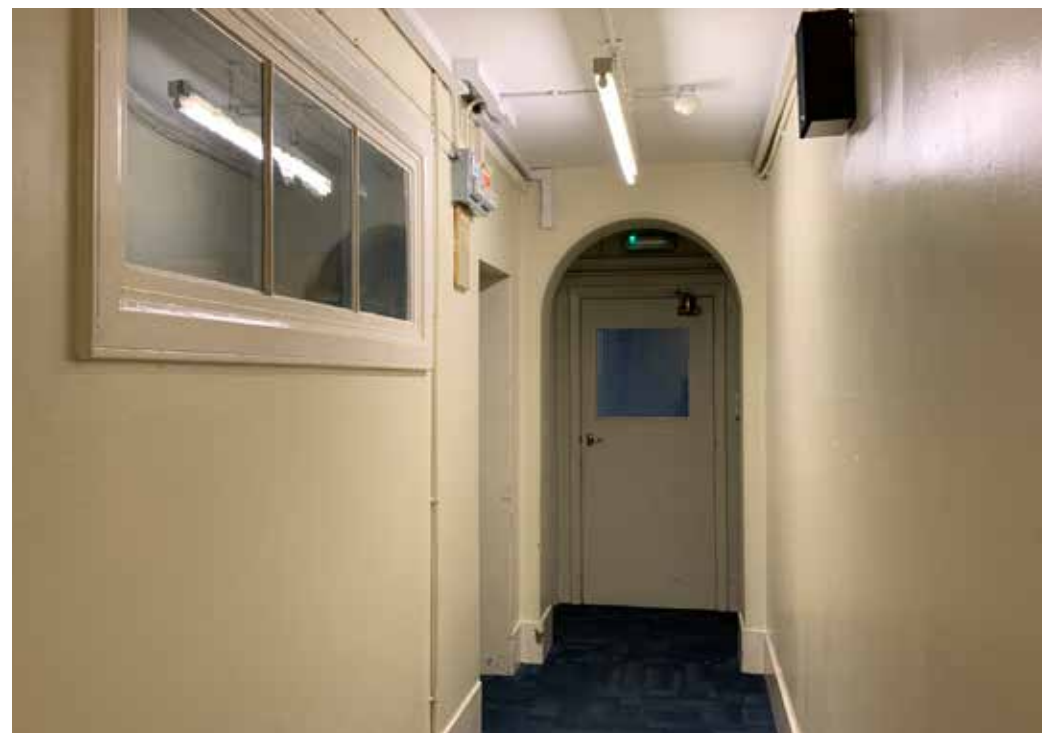
Figure 4.22 Historic arches located at either end of the rear corridor, located behind the chapel at second-floor level, provide a source of interest to the building

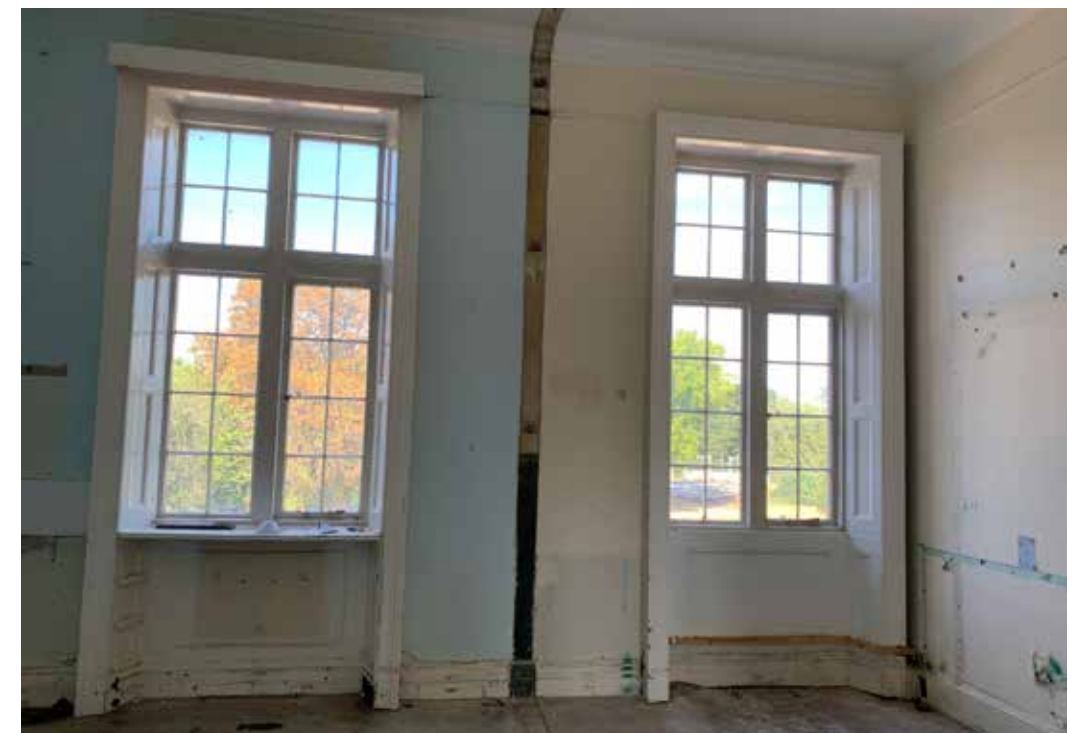
Figure 4.24 A detractive, modern partition has been removed as part of consented enabling works. This exemplifies how the removal of such partitions can reinstate the historic volume of spaces and enhance their significance
