Planning, Design, Access and Heritage Statement – Kneller Hall, Kneller Road, Twickenham, TW2 7DN

“Works to Band Practice Hall comprising repair works to cracking to external walls; underpinning works; localised repair works to slate roof; and internally removal of the internal back wall, introduction of new structural truss and structural tie, and raising the existing ties by 800mm.”

Condition Report
STRUCTURAL / CIVIL ENGINEERING

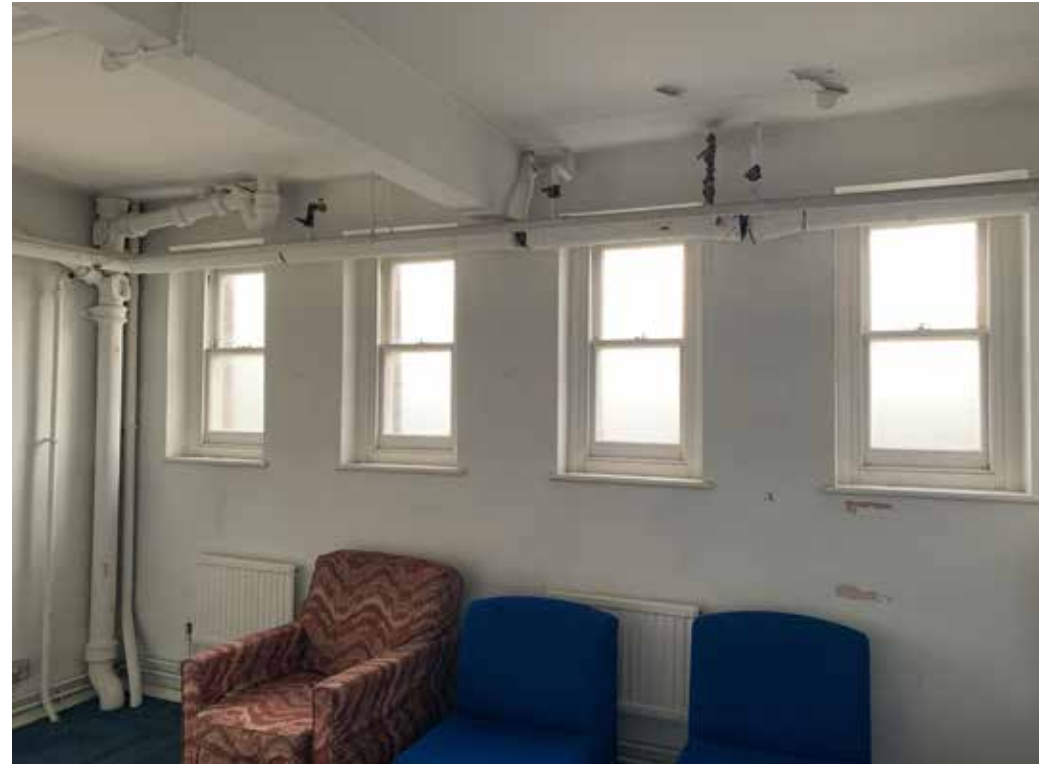
Figure 4.25 The presence of modern MEP equipment is typical within rooms located in the west wing

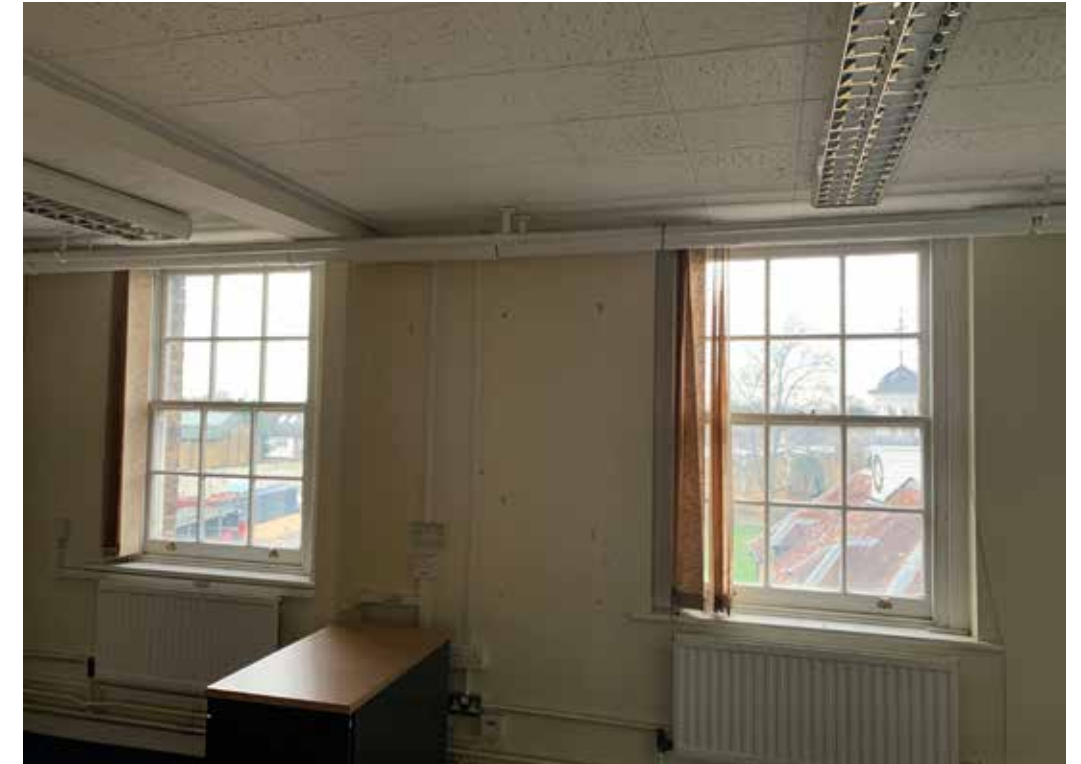
Figure 4.27 A typical modern dropped ceiling located within the west wing conceals the tops of historic windows and negatively alters the historic volume of the space

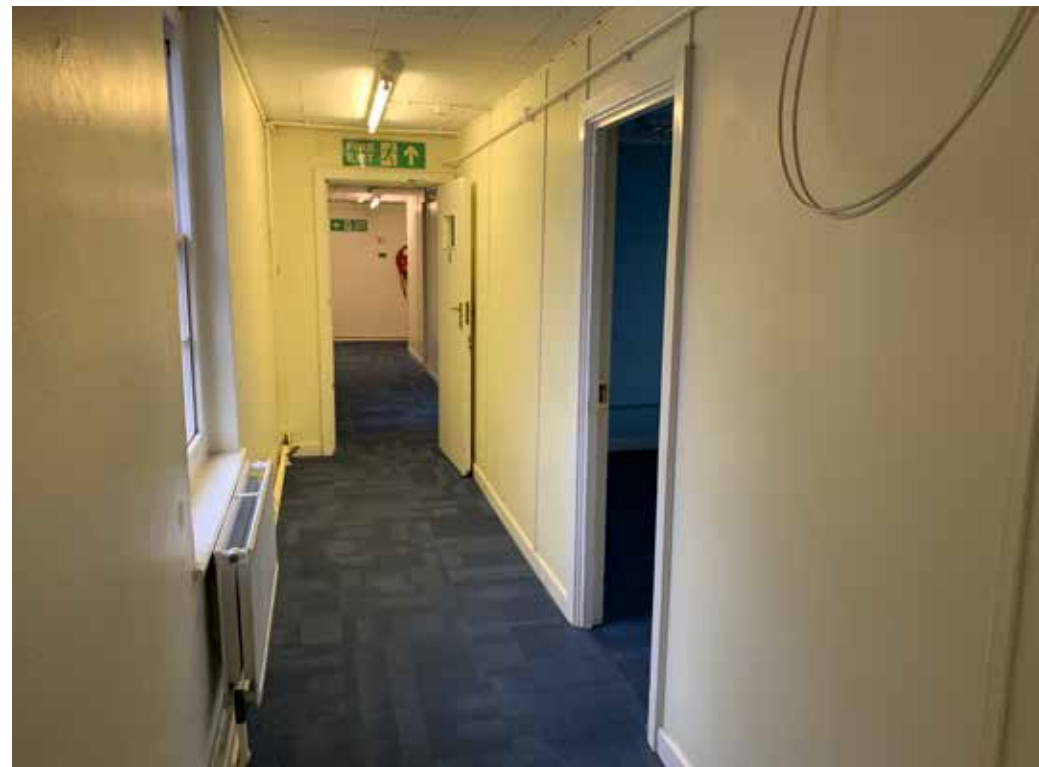
Figure 4.26 Modern partition walls have been introduced into the west wing to create corridors

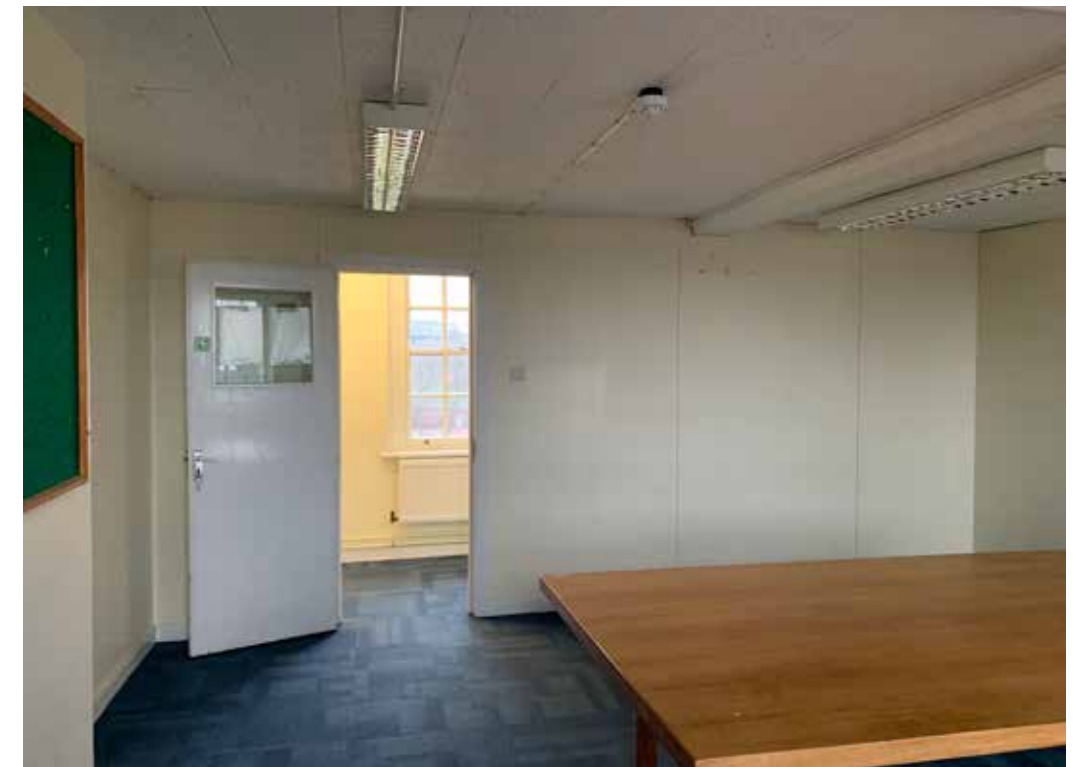
Figure 4.28 Modern finishes typically installed within rooms located in the west wing include partition walls, suspended ceilings, light fixtures, doors and carpet

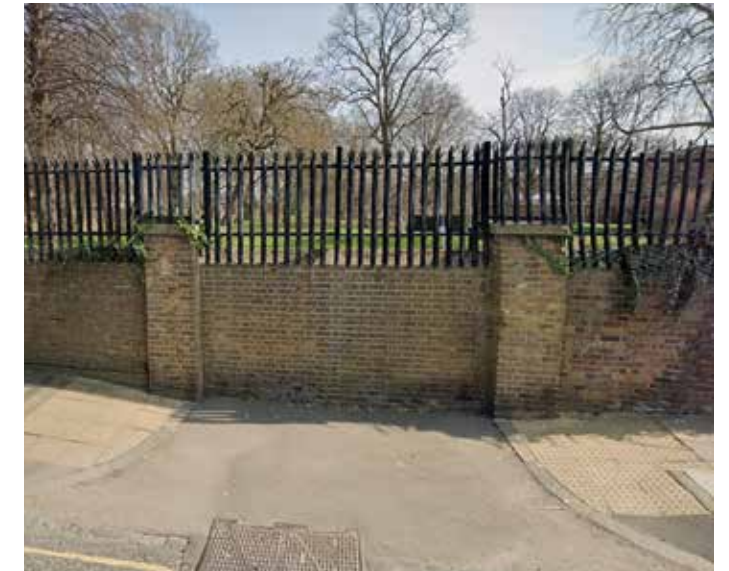
Figure 5.3 Photograph of the existing blocked gate entrance on the west boundary wall of the Site

- 5.37 The entrance derives interest from its status as former access point and expressed role within the circulation of movement throughout the Site. It has experienced extensive alteration through various poor-quality reparations and infilling, and is less sensitive to change. This area of wall is considered to derive interest from its historic function as a secondary entrance to the Site. It derives limited interest from the brick piers which allude to this former function, however the current condition of the entrance, being blocked and in a state of disrepair, is considered to detract from the overall significance of the listed wall.

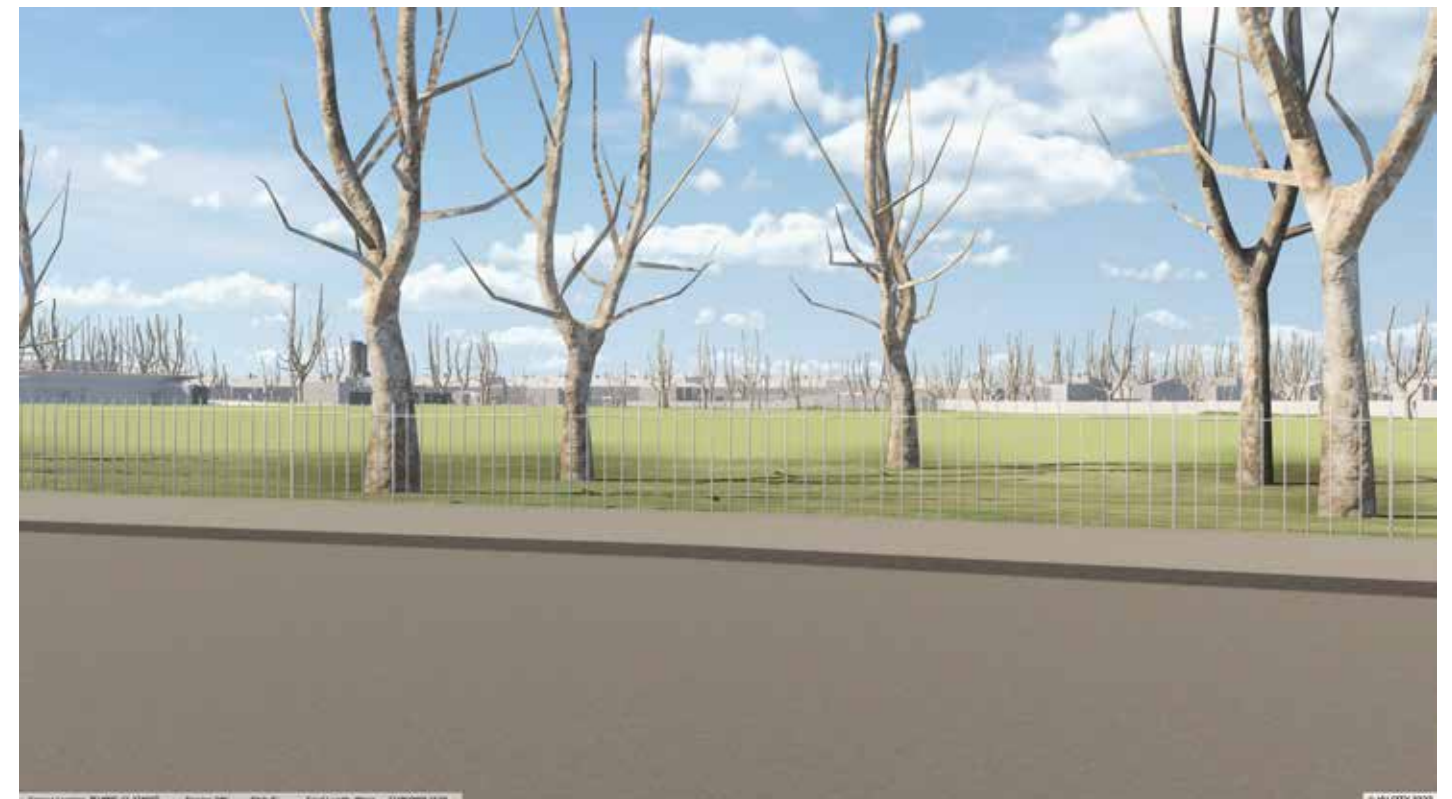
Figure 6.20 Proposed

- 6.24 The proposed development will cause very little change to this view. The new sports pavilion makes a slight improvement to the architectural quality of the view, however the open field will be maintained as a principal source of interest within the view.

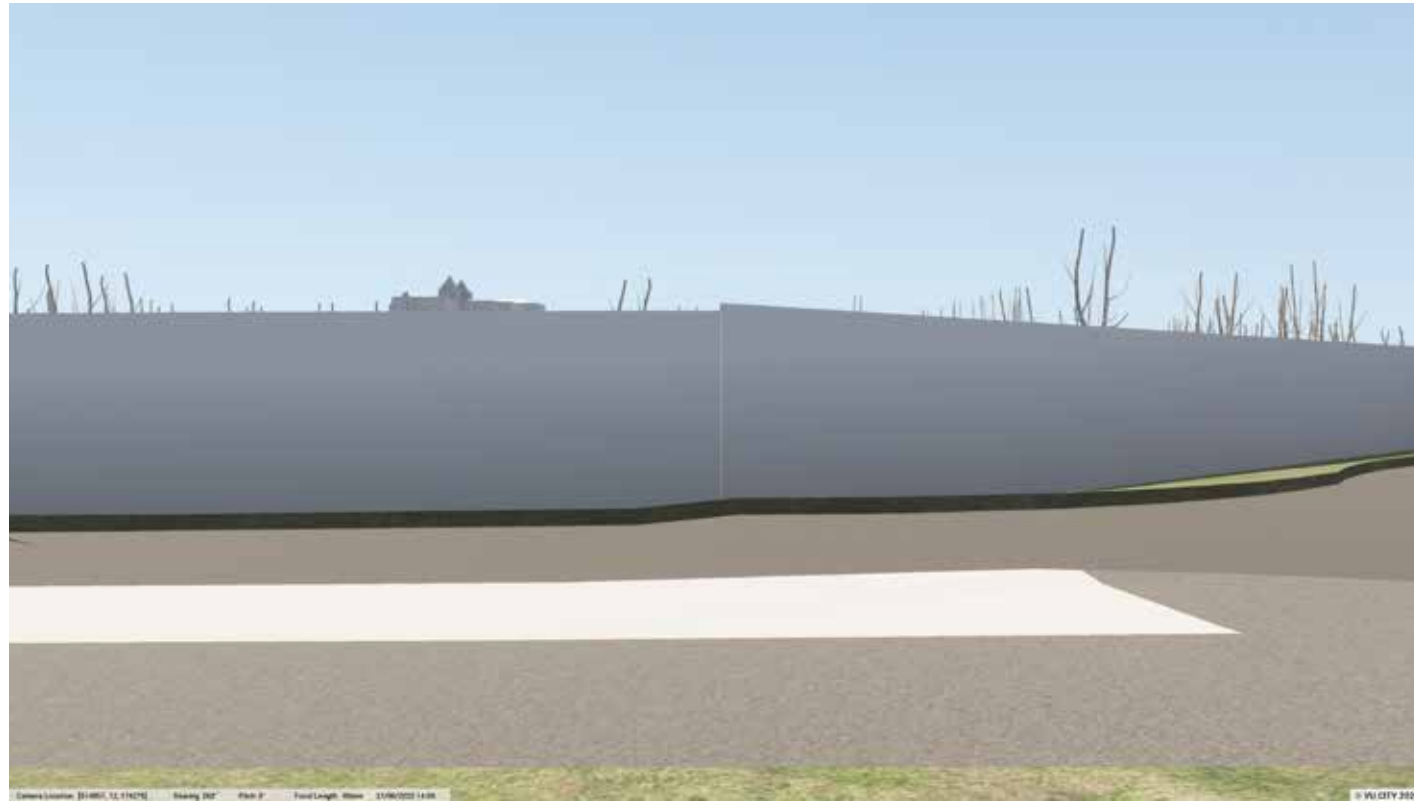
Figure 6.22 Existing

- 6.25 Buildings within the Site are predominantly concealed from the view by the boundary wall. In reality, this boundary is railed, however build forms are nevertheless obscured by their location at the far end of the view. Part of Kneller Hall's roofscape is visible above the Site boundary.

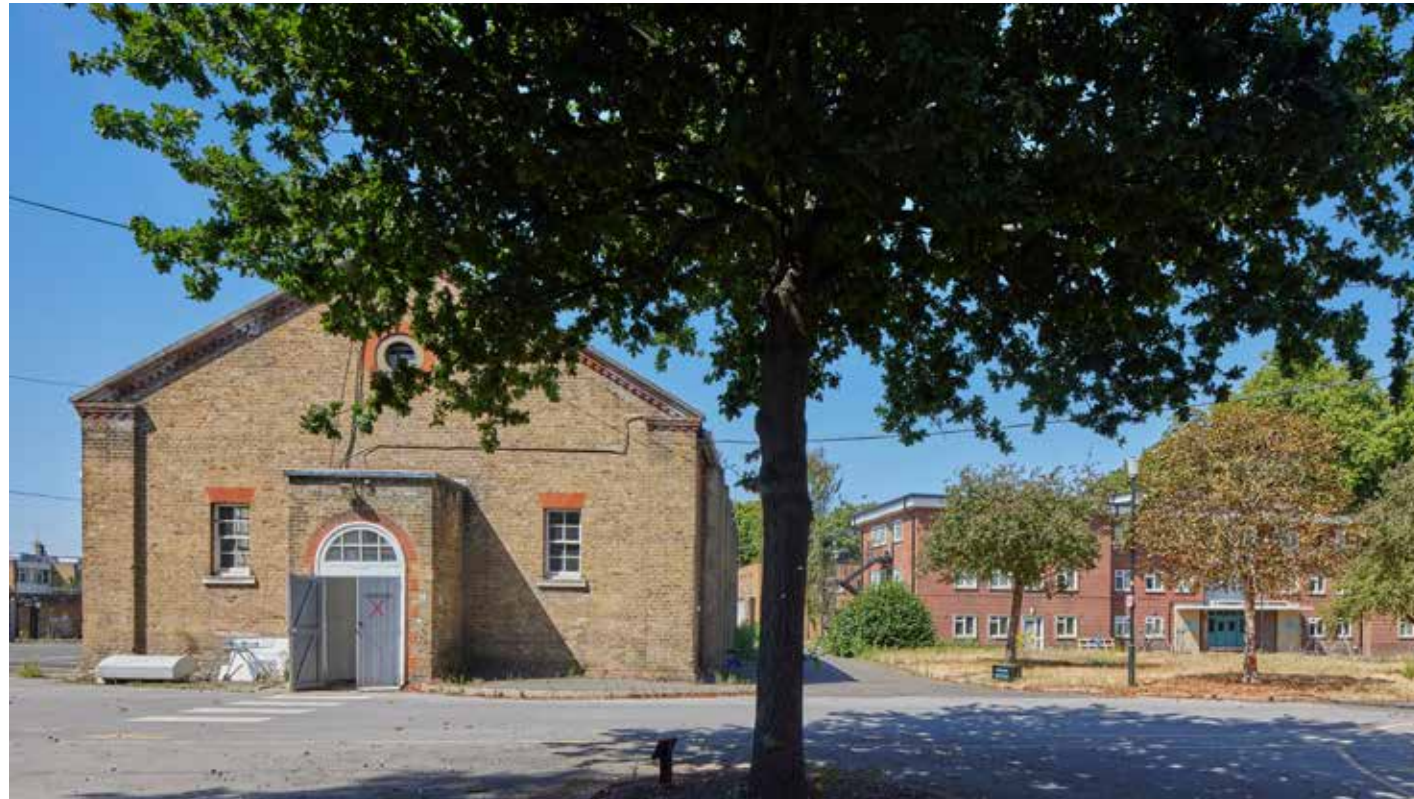
Figure 6.27 Existing

The curtilage listed Band Practice Hall is located in the middle-ground of this view. The setting of this asset does not appropriately respond to the significance of the asset, being composed of detractive tarmac landscaping and poor-quality 1960's buildings. There is an opportunity to better express the significance of the asset and enhance its setting through improvements to its landscaping.

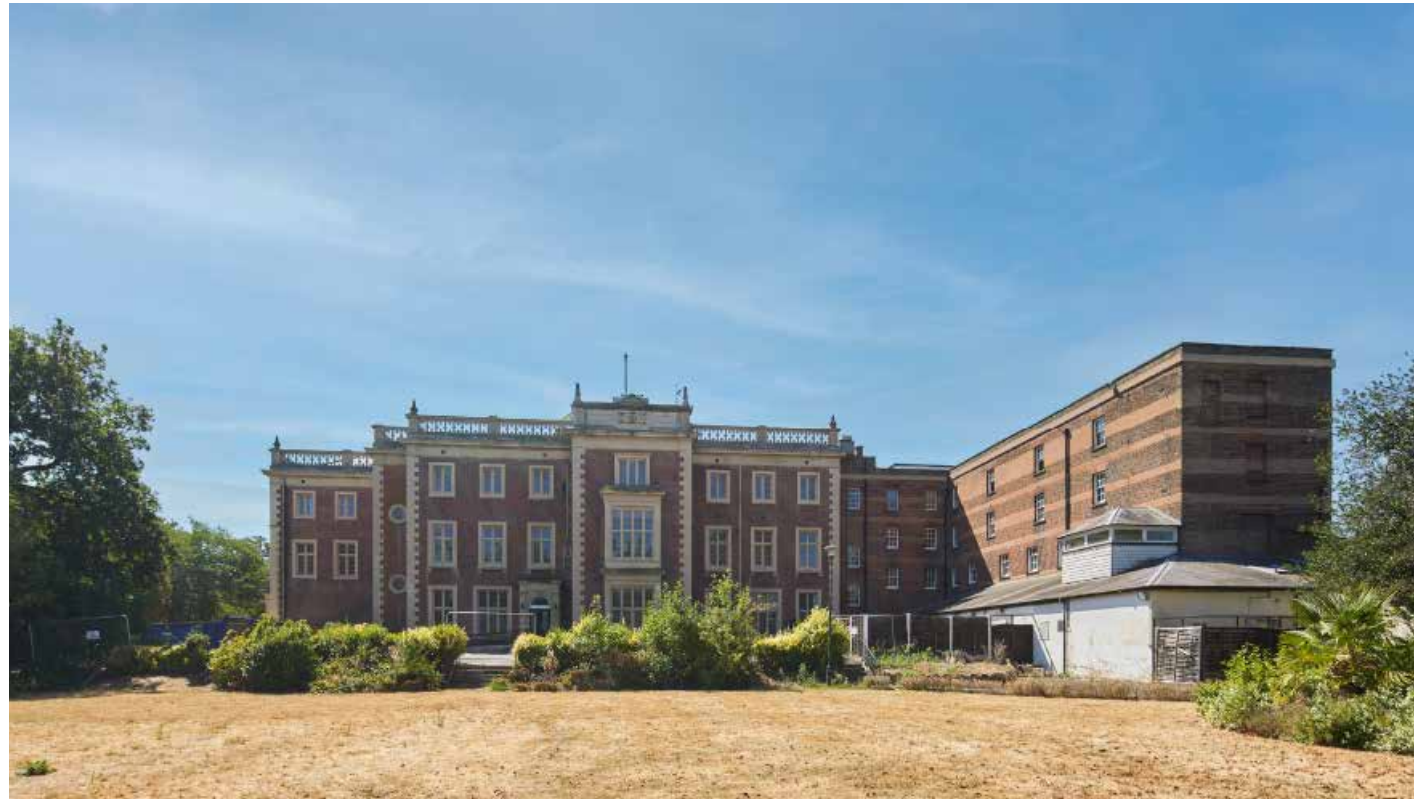
Figure 6.29 Existing

- 6.34 Currently, this view harms the asset; the dilapidated extension and numerous add-ons in the form of steel fencing detracts from the Hall's significance. The landscaping has been largely lost and no longer compliments the Site's primary purpose as a location of relaxation.

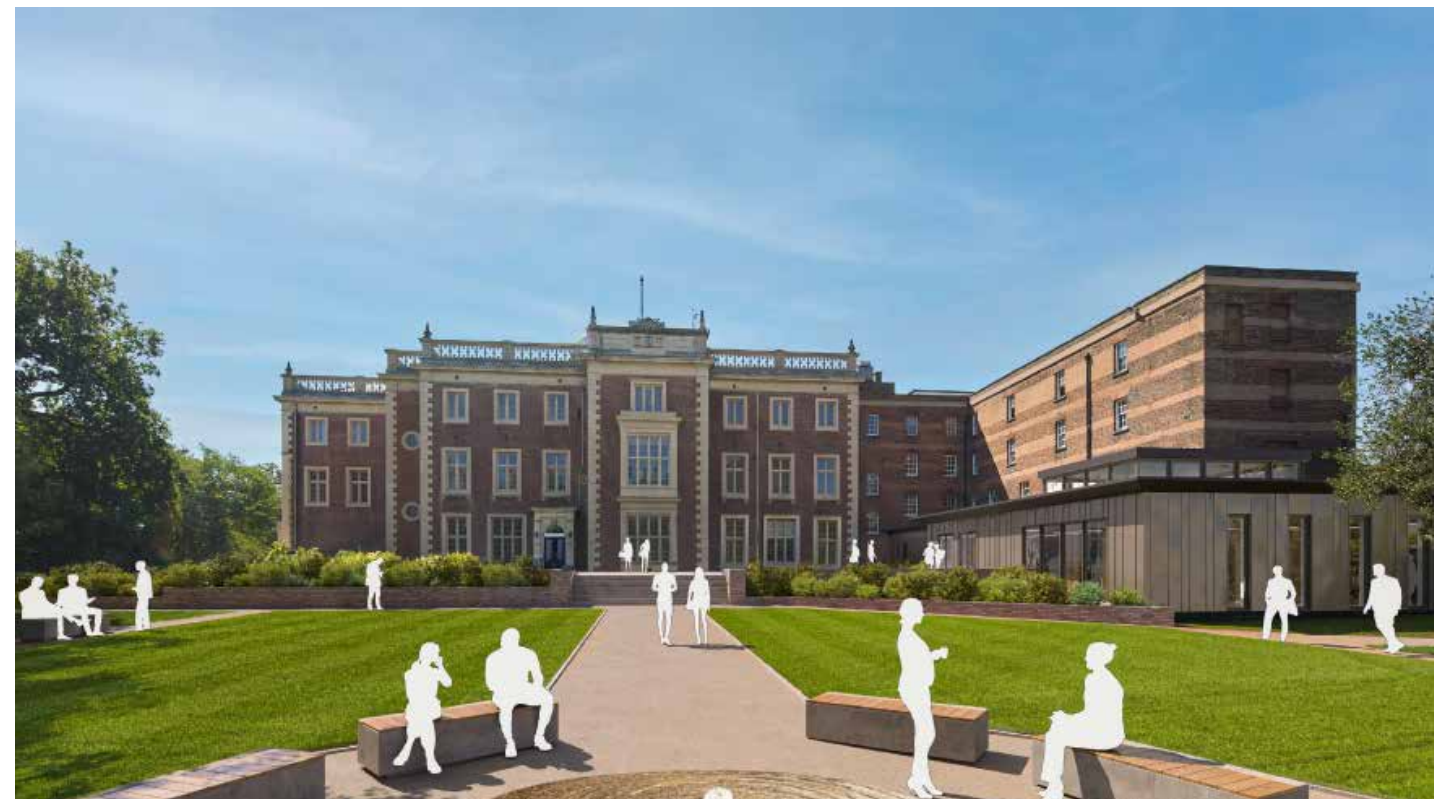
Figure 6.30 Proposed

- 6.35 Currently, the proposed replacement of the detractive addition that abuts the west wing of the Hall would be an improvement upon the existing view. The vertical massing of the proposed structure is less than the current building, whilst the proposed lantern-styled flat roof ensures a more subtle and better connection to the main building. The setting of the listed buildings in relation to the wider landscape and the extension's footprint would also be improved upon. The proposed extension creates better harmony with the hall's historic function as a relaxation space and the construction palette evokes the tranquil character of the setting.

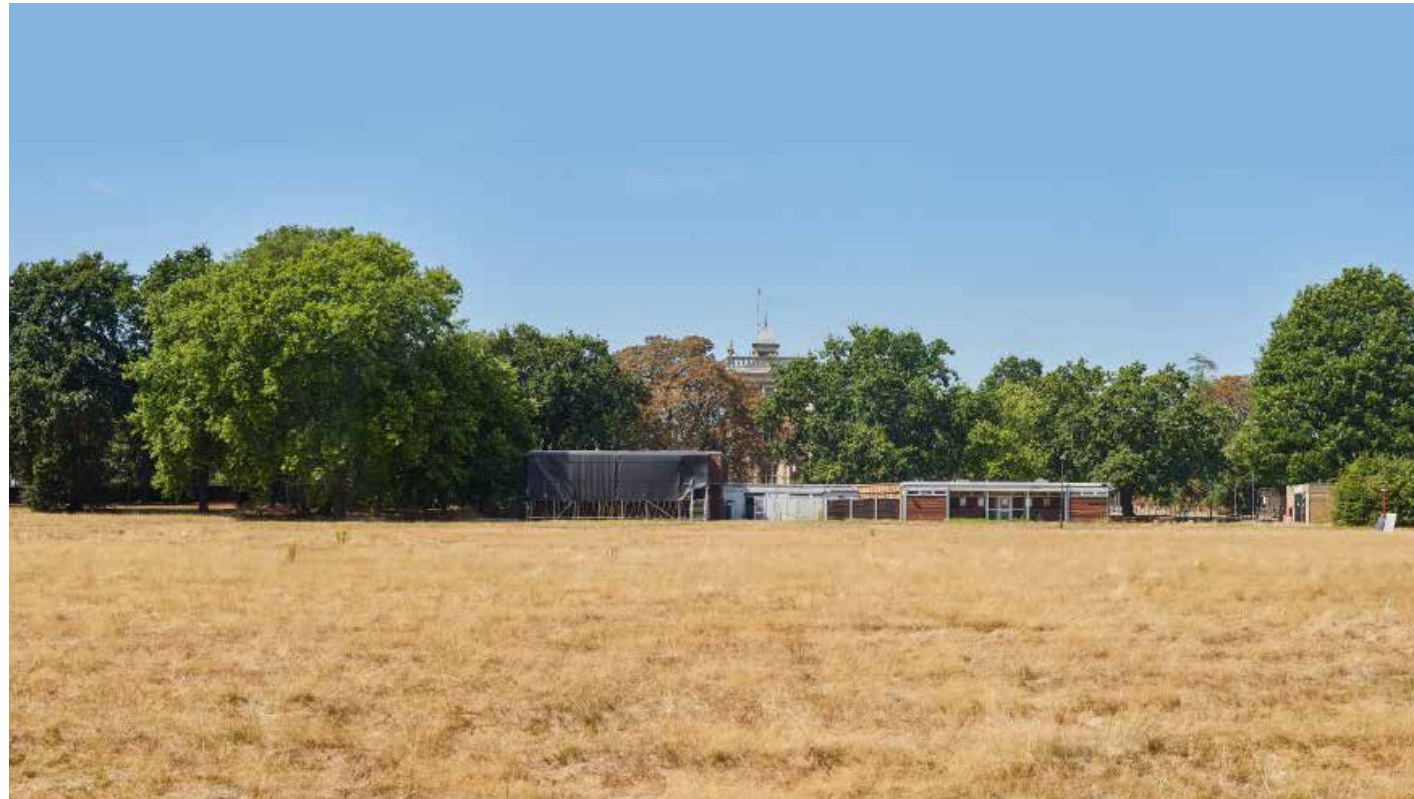
Figure 6.31 Existing

- 6.36 The plain design makes a neutral contribution to this view and the setting of the Listed hall. It stands as an abstract built form that showcases no relatable functionality to the wider setting.

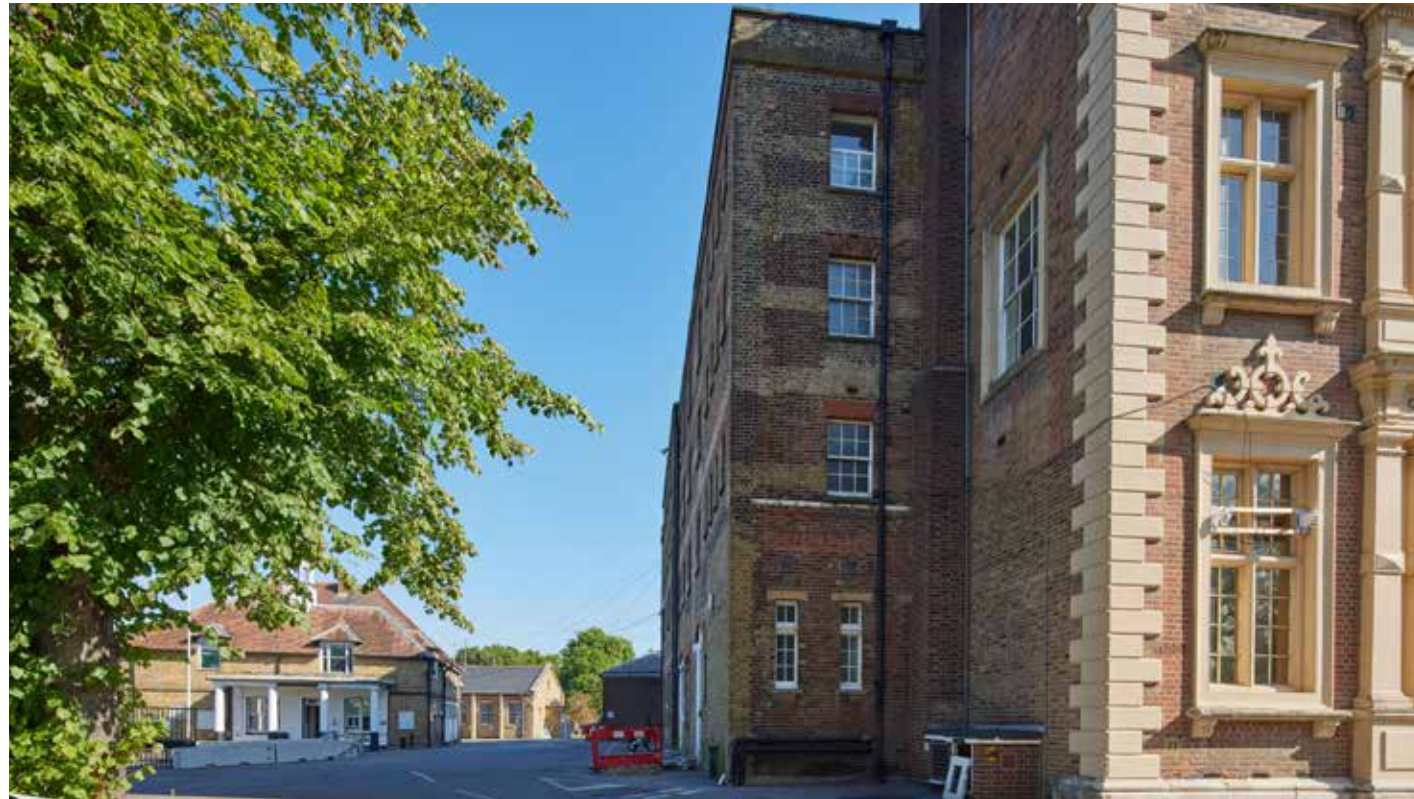
Figure 6.33 Existing

The existing view captures the former yard space between the Listed hall and the curtilage listed buildings. It is a significant view within the Site due to its historic associations with its historic development. Unfortunately, the view fails to express the ancillary character of this area and its poor-quality landscaping and in-distinguished use do not reflect the significance of the view.

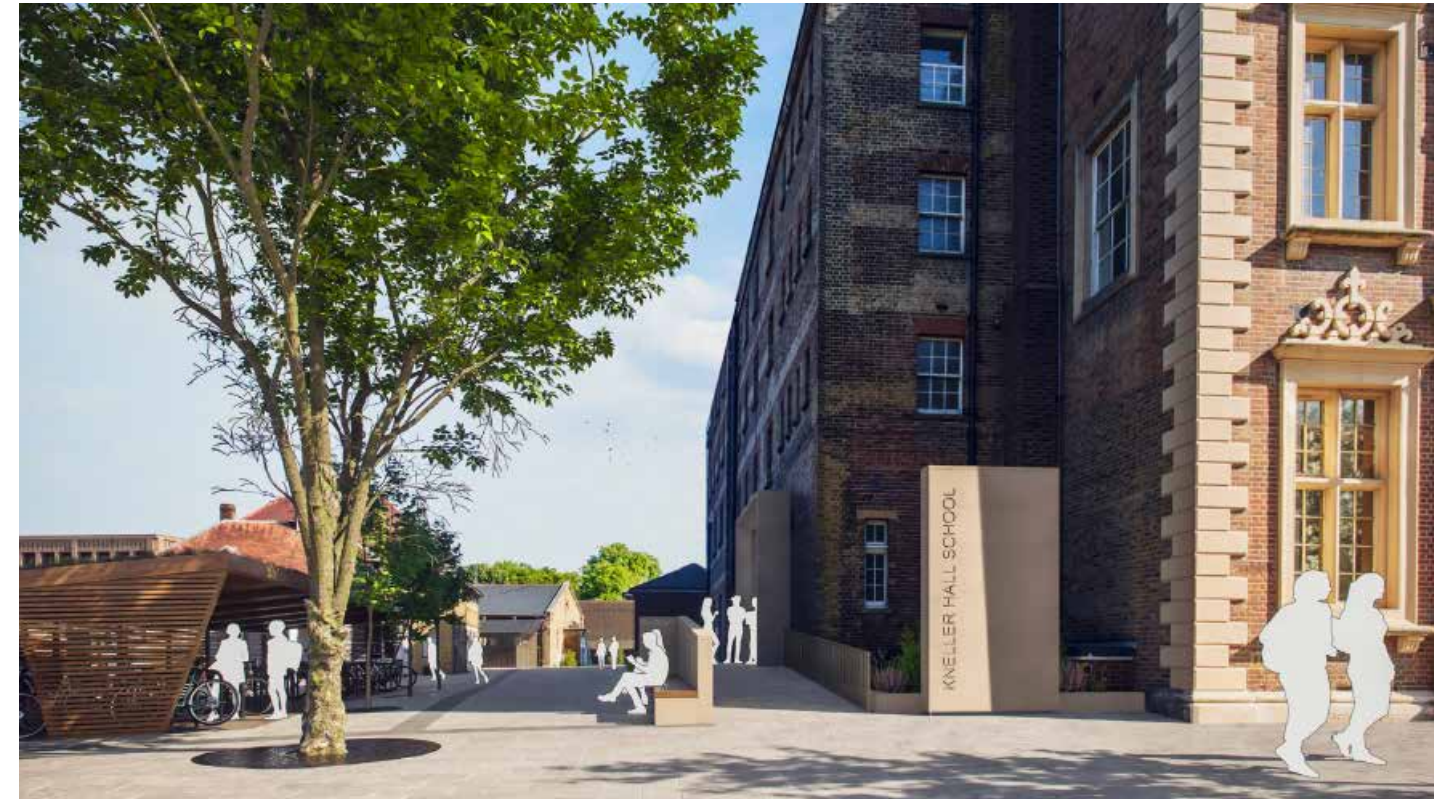
Figure 6.34 Proposed

- 6.39 The propose ramp and signage is considered to better express the main entrance of the hall and improve its overall architectural quality and interest. These new elements are deliberately arranged to mitigate protrusion into the yard space. Whilst their minor change to the layout of the space is considered to cause a small amount of harm to the settings of Listed and curtilage listed buildings, this harm is mitigated by landscape improvements to the yard.
