# BS5837 Arboricultural Impact Assessment & Method Statement

82 Madrid Road, Barnes, London, SW13 9PG

Job Reference: 05209R

Planning Ref: 24/2046/HOT

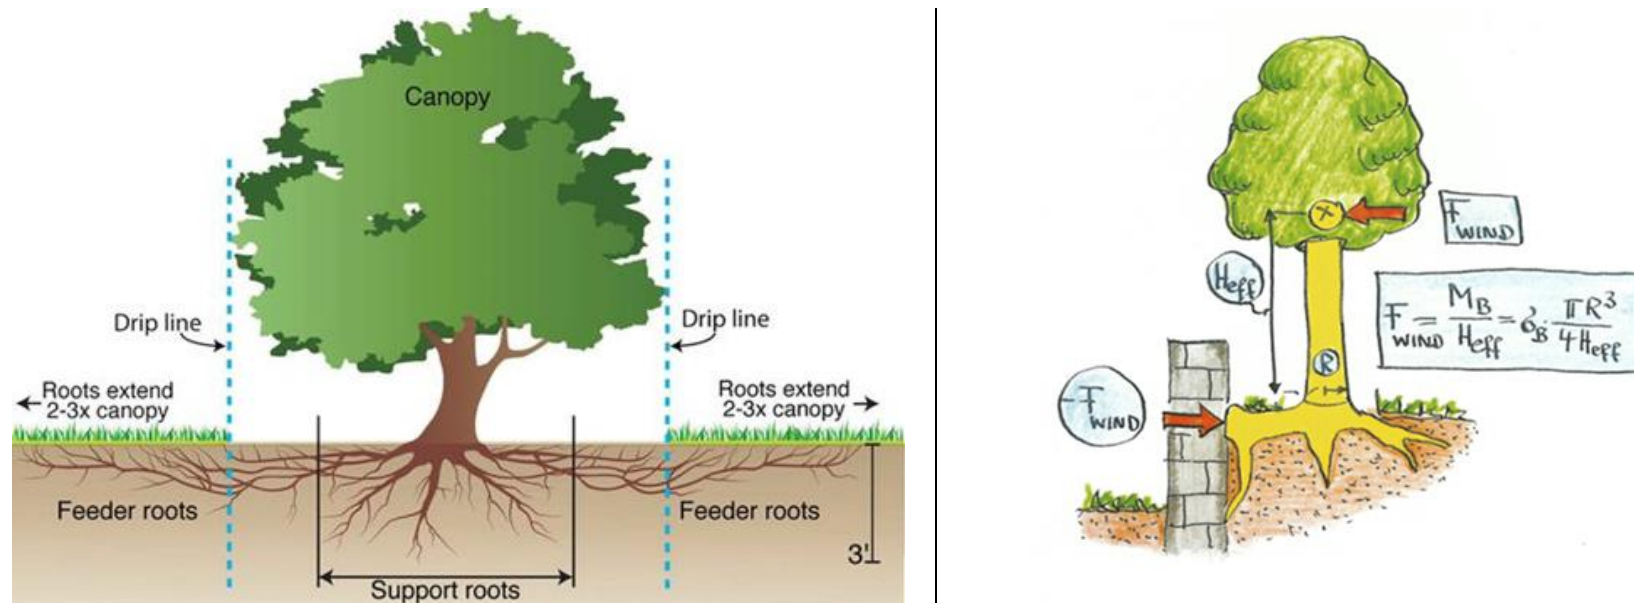
**Fig 2 – Open grown trees or those with minimal obstructions close to their stems will have a network of structural roots supporting feeder/ fine root growth beyond (above left). In certain situations, root morphology can be affected by structures close to the main stem (above right: Mattheck).**

- 5.1.7 Within around 3 to 4m of the base of mature trees there will generally be a structural root system providing both support and the main structure/ root architecture for smaller roots to originate. These larger roots have the very real capacity to be influence by any significant structures (footings, roads to adoptable standard construction etc) where there may be a physical obstruction close to them and this can affect root morphology in such locations. In addition to this there will generally be a noticeable increase in structural rooting to the southwest of mature trees in the UK to reflect the prevailing wind direction, particularly where a tree may be isolated/ open grown increasing its wind exposure. Root growth and location will also be influenced by the presence of other trees, structures sheltering trees etc all of which can combine to affect the shape and location of a structural root system.

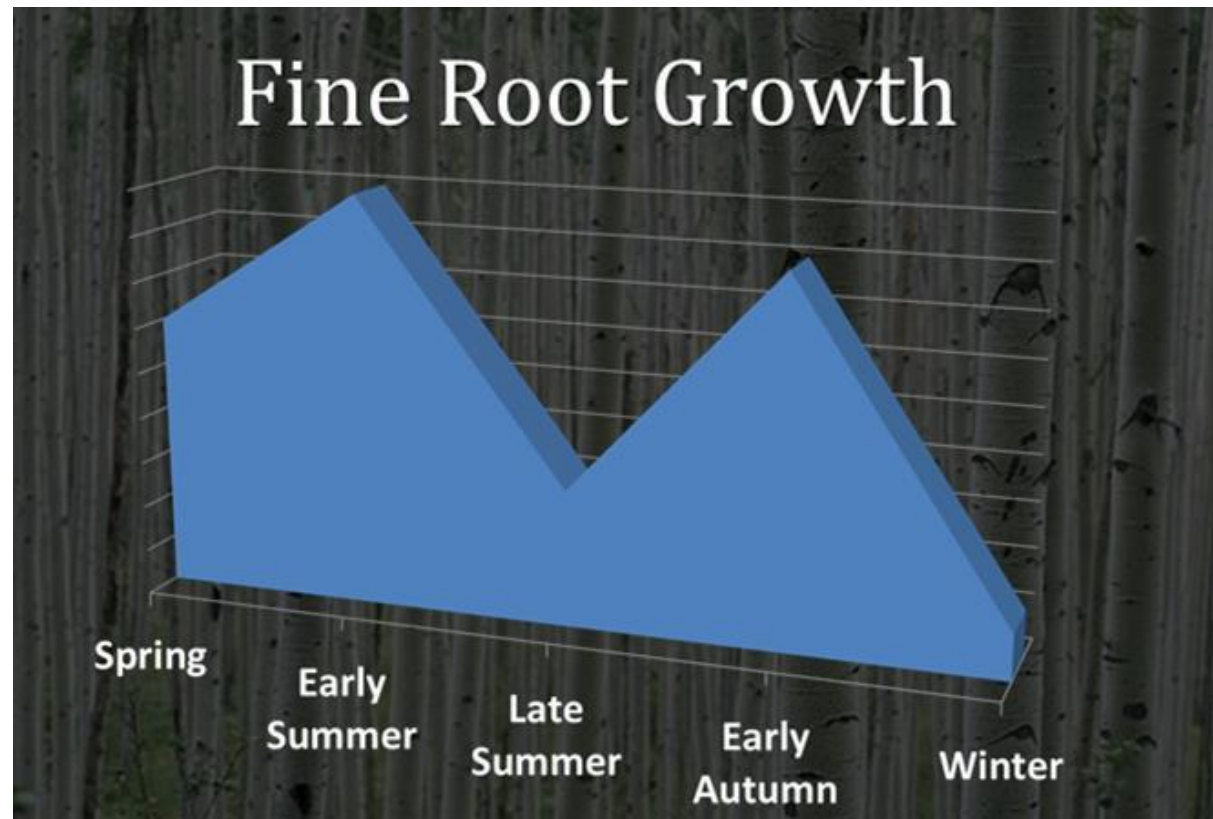
**Fig 3 – Fine root growth is (generally) seasonal peaking in late spring and again in early autumn but dying back in winter dormant periods when photosynthetic production ceases. This is an important part of the soil nutrient cycle and demonstrates that a static RPA as calculated by BS5837 is a ‘simplistic’ view of the tree rooting dynamic. (Image Source: Tamla Trees)**

5.1.8 Beyond the structural (and generally permanent) root system will be a network of smaller roots which in turn subdivide to fine roots. Fine roots will also be found throughout the root system (i.e. both close to and distant from a tree) to maximise soil resource uptake and reflect underlying soil conditions. Some larger roots (>25mm and sometimes much larger) can extend away from this area and remain permanent particularly where there may be a constant supply of water (such as a broken downpipe on a building some distance away) which encourages a roots development. Generally, the smaller roots (<10mm and particularly fibrous roots) outside of the immediate structural root plate can be considered to be in a state of constant change. They will grow seasonally, and tree roots generally grow at night. Small fibrous roots are also mostly short lived (ranging from anything

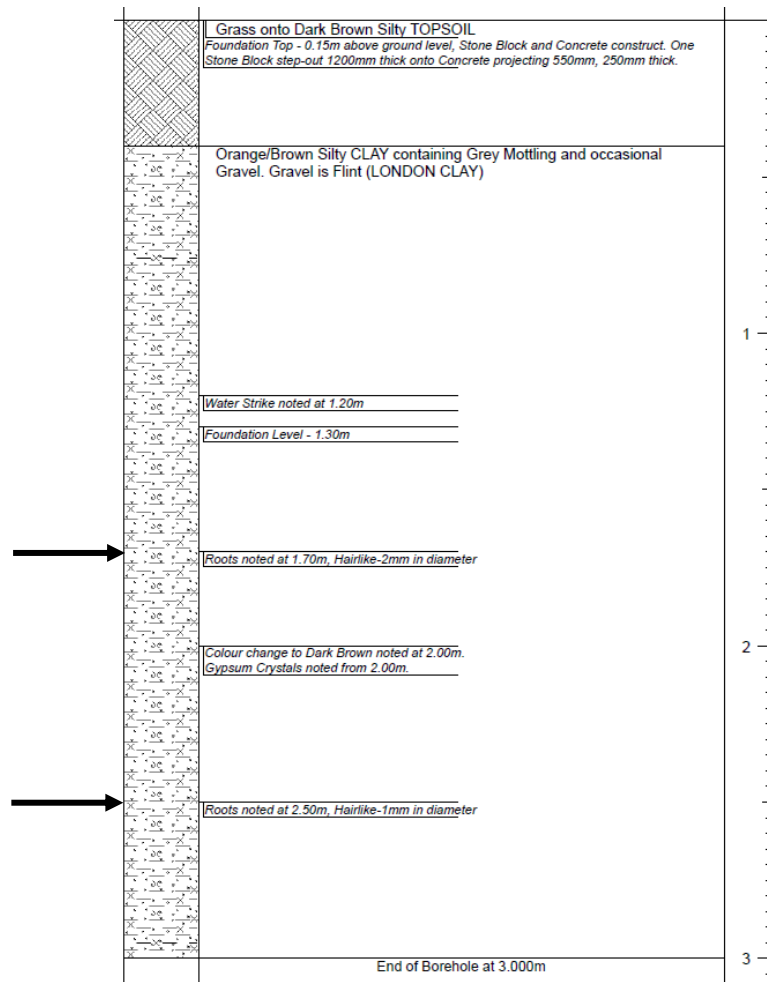
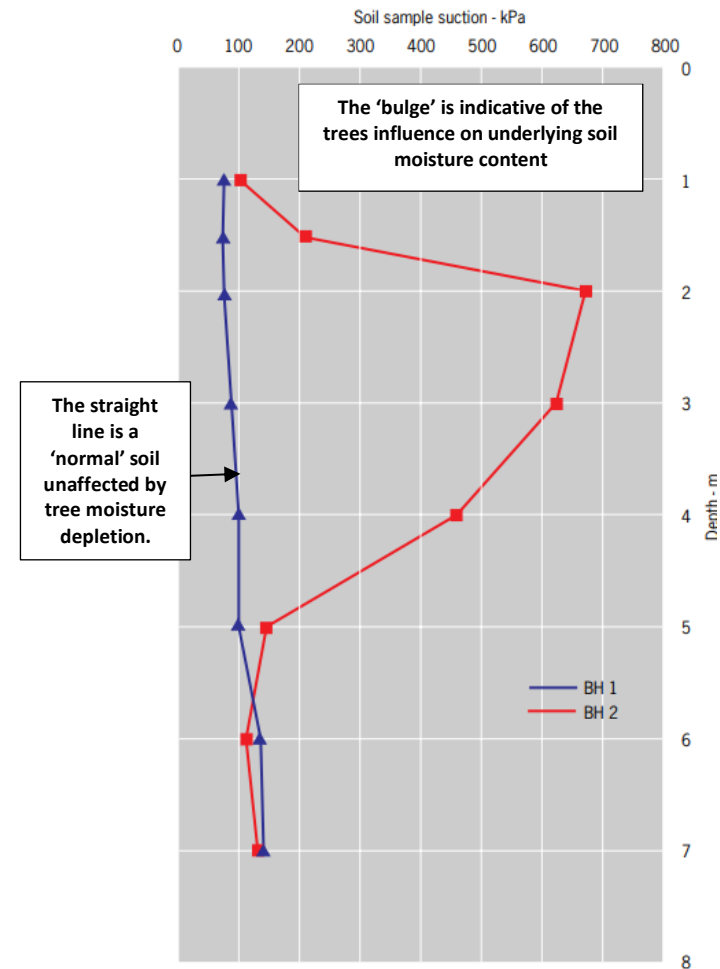
**Fig 4 – Borehole log 10m from mature Oak tree on clay soil detailing fine roots to depths of 2.5m indicated with arrows (Source: Tamla Trees project) and annotated soil moisture depletion by trees showing a peak influence at 2m and extending to 5m (above right)**

5.1.9 The fine root system shows species variation and will also vary in depth (depending on species dynamics and underlying soil conditions). Adopted highways generally have a footing that extends < 0.5m and most UK residential properties have footings in the range of 0.5-1.5m depth. Trees will easily root below these depths, and this is evidenced by the fact that every year in the UK there are thousands of tree related subsidence cases.

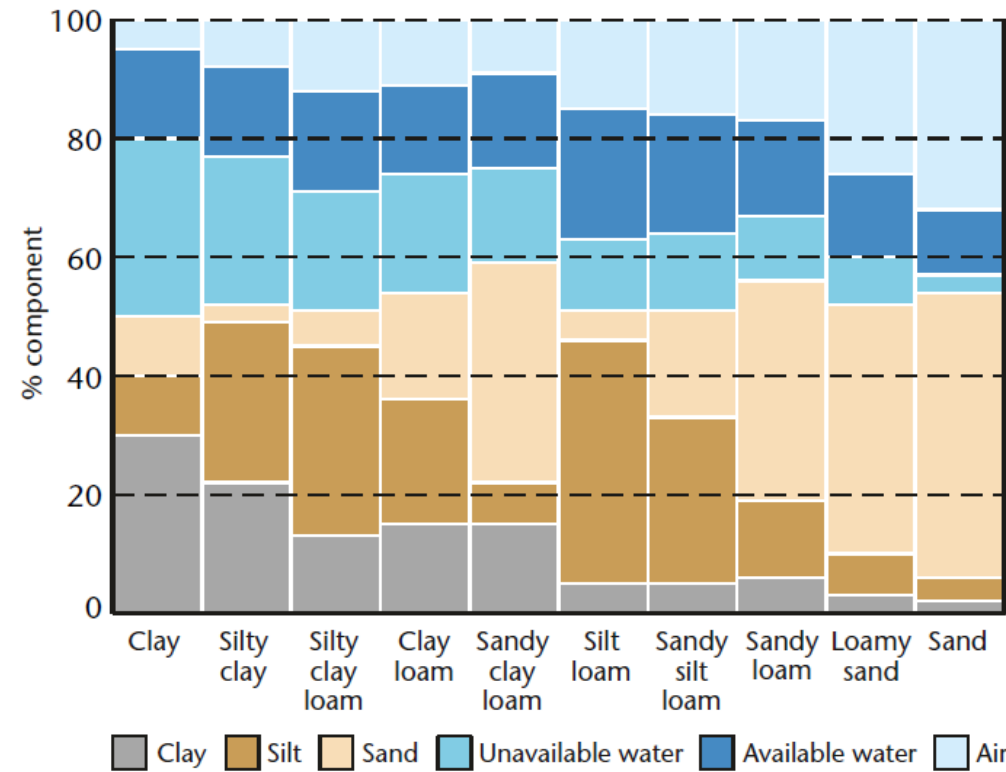
**Fig 6 – Diagram showing the typical particulate composition and air/ water content at field capacity for mineral soil types<sup>5</sup> The variation in soil type has a direct bearing on the potential impact of adverse construction techniques (such as soil compaction) as well as overall root system morphology & development. Clay soils tend to have shallower rooting as moisture remains readily available while soils containing free draining gravel and sand can encourage deeper rooting based on reduce soil bulk density and greater seasonal variations in moisture availability.**

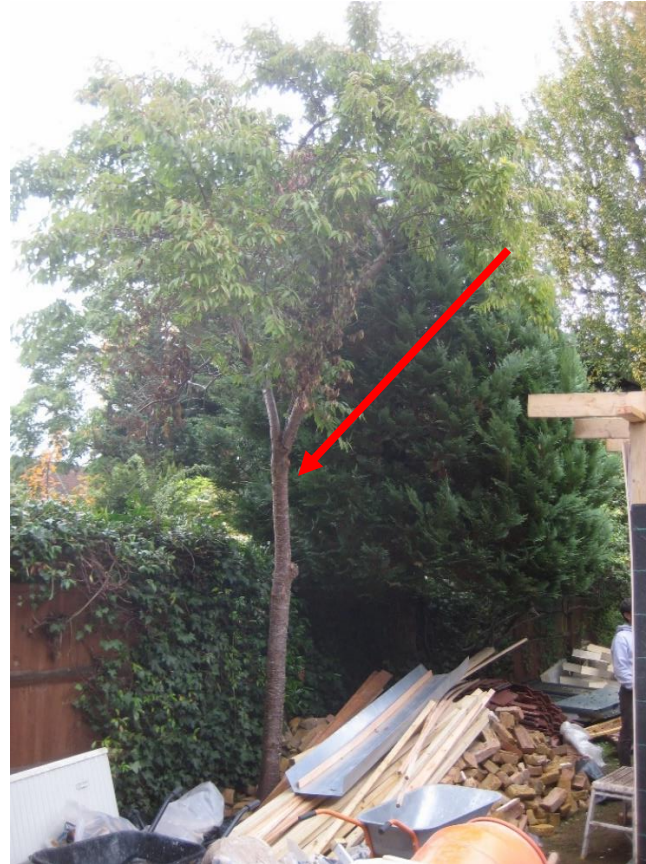
**Fig 7 – T1 (Cherry) October 2024. It is proposed to remove this tree.**

5.3.1 T1 (Cherry) is proposed for removal. T1 (Cherry) is a small tree and whilst tree removal is regrettable the size and low visual amenity associated with this tree mean it is not considered a constraint tree worth of design manipulation.

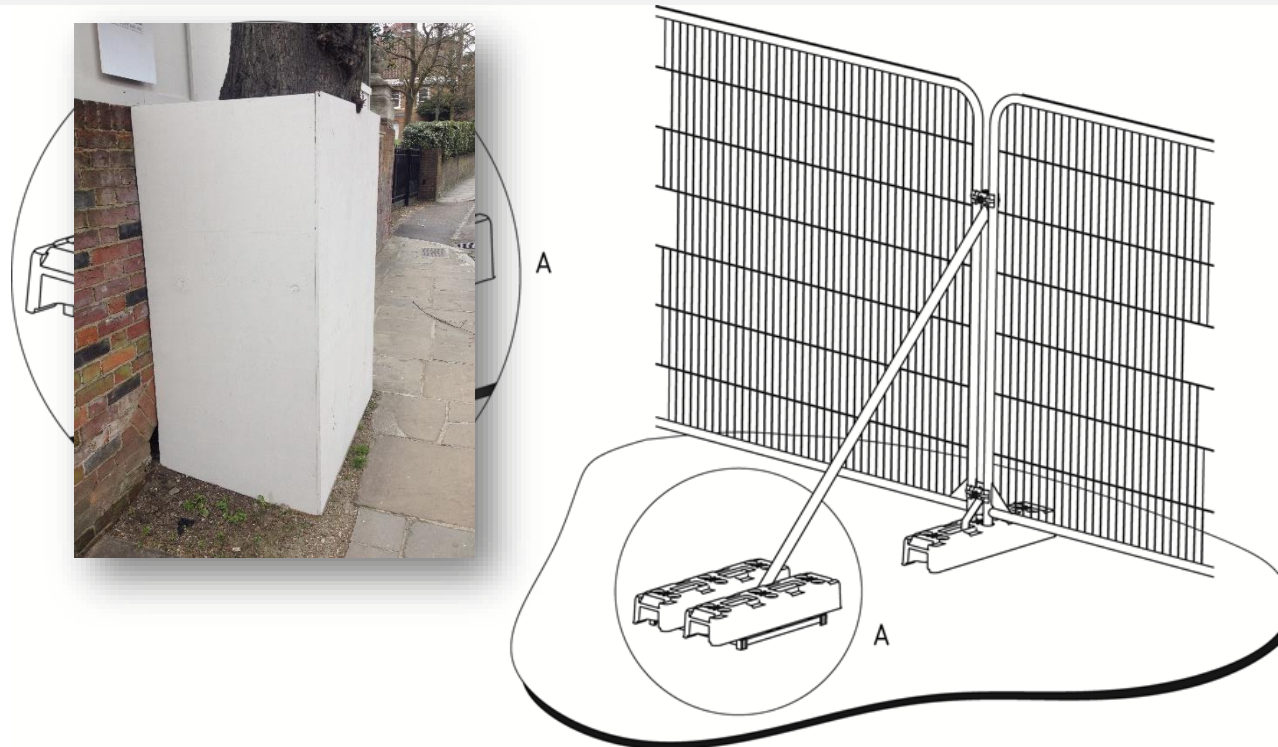
- *Braced feet fence spec (left).*
- *Note: To be marked with signs (inset) and purpose to be briefed to all ground workers.*
- *Maintained for duration of the build.*
- *Combined with basal shuttering for T5 (inset).*

5.4.2 High quality BS5837 compliant fencing will be installed **prior to any further on-site activity.**

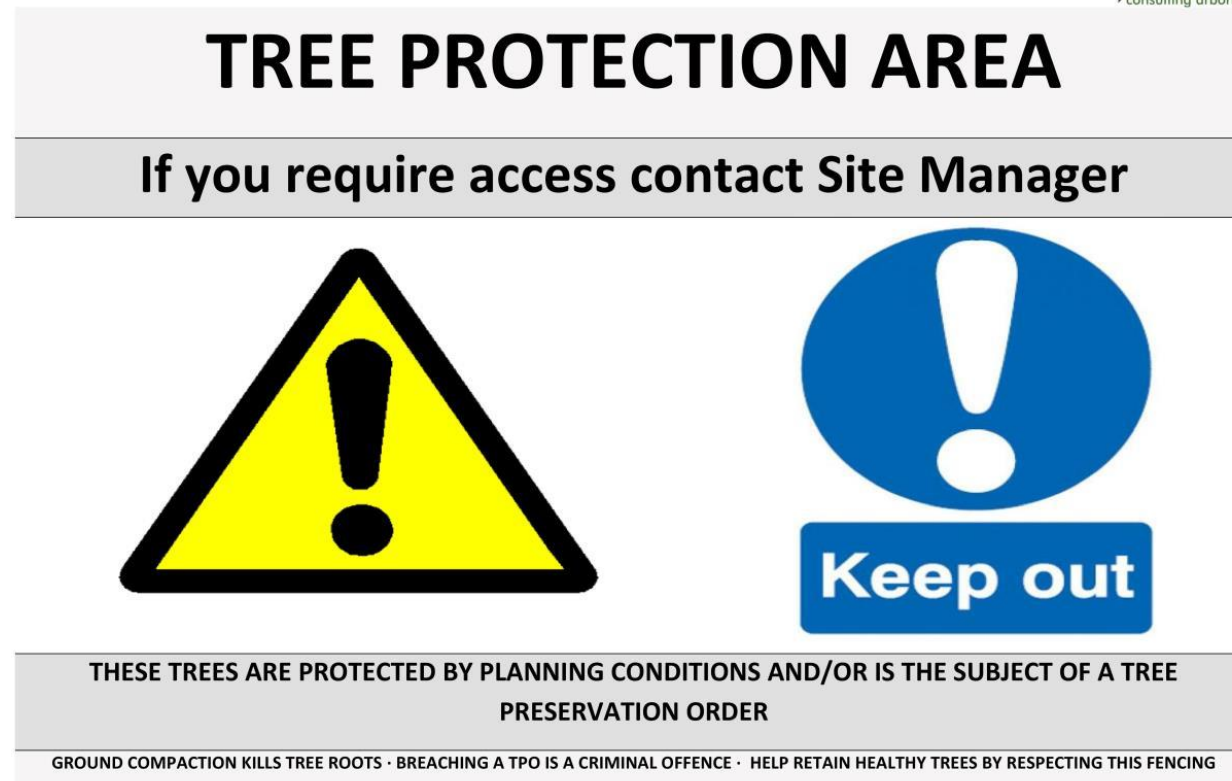
**Fig 8 – Professional grade weatherproof tree protection signs no smaller than 297 x 420 mm (A3) should be placed on protective fencing.**

5.4.3 All internal tree protection must be appropriately signed to ensure that all site operatives know its purpose.

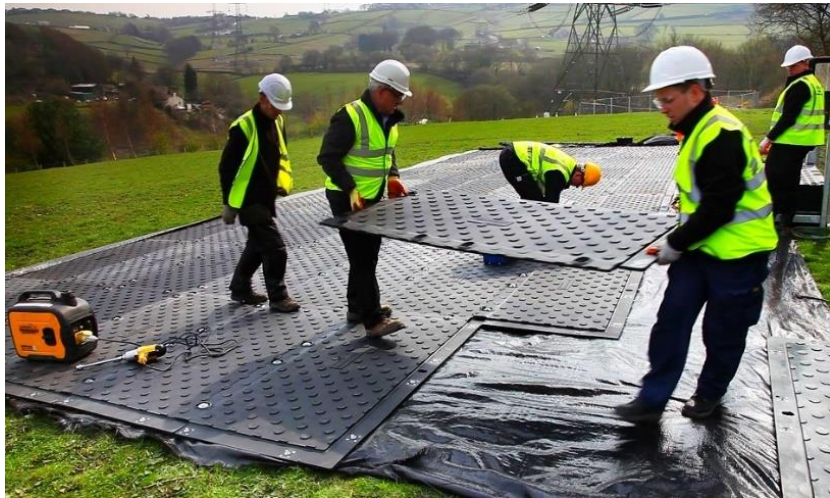
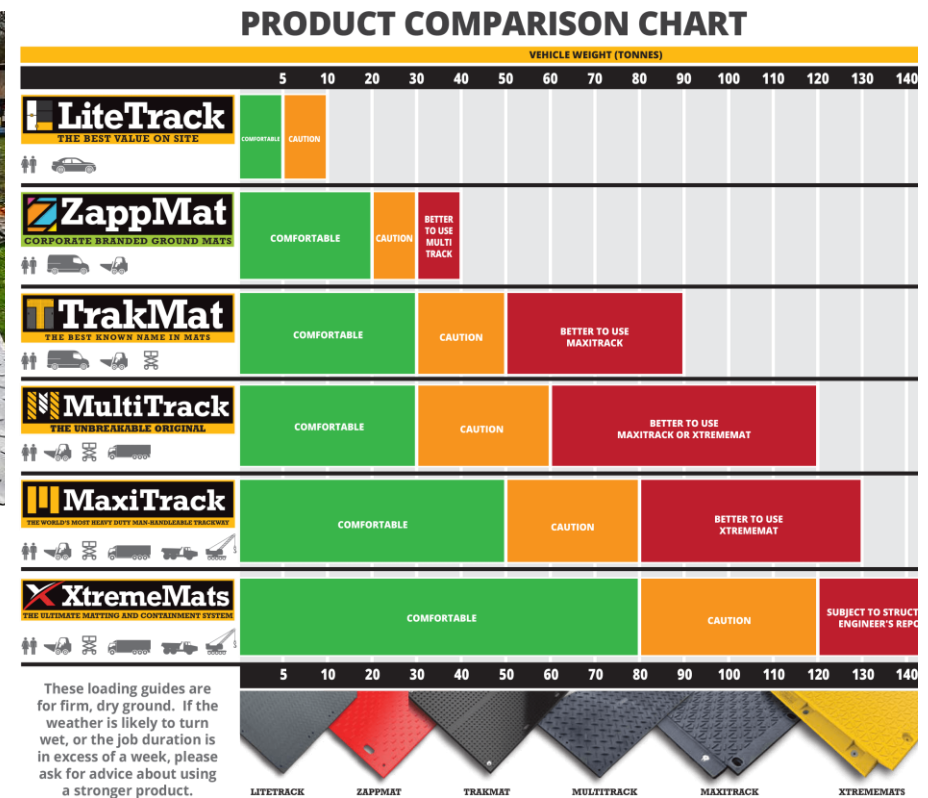
**Fig 9 – Overview of ground protection. The contractor must ensure the specification is suitable for the works (overview of this above right). To be kept under review and installed as required (i.e. if there are any changes to the proposed fencing detailed at Appendix 6).**

5.4.4 Temporary ground protection is not formally indicated at this stage but should any manipulation to protective fencing be required to generate incursions towards trees it will be laid. This should be kept under formal review by the site manager. Please note damaging trees in a Conservation Area can constitute a criminal offence.

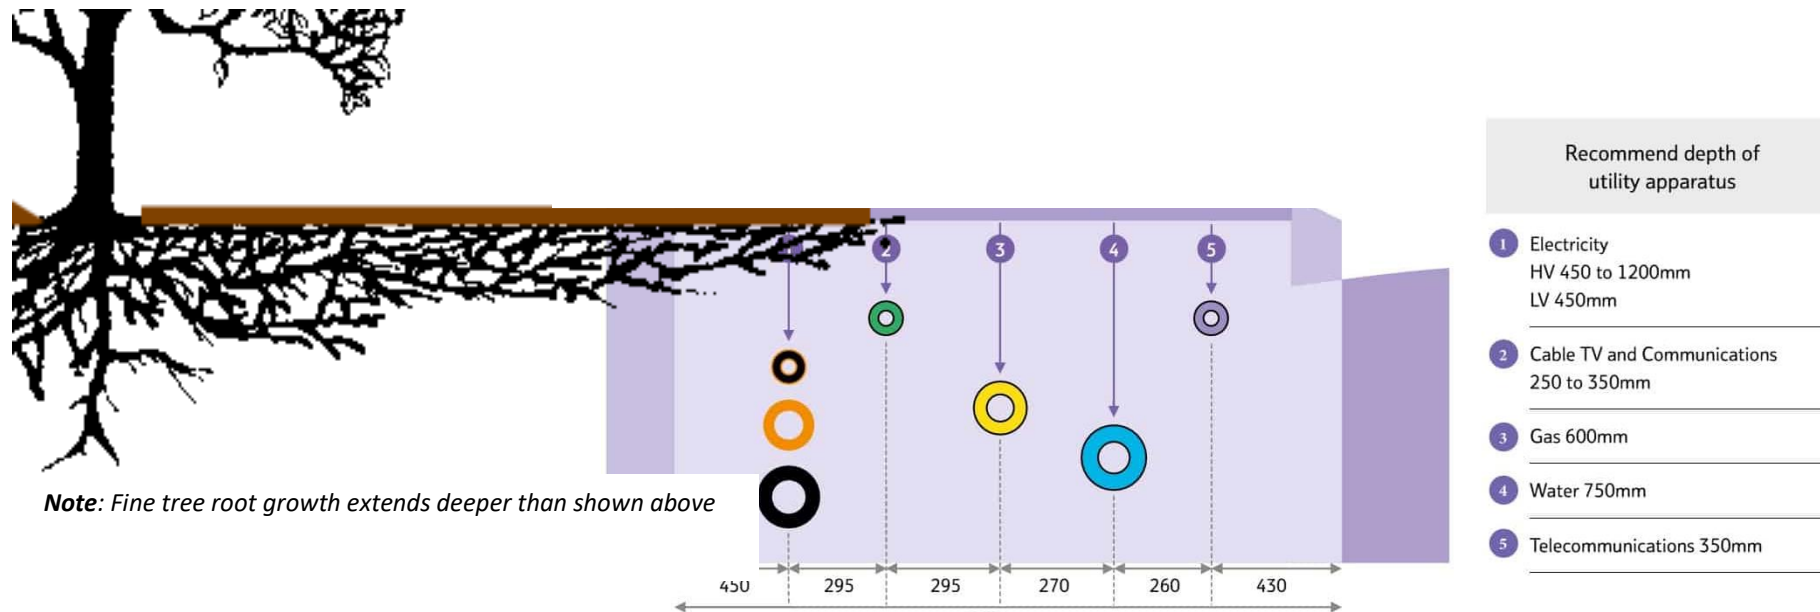
**Fig 11 – Annotated service installation depth drawing (source: Thorne & Derrick). Service installations occupy the same soil volume/ depth where the greatest level of tree roots will likely be found. It is envisaged that services will connect with existing ones present on site serving the existing property. If a new soakaway is proposed it should be located within the part of the rear garden not affected by the RPA of trees. Please note the overspill RPA of T4 (Poplar) into the site.**

5.6.1 All services should be designed outside the RPA where possible and no manhole/ chambers should be located within the retained tree RPA. Where further excavations are required, these will be undertaken by hand if within the RPA of retained trees.

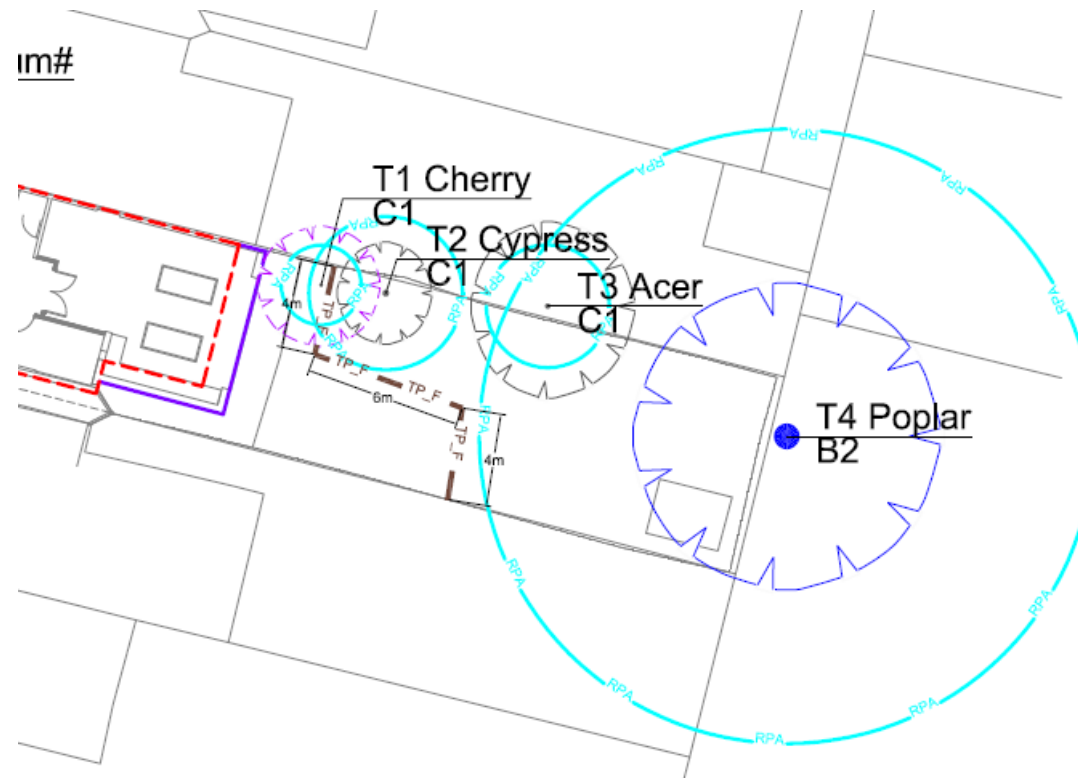
**Fig 12 – In the event of a soakaway being required it must be located outside of tree root RPA's. Note out building/ garden room not shown which likely makes a soakaway difficult to achieve given the lack of available space.**

5.6.2 **Soakaway** – A new soakaway is not advised but should one be proposed, it should be located in the area of the rear garden which is not within the RPA of retained trees.

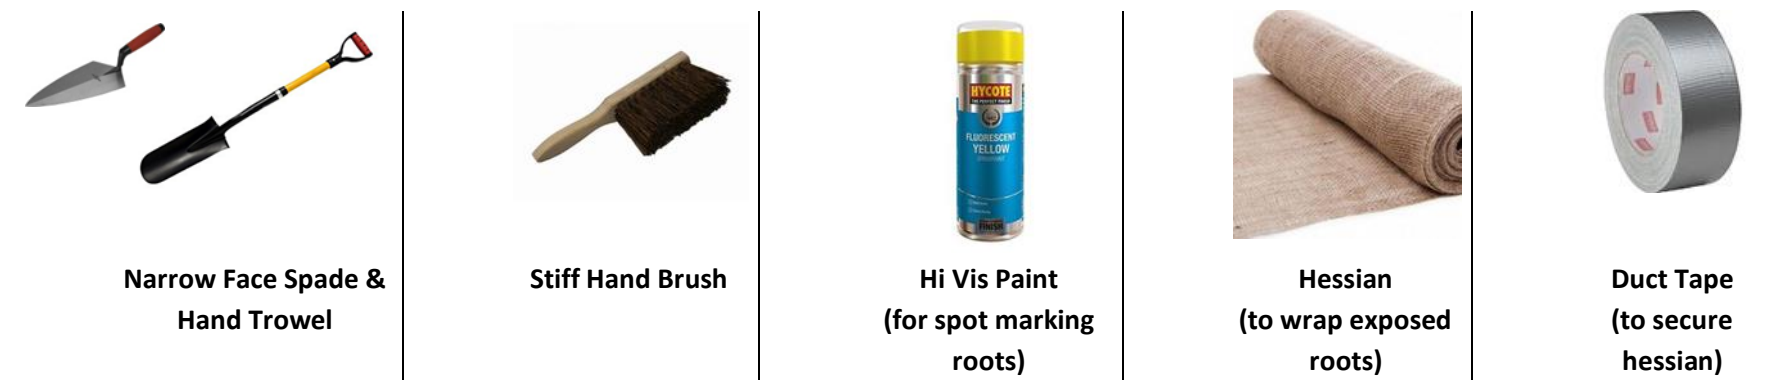
**Fig 13 – Advised tools/ materials which should be available for all excavation works within RPA**

5.6.4 **Planning the excavation:** A ‘toolbox talk’ will spot mark and agree the locations and working practices. In the event tree roots (multiple &/or roots >25mm in diameter) are encountered work will stop and progress with hand tools only. Please note this process should also be utilised for the excavation of the leading edge of the expanded lower ground floor/ terrace area with an inspection of all uncovered roots prior to any tanking/ wall construction to ensure no significant roots from t1 have been adversely affected.

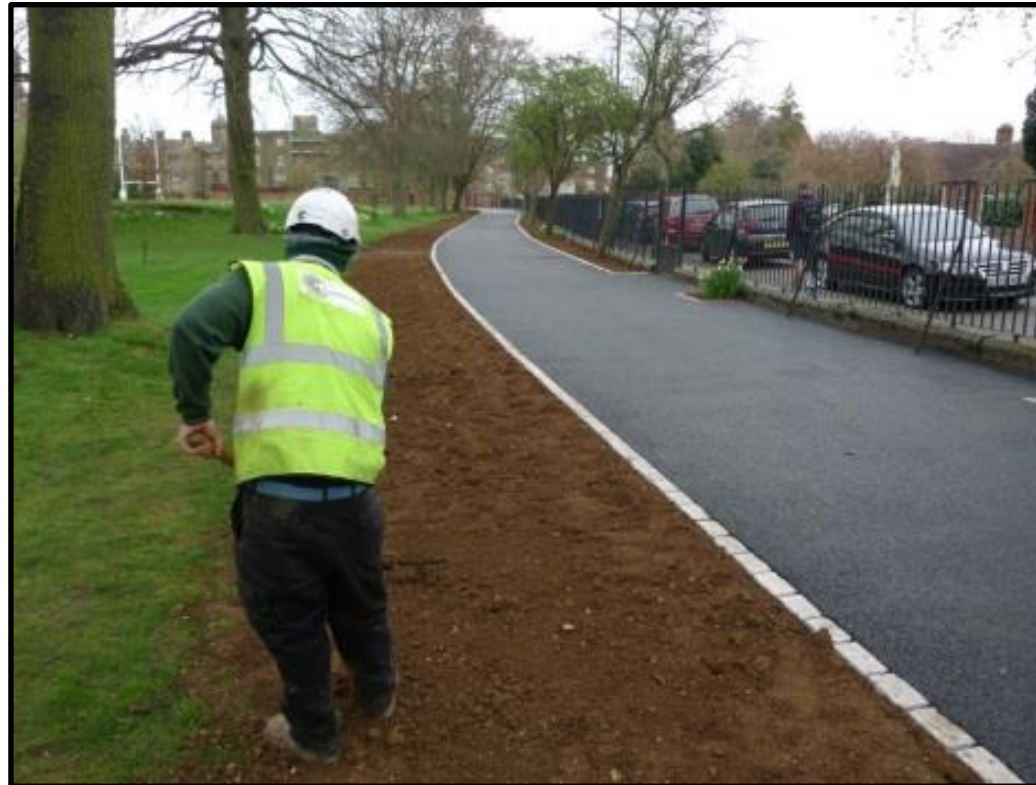
Fig 14 – All 'making good' topsoil will be BS3882 compliant and raked out by hand to no greater depth than 100mm.

- 5.7.1 All 'making good' will be with BS3882 compliant topsoil raked out by hand (to no more than 100mm depth within any tree RPA) and then seeded/planted as appropriate. Further comment on full landscaping details is beyond the scope of this report.

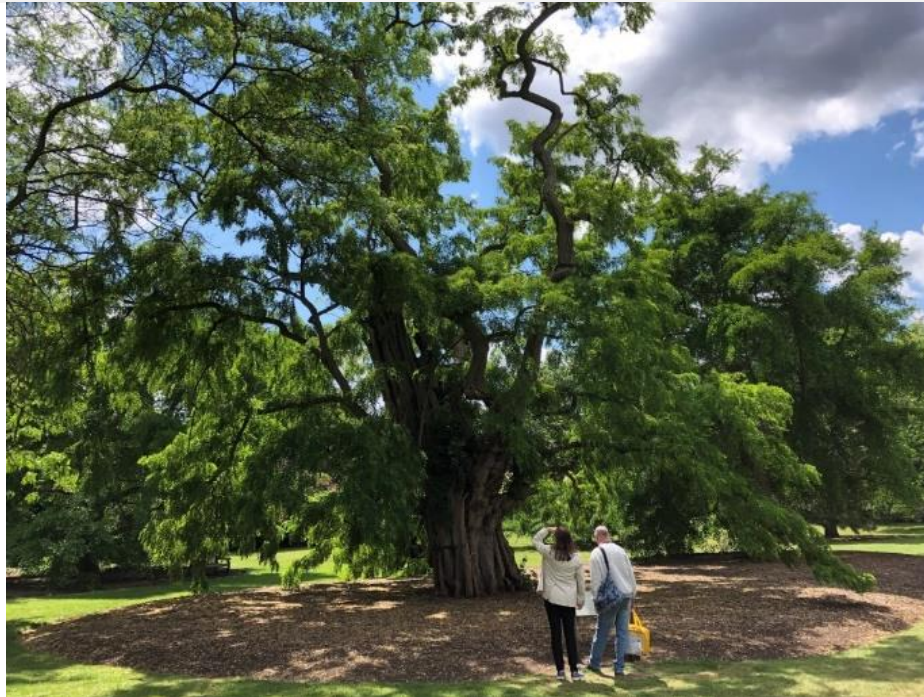
- *Circular area edged to 50-100mm depth to stop mulch from 'creeping' on to surround lawn.*
- *Composted mulch then spread around below tree by hand – no need to lift or remove underlying grass.*
- *Mulch topped up annually/ as required.*
- *Positive benefits for mulched trees*

5.7.2 We encourage the use of composted bark mulch below tree canopies where possible to aid water retention and increase soil microbial activity. This is particularly relevant to mature retained trees.

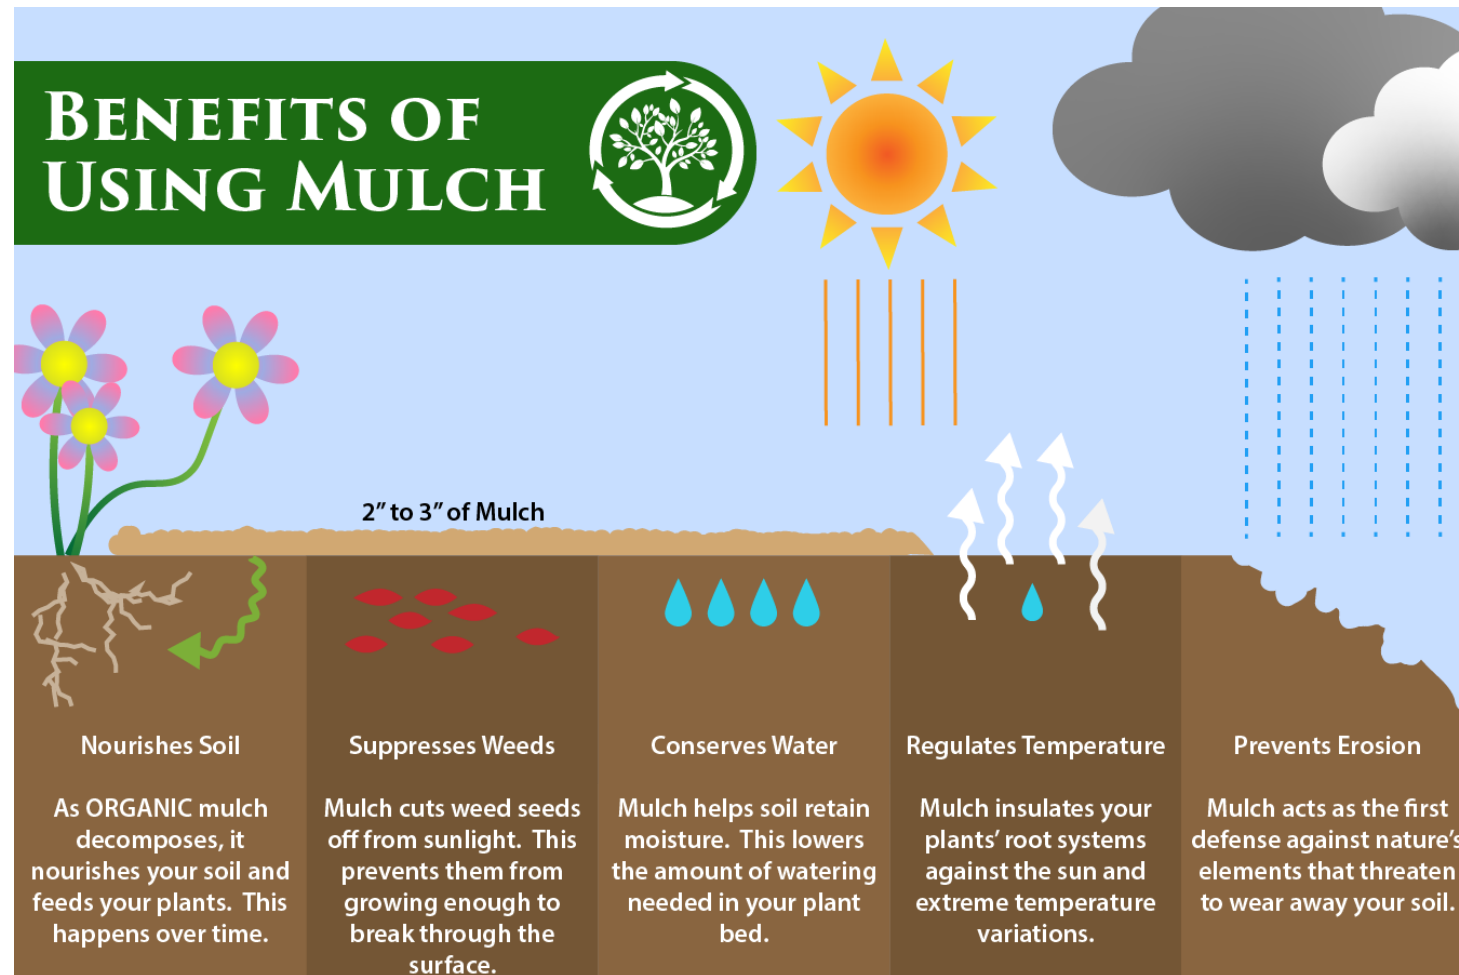
Fig 15 – Benefits of Mulch (Image Source 1<sup>st</sup> Stop Landscape Supply (US))

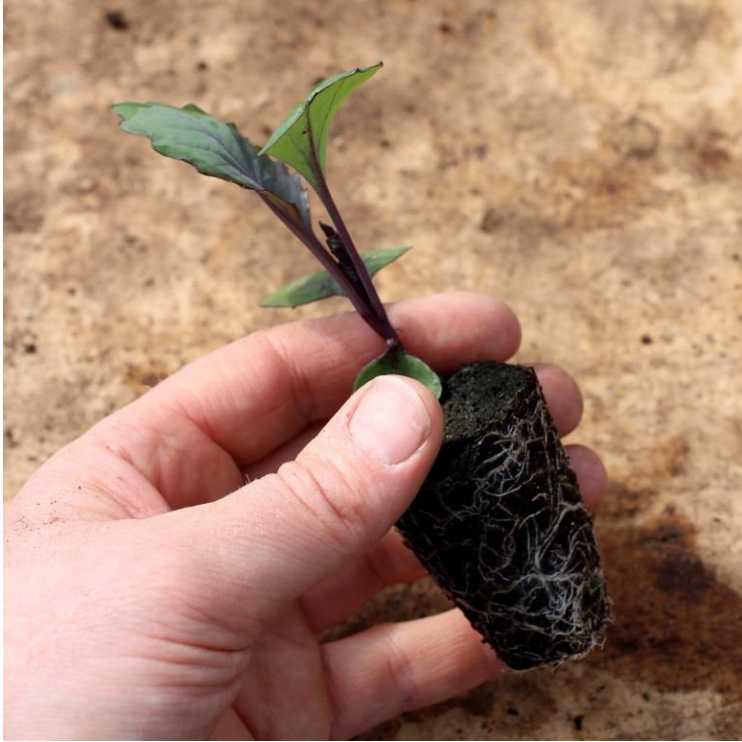
<p><b>Overview</b></p> <ul style="list-style-type: none"> <li>• <i>Within 1.5m of retained trees planting should be with plug stock (left)</i></li> <li>• <i>Small plant pot sizes &lt;3l utilised for new planting in further areas.</i></li> <li>• <i>Hand dug planting holes.</i></li> <li>• <i>Top dressed in compacted bark mulch/ soil as appropriate.</i></li> <li>• <i>Watered weekly May – September during season 1 &amp; 2.</i></li> </ul>
<b>Threat Level to Retained Trees</b>	<b>LOW</b>

5.7.3 Where soft landscape planting occurs within the RPA of retained trees, we advise the use of small pot sizes and plug planting where possible to minimize the risk of root disturbance.

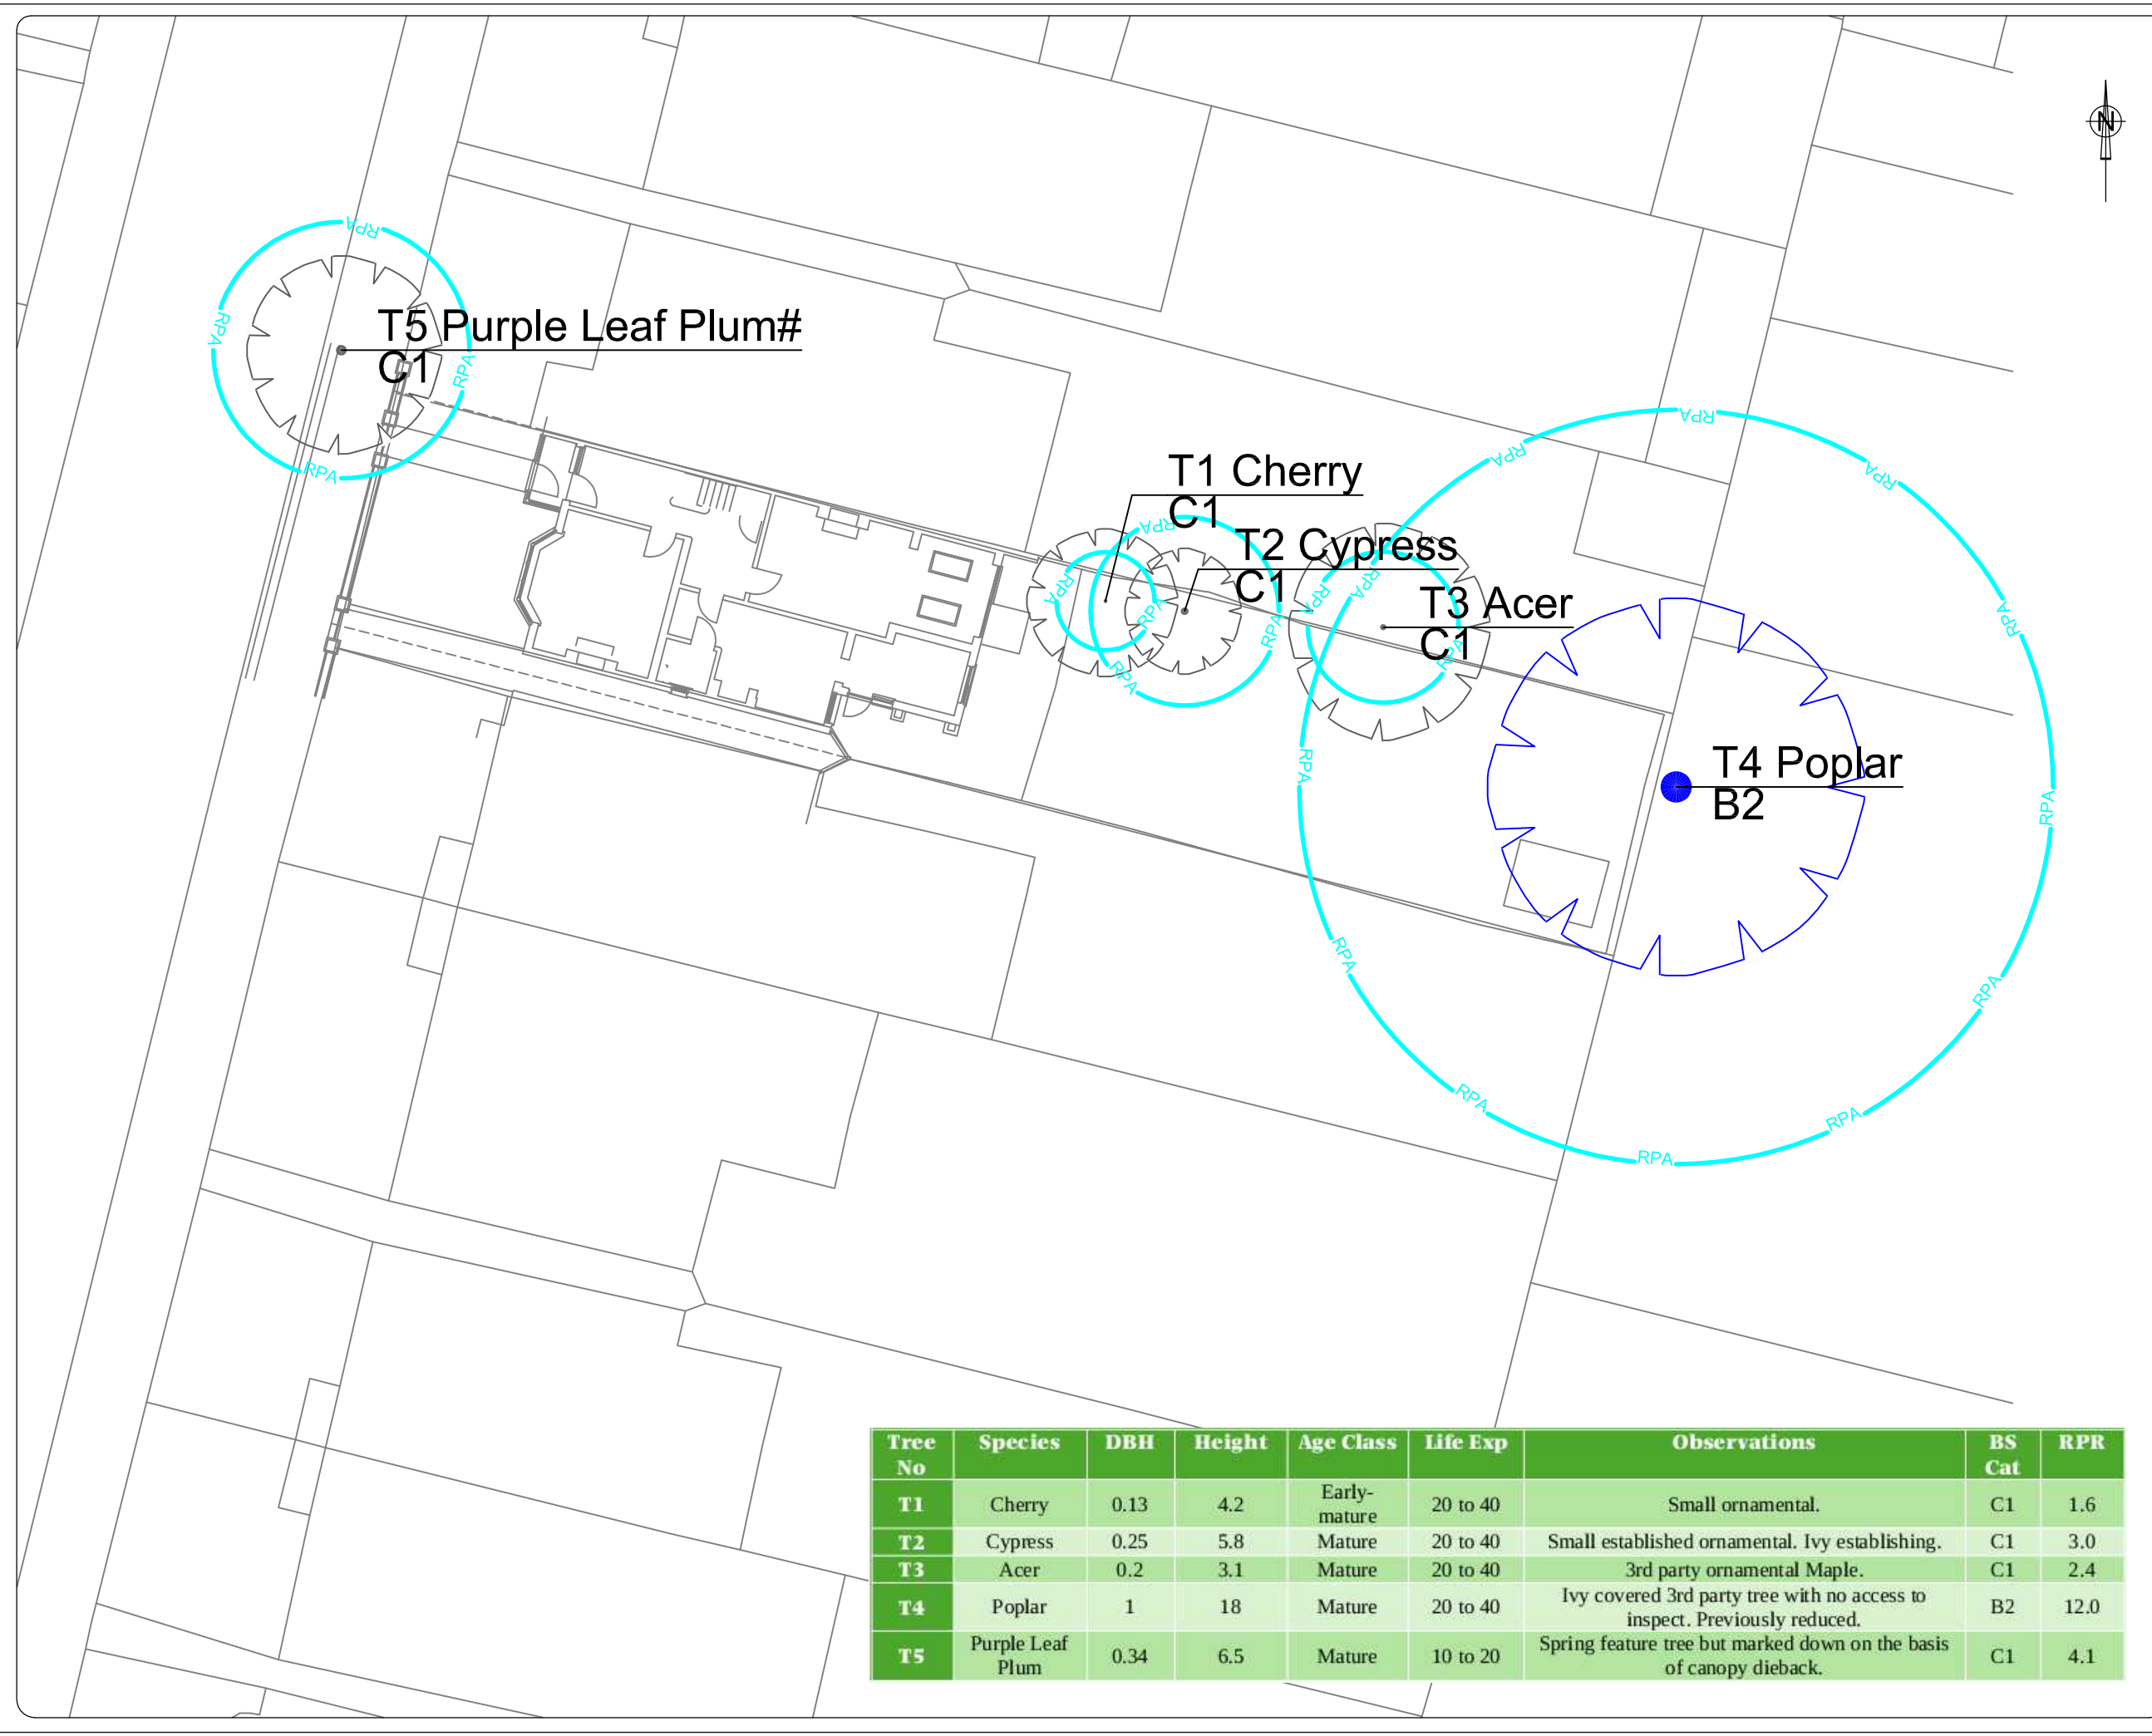
Job	05209R	Scale	1:200 @ A3	DRG NO		Revision	
Date	10/10/2024	Type	a		05209P_TCP_01		-

T5 Purple Leaf Plum#  
C1

T1 Cherry  
C1

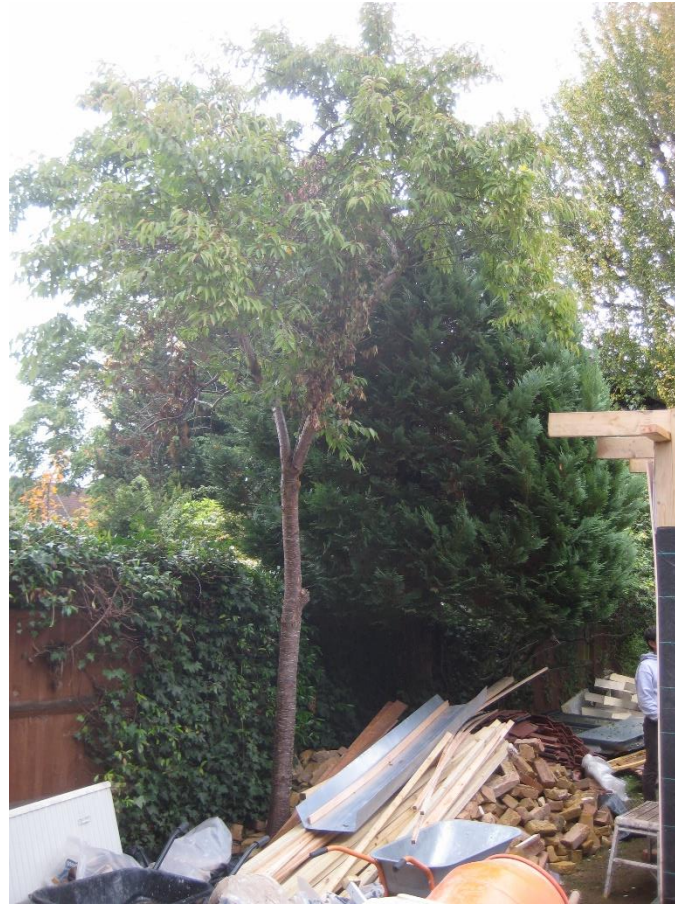
**Image 1 – T1 & T2 – Existing materials to be removed carefully by hand before tree protection is installed.**

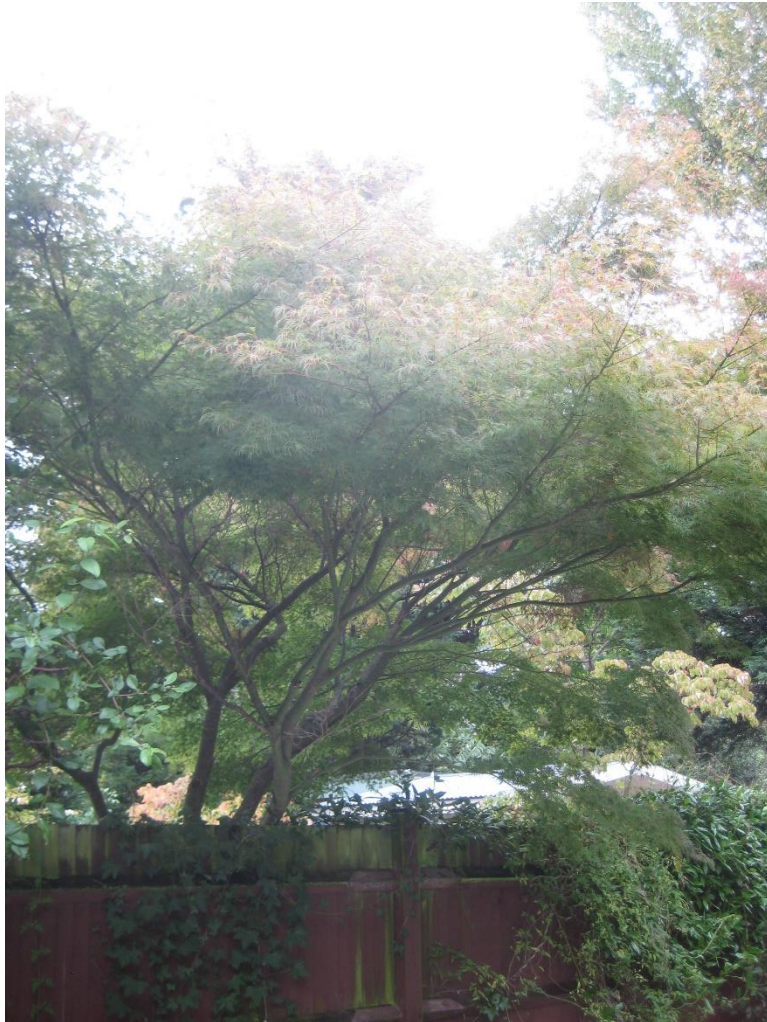
**Image 2 – T3 – 3<sup>rd</sup> party Acer**

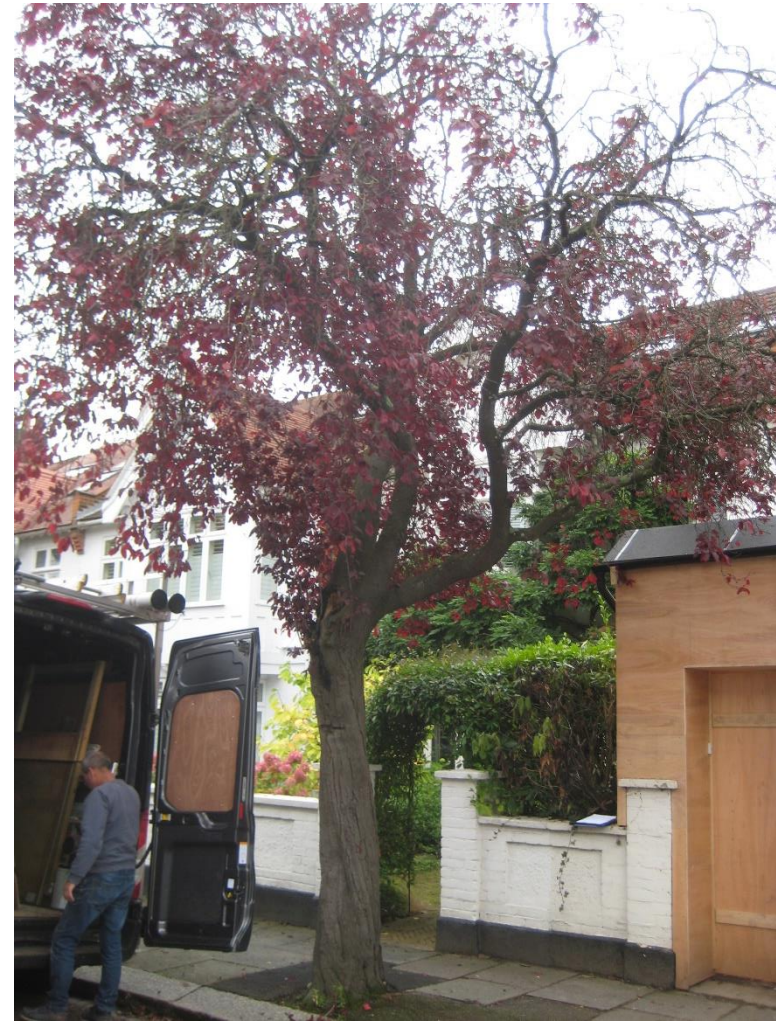
**Image 3 – T5 Purple Leaf Plum – Basal shuttering advised.**
