B. GROUND INVESTIGATION REPORT

**Strawberry Hill Campus, St Mary's University,
Waldegrave Road, Strawberry Hill, Twickenham
TW1 4SX**

Ground Investigation

P24-234

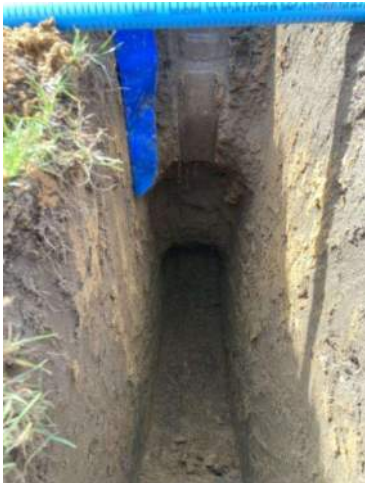
1.50-1.75	B				(0.35) 1.75	Complete at 1.75m

Remarks

Trial pit backfilled with arisings and finished with turf.
No groundwater encountered.
No obvious visual or olfactory evidence of contamination.
Trial pit utilised for infiltration testing.
Trial pit sides remained stable.

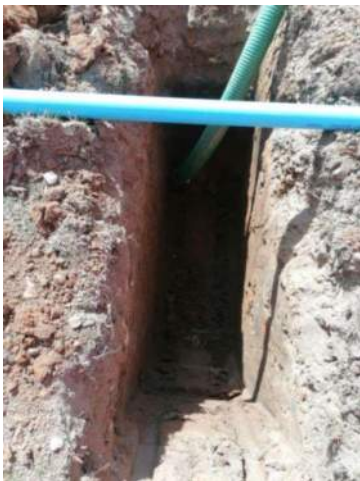
Excavation Method Trial Pit	Dimensions 1.20m L x 0.30m W	Ground Level (mOD)	Client St Mary's University	Job Number P24-234
	Location	Dates 13/08/2024	Engineer PGE	Sheet 1/1

Depth (m)	Sample / Tests	Water Depth (m)	Field Records	Level (mOD)	Depth (m) (Thickness)	Description	Legend	Water
0.10	C				0.15	Grass onto, dark grey sandy slightly gravelly organic CLAY. Gravel of fine rounded flint, quartzite and occasional brick. (TOPSOIL LIKE MADE GROUND)		
0.40	C				0.35			
0.60-1.00	B				0.50	Dense orange gravelly SAND. Gravel of fine to coarse angular brick, quartzite and flint. (MADE GROUND)		
0.70	C				0.50			
					1.00	Medium dense orange brown slightly gravelly SAND. Gravel of fine sub-rounded flint. (KEMPTON PARK GRAVEL)		
						Complete at 1.00m

Remarks

Trial pit sides remained stable.
 Trial pit utilised for infiltration testing.
 No obvious visual or olfactory evidence of contamination.
 No groundwater encountered.
 Trial pit backfilled with arisings and finished with turf.

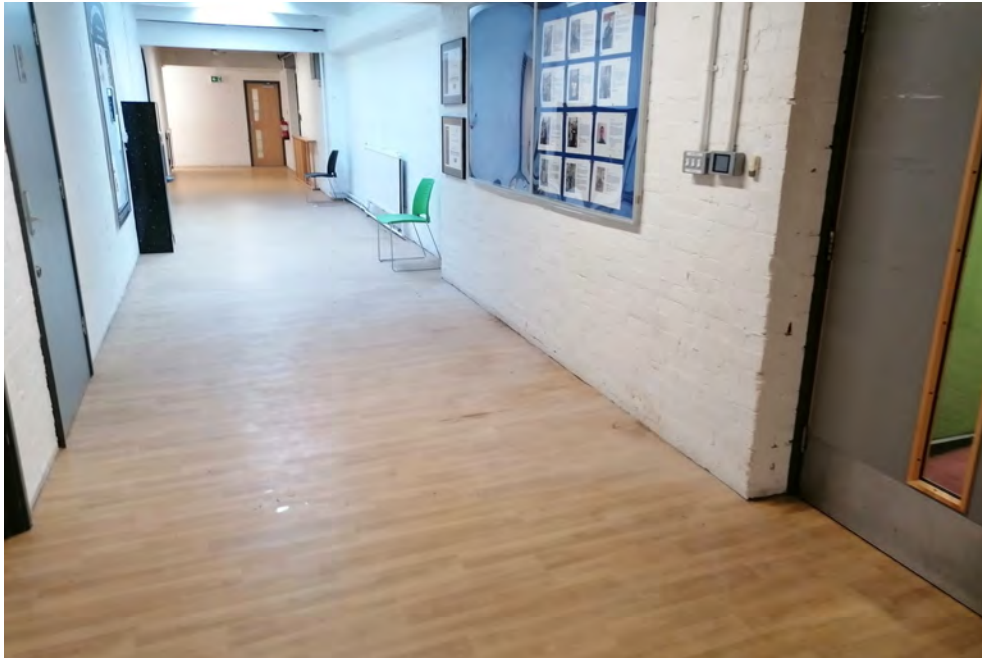
Situated internally at location FTP03 showing corridor.

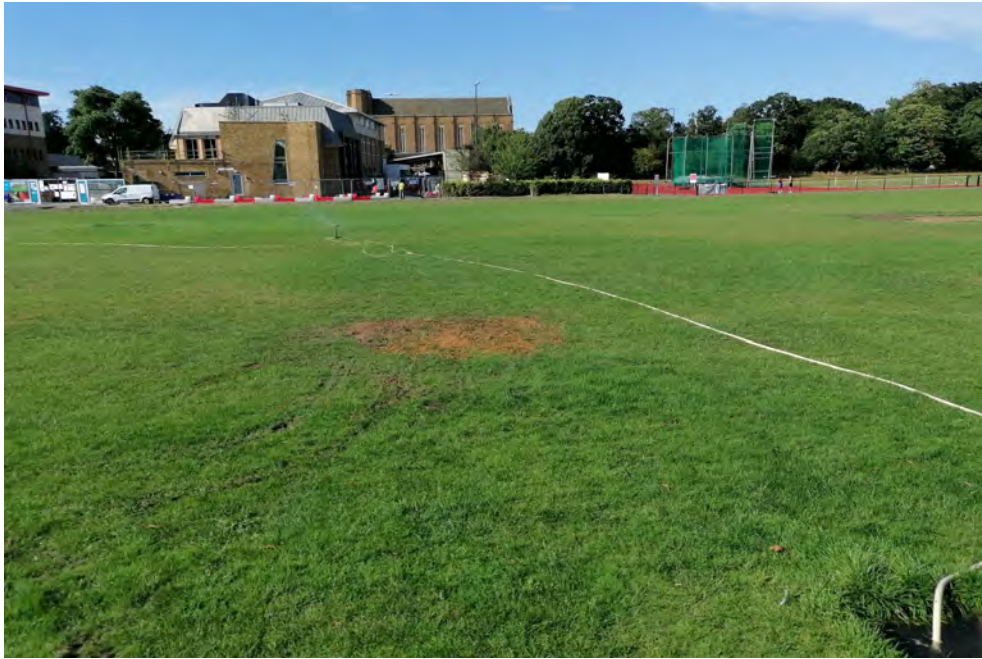
Situated externally, north of the subject building facing north showing sports pitch and location SA01.

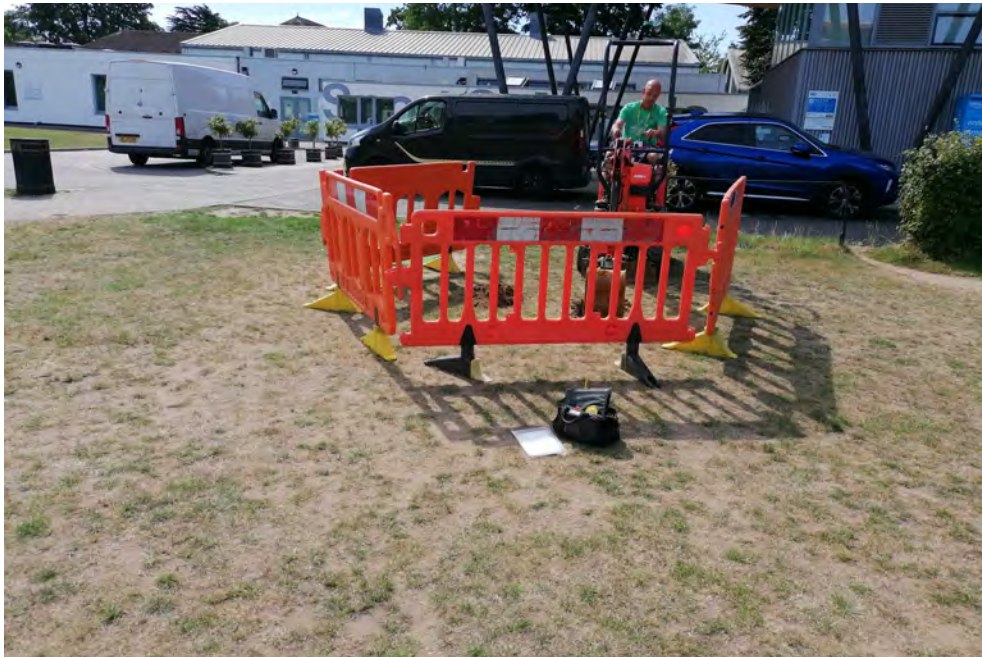
Situated externally, north of the subject building facing south showing the sports pitch and location SA02

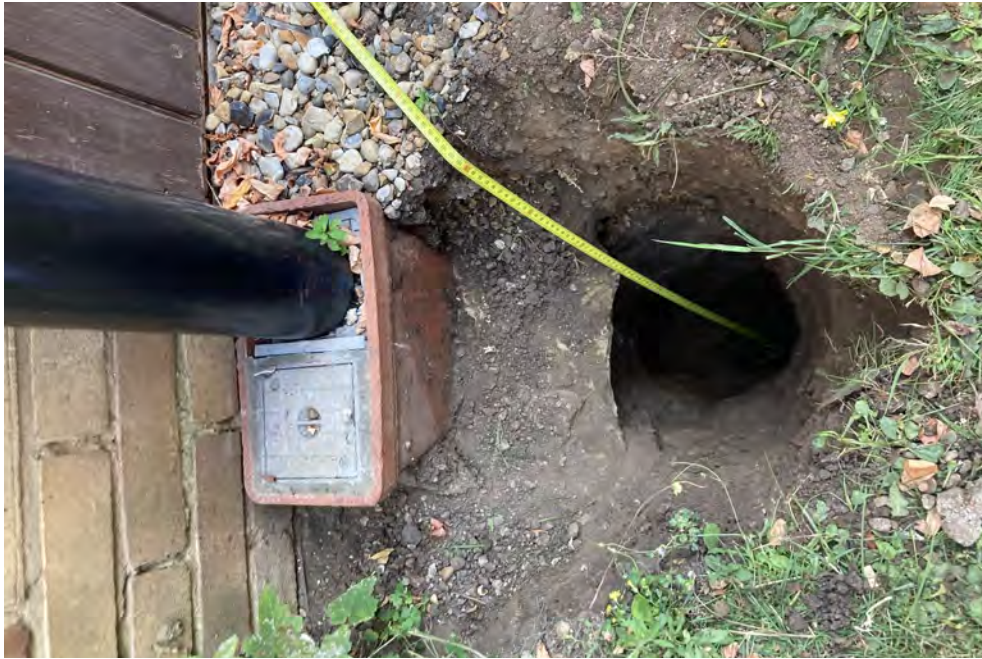
Photo of FTP01

Zinc was recorded to be present at concentration elevated compared to the phytotoxicity guidance values employed, exceeding the adopted threshold value of 111 mgkg⁻¹. Given this exceedance the Topsoil in the area of FTP01 is unlikely to be suitable for reuse on this site and should be stripped off and replaced with suitable clean soil to reduce phytotoxicity and allow a suitable growth medium.

Zinc was found to be elevated when compared to phytotoxic thresholds in the area FTP01. Therefore, the Topsoil like Made Ground in this area is considered a risk to possible proposed new planting.

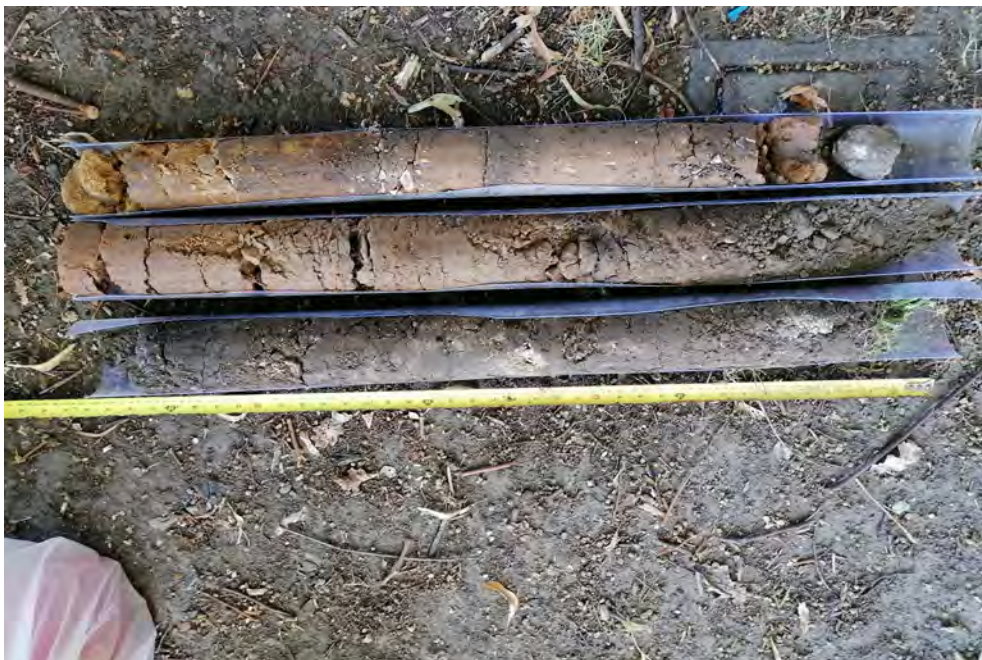
Photo of WS02 arisings

The Made Ground was encountered in all locations, from surface to depths of 0.20m to 0.70m, locally 1.30m in WS02. The Made Ground was represented by a loose to dense dark brown slightly gravelly slightly clayey SAND with the gravel comprised of fine angular brick, tarmac and limestone or firm dark grey brown sandy organic CLAY.

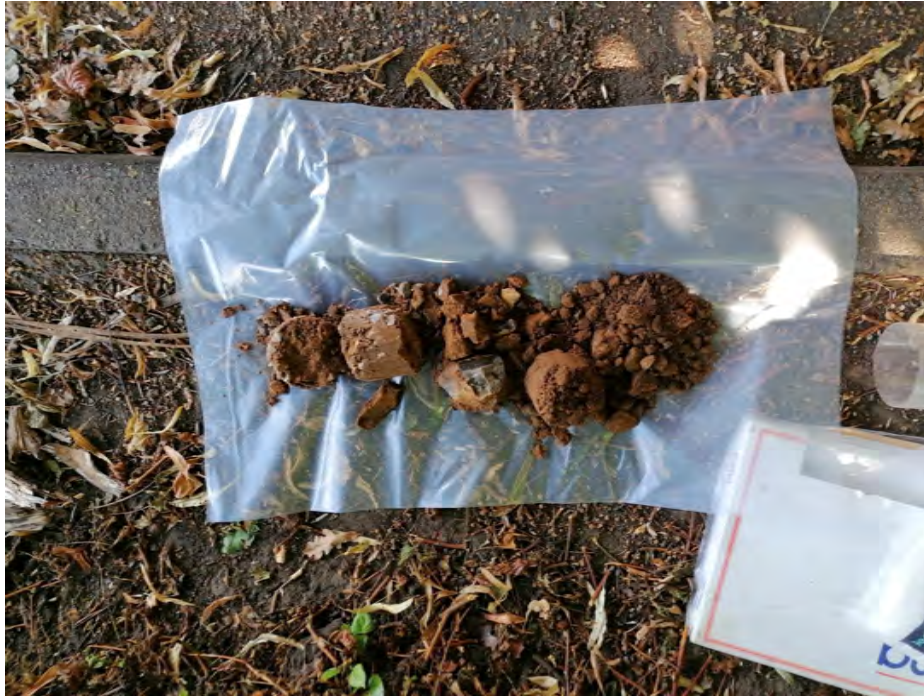
Photo of WS04

Remarks No obvious signs of contamination observed. Borehole refused on very dense gravel strata. Borehole backfilled with arisings. No groundwater encountered. Borehole sides remained stable.	Scale (approx)	Logged By
	1:50	MG
	Figure No. P24-234.WS04

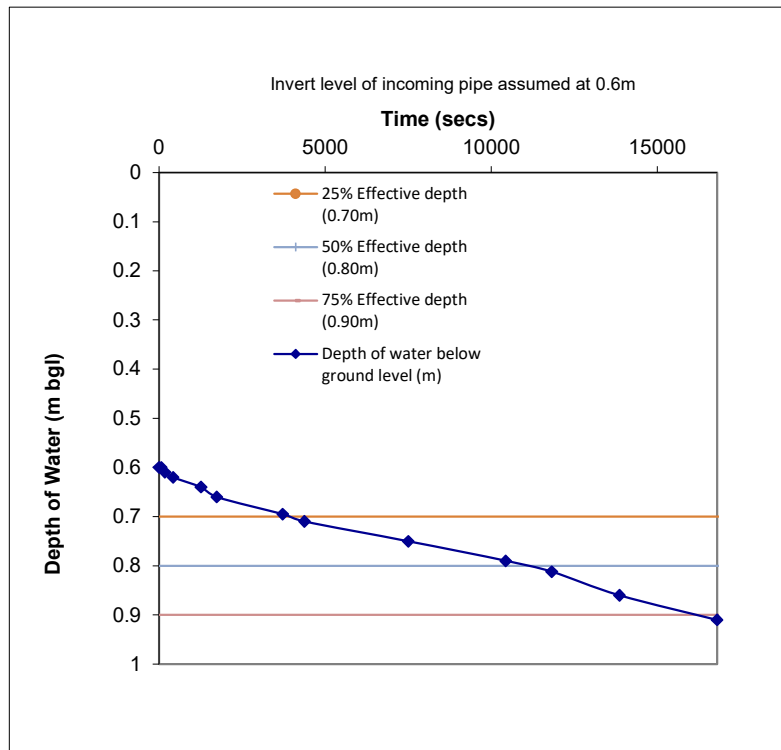
1.20m	SA02 - 1.0 m depth assumed invert level of incoming drain is 0.6m bgl. Effective depth = 0.4m	Pit Depths (m bgl)
		Length 1.20 Width 0.30 Depth 1.0 25% Effective Depth 0.70 75% Effective Depth 0.90 Inlet Depth 0.60
	0.30m

$$\text{Soil Infiltration Rate}(f) = V_{p75-25} / (a_{p50} \times t_{p75-25})$$

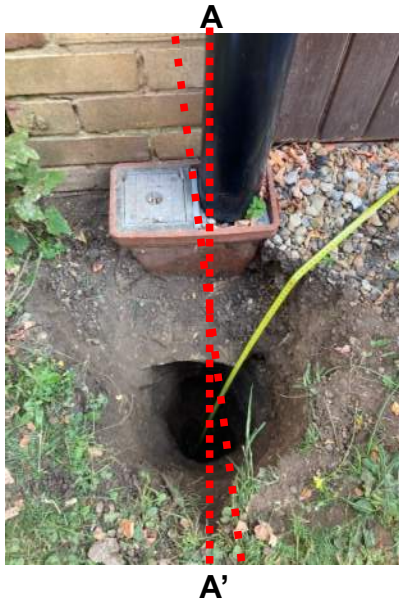
FTP1 - Photo and section line

Foundation Trial Pit (FTP1) Section
