Arboricultural Impact Assessment to B\$5837:2012

Country Court Care

Marling Court, Care Home Bramble Lane, Hampton, Middlesex, TW12 3XB

01 May 2024

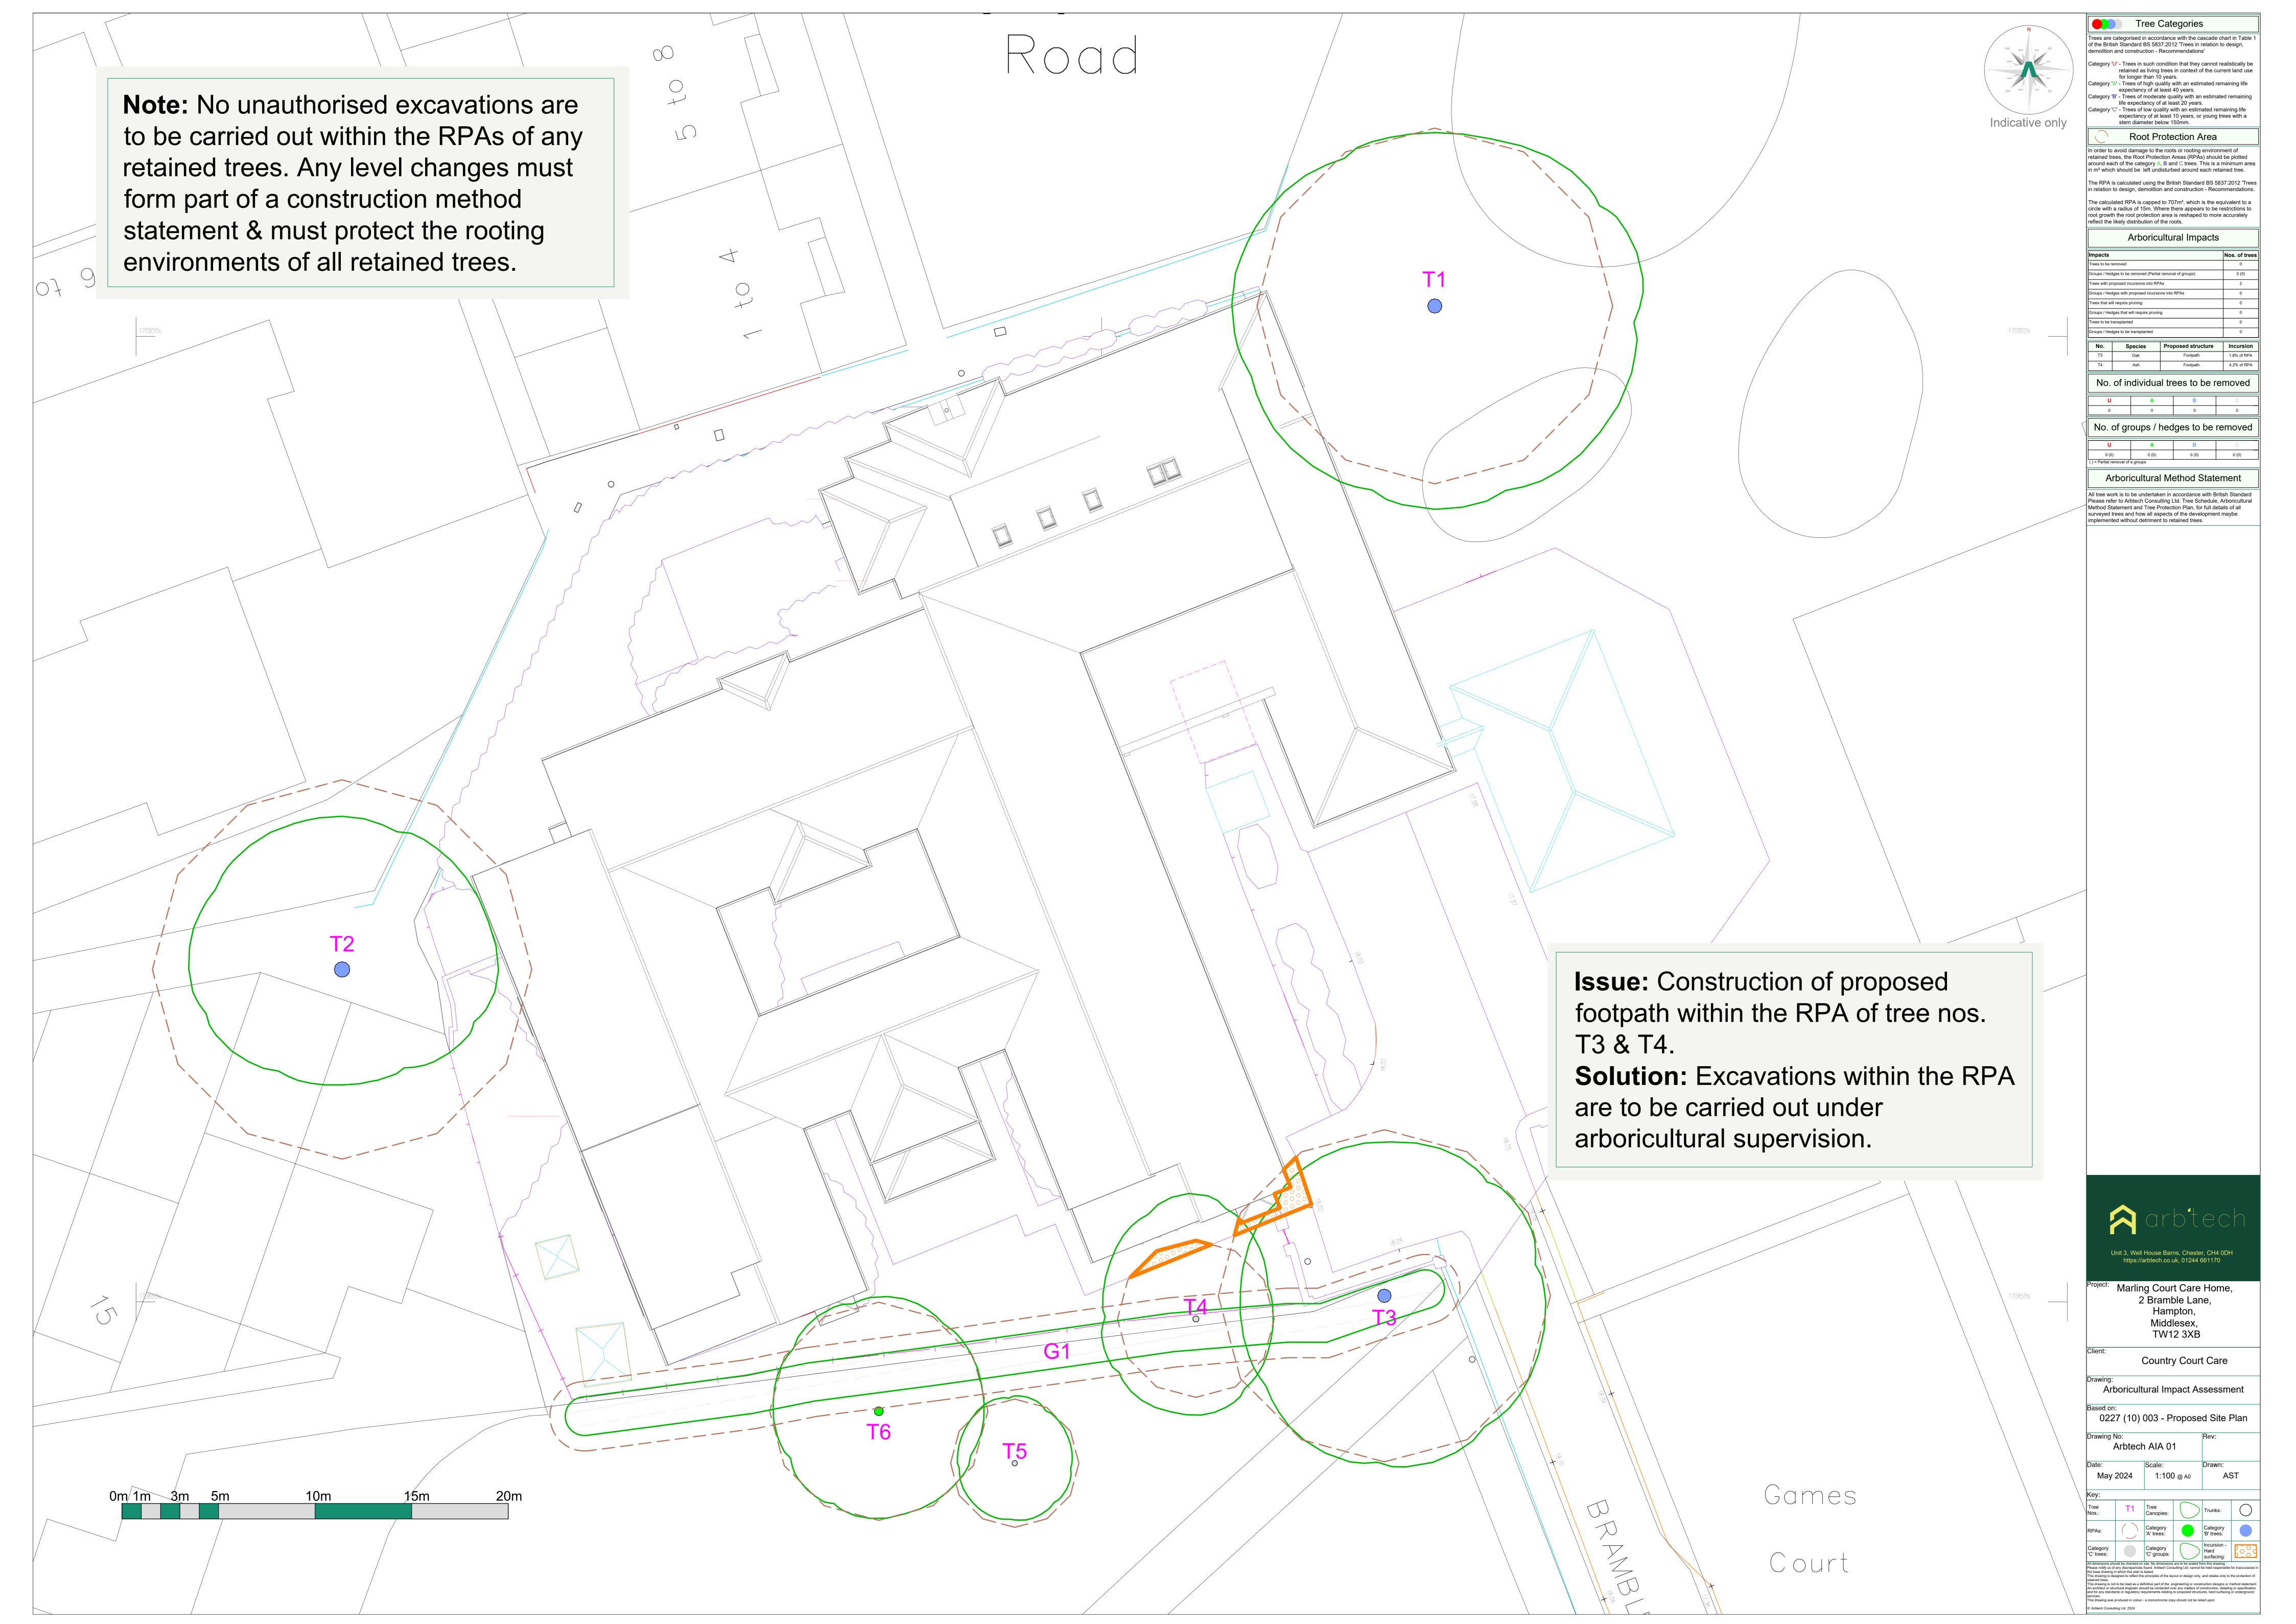
Appendix 1: Arboricultural Impact Assessment Plan

The proposed footpath causes an incursion into the RPA of trees T3 & T4. The required excavations within RPA are to be undertaken manually under arboricultural supervision.

Tree Number	Species	Structure	Incursion		
Т3	Oak	Footpath	1.8% of RPA		
T4	Ash	Footpath	4.2% of RPA

These impacts can be seen on the Arboricultural Impact Assessment drawing number Arbtech AIA 01
