**Marling Court Care Home  
2 Bramble Lane  
Hampton  
London**

## **In Situ Infiltration Test Report**

**Project Reference: P16581**

**Report Reference: R16182**

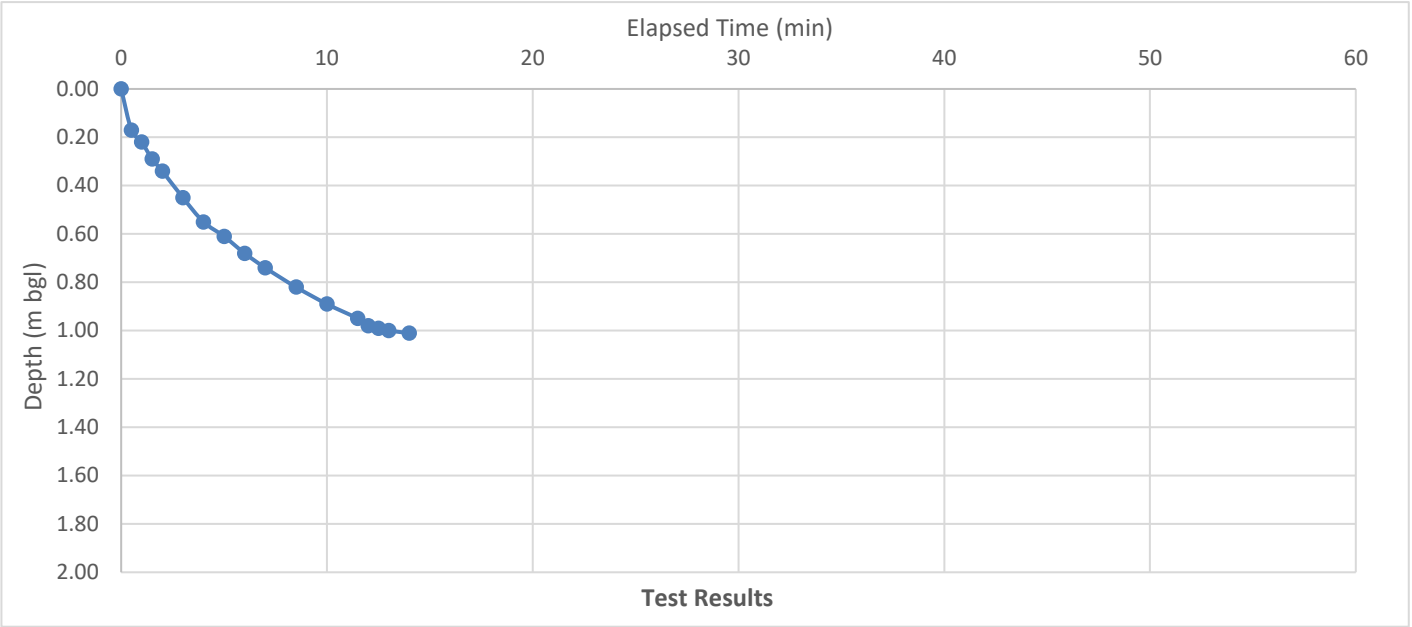
Test Position              WS01  
 Test No.                    2  
 Project No.                P16581  
 Project Name               Marling Court Care Home, 2 Bramble Lane, Hampton, London

Casing Depth                               1.00 m bgl  
 Borehole Depth                            2.00 m bgl  
 Casing Diameter                           0.105 m  
 Average Borehole Diameter              0.092 m

Length of Test Zone	1.00 m	L
Depth to Center of Test Zone	1.50 m	X
Water level at start of test	0.00 m	
Water level at end of test	1.01 m	
Duration of test	14 min	
Average Depth Of Water	1.50 m	
Average Drained Area	0.44 m <sup>2</sup>	
Volume of Water Lost	0.01 m <sup>3</sup>

<b>Driving Head</b>	<b>1.2</b>	<b>0.8</b>	<b>0.5 m</b>
<b>Infiltration rate</b>	<b>5.79E-05</b>	<b>3.03E-05</b>	<b>1.11E-05 m/sec</b>

Exploratory Hole	Test Response Zone Depth (m)		Stratum	Infiltration Rate (f) (m/sec)		
				Driving Head of Water (m)		
	Top	Bottom		1.20	0.80	0.50
<b>WS01 Test 1</b>	1.00	2.00	Taplow Gravel Member	$9.99 \times 10^{-5}$	$4.79 \times 10^{-5}$	$2.28 \times 10^{-5}$
<b>WS01 Test 2</b>	1.00	2.00	Taplow Gravel Member	$5.79 \times 10^{-5}$	$3.03 \times 10^{-5}$	$1.11 \times 10^{-5}$
<b>WS01 Test 3</b>	1.00	2.00	Taplow Gravel Member	$5.56 \times 10^{-5}$	$2.51 \times 10^{-5}$	$1.39 \times 10^{-5}$
<b>WS02 Test 1</b>	1.00	2.00	Taplow Gravel Member	$4.07 \times 10^{-5}$	$2.05 \times 10^{-5}$	$1.30 \times 10^{-5}$
<b>WS02 Test 2</b>	1.00	2.00	Taplow Gravel Member	$2.54 \times 10^{-5}$	$1.71 \times 10^{-5}$	$9.99 \times 10^{-6}$
<b>WS02 Test 3</b>	1.00	2.00	Taplow Gravel Member	$1.29 \times 10^{-5}$	$8.79 \times 10^{-6}$	$5.76 \times 10^{-6}$
<b>WS03 Test 1</b>	1.00	1.45	Made Ground - Gravel	$2.54 \times 10^{-3}$

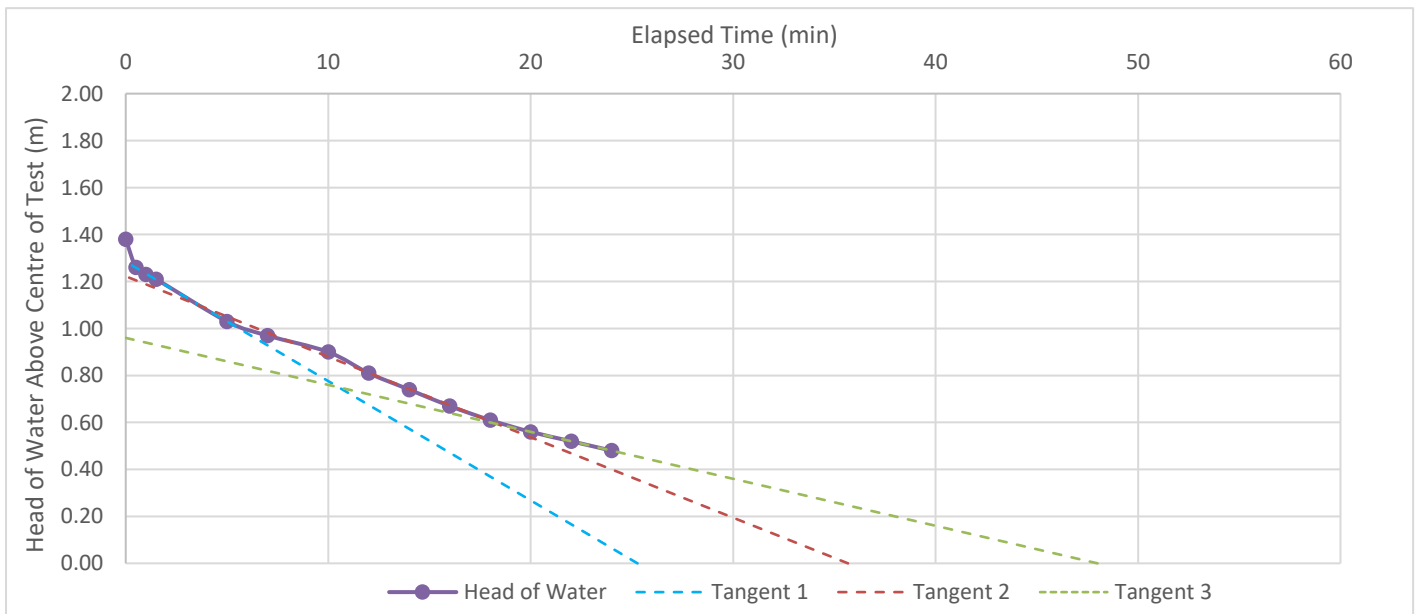
Test Position                 WS02  
 Test No.                     2  
 Project No.                 P16581  
 Project Name               Marling Court Care Home, 2 Bramble Lane, Hampton, London

Casing Depth                 1.00 m blg  
 Borehole Depth             2.00 m bgl  
 Casing Diameter            0.105 m  
 Average Borehole Diameter 0.092 m

Length of Test Zone                 1.00 m     L  
 Depth to Center of Test Zone         1.50 m     X  
 Water level at start of test           0.12 m  
 Water level at end of test           1.02 m  
 Duration of test                     24 min  
 Average Depth Of Water             1.43 m  
 Average Drained Area                0.42 m<sup>2</sup>  
 Volume of Water Lost                 0.01 m<sup>3</sup>

**Driving Head**                             **1.2**                               **0.8**                               **0.5 m**  
**Infiltration rate**                        **2.54E-05**                       **1.71E-05**                       **9.99E-06 m/sec**

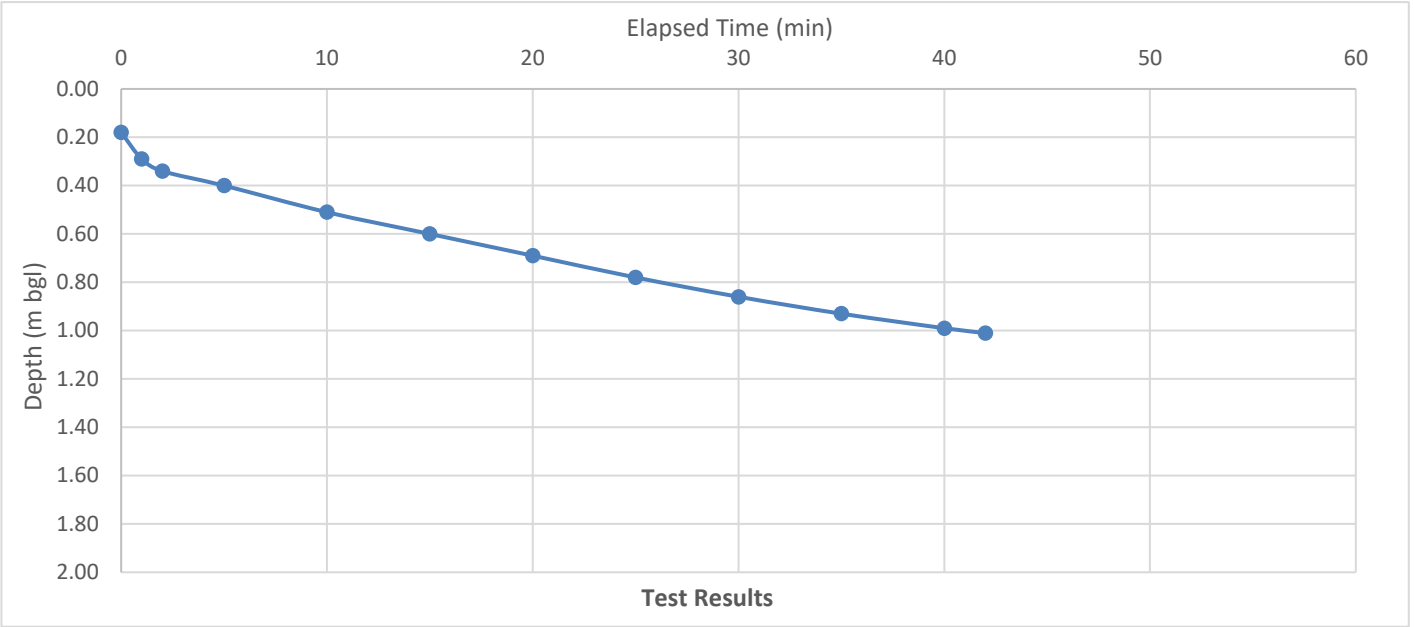
Test Position            WS02  
 Test No.                 3  
 Project No.             P16581  
 Project Name            Marling Court Care Home, 2 Bramble Lane, Hampton, London

Casing Depth                 1.00 m bgl  
 Borehole Depth             2.00 m bgl  
 Casing Diameter            0.105 m  
 Average Borehole Diameter   0.092 m

Length of Test Zone                 1.00 m    L  
 Depth to Center of Test Zone        1.50 m    X  
 Water level at start of test         0.18 m  
 Water level at end of test         1.01 m  
 Duration of test                     42 min  
 Average Depth Of Water             1.41 m  
 Average Drained Area                0.41 m<sup>2</sup>  
 Volume of Water Lost                0.01 m<sup>3</sup>

**Driving Head**                                **1.2**                                **0.8**                                **0.5 m**  
**Infiltration rate**                            **1.29E-05**                            **8.79E-06**                            **5.76E-06 m/sec**

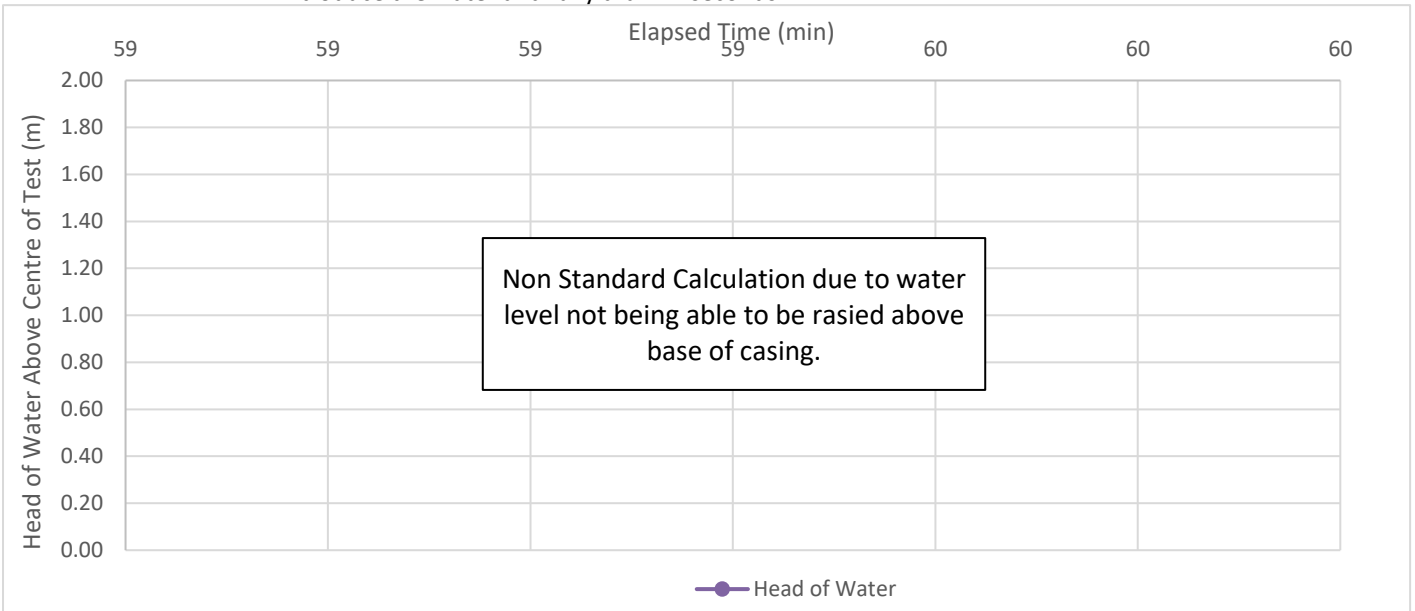
Test Position: WS03  
 Test No.: 3  
 Project No.: P16581  
 Project Name: Marling Court Care Home, 2 Bramble Lane, Hampton, London

Casing Depth: 1.00 m bgl  
 Borehole Depth: 1.45 m bgl  
 Casing Diameter: 0.105 m  
 Average Borehole Diameter: 0.092 m

Length of Test Zone: n/a m     L  
 Depth to Center of Test Zone: n/a m     X  
 Water level at start of test: n/a m  
 Water level at end of test: n/a m  
 Duration of test: 1.42 min  
 Length of Response Zone: 0.45 m  
 Drainage Surface Area: 0.14 m<sup>2</sup>  
 Volume of Water Lost: 0.025 m<sup>3</sup>

**Infiltration rate** **2.15E-03 m/sec**

Calculation method: Non-Standard -The soil infiltration rate has been calculated by dividing the volume of water introduced into borehole by the product of the surface area of the test section of borehole and the time taken to introduce the water and fully drain in seconds.

Due to the fact that water levels could not be raised significantly above the base of the casing within borehole WS03, calculation of the soil infiltration rates in accordance with the guidance was not possible. For the testing carried out within borehole WS03 the soil infiltration rate has been calculated by dividing the volume of water introduced into the borehole, by the product of the surface area of response/exposed test zone and the test duration in seconds.

<b>WS03 Test 2</b>	1.00	1.45	Made Ground - Gravel	$2.26 \times 10^{-3}$		
<b>WS03 Test 3</b>	1.00	1.45	Made Ground - Gravel	$2.15 \times 10^{-3}$
