Phase 1 & 2 Desk Study & Contamination Investigation
14 - 16 Tudor Road, Hampton

Report Title
Phase 1 & 2 Desk Study & Contamination Investigation

Project	Project No./Report Type
14 - 16 Tudor Road, Hampton	24-077/P1&P2

Client Name
The White House Design Ltd

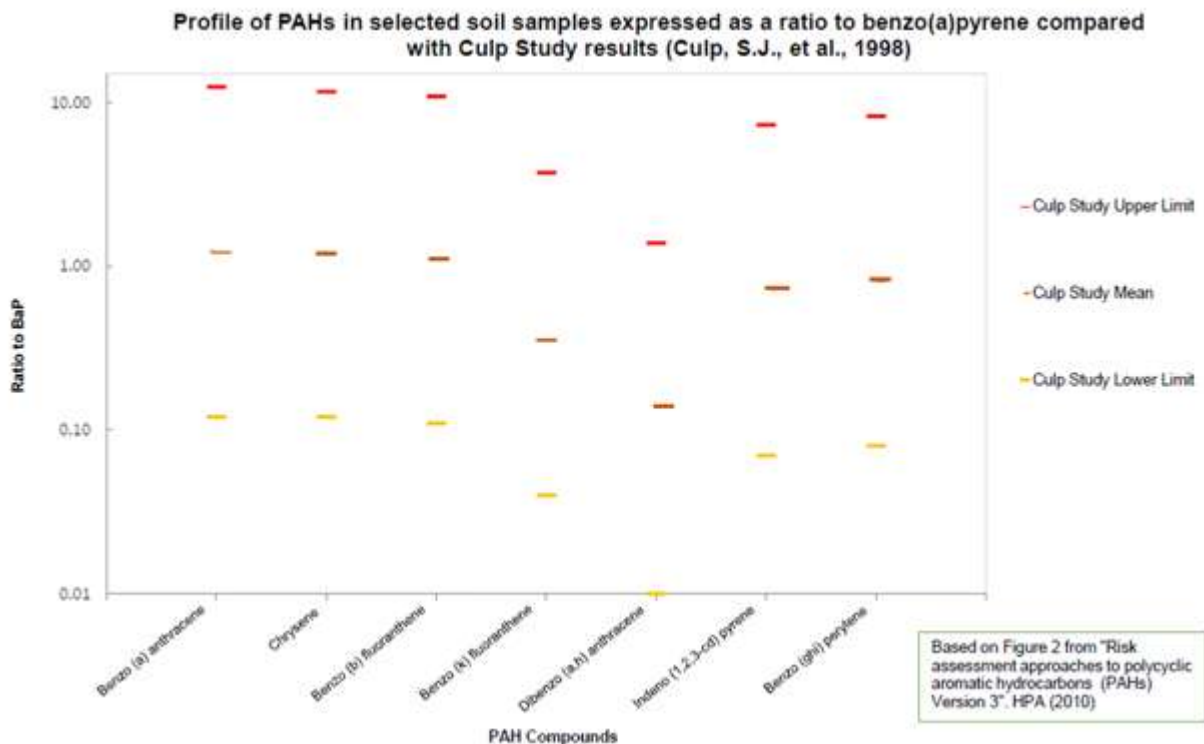
Therefore, in accordance with HPA guidance 13 and as detailed in SP101014, PAH profiling has been undertaken to determine the suitability of the Benzo(a)pyrene (BaP) surrogate marker approach in assessing the significance of the elevated PAHs. The Culp Study found the PAH profile across most sites to be as the plot below.

The assessment of PAHs as **single chemicals** is likely to be inappropriate for the majority of sites, due to the fact that they are usually present in soils as **mixtures**. An assessment of **mixtures** was therefore judged by SOBRA (Society Of Brownfield Risk Assessment)(2010) to be more suitable, since it takes into account the fact that **PAH mixtures** have been found to be comparatively more toxic than individual PAH compounds, and a mixture assessment will therefore provide a more

appropriate level of conservatism when assessing exposure to soil. Such considerations underpin the surrogate marker approach.

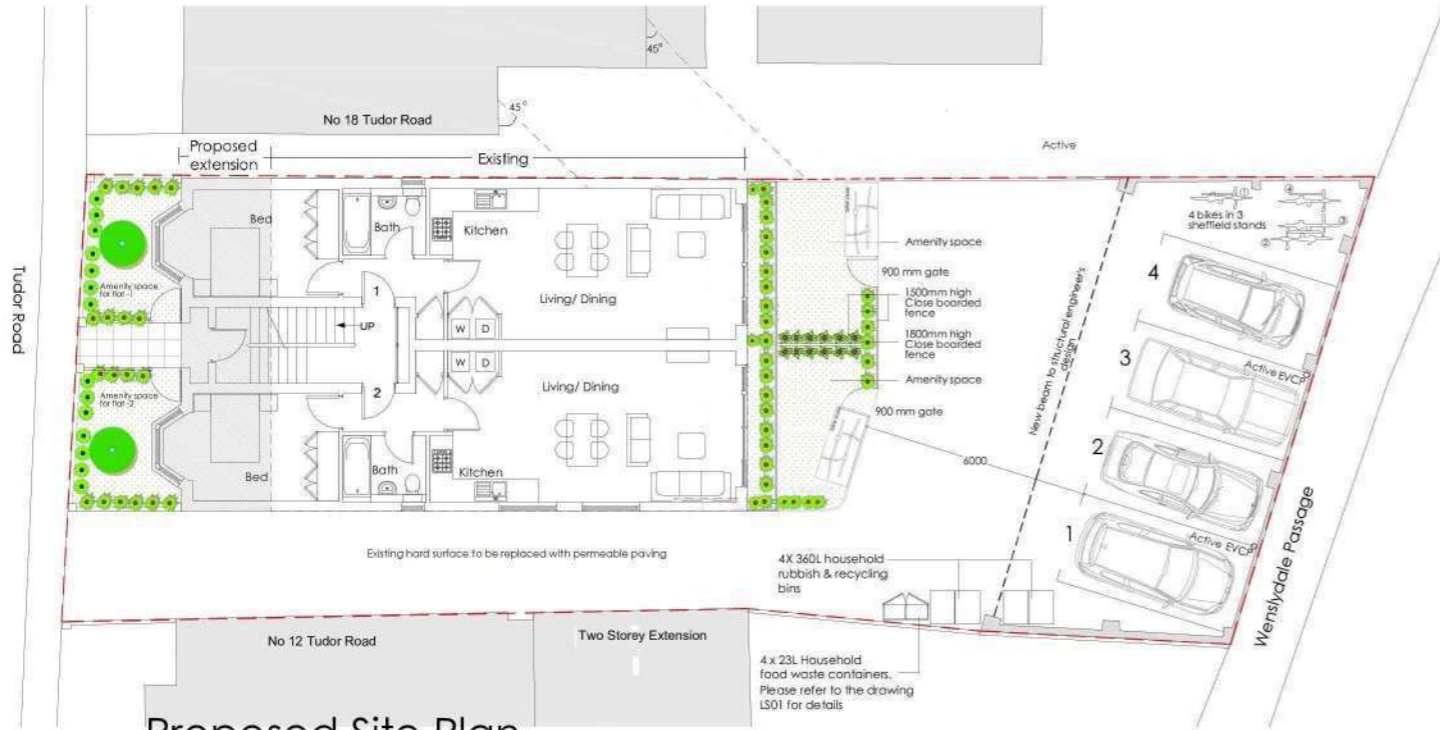
Proposed Site Plan
Scale 1:200

NB. Indicative landscaping proposals only. Details to be secured by condition.
