# **Preliminary Ecological Appraisal and Roost Assessment**

2-4 Ennerdale Road, Richmond, Richmond upon Thames, London, London, TW9 3PG

The Park Property Group (Kew) Ltd

21 May 2024

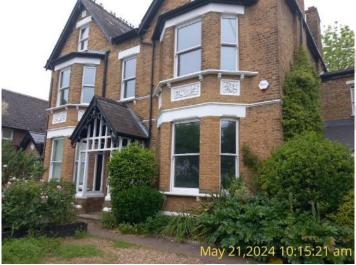
B1 - Southeast elevation.

B1 is an old Victorian two-storey, brick-built building. B1 has a pitched and gabled roof, clad in clay tiles. The brickwork around the building appears in excellent condition with no gaps or cracks in which bats can roost. Soffits and fascias, as well as window and door frames are of timber construction. There are no loft spaces within B1. The loft spaces have vaulted ceilings and have been converted to habitable living space.

Given the limited number of features identified on the property and the sub-optimal bat habitat on site, it is assessed that B1 provides **low** habitat value for roosting bats.

**One bat emergence survey** is required on **B1** during the active bat season (May – September) to confirm presence/likely-absence of bats roosting in or on the building.

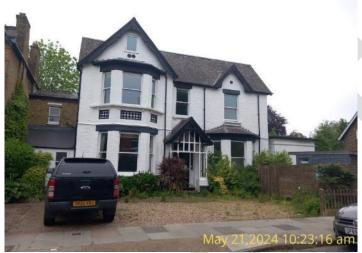
B2 - South elevation.

B2 is an old Victorian two-storey, brick-built and rendered building. B2 has a pitched and gabled roof, clad in clay tiles. The brickwork around the building appears in excellent condition with no gaps or cracks in which bats can roost. Soffits and fascias, as well as window and door frames are of timber construction. There are no loft spaces within B1. The loft spaces have vaulted ceilings and have been converted to habitable living space.

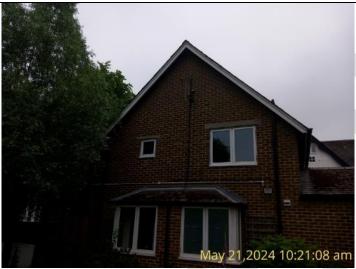
B3 - East elevation.

B3 is a two-storey, brick-built building modern extension. B3 has a pitched and gabled roof with dormer windows, clad in clay tiles. The brickwork around the building appears in excellent condition with no gaps or cracks in which bats can roost. Soffits and fascias, as well as window and door frames are of timber construction. There are no loft spaces within B3. The loft spaces have vaulted ceilings and have been converted to habitable living space. B3 is connected to B2 by a single storey enclosed walkway (with no loft space or suitable roosting features).

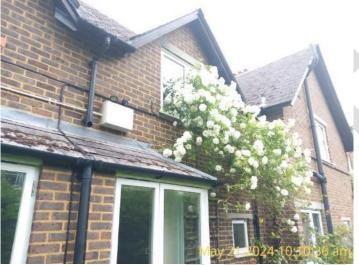
B4 - Southwest elevation.

B4 is a two-storey, brick-built building modern extension. B4 has a pitched and gabled roof with dormer windows, clad in clay tiles. The brickwork around the building appears in excellent condition with no gaps or cracks in which bats can roost. Soffits and fascias, as well as window and door frames are of timber construction. There are no loft spaces within B4. The loft spaces have vaulted ceilings and have been converted to habitable living space. B4 is connected to B1 internally.

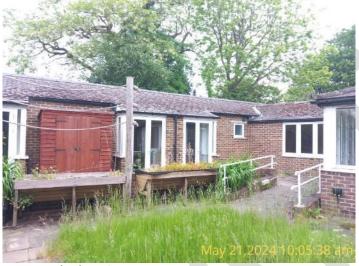
B5 - South elevation.

B5 is a single storey, brick-built building modern extension. B5 has a pitched and gabled roof, clad in clay tiles. The brickwork around the building appears in excellent condition with no gaps or cracks in which bats can roost. Soffits and fascias, as well as window and door frames are of timber construction. There are no loft spaces within B5. The loft spaces have vaulted ceilings and have been converted to habitable living space. B5 is connected to B1 internally.

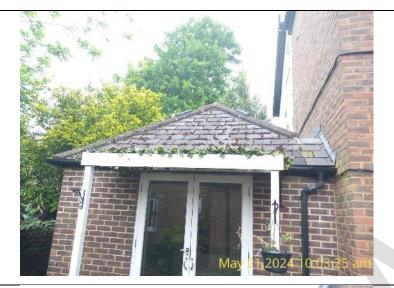
#### B1 - West elevation

The roof tiles on all the buildings are in good condition (with the exception of the aforementioned lifted tiles on the southern elevation of B1). The tiles are tight-fitting, there are none missing nor raised. There are therefore no suitable roosting features for bats.

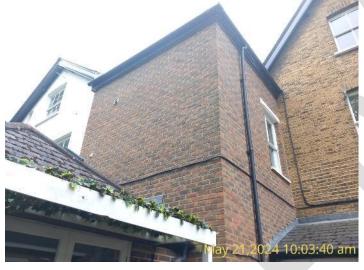
#### **B1** – North elevation

The brickwork on all the buildings is in good condition, it is well-mortared and there are no gaps or cracks in which bats could roost.
