Preliminary Ecological Appraisal

Thomas's College, Queen's Rd, Richmond Hill, London, TW10 6JP

This report is prepared to inform a planning application with the London Borough of Richmond. The proposal is described as: New covered MUGA to replace the existing open air MUGA like for like.

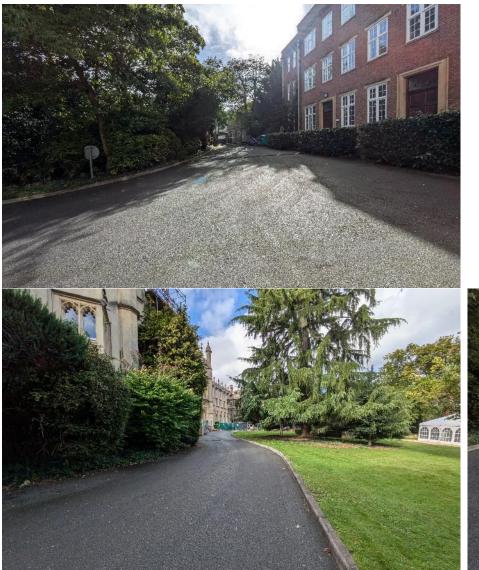
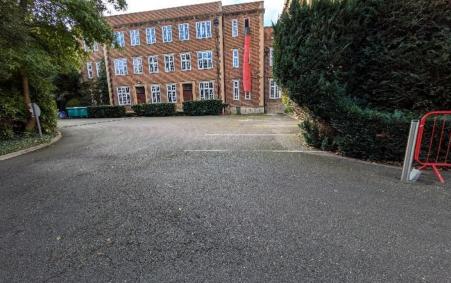
Figures 1 (opposite), 2 (bottom left), and 3 (bottom right).

Sealed surface pathway which leads to the existing MUGA, lined with grasslands, trees, hedgerows, and introduced shrubs.

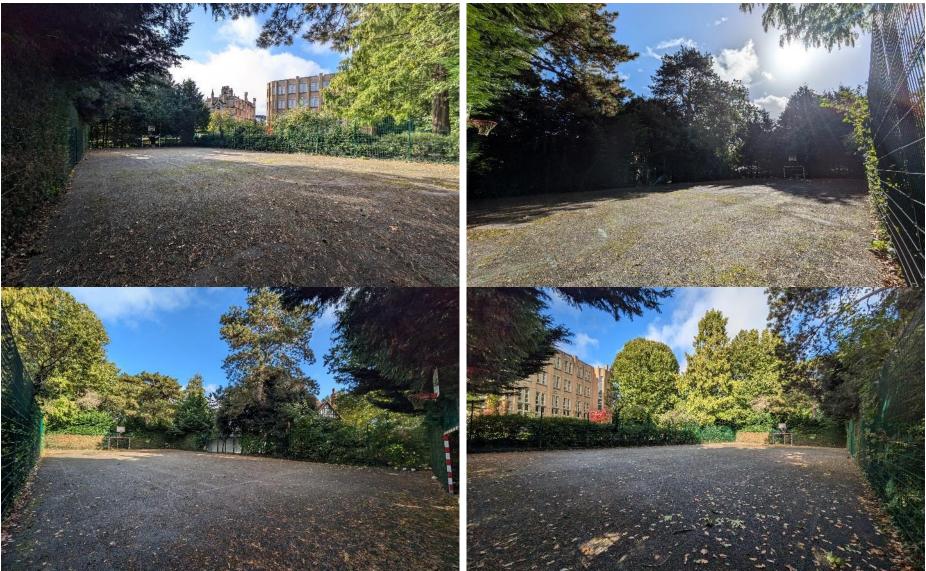
Figures 4 (top left), 5 (top right), 6 (bottom left), and 7 (bottom right). Existing MUGA from each corner, demonstrating the extent of vegetation in close proximity to the border fence.

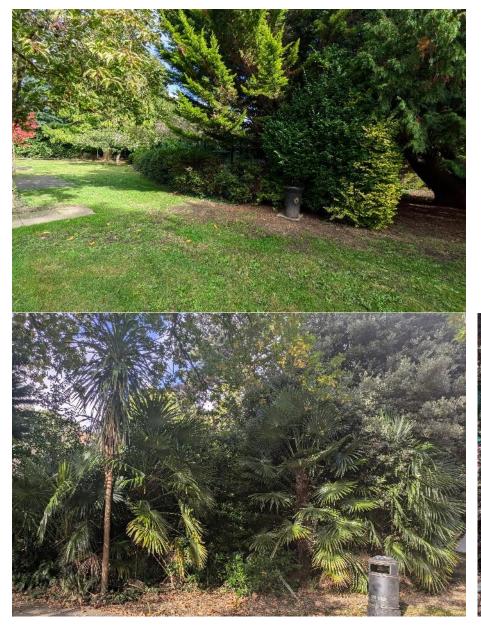
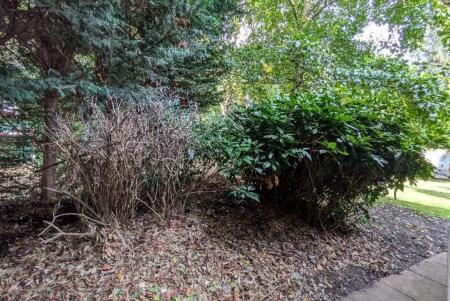
Figures 8 (opposite), 9 (bottom left), and 10 (bottom right).

Urban: suburban mosaic of developed and natural surface - educational premises open space with introduced shrubs, bare ground, and scattered trees [u1d 814 847 540 32] - Figures 8-10 and 13-18 Introduced shrubs are planted along the western and the majority of the eastern periphery of the existing MUGA. Species comprise Hypericum sp., holly, Japanese laurel, privet, palms, rhododendron, and cherry laurel. Introduced shrubs are not subject to condition assessments. Areas of bare ground are present under the cypress hedges and along the understorey of trees which serves as the entrance from the driveway to the MUGA. Such areas comprise minimal vegetation, including sparse ryegrass and forbs such as white clover, daisies, and dandelions. Scattered trees surrounding the MUGA range from young to mature and comprise mature Austrian pine,
 introduced shrubs, bare ground, and scattered trees [u1d 814 847 540 32] – Figures 8-10 and 13-18 Introduced shrubs are planted along the western and the majority of the eastern periphery of the existing MUGA. Species comprise Hypericum sp., holly, Japanese laurel, privet, palms, rhododendron, and cherry laurel. Introduced shrubs are not subject to condition assessments. Areas of bare ground are present under the cypress hedges and along the understorey of trees which serves as the entrance from the driveway to the MUGA. Such areas comprise minimal vegetation, including sparse ryegrass and forbs such as white clover, daisies, and dandelions. Scattered trees surrounding the MUGA range from young to mature and comprise mature Austrian pine,

Introduced shrubs surrounding the existing MUGA.

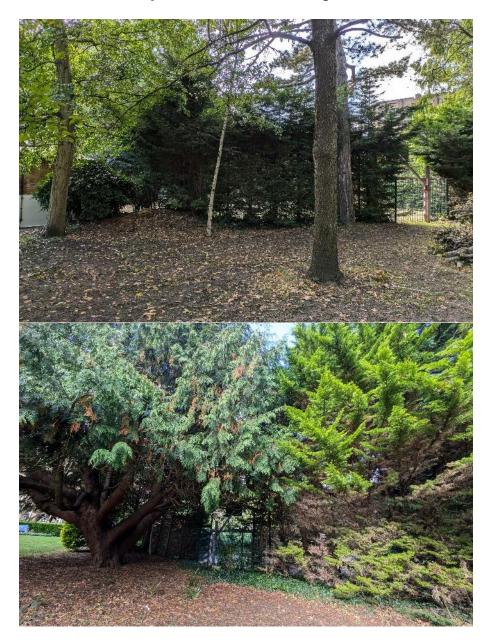
Figures 11 (top) and 12 (bottom).

Cypress hedges H1 (Figure 11) and H2 (Figure 12).

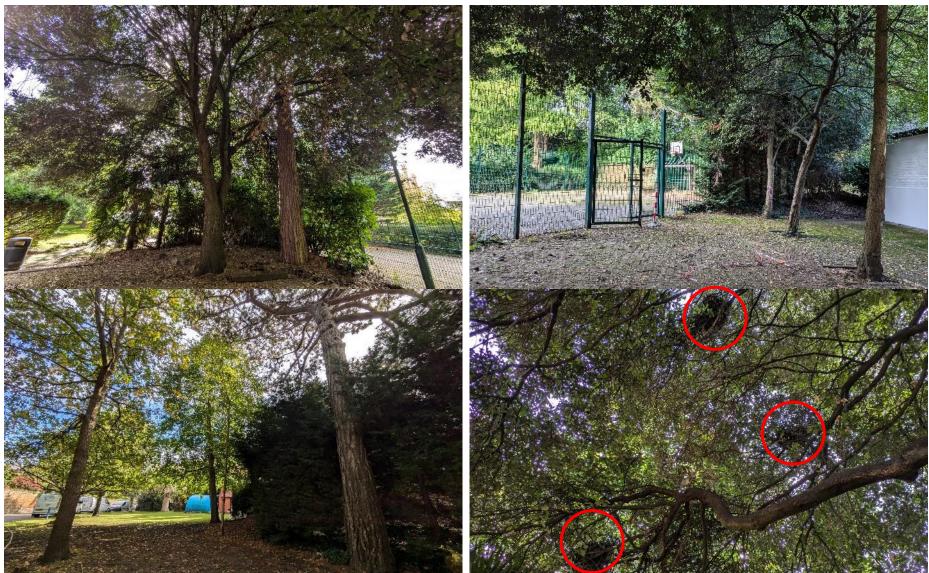
and void-dwelling species such as the Schwegler 45/2F Bat Box 2FDFP (WildCare) or a similar	
	alternative brand.	
Birds		
Summary of Survey Findings	No habitat for schedule 1 birds was observed. Evidence of disused birds' nests were found on mature	
	trees in close proximity to the existing MUGA (Figure 16).	
Foreseen Impacts	The proposed development could result in the destruction or the disturbance and subsequent	
	abandonment of active bird nests.	
Recommendations	Any tree works should be undertaken outside the period 1 st March to 31 st August. If this timeframe	
	cannot be avoided, a close inspection of the vegetation should be undertaken immediately, by a qualified	
	ecologist, prior to the commencement of work. All active nests will need to be retained until the young	
	have fledged. Precautions should be taken with machinery and noise levels when working close to any	
	active nests so as not to disturb any nearby nesting birds during construction works. At least a 3-5m

Figures 13 (top left), 14 (top right), 15 (bottom left), and 16 (bottom right). Scattered trees in close proximity to the MUGA. Disused bird's nests are pictured in Figure 16.

buffer should be created between any machinery and active nests until the young have fledged.	
	Enhancement opportunities for birds include:	
	Installation of 3no. bird boxes mounted on retained, mature trees along the site's boundaries wil	
	provide additional nesting opportunities for birds. Nest boxes should be sheltered from prevailing	
	wind, rain, and strong sunlight, and should be placed on an open aspect with no trees or large	
	shrubs potentially obstructing flight paths.	
Herpetofauna		
Summary of Survey Findings	There are no ponds on site, and one pond within a 500m radius (P1, ~250m southeast) which is situated	
	within Richmond Park. Habitats on site are largely unsuitable for great crested newts due to their intensely

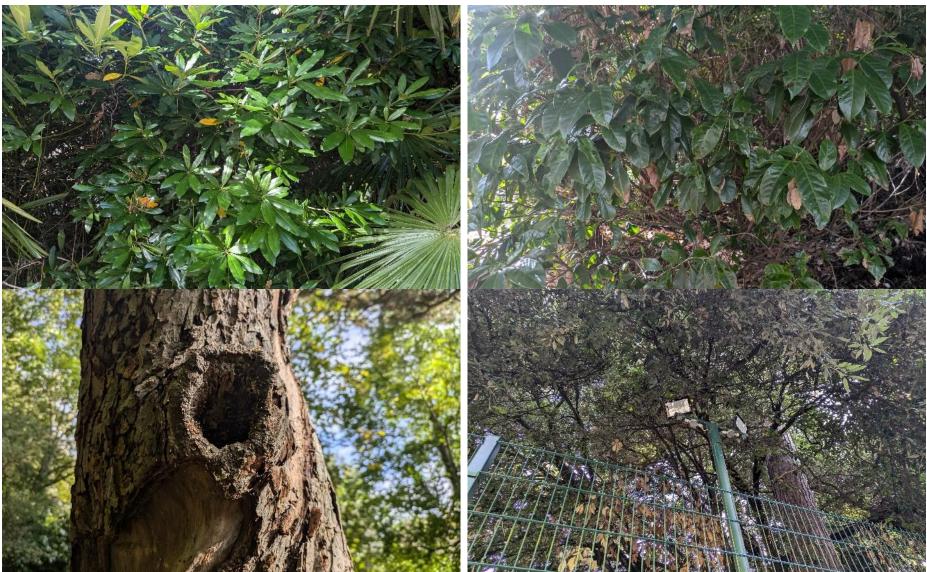
Recommendations	N/A					
Invasive / Non-native species	•					
Summary of Survey Findings	No Schedule 9 invasive	species were identifie	ed on site. Rhododendro	on (Rhododendron ponticum) and		
	cherry laurel (Prunus la	a <i>urocerasus</i>) were ide	ntified on the site (Fig	ures 17-18). Rhododendron is a		
	Schedule 9 species per t	he Wildlife and Country	/side Act 1981, while ch	erry laurel is an additional invasive		
	species relevant to Lond	on per the London Inva	sive Species Initiative (L	ISI).		
Foreseen Impacts	Existing specimens of rh	nododendron and cher	ry laurel are understood	to be retained in full. As such, no		
	risk of the spread of suc	h species is anticipated	J.			
Recommendations	No further surveys but re	emain vigilant.				
Bats						
Summary of Survey Findings	A review of the MAGIC database revealed 3no. granted European Protected Species Licences (EPSLs)					
	within a 2km radius, which are summarised in the table below.

commuting resource for bats in the context of the wider landscape, though bats may utilise habitats
	within the wider site ownership boundary as a whole for foraging and commuting purposes. Three
	existing light structures were found along the eastern periphery of the existing MUGA, an example of
	which is pictured in Figure 20. Habitats in the wider landscape, such as woodland copses, grasslands,
	linear features such as hedgerows, and water features such as ponds within green spaces such as
	Richmond Park and neighbouring golf courses provide more ideal habitats for foraging and commuting
	bats.
	A dead, unidentified tree is located centrally north of the northern periphery of the MUGA (TQ 18460
	74061). There is a knot hole (Figure 19) present on its western aspect approximately 2m above ground
	level. Due to the uncertain extent of the knot hole, notably whether there are suitable crevice-dwelling

features internally, this tree is, at this point, classed as having potential roosting features (PRF).
Foreseen Impacts	The proposed development may lead to an increase in the amount of current lighting of surrounding
	habitats or the retained building without mitigation. This may disturb commuting bats.
	The dead tree has a PRF, which could be suitable for roosting bats. If this dead tree will be removed,
	further survey efforts will be required, as the removal of this tree could result in the destruction of any
	bat roosts present and could cause disturbance, death, or injury to bats.
Recommendations	A low impact lighting strategy will be adopted within the proposed development. This will be designed in
	accordance with Guidance Note GN08/23 Bats and Artificial Lighting at Night (Institution of Lighting
	Professionals, 2023).

Figures 17 (top left), 18 (top right), 19 (bottom left), and 20 (bottom right). Target notes: rhododendron, cherry laurel, knothole within dead tree, and existing lights for the MUGA.

ne dead tree, if set for removal, will require an endoscope survey to discern whether the PRF identified is
su	uitable for roosting bats or contain evidence of a roost. The survey is not seasonally restricted and can
tal	ke place at any time. If the endoscope survey reveals suitability for roosting bats or signs of previous
oc	ccupancy by bats, the appropriate amount of dusk bat emergence surveys will be required: for low roost
su	uitability (PRF-I), no further emergence surveys required; for high roost suitability (PRF-M), 3no.
en	mergence surveys required with each visit spaced at least three weeks apart during the active bat season
(m	nid-May to September inclusive, with 2no. visits required between mid-May and August inclusive). These
en	nergence surveys will require 2no. surveyors per visit and infrared cameras should be used as an aid. If
ba	at roosts are confirmed an EPSL application to Natural England will be required. The EPSL application
