# STOKES HOUSE, HAM STREET

# Heritage, Design and Access Statement Planning Application

Proposal for the replacement of the existing single-storey outbuildings with a new single-storey outbuilding for a gym/office.

Stokes House Ham Street, Richmond TW10 7HR

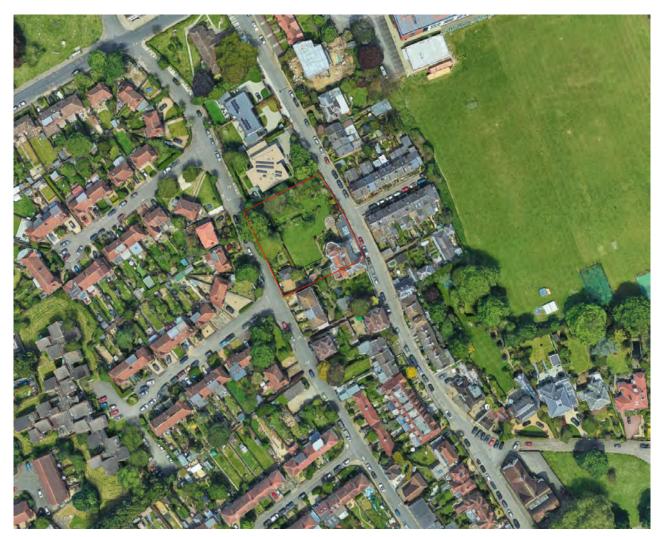
Fig. 02: Aerial photograph showing outline of site at Stokes House, Ham

This document outlines our proposal to rebuild an outbuilding that currently sits along the southern boundary of the site. The existing building is in a poor state of repair, and the proposed replacement will sit on the existing concrete subbase so does not result in extensive excavations nor an increase in impermeable footprint . The fenestration design will mimic the timber framed windows of the ground floor extension approved in the granted application 23/3452/HOT. Applying a traditional breathable lime render and capping the wall with stone copings to match the lime render granted in application 24/2040/HOT. If granted, this proposal will be implemented alongside these two approvals.

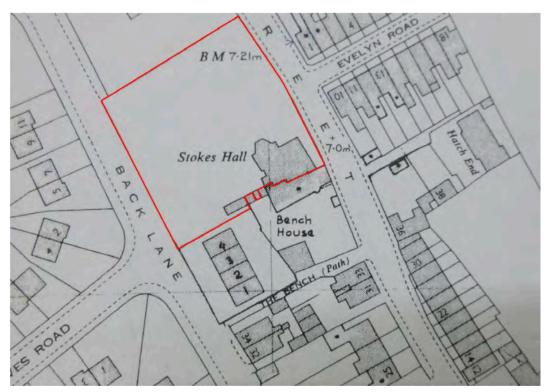
Fig.06 1982 Map (OS). Subject site outlined in red

The analysis of historic maps and images reveals that Stokes House was originally a single structure named Stokes Hall before it was divided in 1972 into Bench House and Stokes House. The map below shows the original building including both what we now know as Stokes House and Bench House, with the current boundary line in red showing that division of the property as we know it today.

The elongated single-storey wing containing outbuildings more than likely originally provided garden storage space to the occupants of Stokes Hall. When Stokes Hall was divided to form Stokes House and Bench House in 1972, this single-storey storage extension was apportioned between the two sites. Its north elevation has retained its historic appearance, with painted brickwork up to the height of the top of the brick architrave, and a shallow, pared back cornice. The pitched clay-tiled roof is not visible from the garden.

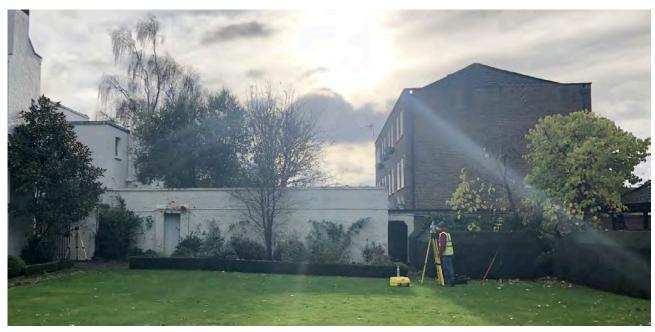
Fig.08: View of existing northern elevation looking towards The Bench

The existing outbuilding today is a single-storey structure attached to the side of the historic building, constructed with low-quality materials that do not complement the architectural merit of the main building. Its exterior is characterised by both painted and weathered brickwork that has suffered from exposure to the elements, leading to visible cracks and signs of serious deterioration. Faded and flaking modern non-breathable masonry paint, likely added in an attempt to address defects and enhance its appearance, has peeled and chipped, revealing underlying issues that compromise both its integrity and visual appeal.

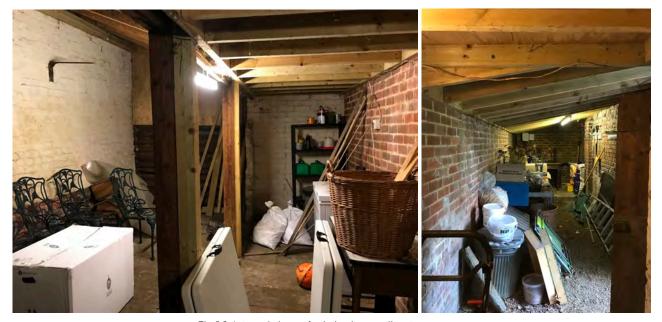
Fig.09: Internal views of existing low quality storage areas

Upon entering the structure, the interior layout is basic and poorly lit due to the lack of windows, resulting in no natural light. Given its state of neglect and misalignment with the architectural integrity of the historic property, this outbuilding requires rebuilding to restore both its functionality and aesthetic appeal, ensuring it harmonises seamlessly with the main structure and enhances the overall setting of nearby heritage assets.
