## GROUND INVESTIGATION & BASEMENT IMPACT ASSESSMENT REPORT

26 AMYAND PARK ROAD  
TWICKENHAM  
TW1 3HE

**Report Title:** Ground Investigation & Basement Impact Assessment for 26 Amyand Park Road, Twickenham, TW1 3HE

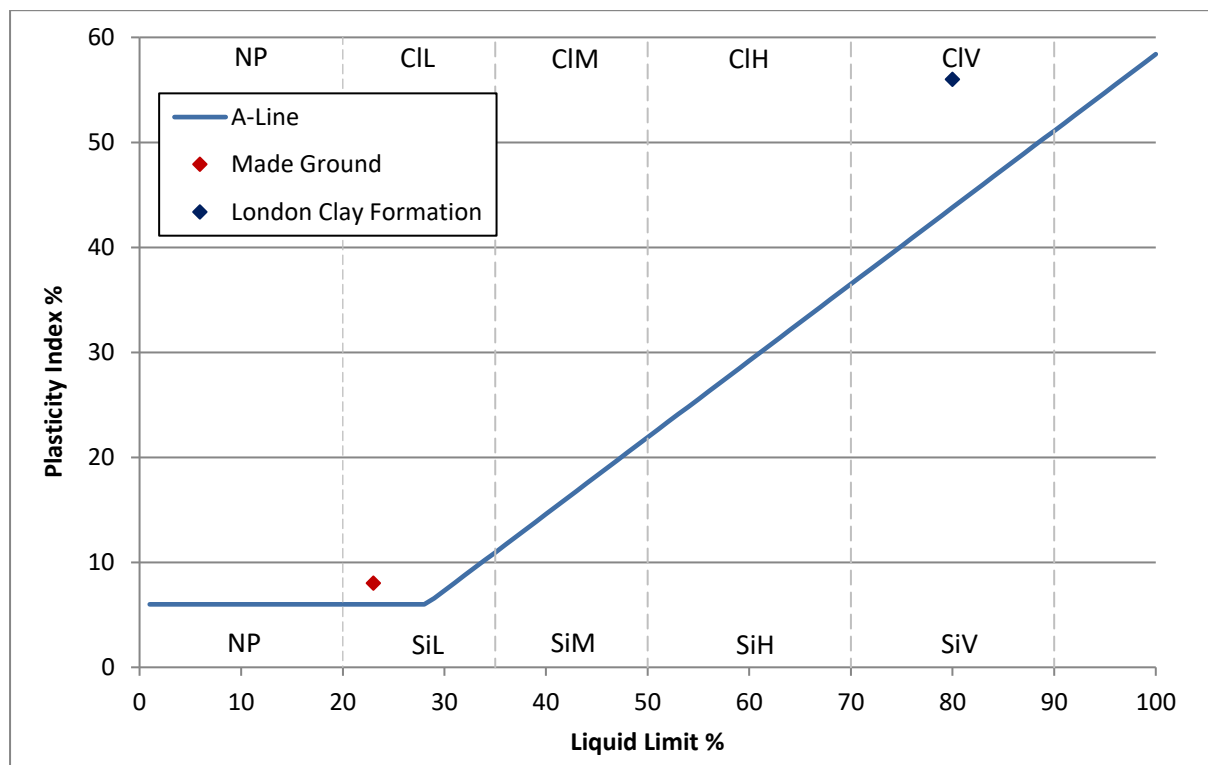
Figure 5.1: Plasticity Chart

5.2.3 The plasticity index value within the London Clay Formation was 56% and was indicative of very high plasticity. The modified plasticity index value was 53.2%, indicating soils with high volume change potential.

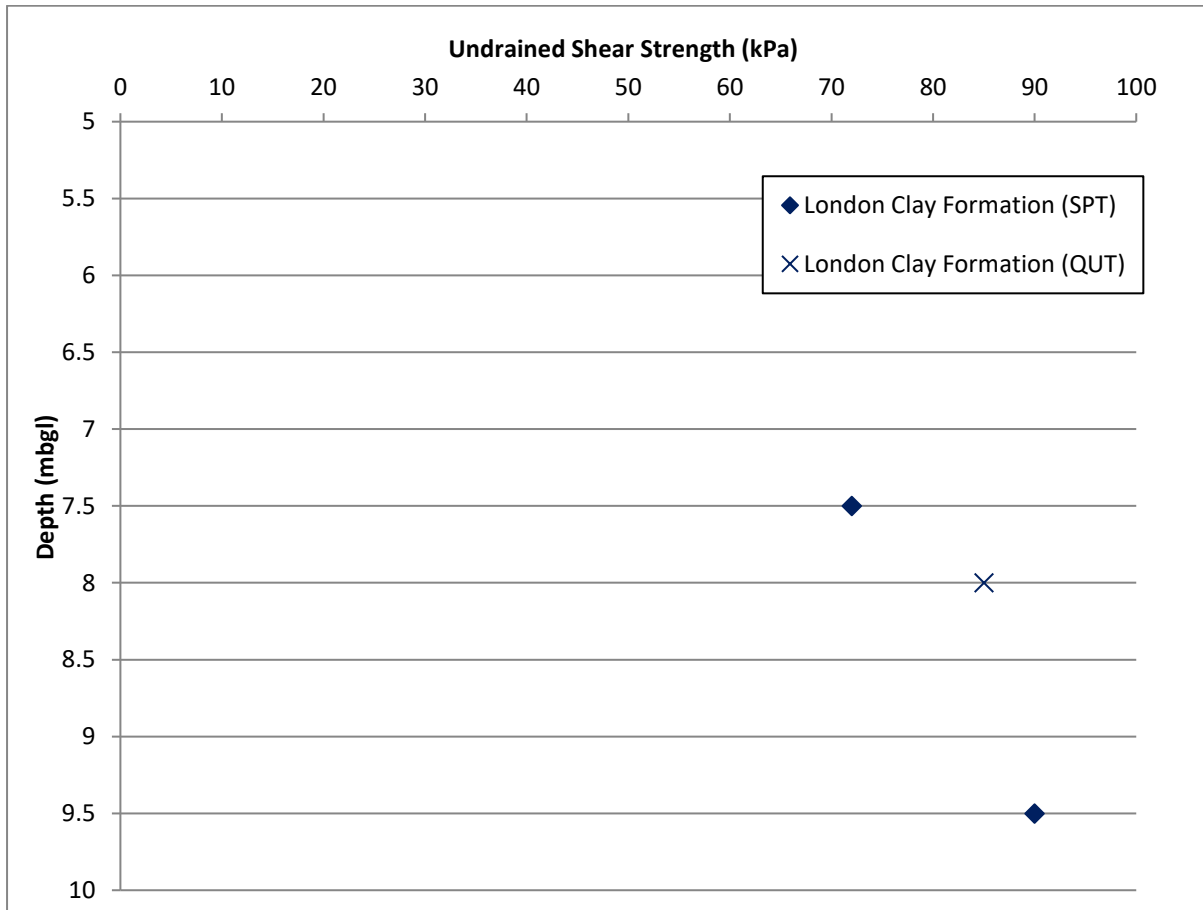
**Figure 5.3: Undrained Shear Strength v Depth**

5.4.3 The graph below shows the shear strength profile of the encountered cohesive materials at the site, based on the SPT to shear strength correlation described above, as well as the results of quick undrained triaxial (QUT) testing on undisturbed samples taken from the borehole.

5.4.4 As shown above, a general trend of increasing undrained shear strength with depth can be seen within the limited results from the London Clay Formation.

5.4.1 As discussed above, the N values recorded in the clay vary with depth, this infers that the undrained shear strength of the clay similarly varies. Figure 5.3 below shows the undrained shear strength inferred by the correlation suggested by Stroud (1974);

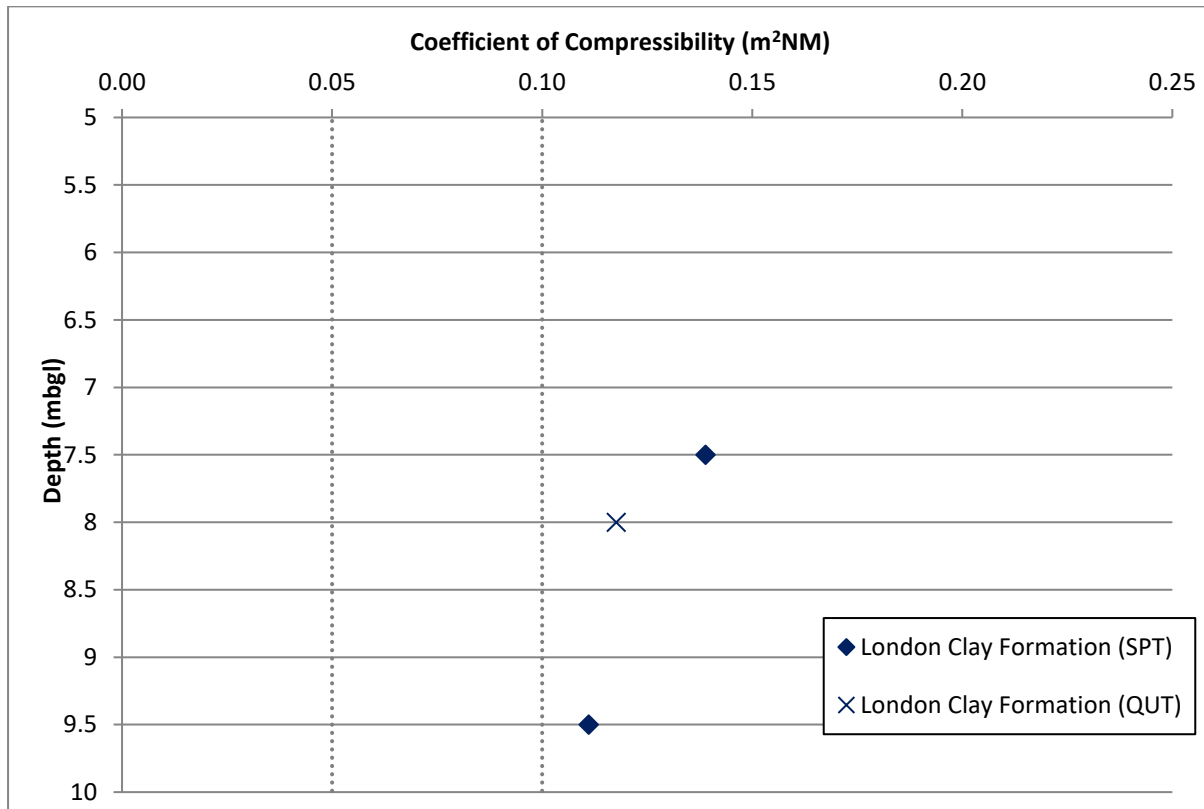
**Figure 5.4: Coefficient of Volume Compressibility ( $m_v$ ) v Depth**

- 5.5.2 Using the plasticity indices obtained and the graphs provided in Tomlinson (2001) a value of  $f_2$  of 0.45 has been taken and used with the SPT N-values to infer coefficient of compressibility ( $m_v$ ).
- 5.5.3 Where the undrained shear strength of the clays was measured using the quick undrained triaxial methodology, the  $m_v$  value was calculated by rearranging the equations for  $f_1$  and  $f_2$  and substituting in the measured undrained shear strength.

- 5.5.4 As shown above, the results from the London Clay Formation are of “medium compressibility”.
