RESTORATION OF THE DOUBLE-GALLERY

Alteration	Historic Context	Works and Justification
<p>Provide a tea room in the Great Cloister (G8) and restore the arched openings to the Great Cloister and install new glazed doors to facilitate new use as tea room.</p>	<p>1758 The Great Cloister designed as part of the new rooms to the west forming a circuit of state rooms at first floor level. The sequence of brightly decorated State Apartments were contrasted with consciously austere, plain painted Back Stairs and Great Cloister.</p> <p>1762 Great Cloister completed with five bays, pierced with arches opening directly into the pleasure ground.</p> <p>1820s The arches bricked up and the Great Cloister divided into three rooms used as a dressing room, bedroom and housekeeper's room.</p> <p>1962 Partitions demolished, western partition rebuilt.</p> <p>2006 Listed Building consent given to remove 1962 partition and reinstate articulation of bays and internal windows.</p>	<p>(Consent given for restoration of the internal windows and doors on the north wall)</p> <p>(Consent given for the removal of all subdivisions)</p> <p>(Consent given for the restoration of the niche at the east and west ends o

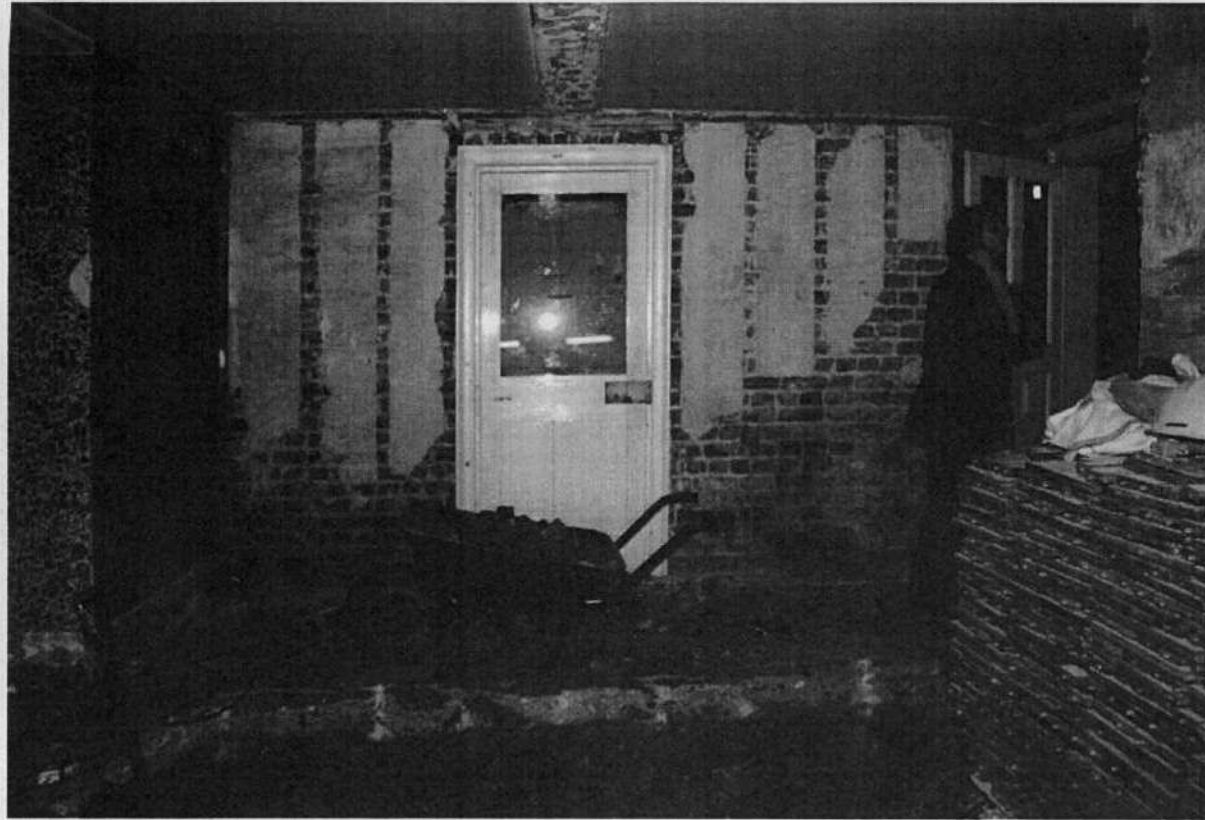
Alteration	Historic Context	Works and Justification
Waiting Parlour (Shop) G13 D3:	<p>1700 Door frame constructed as part of pre-Walpole house.</p> <p>1860s Door leaf renewed, lock set salvaged from earlier doorleaf</p> <p>1920s Door furniture renewed.</p>	<p>Dismantle C20 door to store to facilitate circulation within new shop. The dating of the door was established using paint analysis.</p> <p>The retail operation is key to supporting the operation of the house as a single building preservation trust. Rooms G13 and G14 have are on a small scale. The dismantling of the door allow much needed display space for the retail facility.</p>
