## Second Floor Plan Shutter Repair Notes

PROJECT
Marble Hill House

TITLE
Main House:
Second Floor Plan; repairs to shutters

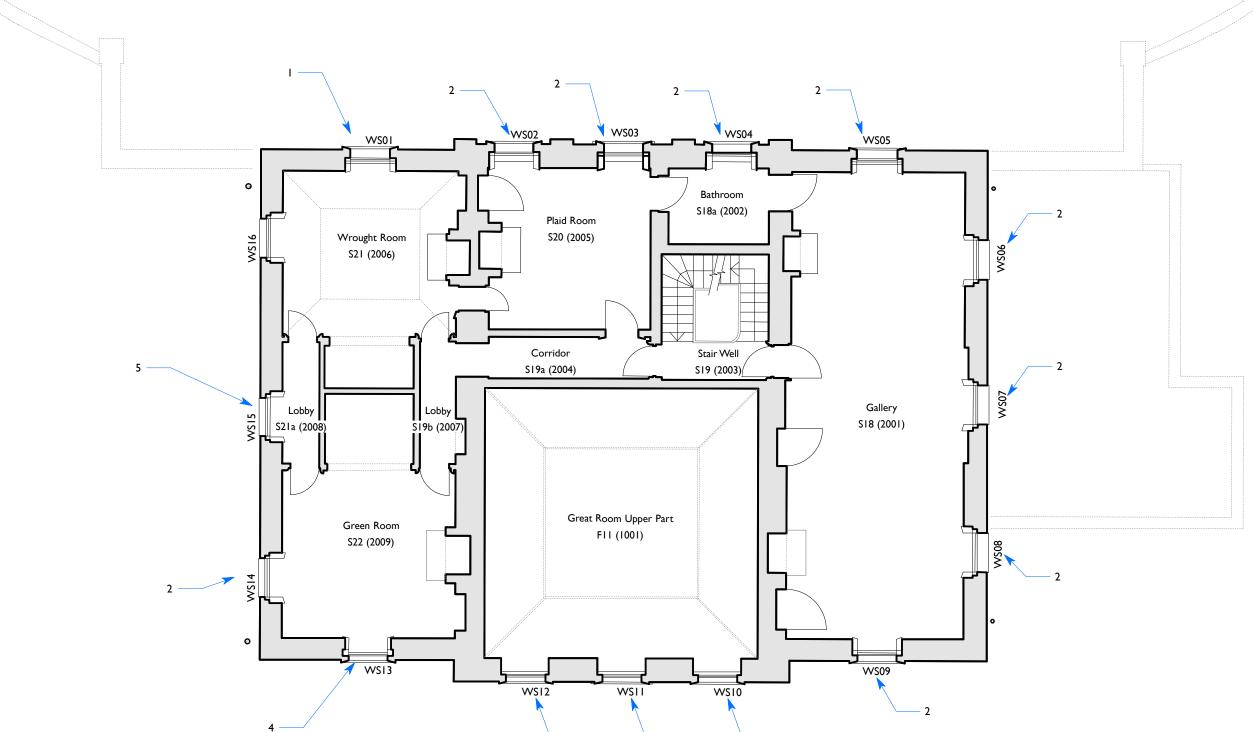
Second Floor Plan

1. WS01: The pulleys to the lower 'sliding sash shutter' are broken/missing; remove the retaining beads and open up sash box. Install 2no. new sash cords, 2no new pulleys and refix weights. Reassemble window. The upper 'sliding sash shutter' is stiff, allow to ease. If boxing is opened up, allow to refurbish including rebalencing or replacing the sash weights if required.

2. Window shutters and ironmongery appears to be in an acceptable condition. Generally to the 'sliding sash shutter' wax the cords and oil the pulleys.

3. Allow a provisional sum to repair windows WS10,11,12 as required.
4. WS13; 'sliding sash shutter' mechanism is broken and disused. The 'new' shutters are in an acceptable condition. No work required.

5. WS15; the LH sash weight has become detached. Remove the beads, open up the sash box using the access doors, lift out the sashes. Replace the sash cords to both sides and refix/reinstall the sashes, refixing the beads. Generally to the 'sliding sash shutter' wax the cords and oil the pulleys.
