## Latchmere House, Kingston-upon-Thames Survey of Outbuildings Proposed for Demolition

prepared by **MAA** Architects

February 2014

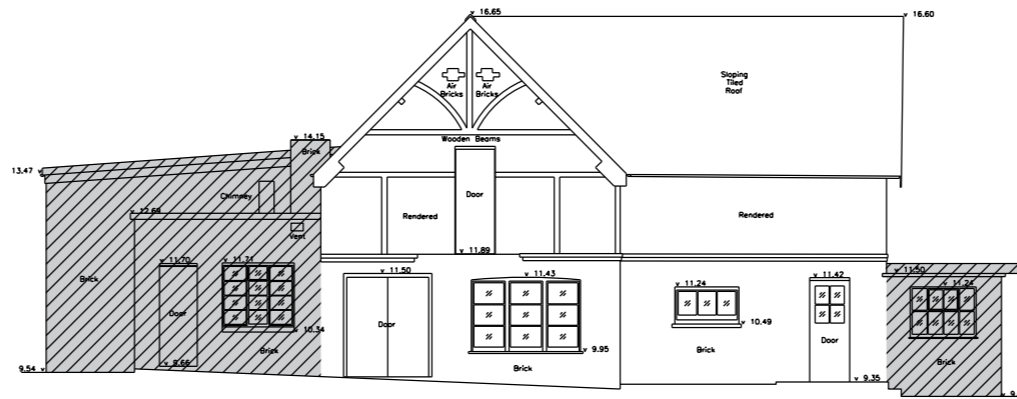
Elevation 1

The timber fascias and the associated timber features on the elevation 1 require complete replacement.

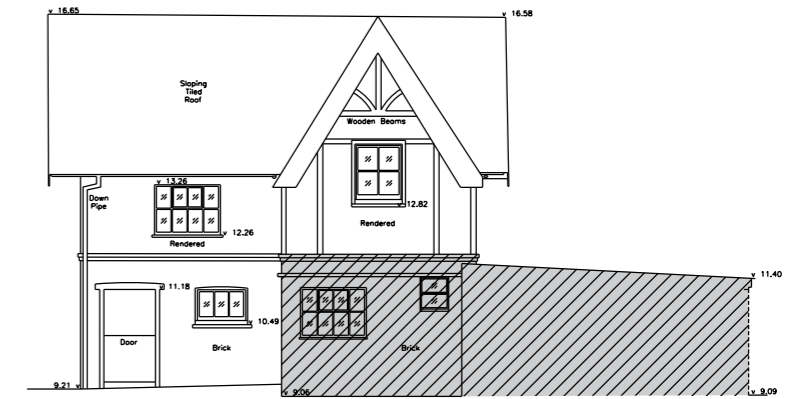
Elevation 2

As a result of this, the structure has lost its original structural integrity and this is evident from the cracks which are beginning to appear on the elevations, particularly on elevation 2.

The ridge tiles and the associated mortar beddings are beyond repair and the roof requires complete replacement in order to achieve a decent life span. Access wasn't possible into the roof space to inspect the condition of the structural members but judging from the protruding structural members outside it would appear that they would need replacement and possibly strengthening. As is normally the case with old structures of this nature, it is highly possible that the lack of or ineffective tying at approximately at eaves level may have also contributed towards the cracking of the brickwork as shown on elevation 2 thus losing its structural integrity.

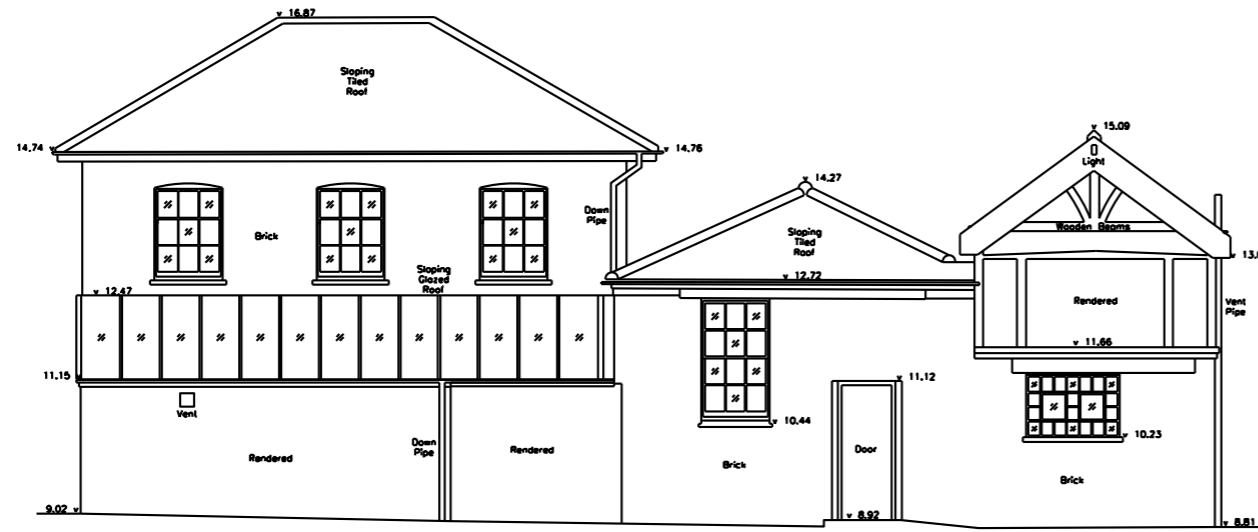
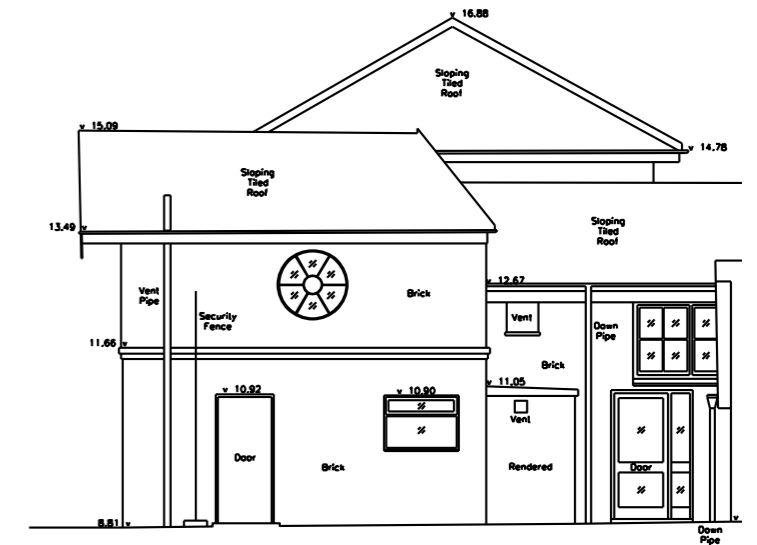
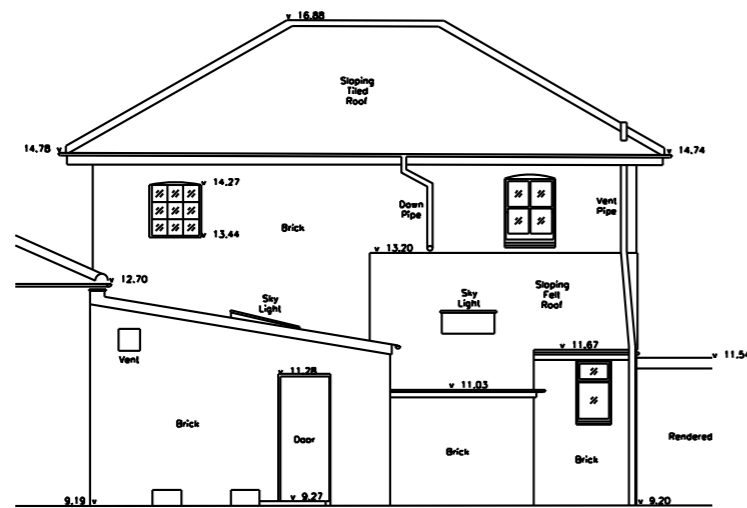
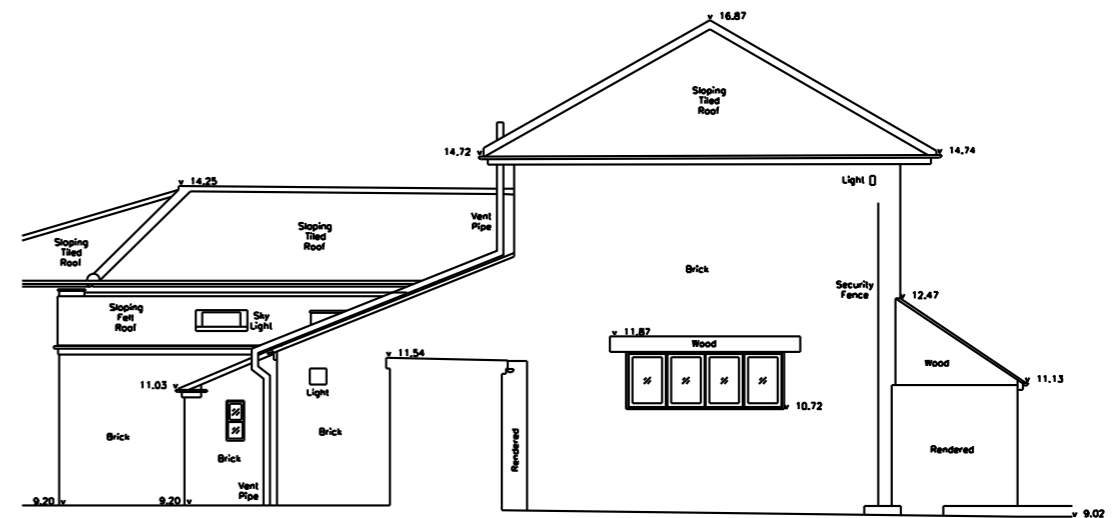
The identified building is surrounded by later extensions with small amounts of the upper elevations visible and all of elevation 4.

As it stands, the high level arched window openings are already showing signs of distress in the way of cracks. See mark up on the elevations.

On the first floor level, cracks are evident above the windows. The window frames with their sash windows require replacement. The brickwork either side of these windows are already showing signs of distress and losing their structural integrity. The thickness of the upper floor walls reduces in thickness towards the top starting from approximately at the window cill level. Therefore it would be virtually impossible to justify the structural integrity of the wall
