8.27 STABLE BLOCK & CAFE - STABLE WALL ARCHAEOLOGICAL INVESTIGATION

**STABLE YARD WALL
AT MARBLE HILL,
TWICKENHAM,
LONDON BOROUGH OF
RICHMOND-UPON-THAMES**

Archaeological Investigation

2016

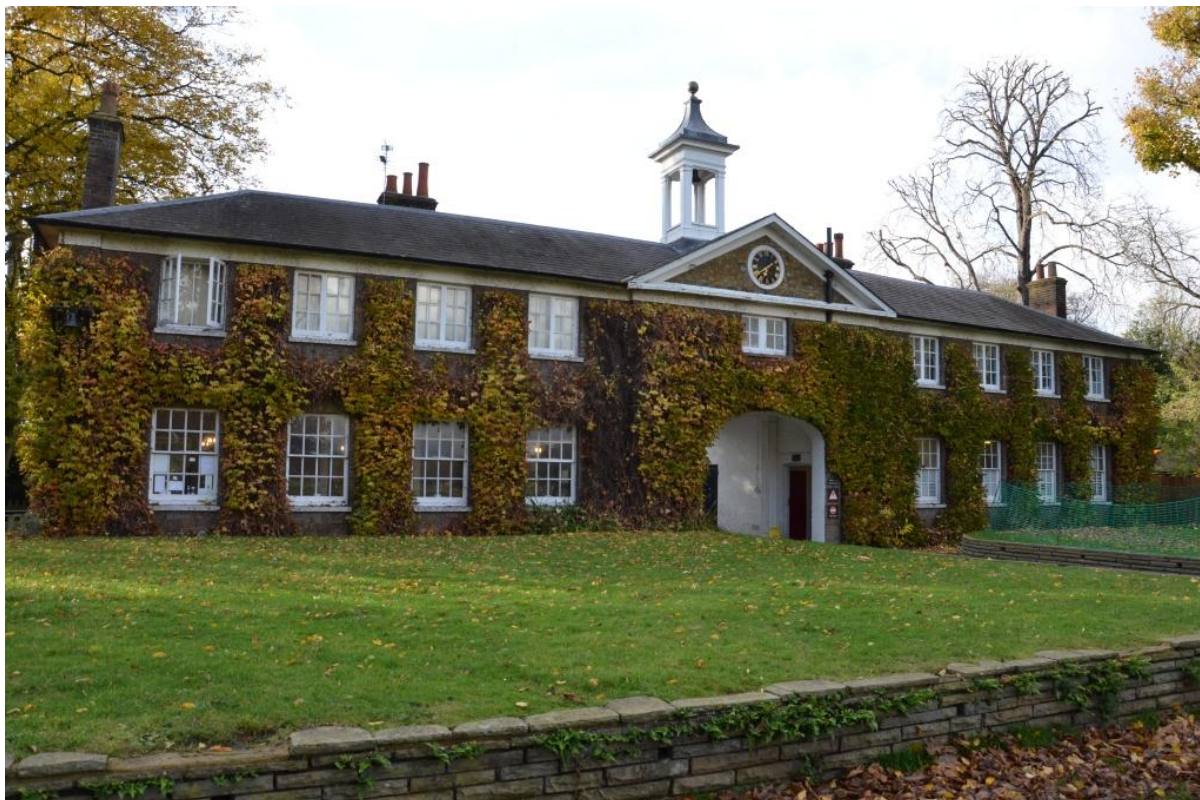
4.1 The stable block is a typical early 19th century building of its type, comprising two wings flanking a central carriage arch and surmounted by a small decorative cupola (Plate 1). The arch leads to an enclosed stable yard to the rear, western part of the site, which preserves traces of its original cobbling, though much has been replaced in modern tarmac.

Plate 1 View of the stable block from the south-east,
