tree:fabrik/ar/tf913/01

14th July 2017

LATCHMERE HOUSE, RICHMOND SYCAMORE – T65

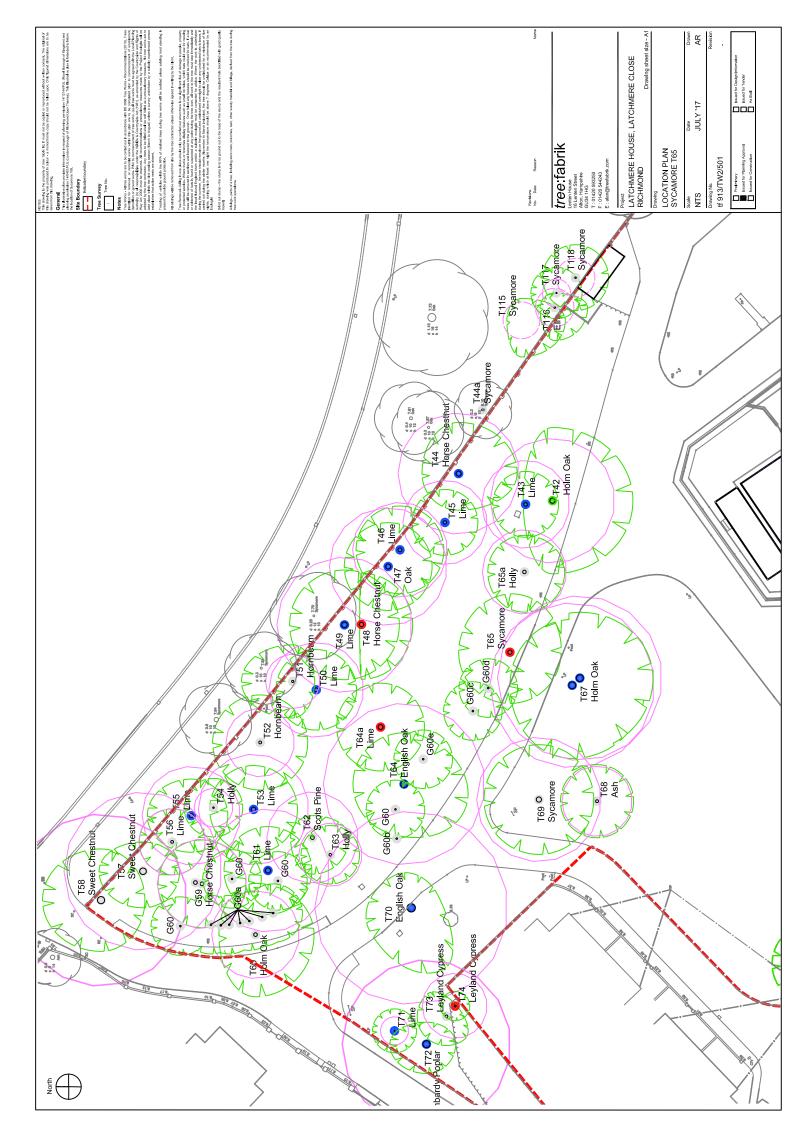
Outwardly, the tree appears to be of fair health with minor upper crown die-back and occasional squirrel damage on lateral branches. However, on detailed inspection fungi is noted at the base of the tree between the buttress roots at the south east and northeast cardinal points. The fungi is identified as perfect stage **Kretzschmaria deusta**.

This fungi causes decay that compromises the structural integrity of the wood leading to brittle fracture. The importance of this fungi is that the tree displays no other indications prior to fracture.

Sycamore T65 Detailed view of fungi Kretzschmaria deusta (northeast of trunk)

commencement of highway works and increased target risk, I recommend that the tree be felled to
