# West Elevation - Existing Eastbank Road

## Existing Condition

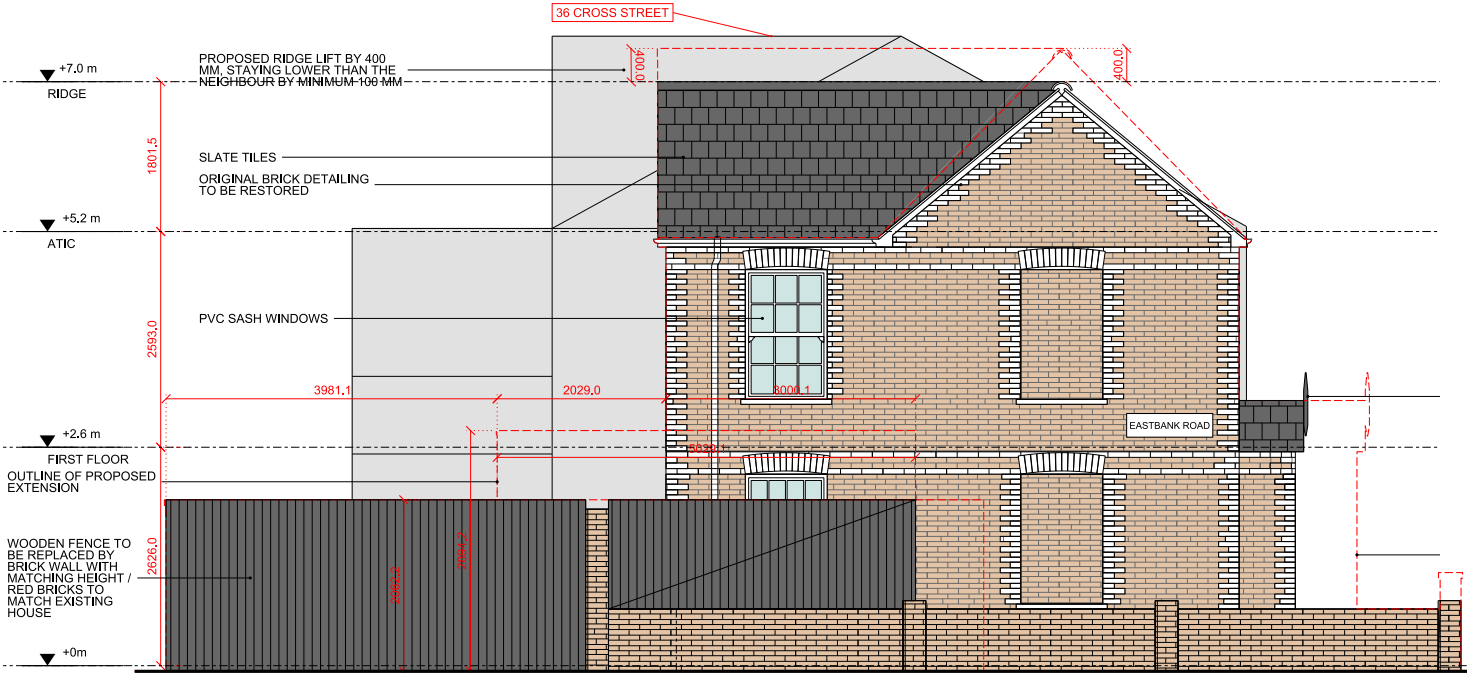
In general, the house is currently in need of restoration.

Wooden fence to be replaced by a brick wall of matching height. Original bricks to be re used as much as possible.

UPVC downpipes to be replaced by aluminium

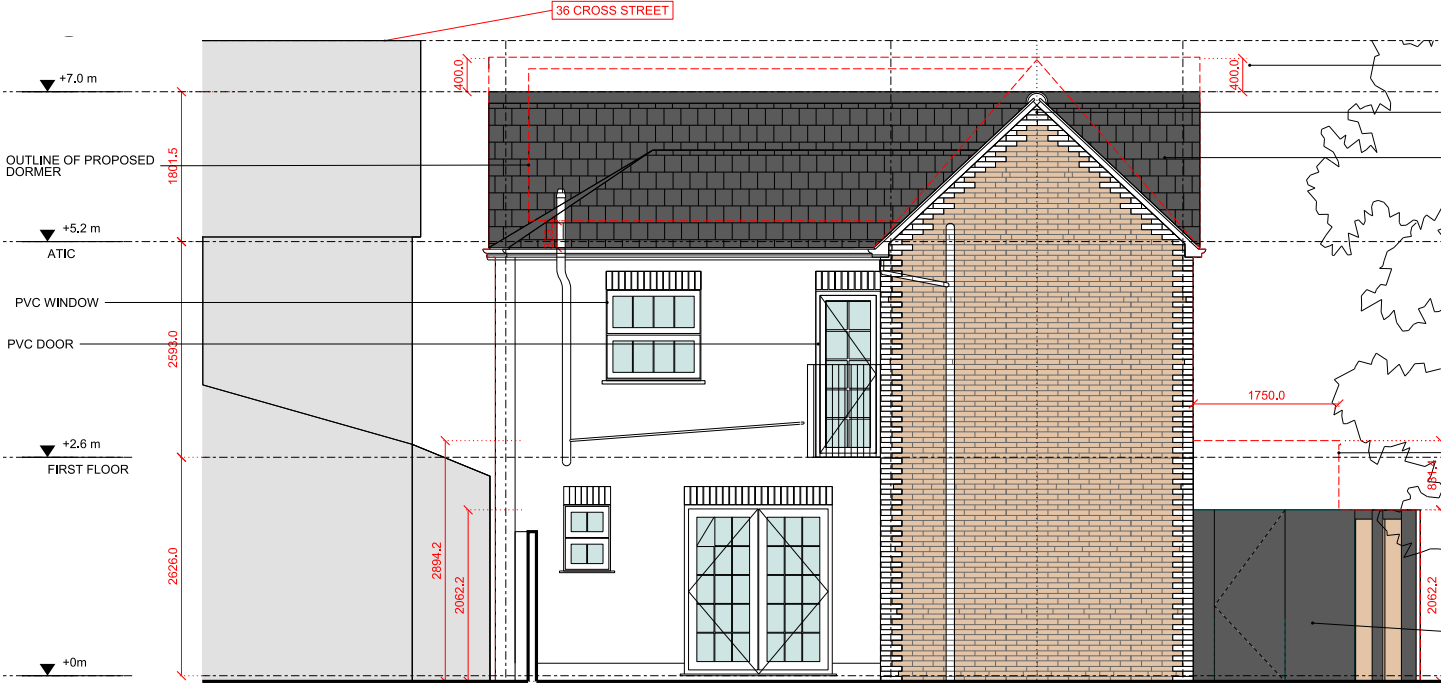
North Elevation - Existing

In general, the house is currently in need of restoration.

UPVC windows, downpipes and soil pipes

Wooden fence to be replaced by a brick wall of matching height. Roof dormer to sit back on rear elevation by at least 500mm.

Original roof detail to be restored

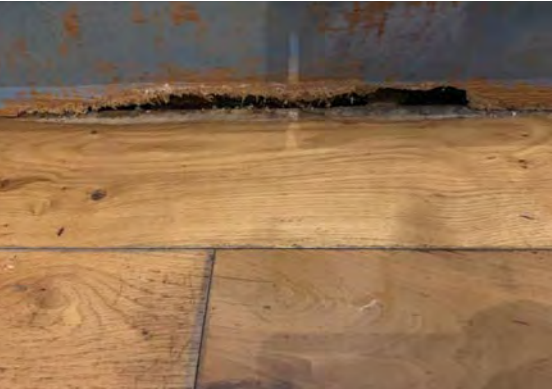
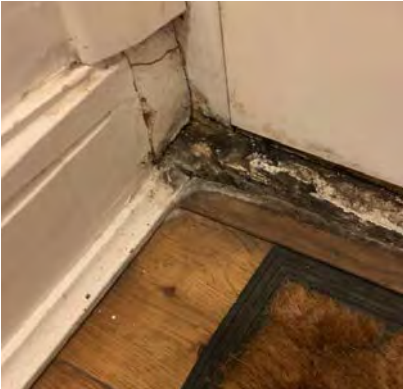
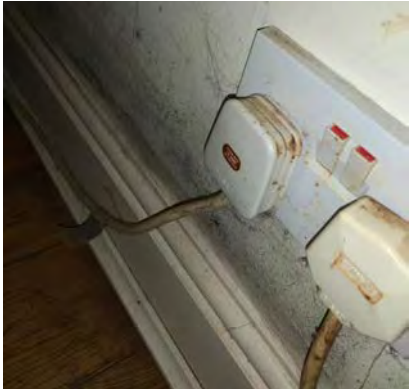
Water ingress and structural damage noticed in different areas of the house, on ground and first floor, as well as attic space.
