ARBORICULTURAL IMPACT ASSESSMENT REPORT

BS 5837:2012 'Trees in relation to design, demolition and construction - Recommendations'

SITE
38-42 Vincam Close, Twickenham
CLIENT
NFC Homes Limited

DATE: 13th August 2021
OUR REF: RA802

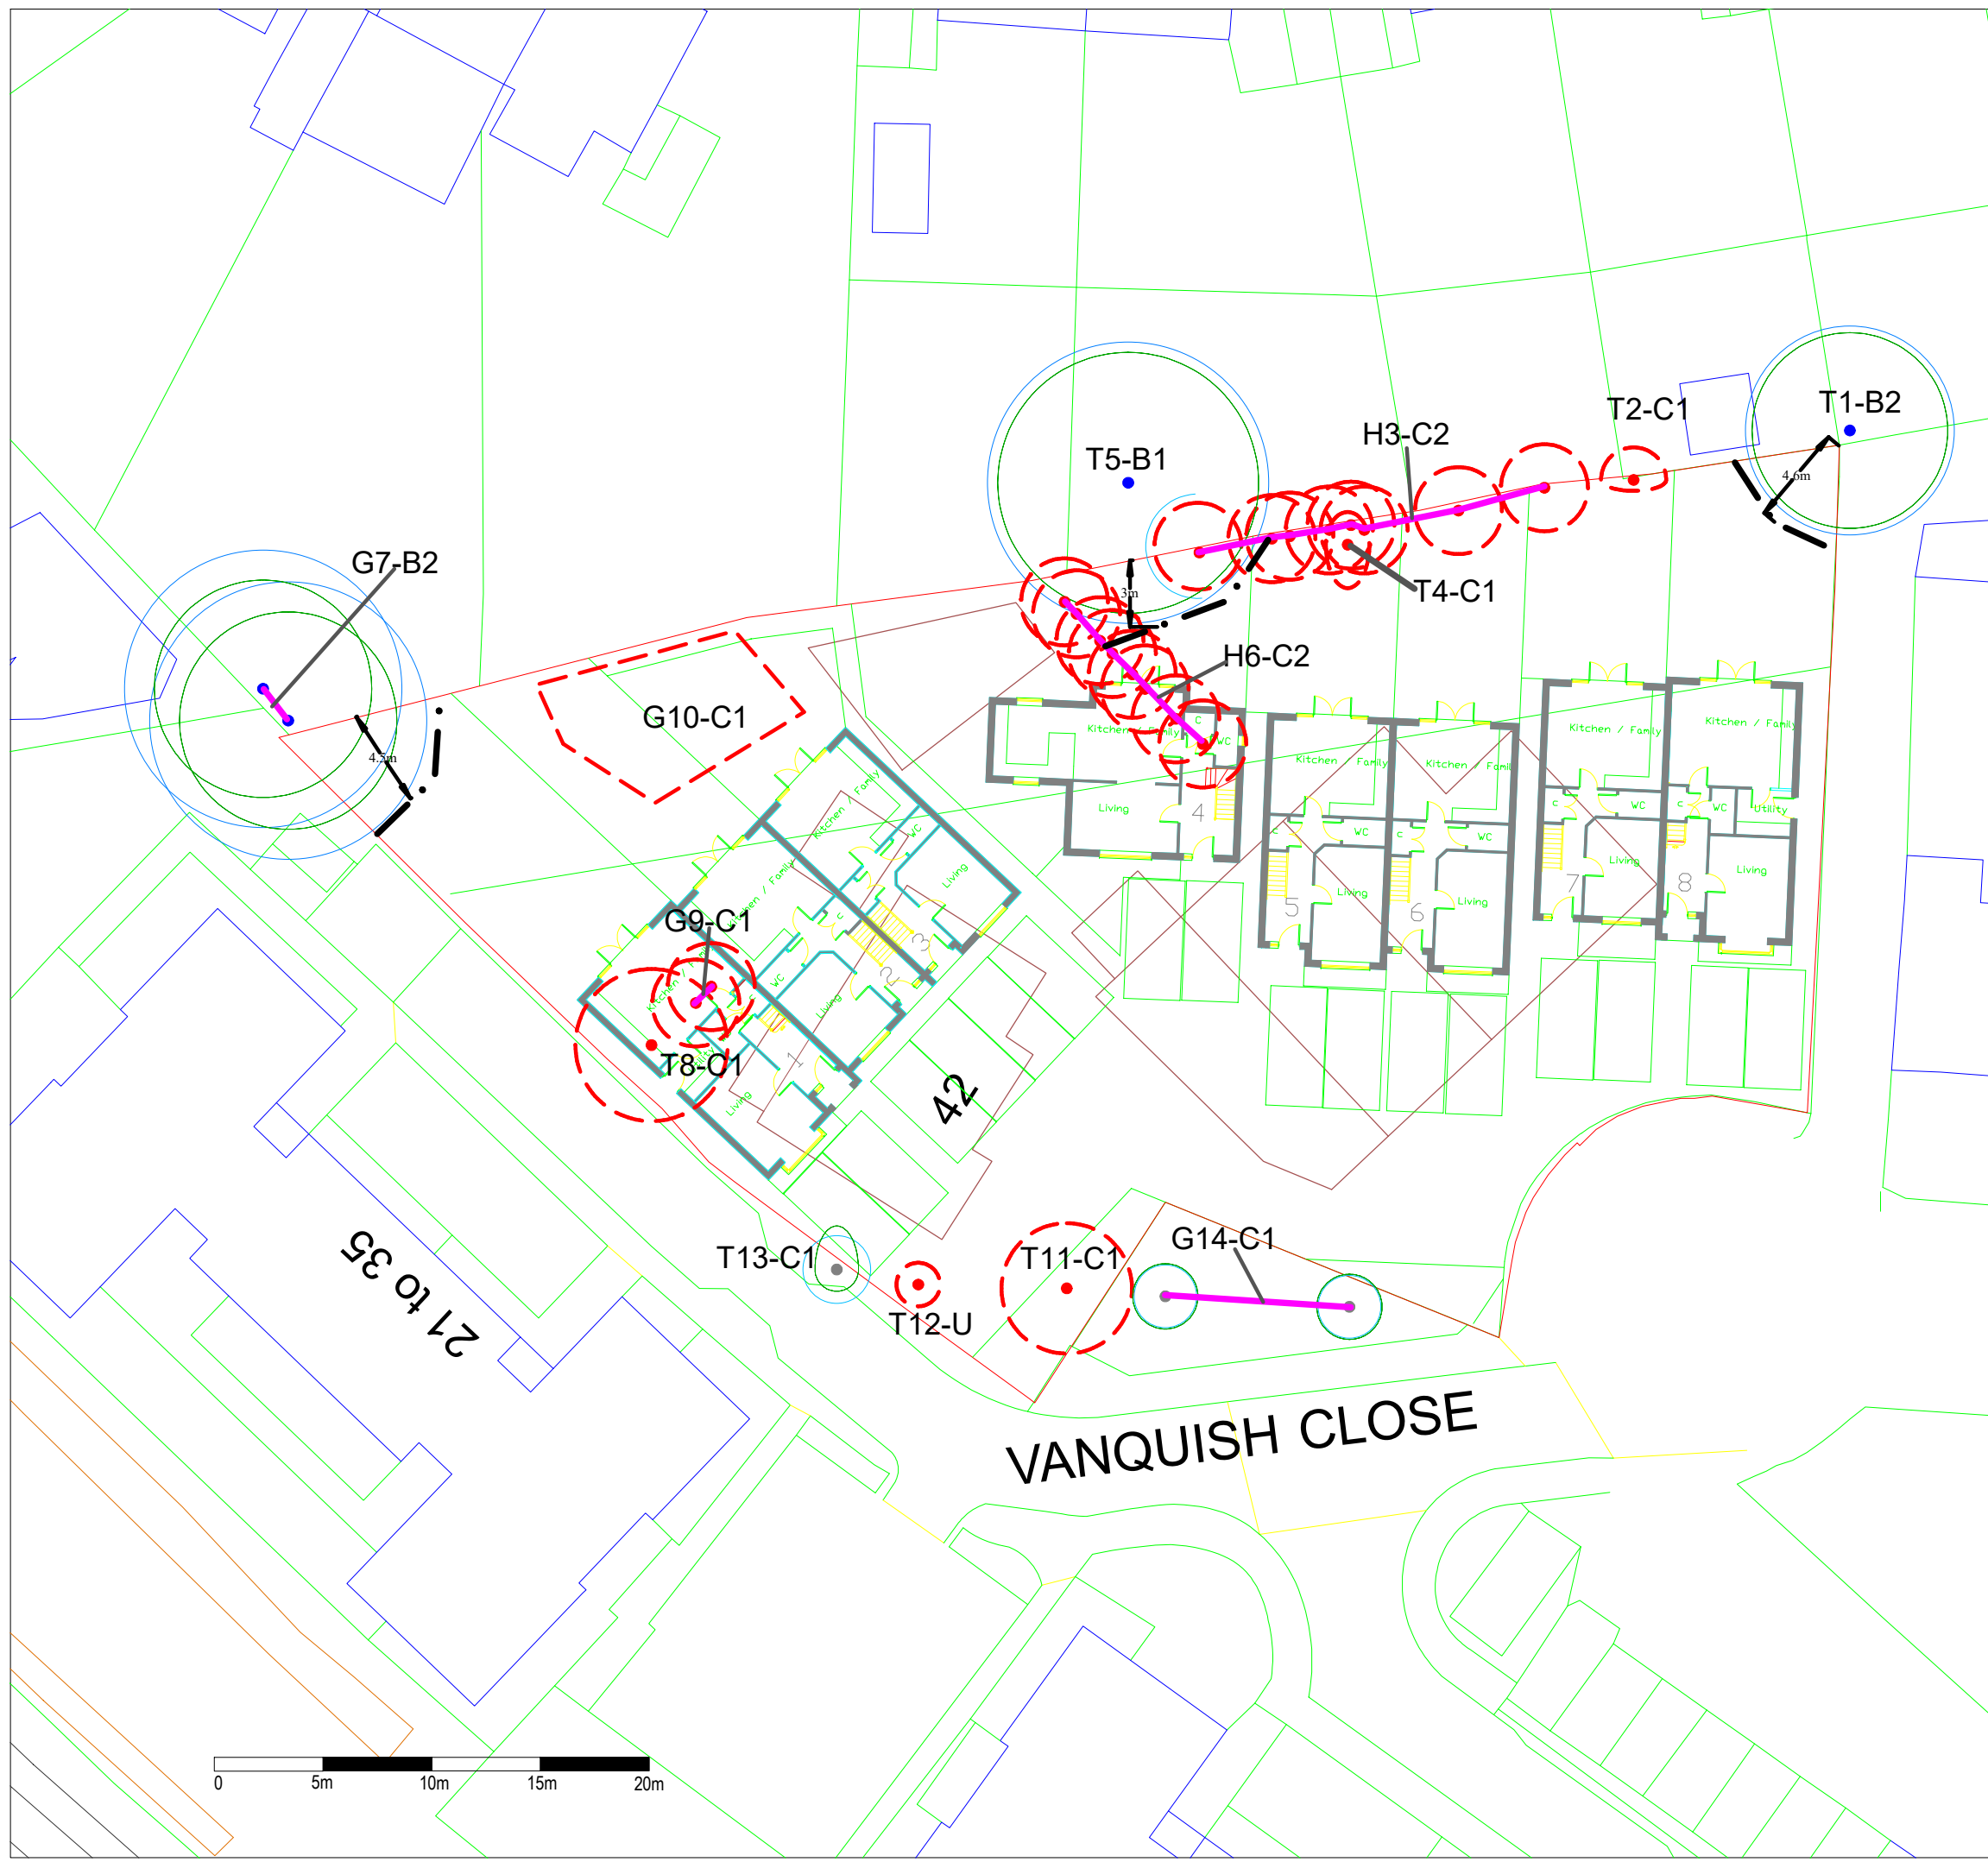
Tree protection plan RA802 TPP

7.2. There are no construction works proposed within the RPA of retained trees. The proposed, replacement dwellings are located at a suitable distance from retained trees, to avoid future conflict.

- 8.2. That the foundation design takes into account trees to be retained, trees to be removed and trees to be planted.
- 8.3. That there are no ground level changes within the area shown on the plan by tree protection fencing.
