Client							
THE ROYAL PARKS							
Project Name Richmond Park Boundary Walls rep Wall backing Roehampton Vale Drawing	airs						
Elevation, Location plan, Sections (Chohole to Beverley Brook)							
Scale 1:200, 1:1250 & 1:20 @ A1							
Drawn by GH/MOF December 2021 Checked by

HOFA 17 01. 106 -

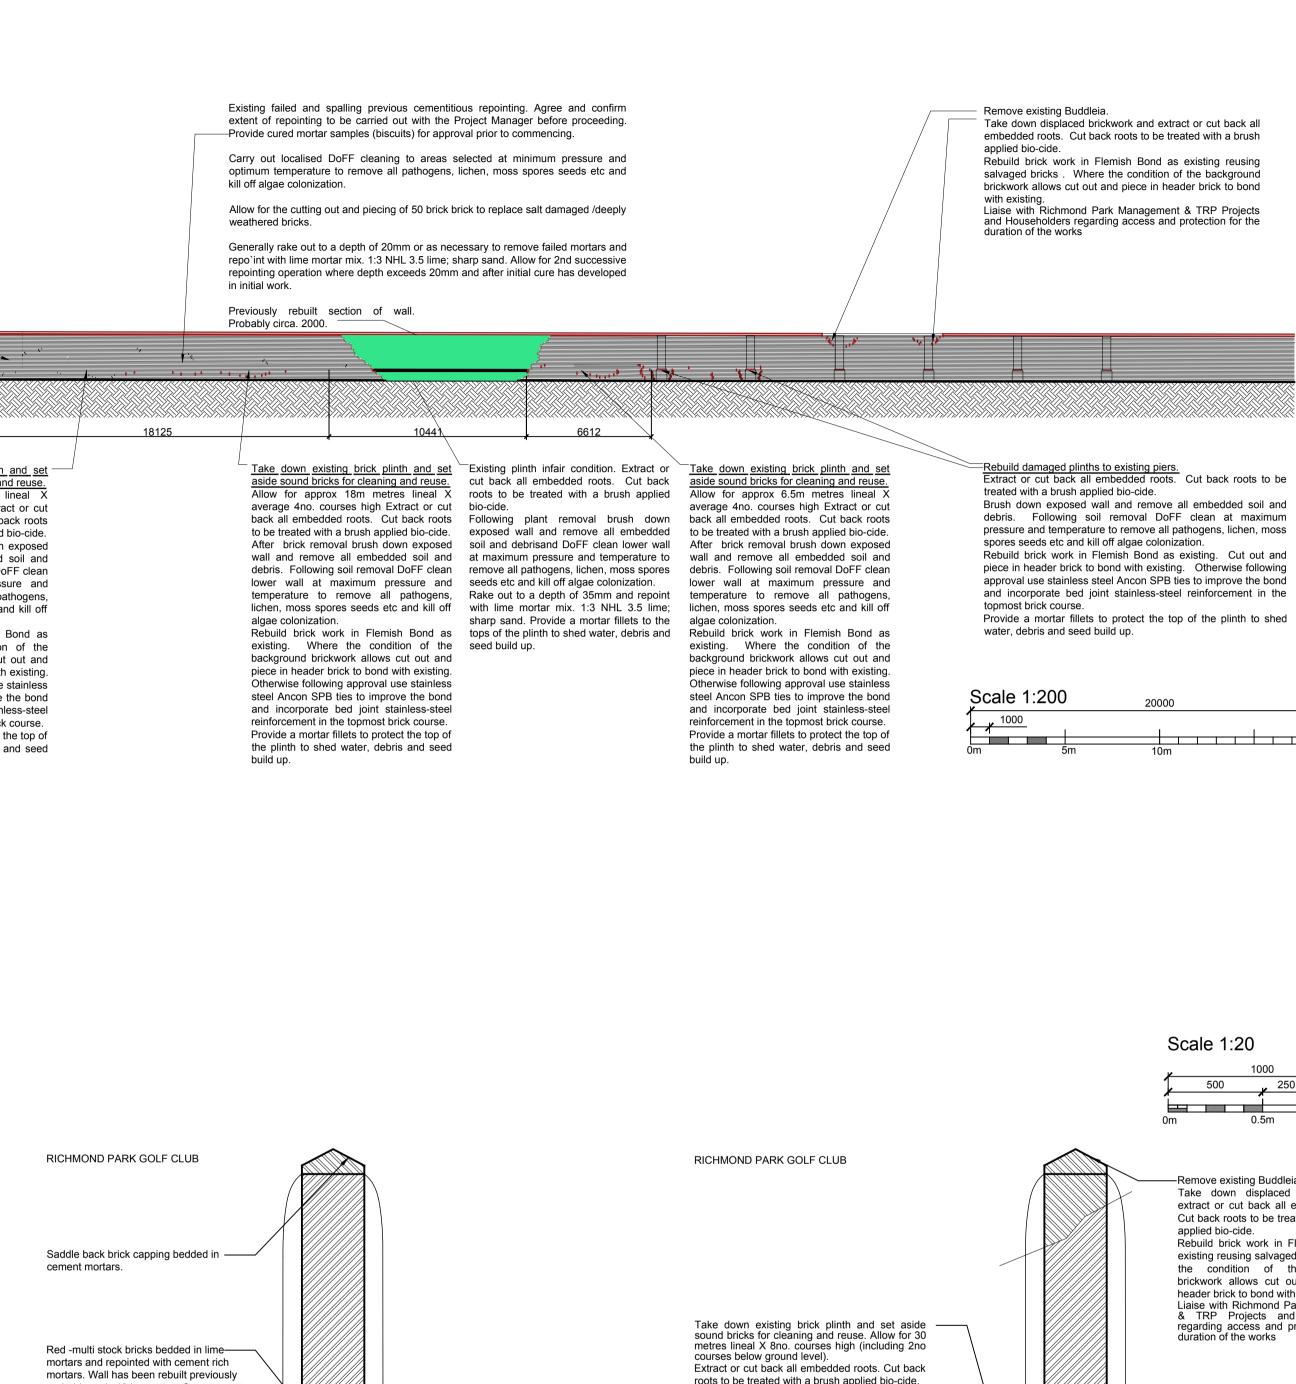
EXISTING SECTION

probably early 19th century. Some recent rebuildina.

Brick plinth missing or spalling away fromthe wall due principally to embedded ivy and buddleia rooting in the brickwork where the pointing has previously failed. PUBLIC FOOTPATH

roots to be treated with a brush applied bio-cide. After brick removal brush down exposed wall and remove all embedded soil and debris. Following soil removal DoFF clean lower wall at maximum pressure and temperature to remove all pathogens, lichen, moss spores seeds etc and kill off algae colonization. Rebuild brick work in Flemish Bond as existing. Where the condition of the background brickwork allows cut out and piece in header brick to bond with existing. Otherwise following approval use stainless steel Ancon SPB ties to improve the bond and incorporate bed joint stainless-steel

reinforcement in the topmost brick course. Provide a mortar fillets to protect the top of the plinth to shed water, debris and seed build up.

Rebuild brick work in Flemish Bond as existing reusing salvaged bricks . Where the condition of the background brickwork allows cut out and piece in header brick to bond with existing. Liaise with Richmond Park Management TRP Projects and Householders regarding access and protection for the duration of the works
