CONDITION SURVEY OF THE FLOOD DEFENCE WALL*

Condition Survey of the Thames River Wall

Stag Brewery

14 December 2016

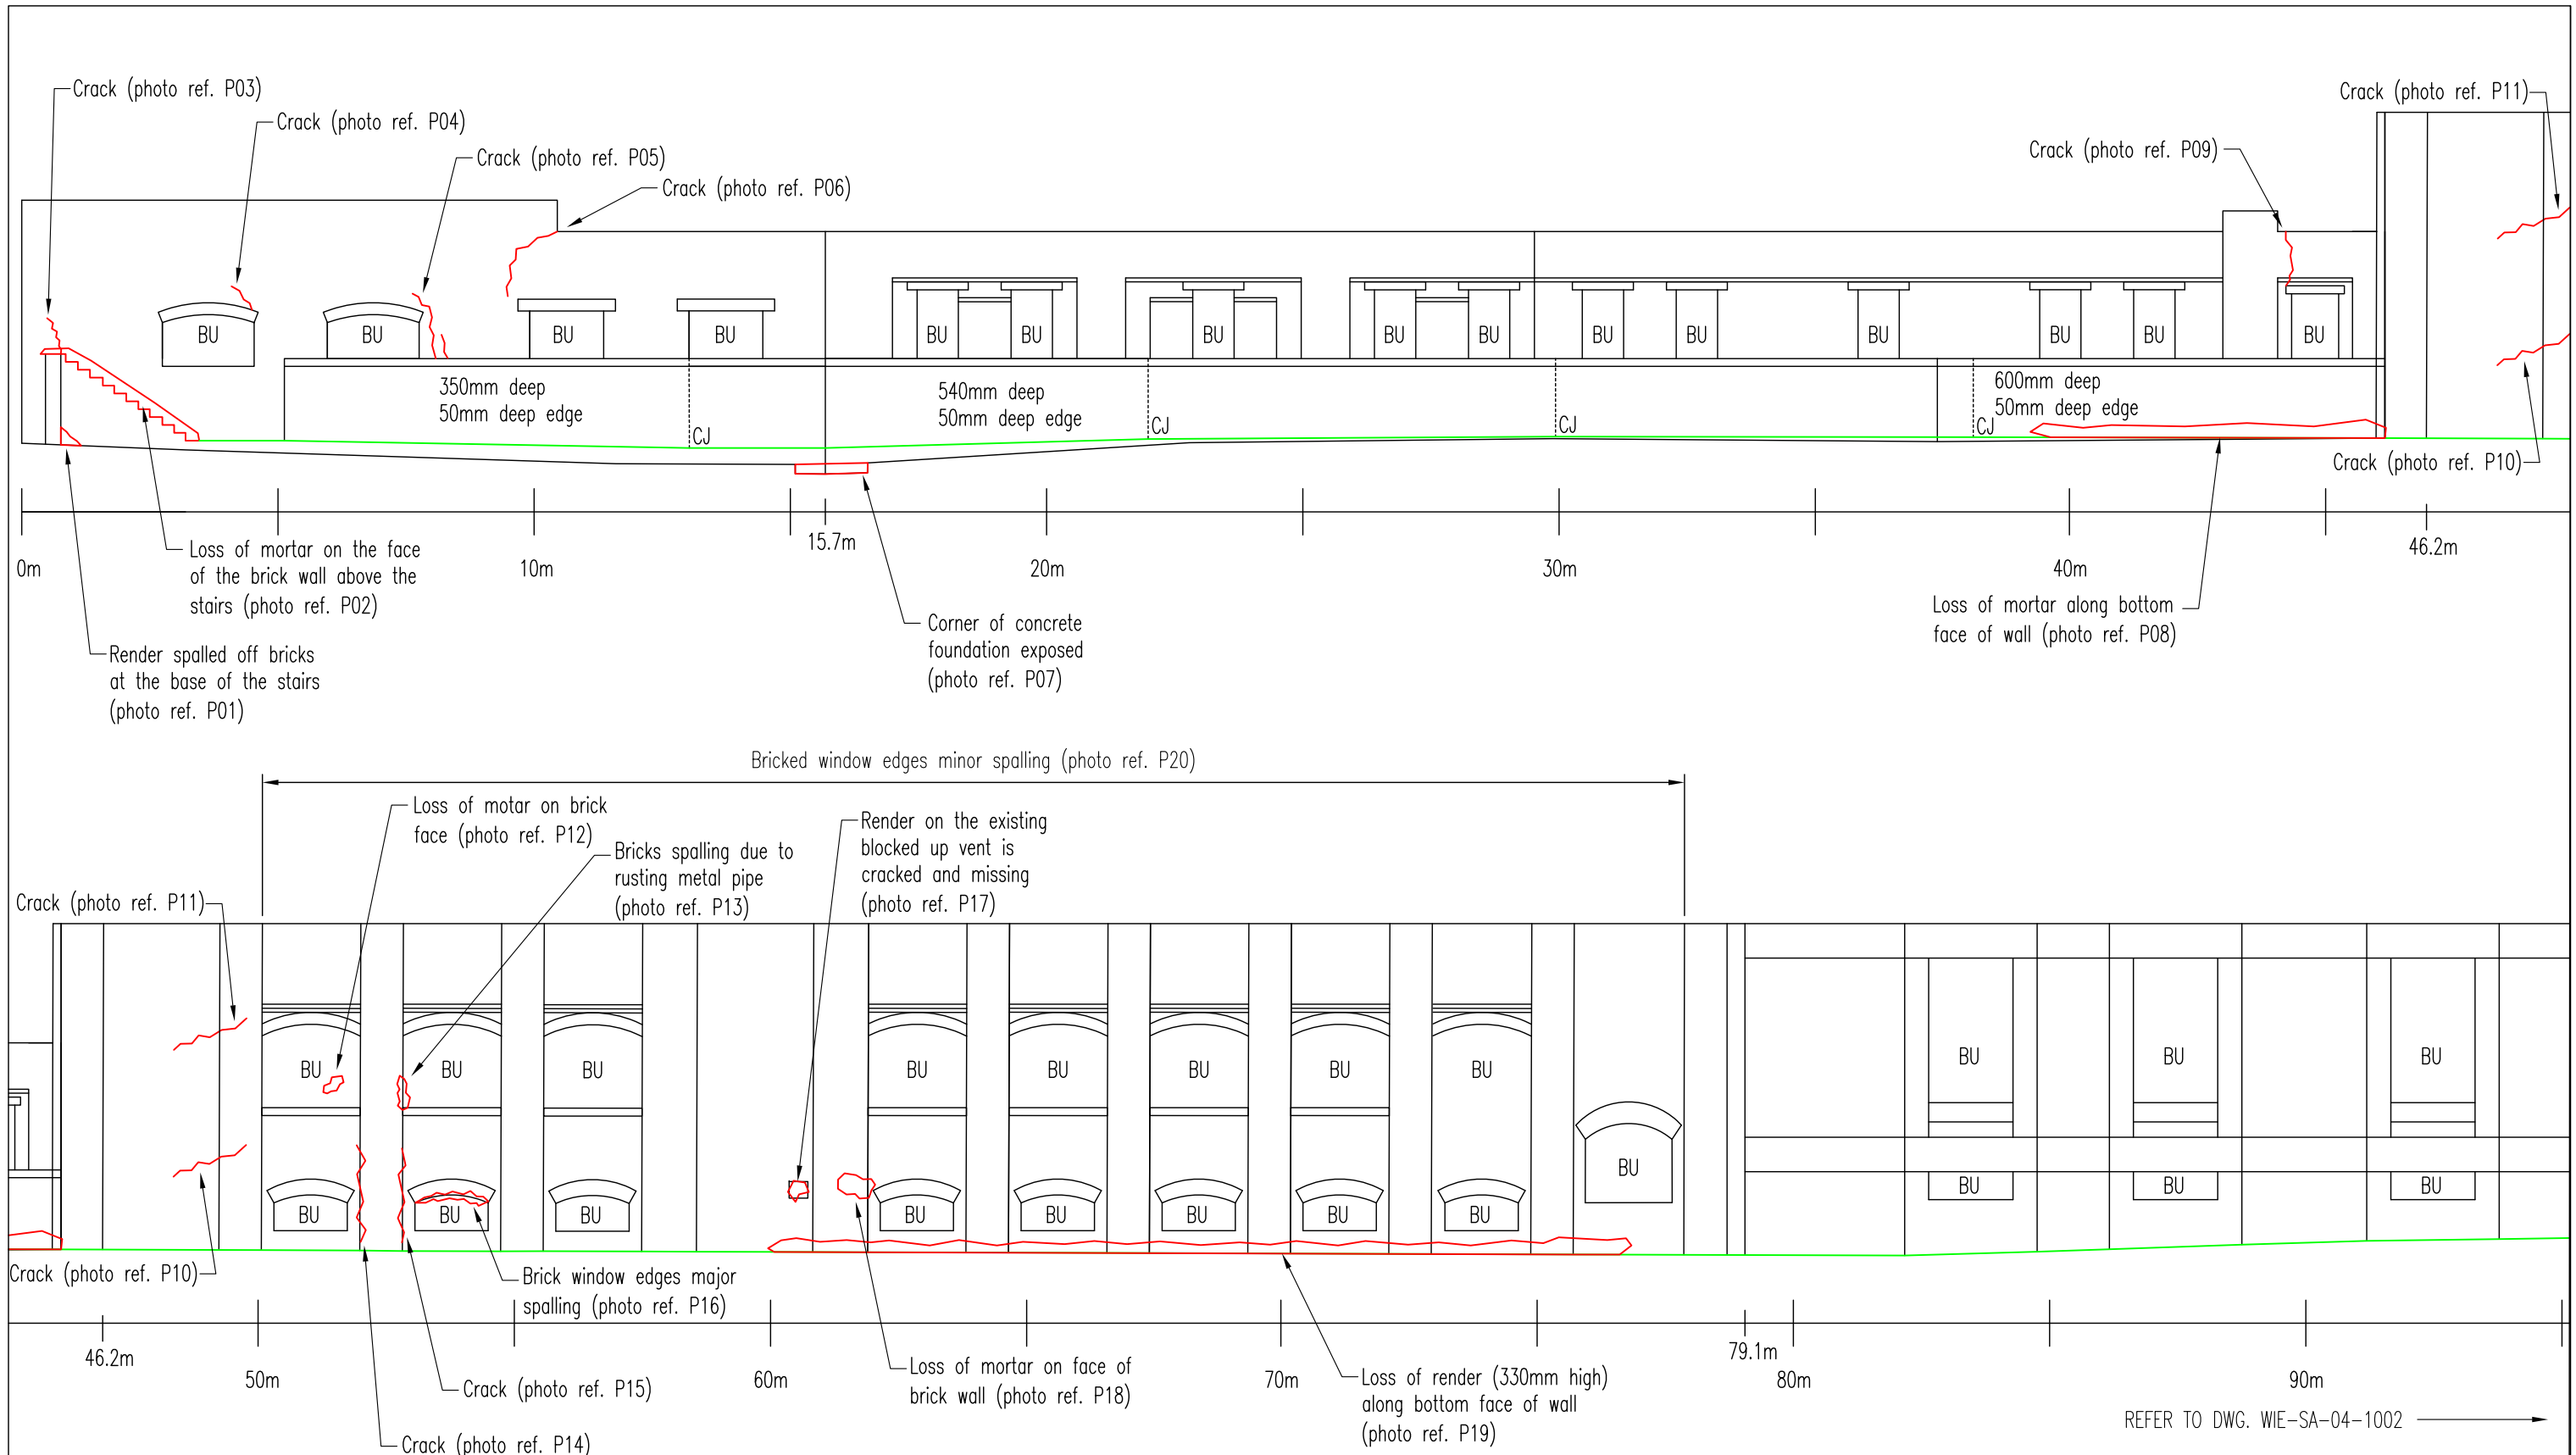
Drawing Status				
PRELIMINARY				
Designed by	TLR	Checked by	AAK	Project No
Drawn by	TLR	Date	DECEMBER 2016	WIE10667
Scales @ A3 work to figured dimensions only			1:125	Computer File No WIE-10667-SA-04-1001.dwg
Publisher	Zone	Category	Number	Revision
WIE	SA	04	1001	A01

This section of wall is in poor condition. In general, there are many cracks, areas with mortar loss, areas where render is cracked/missing, surface spalling of the bricks, vegetation growth and graffiti. Most of these defects are not considered to be structural. The defects observed for this wall section are presented in Table 1. For the locations and photos of these defects, refer to the drawings in Appendix A and B.

Approx. Chainage	Defects	Photo ID
0m	Render spalled off bricks at the base of the stairs.	P01
0m	Crack propagating upwards from the top of the stairs.	P03
0m – 4m	Loss of mortar on the face of the brick wall above the stairs.	P02
5m	Crack propagating upwards from the corner of a bricked up window.	P04
8m	Crack in the brick wall, extending upwards from the top of the RC wall (to the right of a bricked up window).	P05
10m	Crack propagating down from a change in height at the top of the wall.	P06
16m	The foundation of the reinforced concrete retaining wall's south-eastern corner is exposed.	P07
39m – 46m	Loss of mortar along the bottom face of the wall.	P08
45m	Crack from the top of a bricked up window to the top of the wall.	P09
49m	Cracks running diagonally in the wall.	P10 & P11
52m	Loss of mortar on the face of the bricked up window.	P12
53m	Cracks running vertically in corners of the wall.	P14 & P15

53m	Bricks spalling due to a rusting metal pipe in the wall.	P13
60m – 77m	Loss of render (330mm high) along the bottom face of the wall.	P19
61m	Render on a previously blocked up vent shaft is cracked/missing and the vent is now open.	P17
62m	Loss of mortar on face of brick wall.	P18
112m – 125m	Cracks from the top of wall. Vegetation on top of the wall appears to be pushing the concrete capping out.	P21 – P24
129m	Bricks spalled off or missing from the top of the wall.	P25
130m	Crack propagating upwards from the top of a bricked up window.	P26
130m – 161m	Minor spalling on the edges of bricked up windows and doors.	P27
142m	Missing/damaged bricks resulting in a hole through the wall.	P28
145m	Loss of mortar on the face of the brick wall near the top of the wall.	P29
163m	A large crack (approx. 20mm) that runs the height of the wall.	P30 – P32

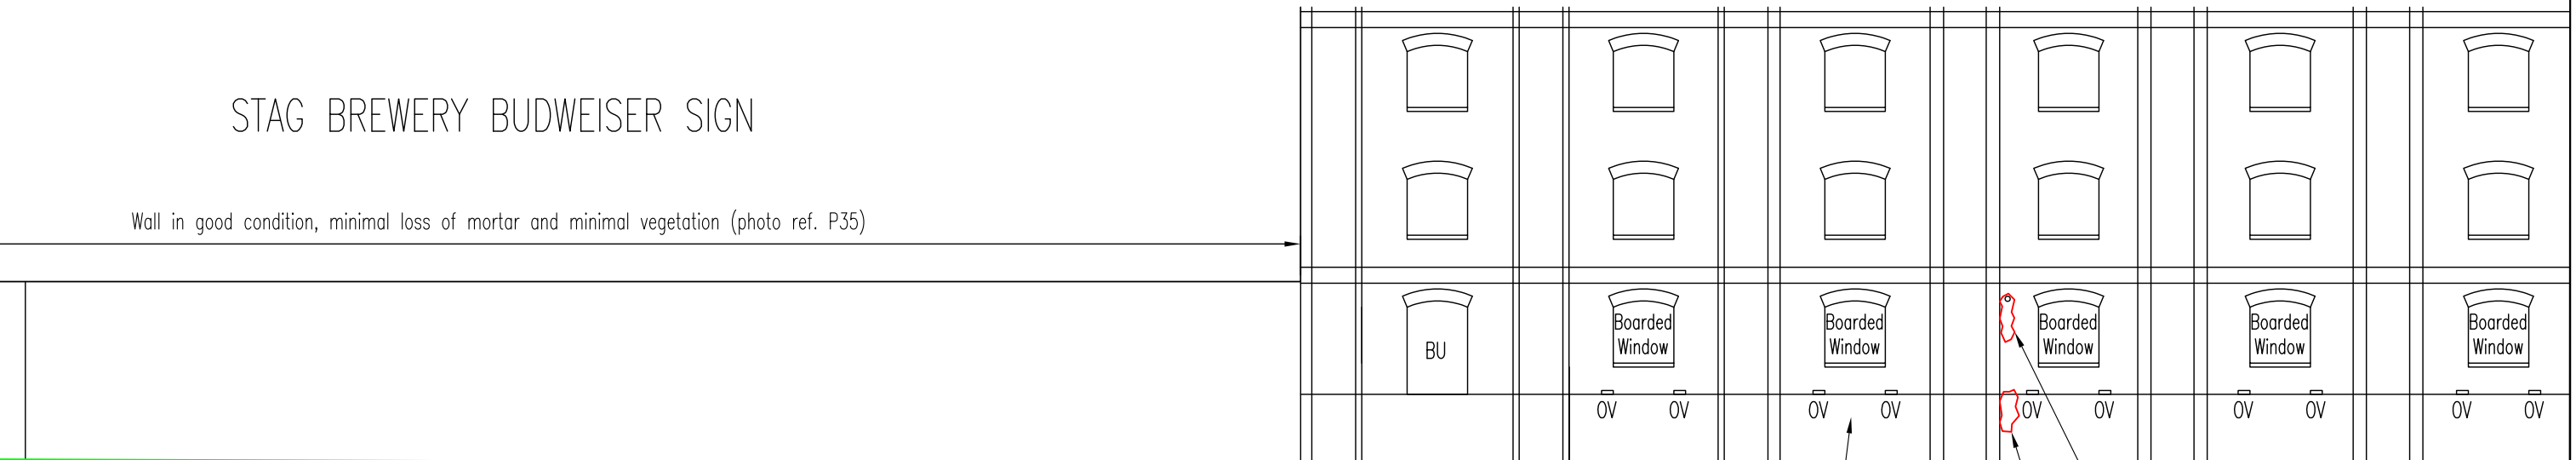
Designed by	TLR	Checked by	AAK	Project No	WIE10667
Drawn by	TLR	Date	DECEMBER 2016	Computer File No	
Scales @ A3 work to figured dimensions only				1:125	WIE-10667-SA-04-1003.dwg
Publisher	Zone	Category	Number	Revision	
WIE	SA	04	1003	A01

This section of wall is in fair condition. In general, there are a few cracks, areas with mortar loss, areas where render is cracked/missing, surface spalling of the bricks, and vegetation growth between the western wall and the Maltings building. Most of these defects are not considered to be structural. The defects observed for this wall section are presented in Table 2. For the locations and photos of these defects, refer to the drawings in Appendix A and B.

Approx. Chainage	Defects	Photo ID
271m	Bricks chipped out around old pipes embedded in the wall.	P37
271m	Mortar loss below metal pipe in brick wall.	P38
287m	Loss of mortar on the face of the brick wall.	P39
288m	Mortar loss below metal pipe in brick wall.	P40
300m	Loss of render along bottom face of wall. Render cracked and broken off.	P41
301m – 318m	Loss of mortar along the bottom face of the western wall.	P43 & P44
303m	The top of the wall to the west of the building is cracked.	P42
314m	Mortar loss and spalling bricks near the top of the western wall.	P45

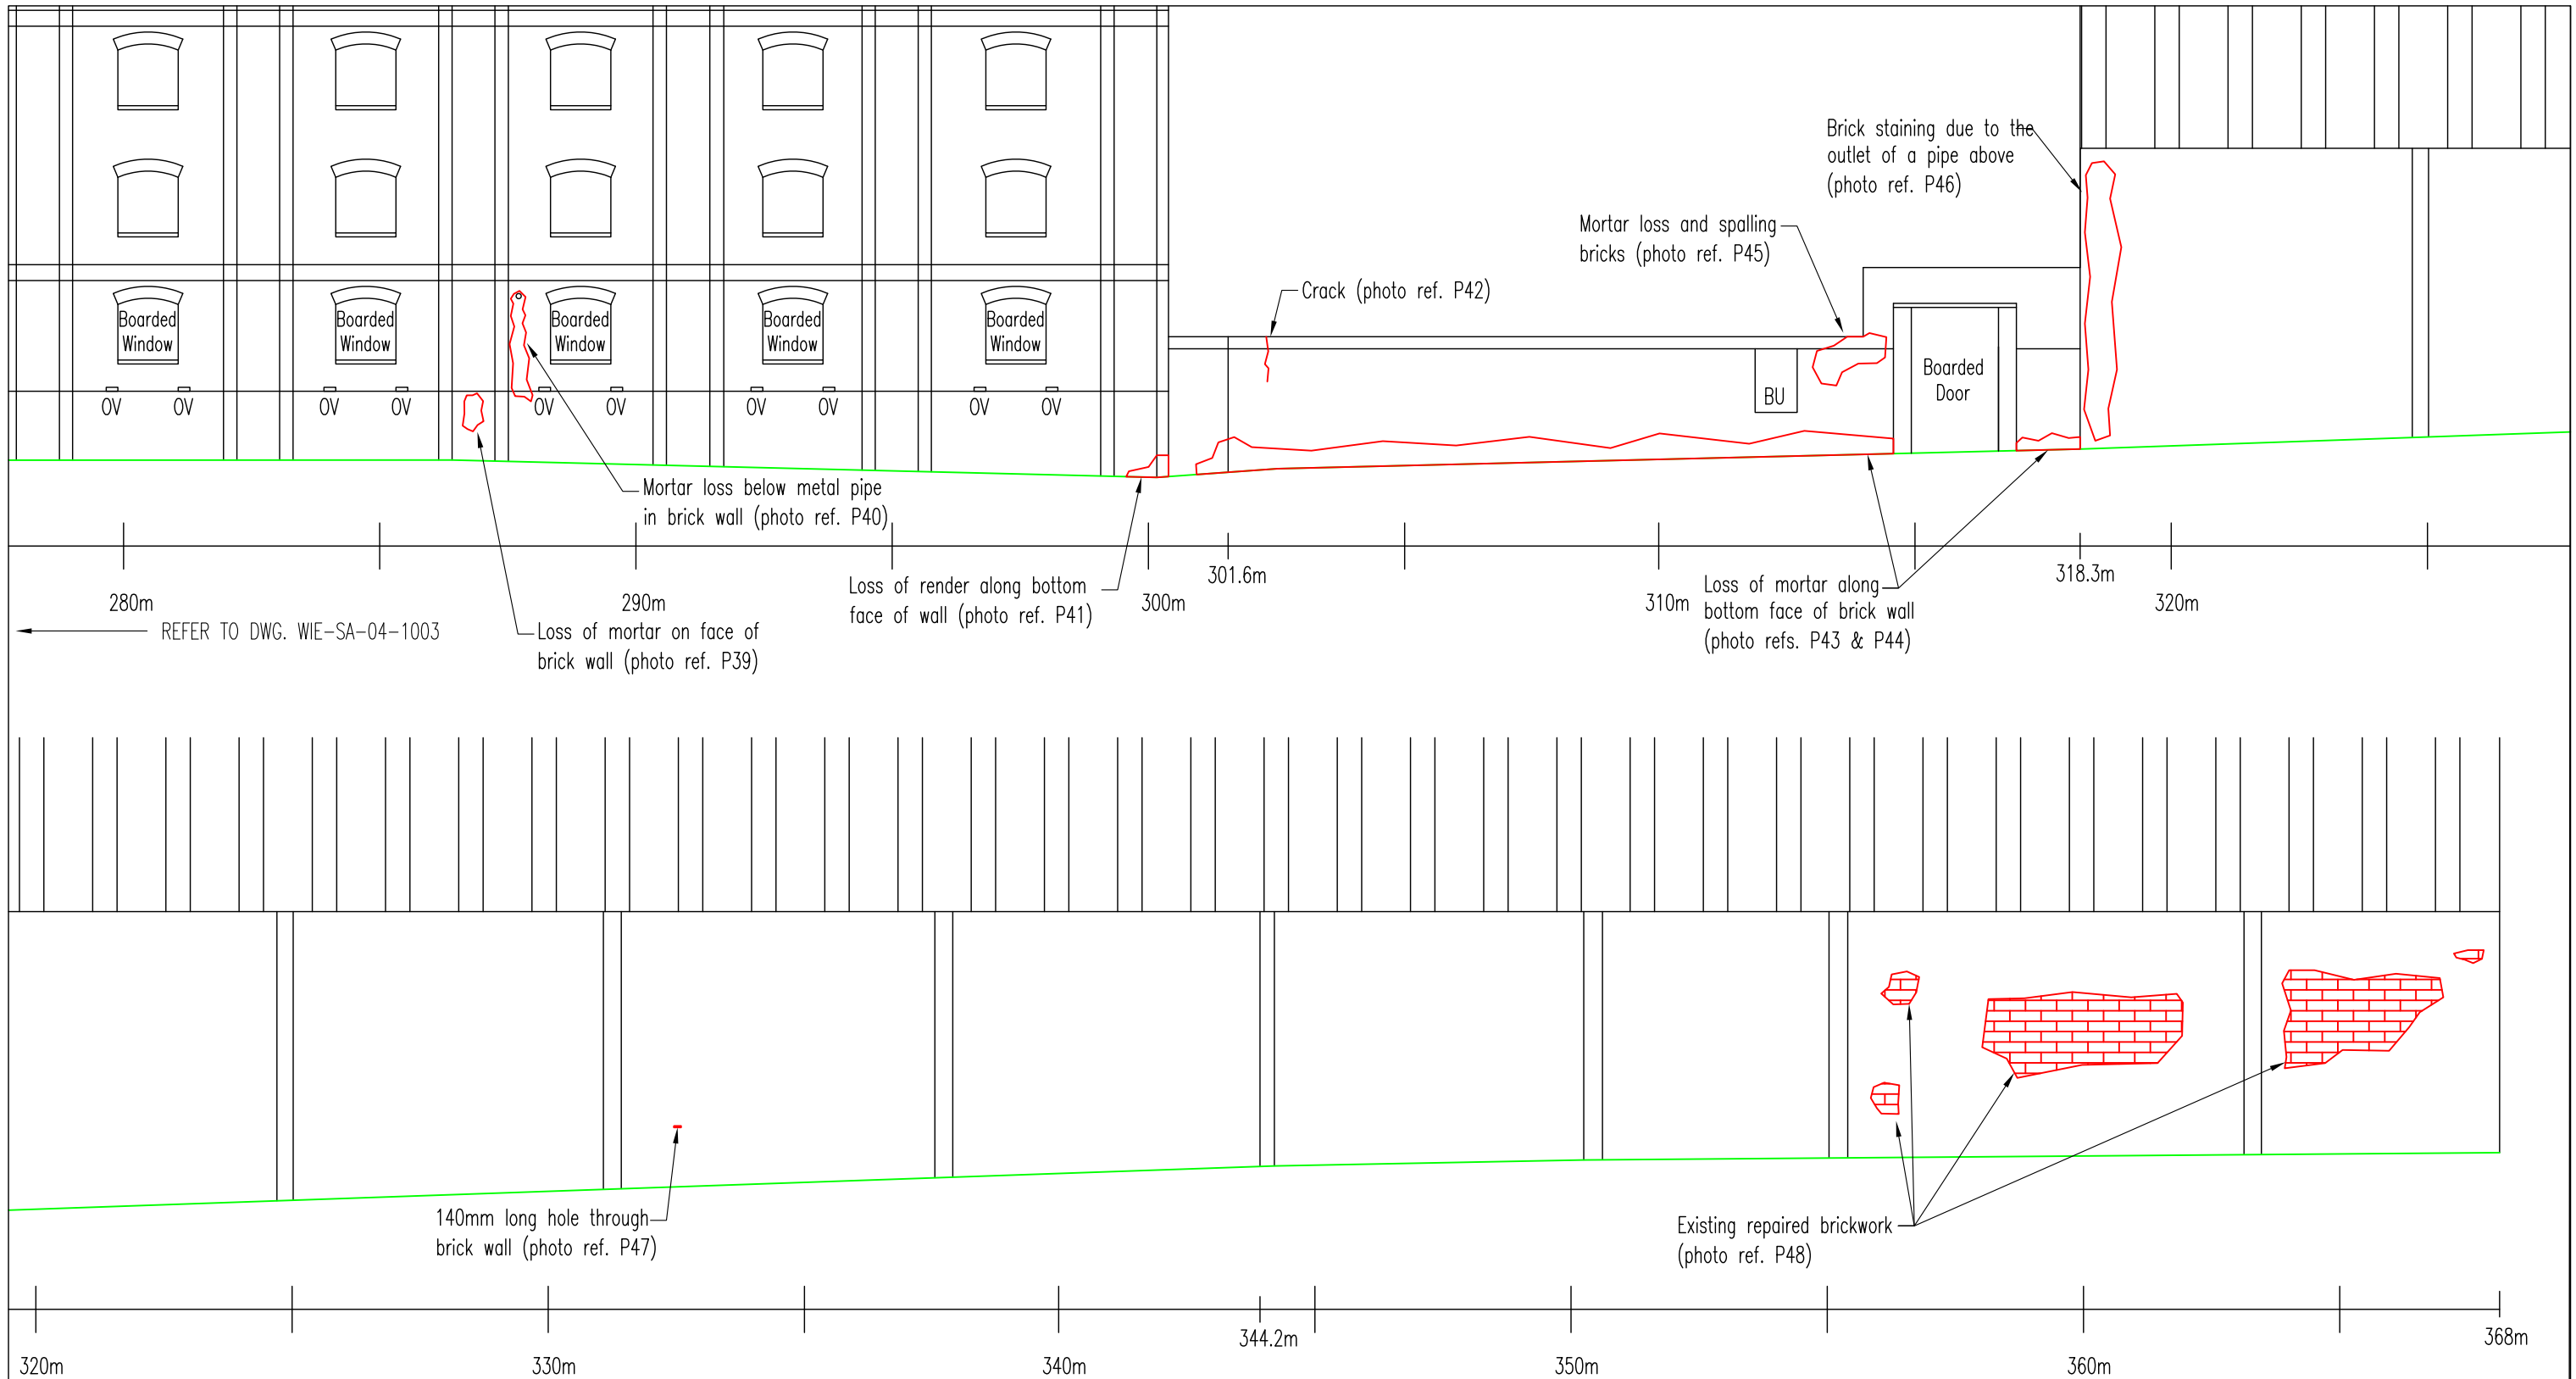
This section of wall is in good condition. In general, there is some brick staining and areas of previously repaired brickwork. Most of these defects are not considered to be structural. The defects observed for this wall section are presented in Table 3. For the locations and photos of these defects, refer to the drawings in Appendix A and B.
