BUILDING SURVEY

**25 HAM FARM ROAD
RICHMOND
SURREY
TW10 5NA**

24th June 2021

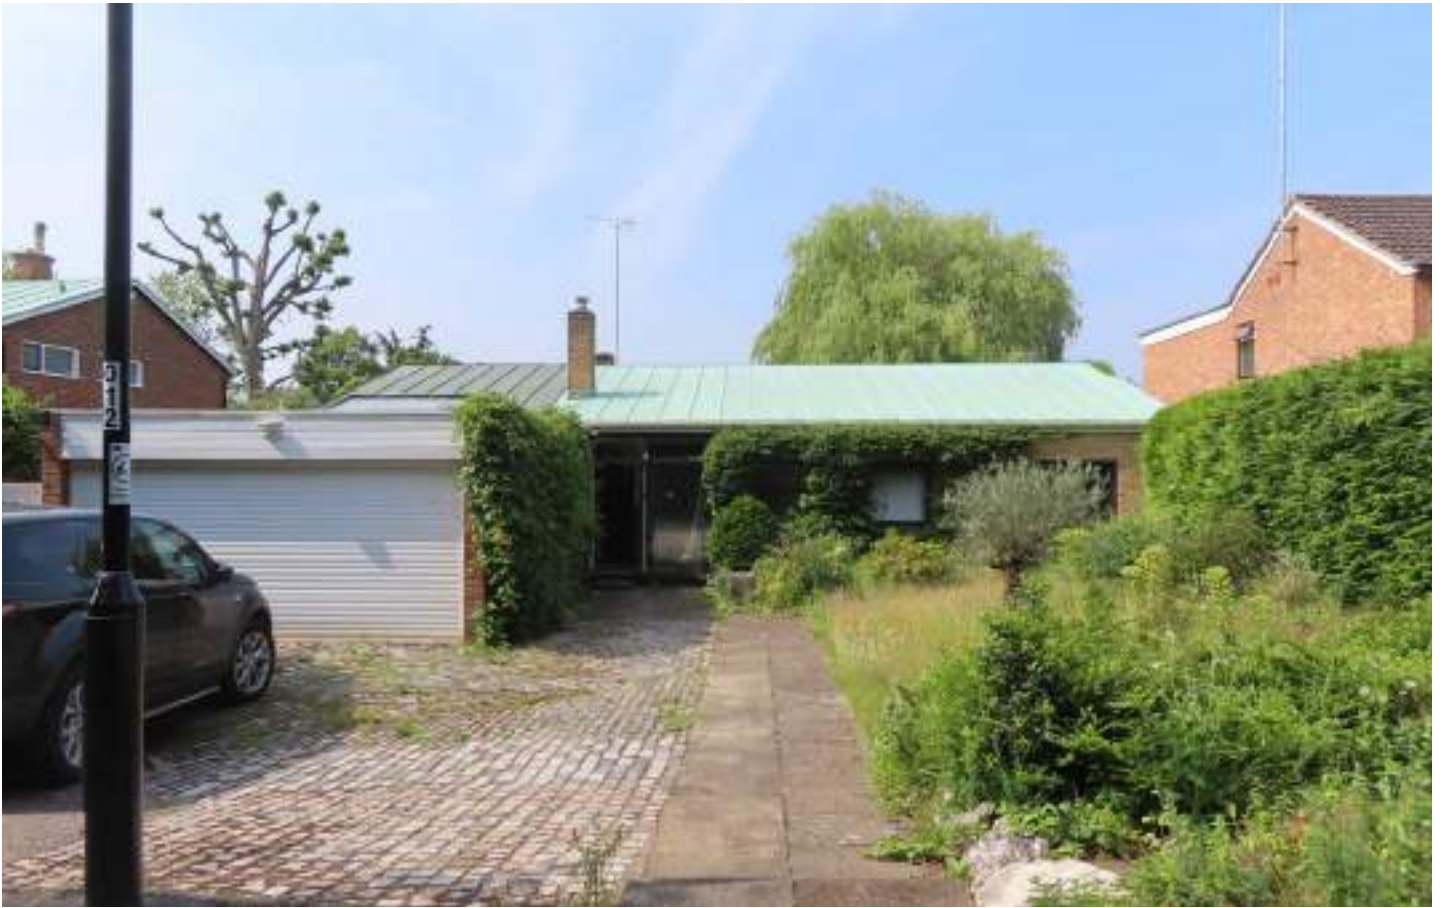
IMG_0847.JPG

- 2.02 The front-north-east facing façade to the property is illustrated in photograph 0847.
- 2.03 It is estimated that the property was constructed during the late 1950's judging from the style and configuration of construction. It is possible that the property was architect designed judging from its style and architectural character.

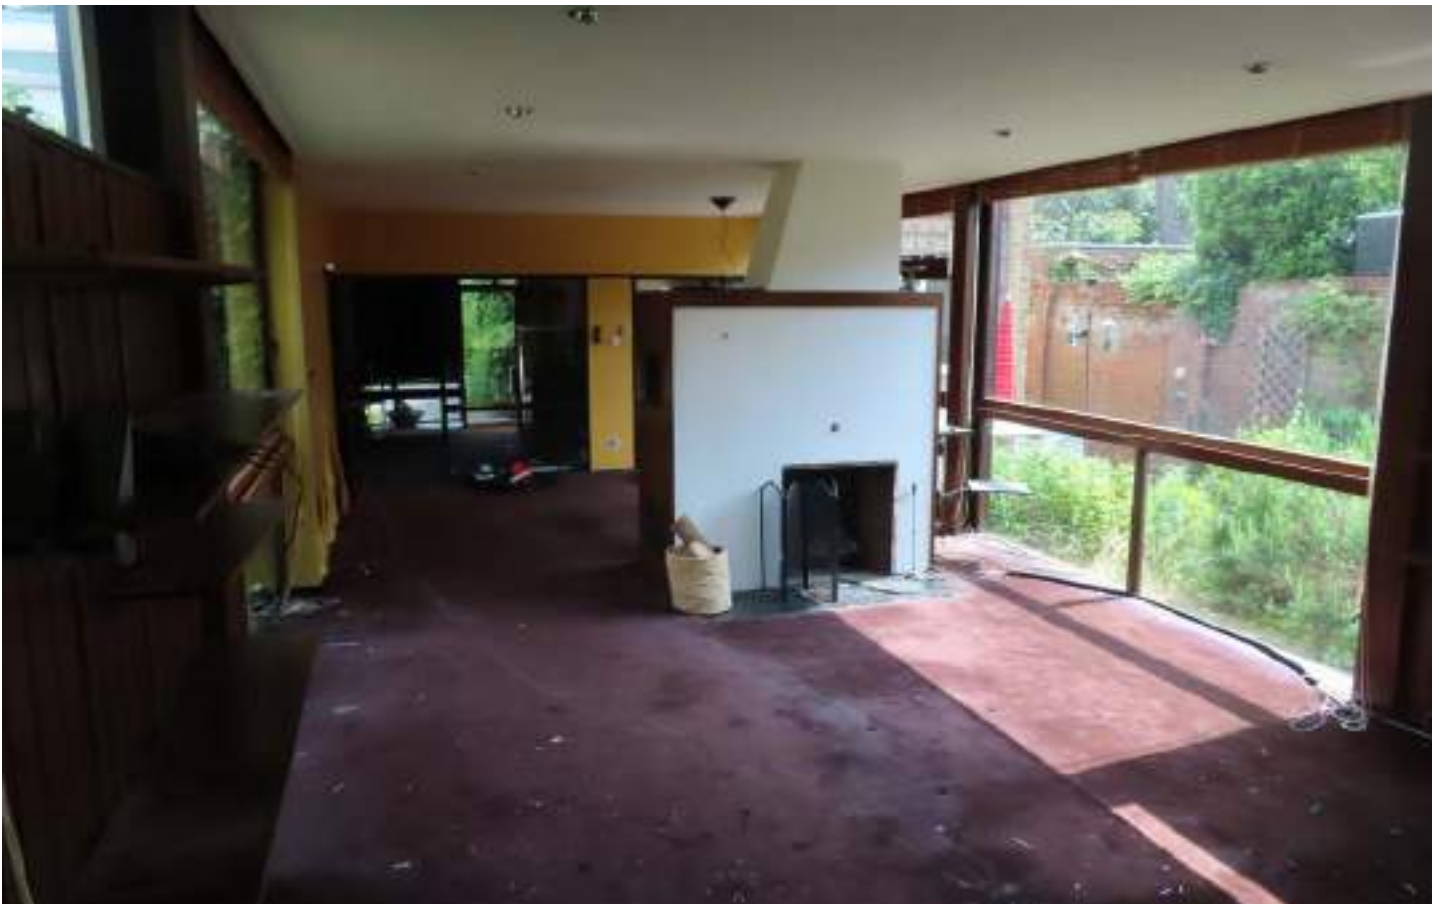
IMG_0848.JPG

- South-west main rear extension living space - photographs 0848 and 0849
- Outrigger 'conservatory room
- Entrance hall - photographs 0850 and 0851
- Entrance porch - photograph 0852
- Kitchen - photograph 0853
- Utility area - photograph 0854
- Lobby/hall - photograph 0855
- Shower lobby - photograph 0856
- W.C./cloakroom - photograph 0857
- Family bath/shower room - photographs 0858 and 0859
- Bedroom 1 - photographs 0860 and 0861
- Centre rear bedroom 2 - photographs 0862, 0863 and 0864
- Bedroom 3 - photographs 0865
- Exterior separate double garage - photographs 0866 and 0867
- External store appurtenant to garage - photograph 0868

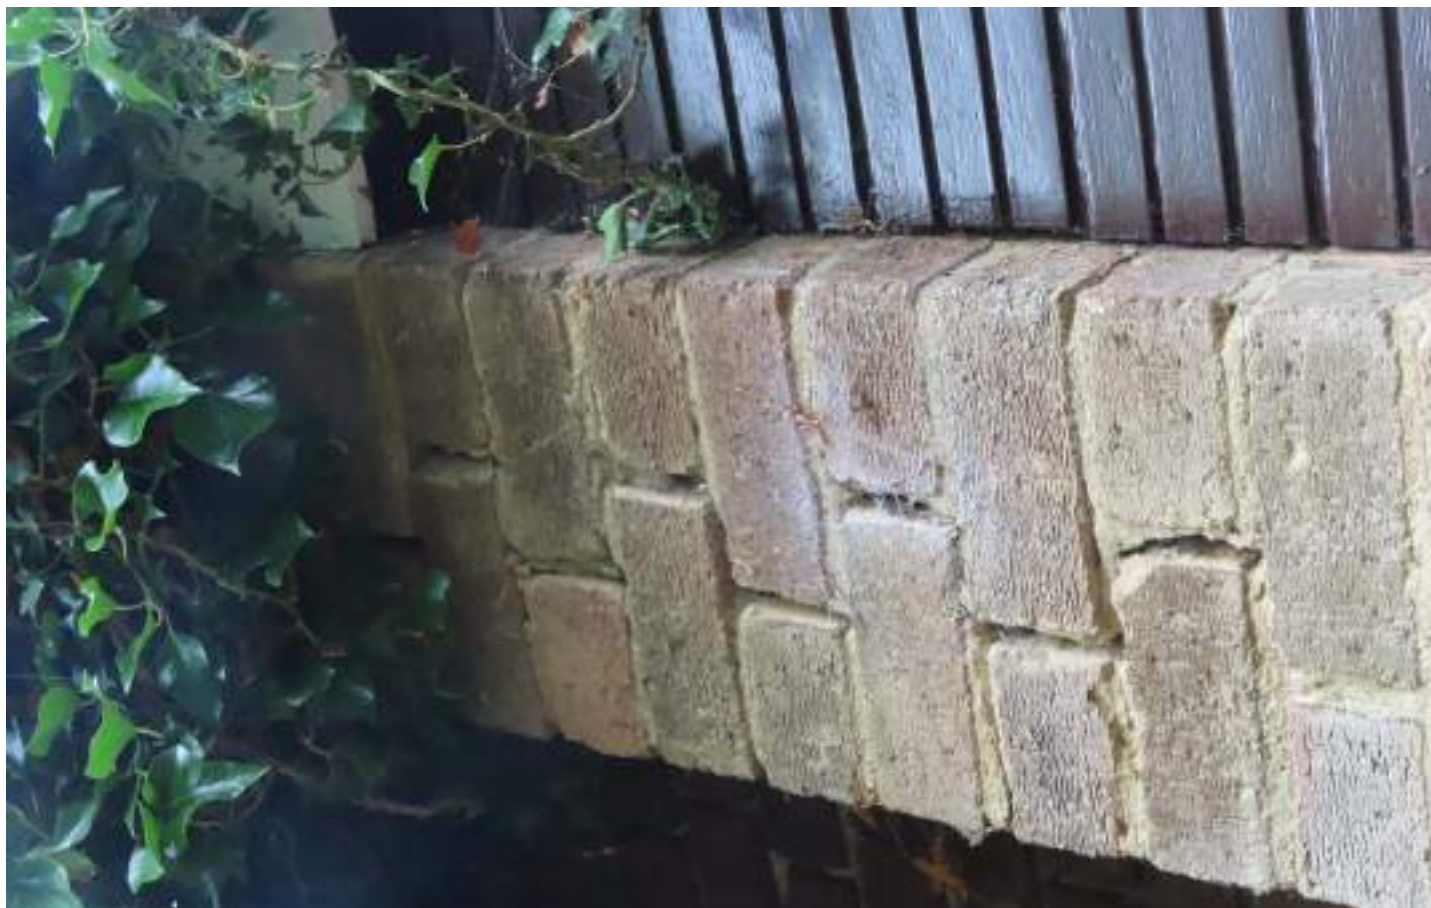
IMG_0883.JPG

- 3.11 On the rear south-western façade to bedroom 1 close to the French doors, the brickwork is eroded and fractures at high level. This is structurally unsatisfactory and requires structural repair to match existing as illustrated in photograph 0883.

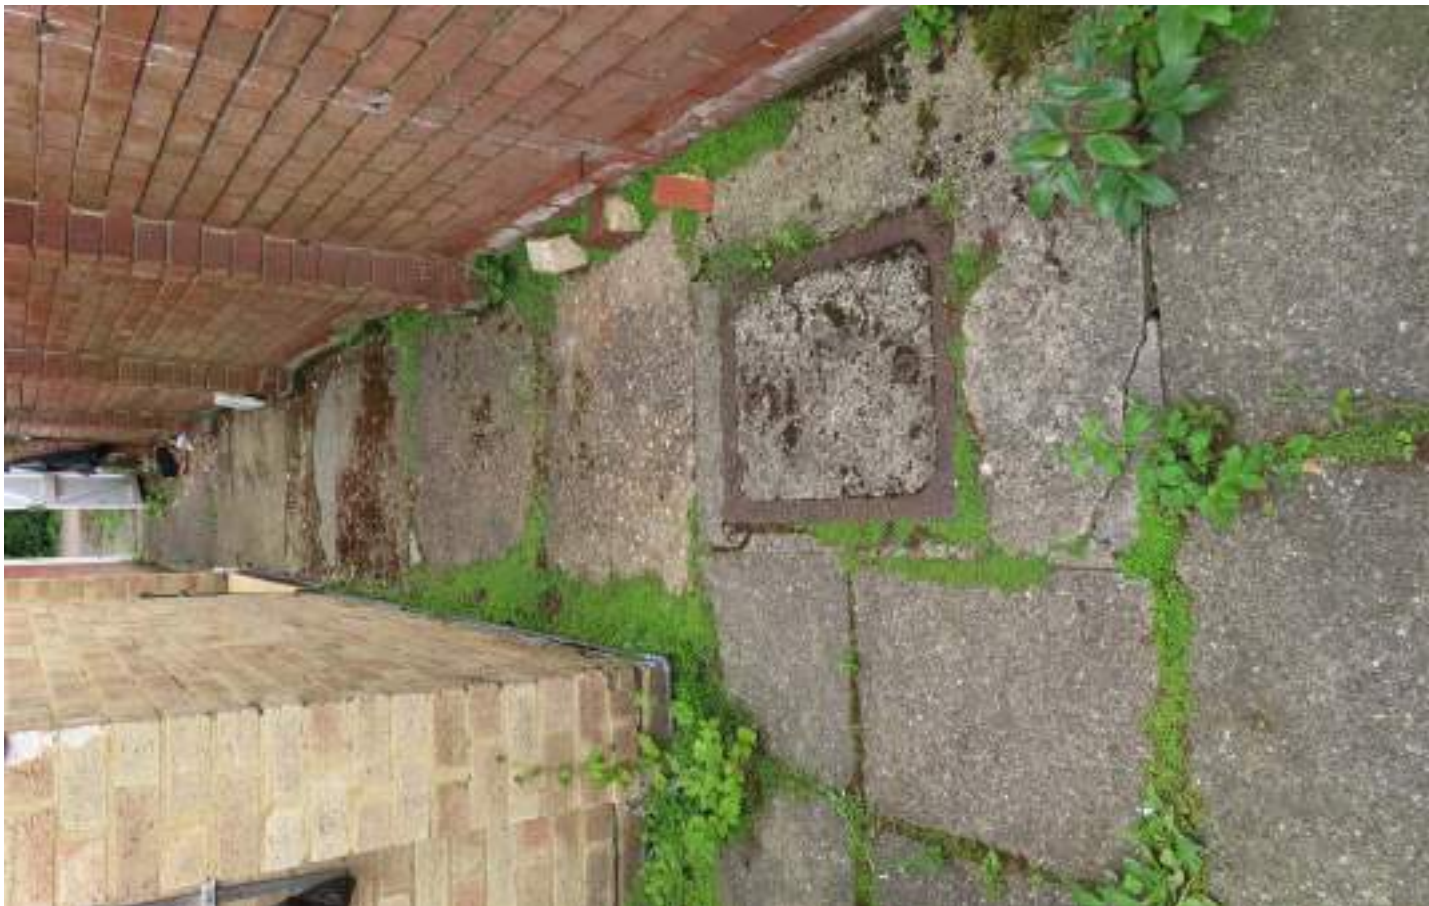
IMG_0921.JPG

This is accessible from heavy duty chamber covers to the south-eastern flank pathway which could not be lifted as these were jammed in position and were too heavy (photograph 0921). The nature and condition of the underground drainage remains unknown. It is strongly recommended that the drains are the subject of a drainage CCTV survey carried

out by a specialist to determine the true nature and condition of the underground drains. Taking account of the close proximity of the Willow in the rear garden described above, there is a possibility that the drains may have been breached by tree roots and therefore further investigation here is clearly warranted.
