# Bridges Healthcare (Richmond) Limited

## RICHMOND INN

**50-56 Sheen Road, Richmond,  
TW9 1UG**

Revised Sustainable Drainage Strategy

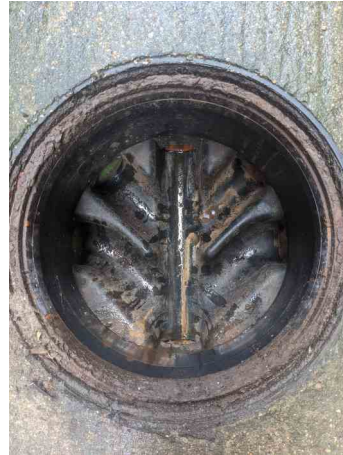
\_50-56 SHEEN ROAD\_RICHMOND\_28\_041.jpg, 00:00:07,  
 1.39 m  
 Finish node, manhole, reference: MH.13

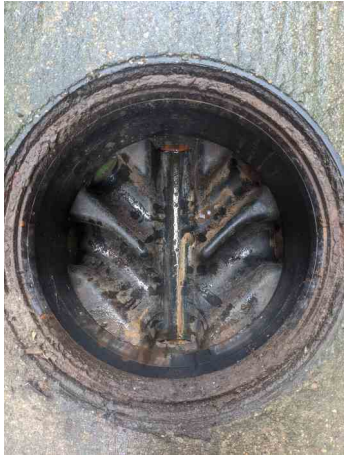
\_50-56 SHEEN ROAD\_RICHMOND\_29\_042.jpg, 00:00:00,  
0.00 m  
Start node, manhole, reference: MH.13
