Kneller Hall School

001506-ADP-01-XX-SC-A-1050

Kneller Hall - Room by Room Alterations Schedule

S2-P2

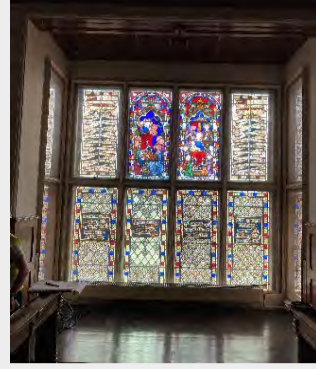
Level	Room No.	Element	Element Ref.	Comment	Picture	Key	Key 2
First	Chapel	Window	WF1	<p>Metal frames will be checked for sitting water. Any weep holes along the base will be checked for blockages and cleared. Any light rust will be removed by hand with a wire brush or sandpaper and frames sanded prior to decoration. More severely corroded metal windows will be cleaned of loose material. Ironmongery will be both maintained and preserved where possible and re-used; it will be gently cleaned with soft cloths or brass brushes. Abrasive creams or solvents will not be used. Moving components of window furniture will be treated with a thin oil to keep on iron and steel window moving components to keep free. Glazing will be carefully cleaned and reinstated and replacement putty installed where needed.</p>

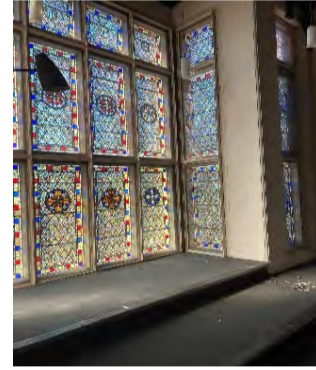
First	Chapel	Window	WF2	Metal window refurbished as above

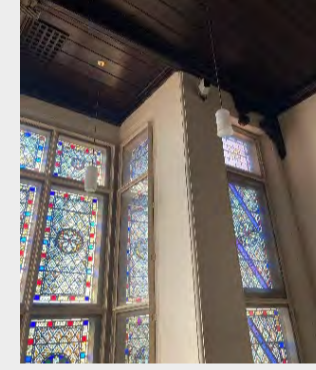
First	Chapel	Window	WF3	Metal window refurbished as above

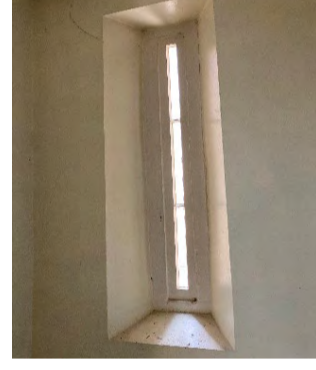
First	Chapel	Window	WF4	<p>Metal frames will be checked for sitting water. Any weep holes along the base will be checked for blockages and cleared. Any light rust will be removed by hand with a wire brush or sandpaper and frames sanded prior to decoration. More severely corroded metal windows will be cleaned of loose material.</p> <p>A zinc based paint will be used as a primer to provide a protective layer to bare metal prior to painting with a suitable system.</p>

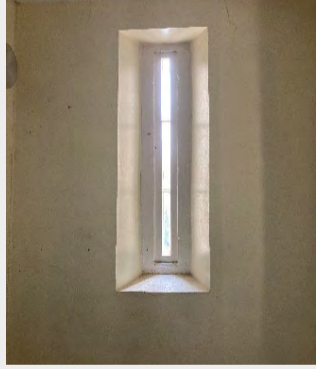
First	Chapel	Window	WF5	Metal window refurbished as above

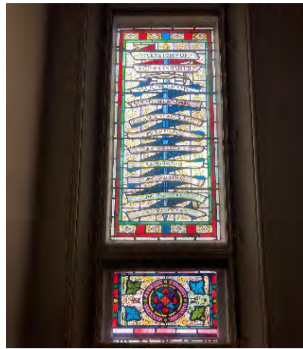
Chapel	Window	WF63	<p>Metal frames will be checked for sitting water. Any weep holes along the base will be checked for blockages and cleared. Any light rust will be removed by hand with a wire brush or sandpaper and frames sanded prior to decoration. More severely corroded metal windows will be cleaned of loose material. Ironmongery will be both maintained and preserved where possible and re-used; it will be gently cleaned with soft cloths or brass brushes. Abrasive creams or solvents will not be used. Moving components of window furniture will be treated with a thin oil to keep on iron and steel window moving components to keep free. Glazing will be carefully cleaned and reinstated and replacement putty installed where needed.</p> <p>A zinc based paint will be used as a primer to provide a protective layer to bare metal prior to painting with a suitable system.</p>

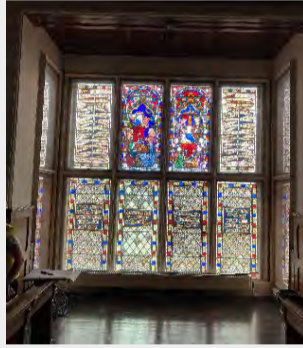
First	Chapel	Window	WF63	Metal window refurbished as above

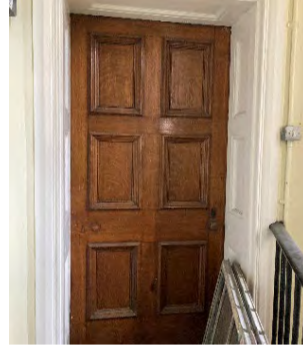
First	Chapel	Doors	DF1	Door in good condition. No refurbishment needed

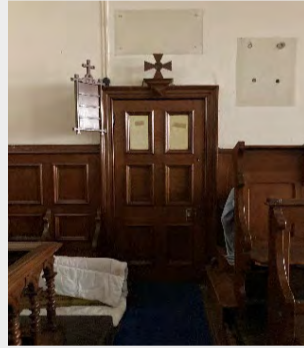
First	Chapel	Doors	DF20	Door in good condition. No refurbishment needed

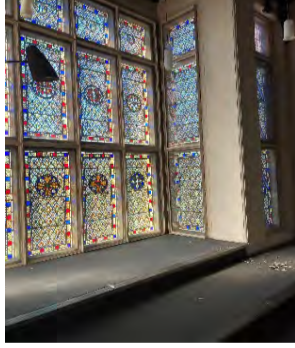
Second	Chapel	Window	WS1 - 2	<p>Metal frames will be checked for sitting water. Any weep holes along the base will be checked for blockages and cleared. Any light rust will be removed by hand with a wire brush or sandpaper and frames sanded prior to decoration. More severely corroded metal windows will be cleaned of loose material. Ironmongery will be both maintained and preserved where possible and re-used; it will be gently cleaned with soft cloths or brass brushes. Abrasive creams or solvents will not be used. Moving components of window furniture will be treated with a thin oil to keep on iron and steel window moving components to keep free. Glazing will be carefully cleaned and reinstated and replacement putty installed where needed.</p> <p>A zinc based paint will be used as a primer to provide a protective layer to bare metal prior to painting with a suitable system.</p>

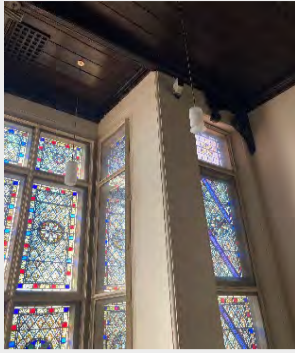
Second	Chapel	Window	WS3	Metal window refurbished as above

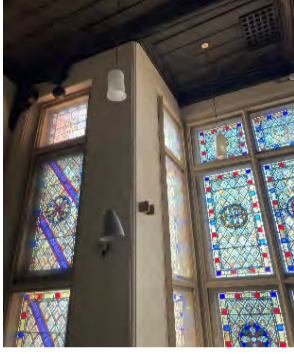
Second	Chapel	Window	WS59 - 60	Metal window refurbished as above

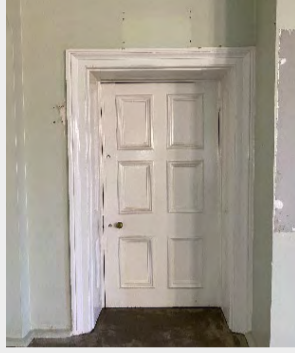
Second	Chapel	Doors	DS1	Door refurbished and redecorated and locked shut. Ironmongery will be both maintained and gently cleaned with soft cloths or brass brushes.

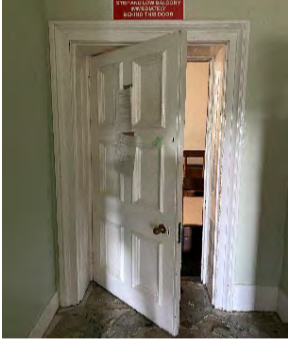
Second	Chapel	Doors	DS22	Door refurbished, decorated. Ironmongery will be both maintained and gently cleaned with soft cloths or brass brushes.

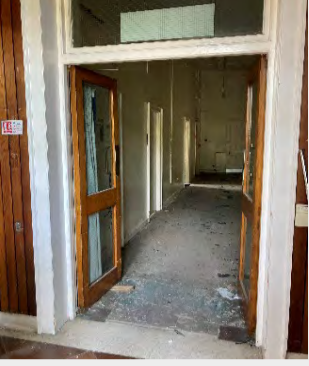
Ground	East Stair	Doors	DG26	Replace with contemporary leaf

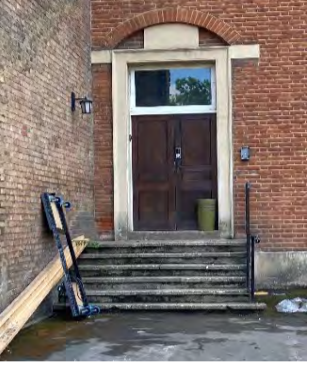
Ground	East Stair	Doors	DG27	Refurbish Door. Historic ironmongery will be retained where possible. It will be gently cleaned with soft cloths or brass brushes. Abrasive creams or solvents will not be used.

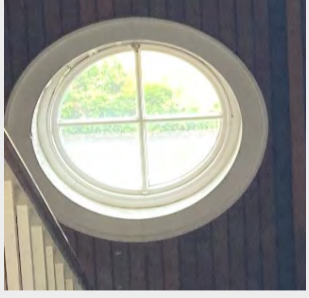
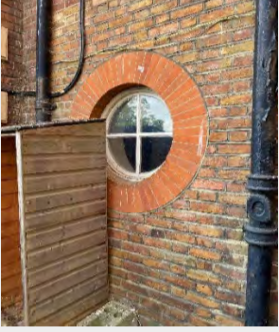
First	East Stair	Window	WF47	Refurbish. Metal frames will be checked for sitting water. Any weep holes along the base will be checked for blockages and cleared. Any light rust will be removed by hand with a wire brush or sandpaper and frames sanded prior to decoration. More severely corroded metal windows will be cleaned of loose material. Ironmongery will preserved and gently cleaned with soft cloths or brass brushes. Abrasive creams or solvents will not be used. Moving components of window furniture will be treated with a thin oil to keep on iron and steel window moving components to keep free. Glazing will be carefully cleaned and reinstated and replacement putty installed where needed. A zinc based paint will be used as a primer to provide a protective layer to bare metal prior to painting with a suitable system.

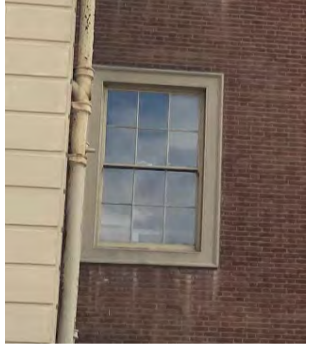
First	East Stair	Window	WF48	Refurbish. Metal frames will be checked for sitting water. Any weep holes along the base will be checked for blockages and cleared. Any light rust will be removed by hand with a wire brush or sandpaper and frames sanded prior to decoration. More severely corroded metal windows will be cleaned of loose material. Ironmongery will preserved and gently cleaned with soft cloths or brass brushes. Abrasive creams or solvents will not be used. Moving components of window furniture will be treated with a thin oil to keep on iron and steel window moving components to keep free. Glazing will be carefully cleaned and reinstated and replacement putty installed where needed. A zinc based paint will be used as a primer to provide a protective layer to bare metal prior to painting with a suitable system.

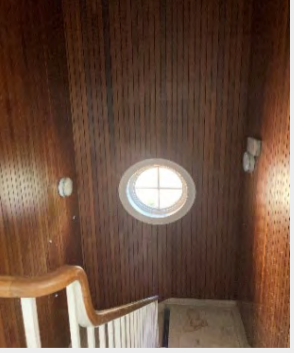
Second	East Stair	Window	WS44	as above

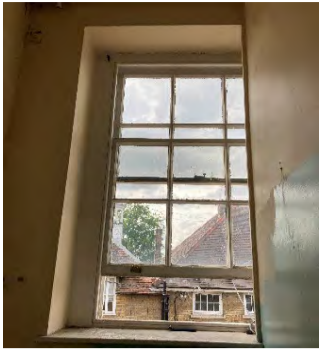
First	F01	Window	WF28	Refurbish. Carry out strengthening of all tenon joints. Ease, adjust, lubricate or renew pulley wheels where necessary. Renew sash cords throughout with waxed sash cord. Renew staff & parting beads. Install draught proofing.

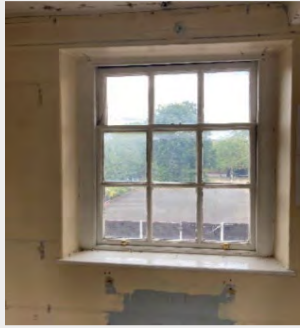
First	F01	Window	WF29	New sash window to match WF30 including moulding and horn details. Within existing door opening to fire escape stair.

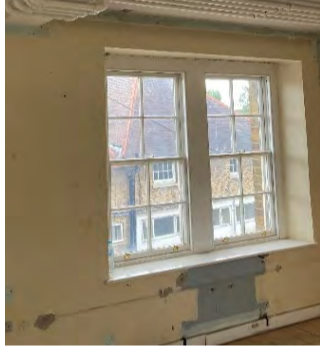
First	F02	Window	WF25	Refurbish, carry out major tenon repair. Ease, adjust, lubricate or renew pulley wheels where necessary. Renew sash cords throughout with waxed sash cord. Renew staff & parting beads and align mid rails. Install draught proofing. Replace non-standard sills with scarfed timber and two part resin system.

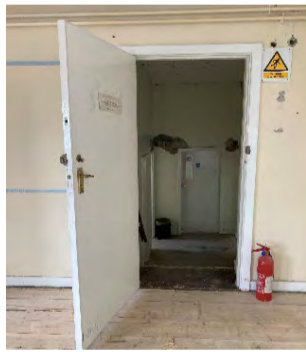
First	F02	Window	WF30	Refurbish. Reglaze window. Carry out strengthening of all tenon joints. Ease, adjust, lubricate or renew pulley wheels where necessary. Renew sash cords throughout with waxed sash cord. Renew staff & parting beads and align mid rails. Install draught proofing.	 		
First	F02	Doors	DF14	Replace with contemporary leaf

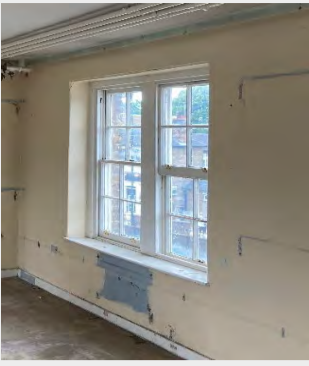
First	F03	Window	WF23	Refurbish, carry out strengthening of all tenon joints. Ease, adjust, lubricate or renew pulley wheels where necessary. Renew sash cords throughout with waxed sash cord. Renew staff & parting beads and align mid rails. Install draught proofing. Replace non-standard sills with scarfed timber and two part resin system.

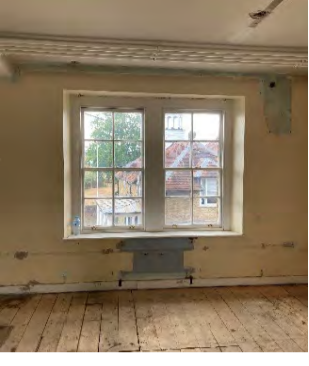
First	F03	Window	WF24	Refurbish, carry out strengthening of all tenon joints. Replace RHS 4 pane bottom sash. Ease, adjust, lubricate or renew pulley wheels where necessary. Renew sash cords throughout with waxed sash cord. Renew staff & parting beads and align mid rails. Install draught proofing. Replace non-standard sills with scarfed timber and two part resin system.

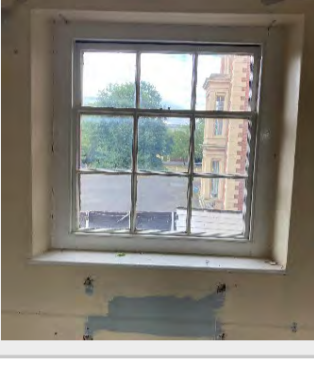
First	F03	Window	WF31	Refurbish, carry out strengthening of all tenon joints. Ease, adjust, lubricate or renew pulley wheels where necessary. Renew sash cords throughout with waxed sash cord. Renew staff & parting beads and align mid rails. Install draught proofing. Repair sill.

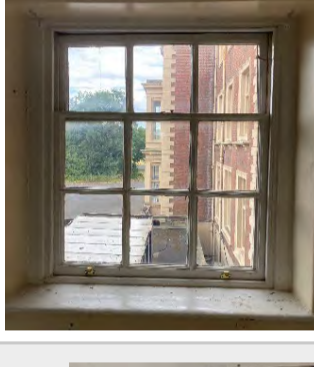
First	F03	Window	WF32	Refurbish, carry out strengthening of all tenon joints. Ease, adjust, lubricate or renew pulley wheels where necessary. Renew sash cords throughout with waxed sash cord. Renew staff & parting beads and align mid rails. Install draught proofing.

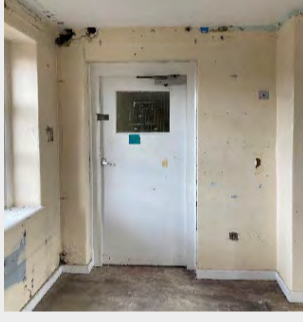
First	F03	Doors	DF13	Replace with contemporary leaf

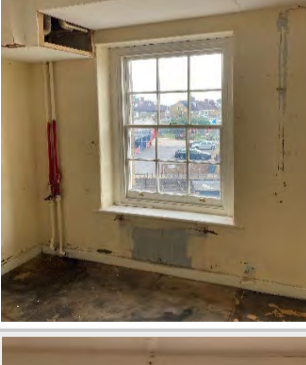
First	F04	Window	WF20	Refurbish, carry out strengthening of all tenon joints. Ease, adjust, lubricate or renew pulley wheels where necessary. Renew sash cords throughout with waxed sash cord. Renew staff & parting beads and align mid rails. Install draught proofing.

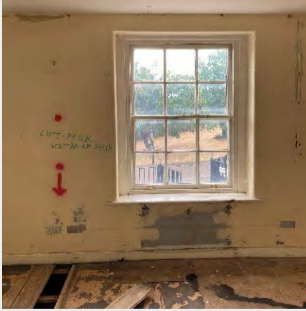
First	F04	Window	WF21	Refurbish, carry out strengthening of all tenon joints. Ease, adjust, lubricate or renew pulley wheels where necessary. Renew sash cords throughout with waxed sash cord. Renew staff & parting beads and align mid rails. Install draught proofing. Replace non-standard sill with scarfed timber and two part resin system.

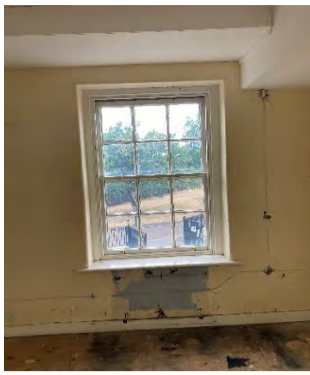
First	F04	Window	WF22	Refurbish, carry out major tenon repair. Ease, adjust, lubricate or renew pulley wheels where necessary. Renew sash cords throughout with waxed sash cord. Renew staff & parting beads and align mid rails. Install draught proofing. Replace non-standard sill with scarfed timber and two part resin system.

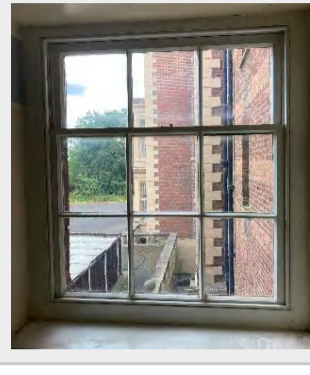
First	F04	Window	WF33	Refurbish, carry out strengthening of all tenon joints. Ease, adjust, lubricate or renew pulley wheels where necessary. Renew sash cords throughout with waxed sash cord. Renew staff & parting beads and align mid rails. Install draught proofing.

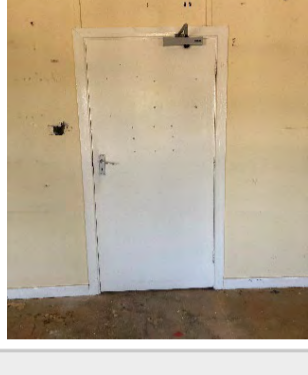
First	F04	Doors	DF12	Block up opening

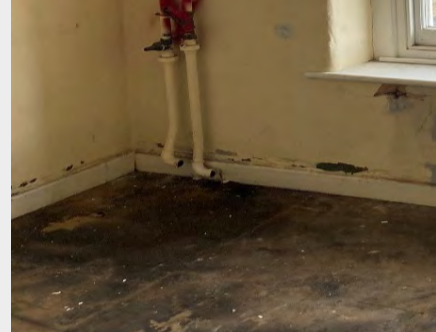
First	F04	Skirting	-	Existing skirting to be sanded down, with localised repairs where needed. All skirting redecorated. Pencil round skirting to match existing on new partition (detail 04).

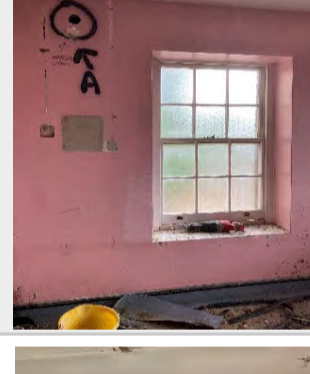
First	F05	Window	WF14	Refurbish, carry out strengthening of all tenon joints. Ease, adjust, lubricate or renew pulley wheels where necessary. Renew sash cords throughout with waxed sash cord. Renew staff & parting beads and align mid rails. Install draught proofing.

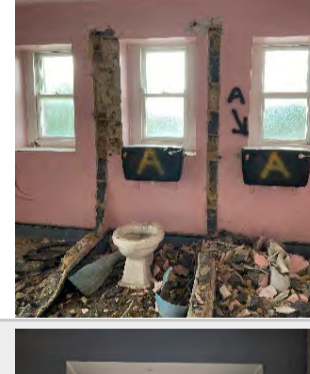
First	F05	Window	WF15 - W17	Refurbish, carry out strengthening of all tenon joints. Ease, adjust, lubricate or renew pulley wheels where necessary. Renew sash cords throughout with waxed sash cord. Renew staff & parting beads and align mid rails. Install draught proofing. Cill repairs where needed with scarfed timber and two part resin system and all new timber primed (excluding putties).

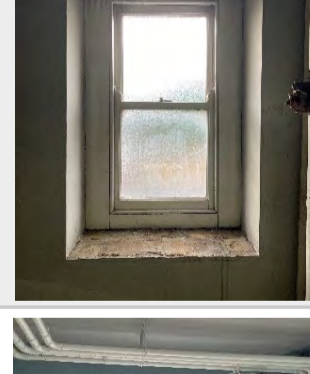
First	F05	Window	WF18	Refurbish, carry out strengthening of all tenon joints. Ease, adjust, lubricate or renew pulley wheels where necessary. Renew sash cords throughout with waxed sash cord. Renew staff & parting beads and align mid rails. Install draught proofing. Cill repairs where needed with scarfed timber and two part resin system and all new timber primed (excluding putties).

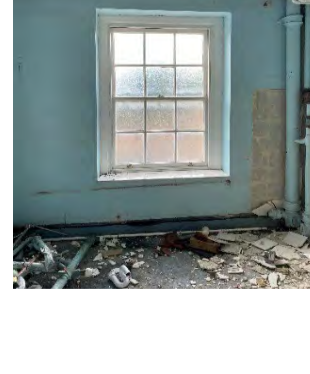
First	F05	Window	WF19	Refurbish, remove non-historic tiles on window sill. Refurbish, carry out strengthening of all tenon joints. Ease, adjust, lubricate or renew pulley wheels where necessary as window currently stuck. Renew sash cords throughout with waxed sash cord. Renew staff & parting beads and align mid rails. Install draught proofing. Cill repairs where needed with scarfed timber and two part resin system and all new timber primed (excluding putties).

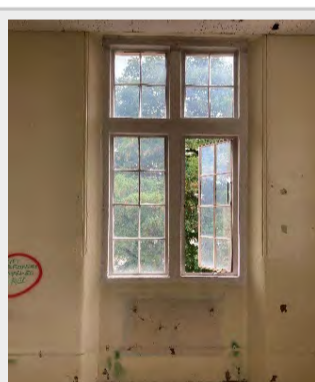
First	F07	Window	<p>Refurbish, remove blue film. Metal frames will be checked for sitting water. Any weep holes along the base will be checked for blockages and cleared. Any light rust will be removed by hand with a wire brush or sandpaper and frames sanded prior to decoration. More severely corroded metal windows will be cleaned of loose material. Ironmongery will be both maintained and preserved where possible and re-used; it will be gently cleaned with soft cloths or brass brushes. Abrasive creams or solvents will not be used. Moving components of window furniture will be treated with a thin oil to keep on iron and steel window moving components to keep free. Glazing will be carefully cleaned and reinstated and replacement putty installed where needed. A zinc based paint will be used as a primer to provide a protective layer to bare metal prior to painting with a suitable system.</p>

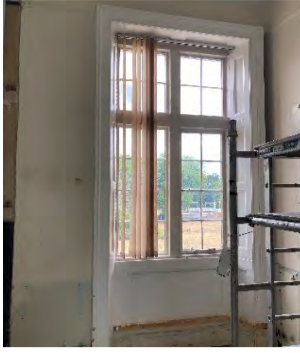
First	F08	Window	WF38	<p>Refurbish window, ensure shutters are functional and remove modern textured plaster finish. Metal frames will be checked for sitting water. Any weep holes along the base will be checked for blockages and cleared. Any light rust will be removed by hand with a wire brush or sandpaper and frames sanded prior to decoration. More severely corroded metal windows will be cleaned of loose material. Ironmongery will be both maintained and preserved where possible and re-used; it will be gently cleaned with soft cloths or brass brushes. Abrasive creams or solvents will not be used. Moving components of window furniture will be treated with a thin oil to keep on iron and steel window moving components to keep free. Glazing will be carefully cleaned and reinstated and replacement putty installed where needed.</p> <p>A zinc based paint will be used as a primer to provide a protective layer to bare metal prior to painting with a suitable system.</p>

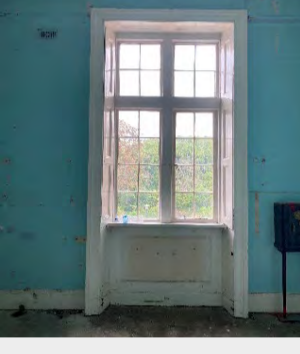
First	F08	Window	WF39	<p>Refurbish window, ensure shutters are functional and remove modern textured plaster finish. Metal frames will be checked for sitting water. Any weep holes along the base will be checked for blockages and cleared. Any light rust will be removed by hand with a wire brush or sandpaper and frames sanded prior to decoration. More severely corroded metal windows will be cleaned of loose material. Ironmongery will be both maintained and preserved where possible and re-used; it will be gently cleaned with soft cloths or brass brushes. Abrasive creams or solvents will not be used. Moving components of window furniture will be treated with a thin oil to keep on iron and steel window moving components to keep free. Glazing will be carefully cleaned and reinstated and replacement putty installed where needed.</p> <p>A zinc based paint will be used as a primer to provide a protective layer to bare metal prior to painting with a suitable system.</p>

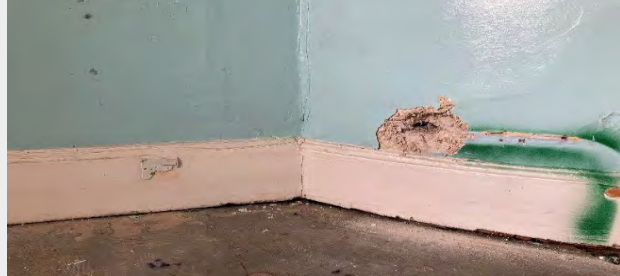
First	F08	Doors	DF16	Blocked up			
First	F08	Doors	DF17	Blocked up			
First	F08	Doors	DF18	Replace with contemporary leaf			
First	F08	Skirting	-	<p>Localised repairs and refurbishment to existing skirting. New boxing detail to existing skirting to conceal low level pipework as per Skirting Detail 03. Pencil round skirting and single square groove skirting proposed on new partition (Detail 02). (see A-1402-Level 01 Skirting Plans for location)</p>

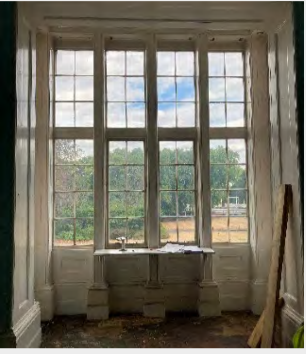
First	F09	Window	WF40- WF42	<p>Refurbish window, ensure shutters are functional and remove modern textured plaster finish. Metal frames will be checked for sitting water. Any weep holes along the base will be checked for blockages and cleared. Any light rust will be removed by hand with a wire brush or sandpaper and frames sanded prior to decoration. More severely corroded metal windows will be cleaned of loose material. Ironmongery will be both maintained and preserved where possible and re-used; it will be gently cleaned with soft cloths or brass brushes. Abrasive creams or solvents will not be used. Moving components of window furniture will be treated with a thin oil to keep on iron and steel window moving components to keep free. Glazing will be carefully cleaned and reinstated and replacement putty installed where needed.</p> <p>A zinc based paint will be used as a primer to provide a protective layer to bare metal prior to painting with a suitable system.</p>

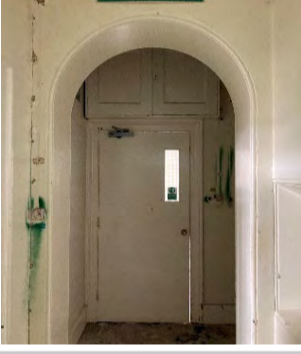
First	F09	Doors	DF19	New door in archway

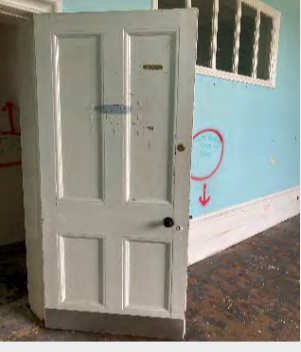
First	F09	Doors	DF21	Refurbish, replace kickplate, refurbish existing ironmongery

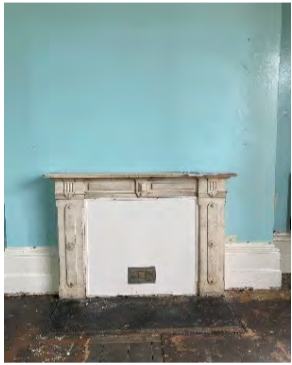
First	F09	Fireplace	FF01	Retain and refurbish existing fireplace surround and remove existing infill to reinstate historic fireplace opening

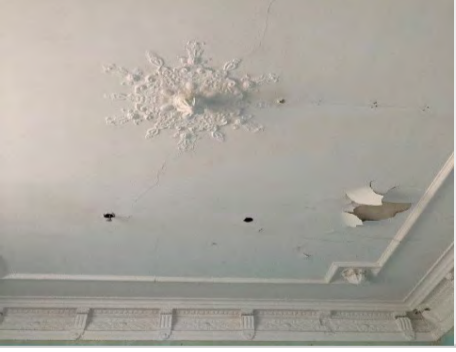
First	F09	Ceiling	-	Existing ceiling and cornicing to be retained, refurbished with localised repairs where necessary. Ceiling rose to be refurbished.

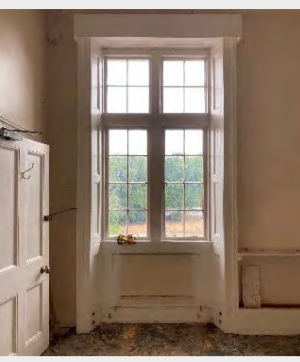
First	F10	Window	WF45	<p>Refurbish window, ensure shutters are functional and remove modern textured plaster finish and blind pelmet. Metal frames will be checked for sitting water. Any weep holes along the base will be checked for blockages and cleared. Any light rust will be removed by hand with a wire brush or sandpaper and frames sanded prior to decoration. More severely corroded metal windows will be cleaned of loose material. Ironmongery will be both maintained and preserved where possible and re-used; it will be gently cleaned with soft cloths or brass brushes. Abrasive creams or solvents will not be used. Moving components of window furniture will be treated with a thin oil to keep on iron and steel window moving components to keep free. Glazing will be carefully cleaned and reinstated and replacement putty installed where needed. A zinc based paint will be used as a primer to provide a protective layer to bare metal prior to painting with a suitable system.</p>

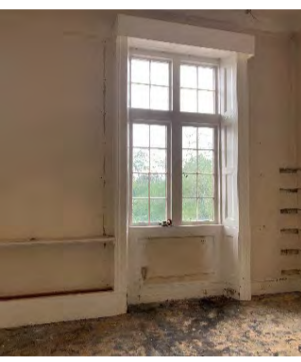
First	F10	Window	WF46	<p>Refurbish window, ensure shutters are functional and remove modern textured plaster finish and blind pelmet. Metal frames will be checked for sitting water. Any weep holes along the base will be checked for blockages and cleared. Any light rust will be removed by hand with a wire brush or sandpaper and frames sanded prior to decoration. More severely corroded metal windows will be cleaned of loose material. Ironmongery will be both maintained and preserved where possible and re-used; it will be gently cleaned with soft cloths or brass brushes. Abrasive creams or solvents will not be used. Moving components of window furniture will be treated with a thin oil to keep on iron and steel window moving components to keep free. Glazing will be carefully cleaned and reinstated and replacement putty installed where needed. A zinc based paint will be used as a primer to provide a protective layer to bare metal prior to painting with a suitable system.</p>

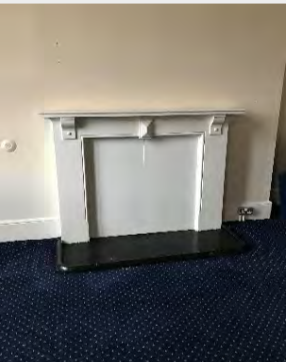
First	F10	Fireplace	FF03	<p>Retain and refurbish existing fireplace surround and remove existing infill to reinstate historic fireplace opening</p>

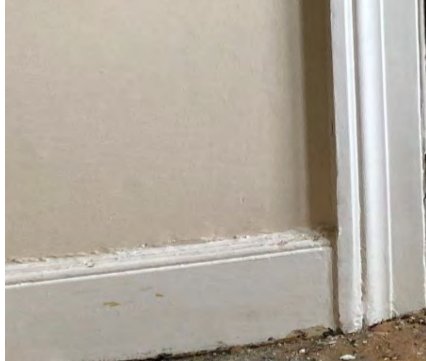
First	F10	Skirting	-	<p>Localised repairs and refurbishment to existing skirting. New boxing detail to existing skirting to conceal low level pipework as per Skirting Detail 03. (see A-1402-Level 01 Skirting Plans for location)</p>

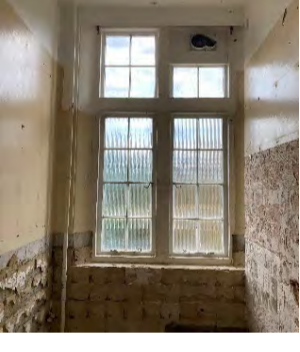
<p>Refurbish, repair LHS top broken windowpane by reglazing the 4 pane sash with replacement putty installed where needed. Metal frames will be checked for sitting water. Any weep holes along the base will be checked for blockages and cleared. Any light rust will be removed by hand with a wire brush or sandpaper and frames sanded prior to decoration. More severely corroded metal windows will be cleaned of loose material. Ironmongery will be both maintained and preserved where possible and re-used; it will be gently cleaned with soft cloths or brass brushes. Abrasive creams or solvents will not be used. Moving components of window furniture will be treated with a thin oil to keep on iron and steel window moving components to keep free. A zinc based paint will be used as a primer to provide a protective layer to bare metal prior to painting with a suitable system.</p>

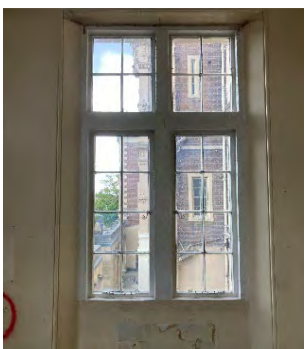
First	F12	Window	WF56	<p>Refurbish and remove textured plaster finish. Metal frames will be checked for sitting water. Any weep holes along the base will be checked for blockages and cleared. Any light rust will be removed by hand with a wire brush or sandpaper and frames sanded prior to decoration. More severely corroded metal windows will be cleaned of loose material. Ironmongery will be both maintained and preserved where possible and re-used; it will be gently cleaned with soft cloths or brass brushes. Abrasive creams or solvents will not be used. Moving components of window furniture will be treated with a thin oil to keep on iron and steel window moving components to keep free. Glazing will be carefully cleaned and reinstated and replacement putty installed where needed.</p> <p>A zinc based paint will be used as a primer to provide a protective layer to bare metal prior to painting with a suitable system.</p>

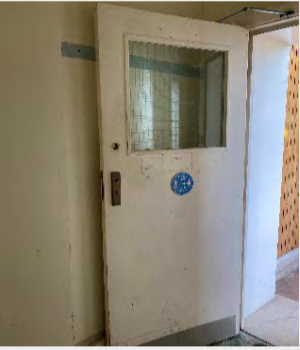
First	F12	Doors	DF29	Replace with contemporary leaf

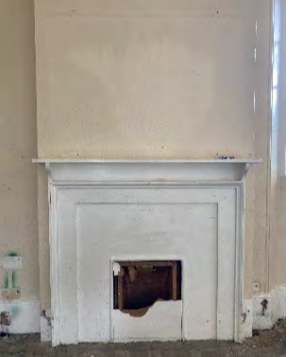
First	F12	Fireplace	FF04	Retain and refurbish existing fireplace surround and remove existing infill to reinstate historic fireplace opening

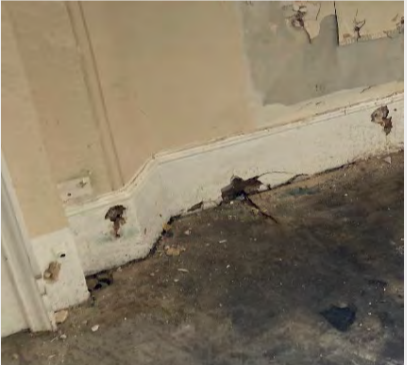
First	F12	Skirting	-	Localised repairs and refurbishment to existing skirting. New boxing detail to existing skirting to conceal low level pipework as per Skirting Detail 03. (see A-1402-Level 01 Skirting Plans for location)

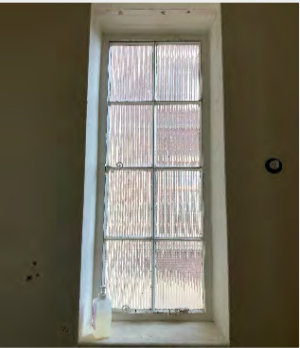
First	F13	Window	WF61	<p>Refurbish, remove film. Metal frames will be checked for sitting water. Any weep holes along the base will be checked for blockages and cleared. Any light rust will be removed by hand with a wire brush or sandpaper and frames sanded prior to decoration. More severely corroded metal windows will be cleaned of loose material. Ironmongery will be both maintained and preserved where possible and re-used; it will be gently cleaned with soft cloths or brass brushes. Abrasive creams or solvents will not be used. Moving components of window furniture will be treated with a thin oil to keep on iron and steel window moving components to keep free. Glazing will be carefully cleaned and reinstated and replacement putty installed where needed.</p> <p>A zinc based paint will be used as a primer to provide a protective layer to bare metal prior to painting with a suitable system.</p>

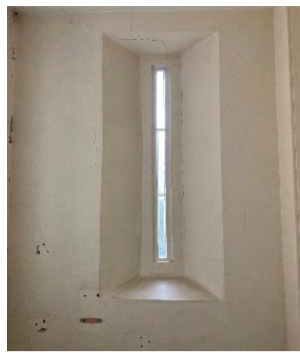
First	F13	Window	WF62	<p>Metal frames will be checked for sitting water. Any weep holes along the base will be checked for blockages and cleared. Any light rust will be removed by hand with a wire brush or sandpaper and frames sanded prior to decoration.</p>

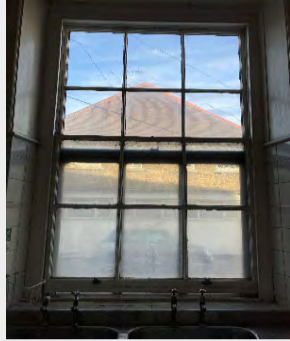
Ground	G01	Window	WG18	<p>Remove film an fly-netting. Carry out strengthening of all tenon joints. Ease, adjust, lubricate or renew pulley wheels where necessary. Renew sash cords throughout with waxed sash cord. Renew staff & parting beads and align mid rails. Install draught proofing. Replace non-standard sill with scarfed timber and two part resin system.</p>

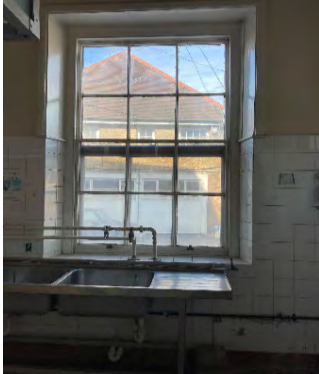
Ground	G01	Window	WG19	<p>Remove film an fly-netting. Carry out strengthening of all tenon joints. Ease, adjust, lubricate or renew pulley wheels where necessary. Renew sash cords throughout with waxed sash cord. Renew staff & parting beads and align mid rails. Install draught proofing. Replace non-standard sill with scarfed timber and two part resin system.</p>

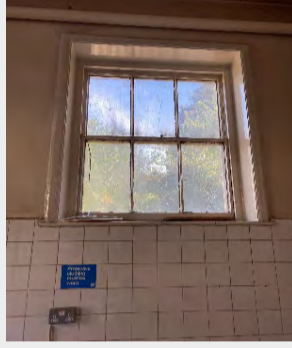
Ground	G01	Window	WG20	<p>Remove film an fly-netting. Carry out strengthening of all tenon joints. Ease, adjust, lubricate or renew pulley wheels where necessary. Renew sash cords throughout with waxed sash cord. Renew staff & parting beads and align mid rails. Install draught proofing. Replace 3 pane bottom sash to match existing</p>

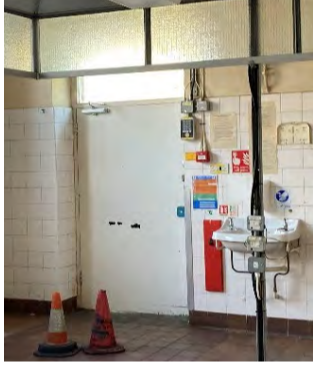
Ground	G01	Doors	DG14	<p>Replace with contemporary leaf</p>

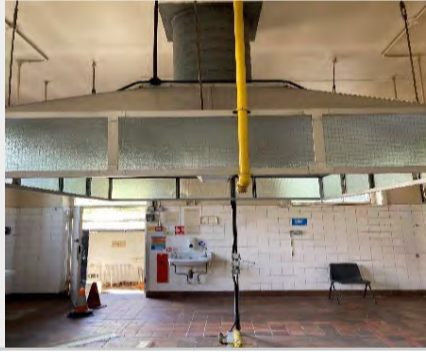
Ground	G01	Ceiling	-	<p>New plasterboard ceiling to line through with library extension, concealing services.</p>

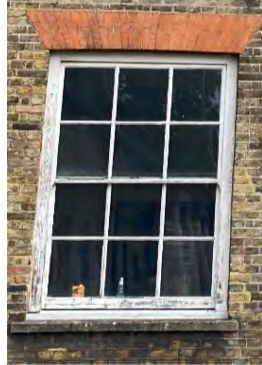
Ground	G02	Window	WG15	<p>Refurbish. Carry out strengthening of all tenon joints. Ease, adjust, lubricate or renew pulley wheels where necessary. Renew sash cords throughout with waxed sash cord. Renew staff & parting beads and align mid rails. Install draught proofing. Replace non-standard sill with scarfed timber and two part resin system.</p>

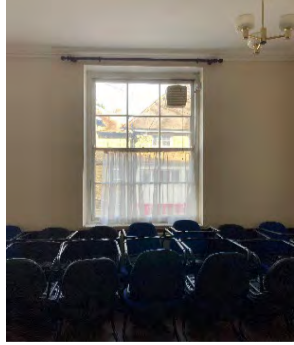
Ground	G02	Window	WG17	<p>Replaced with door for new fire exist. See 001506-ADP-01-XX-DR-A-1251-NORTH AND WEST ELEVATIONS PROPOSED for further details.</p>
