**THAMES YOUNG MARINERS,  
RIVERSIDE DR, LONDON**

**PRELIMINARY BAT ROOST  
ASSESSMENT**

Report No: RT-MME-157100-04

Date: April 2022

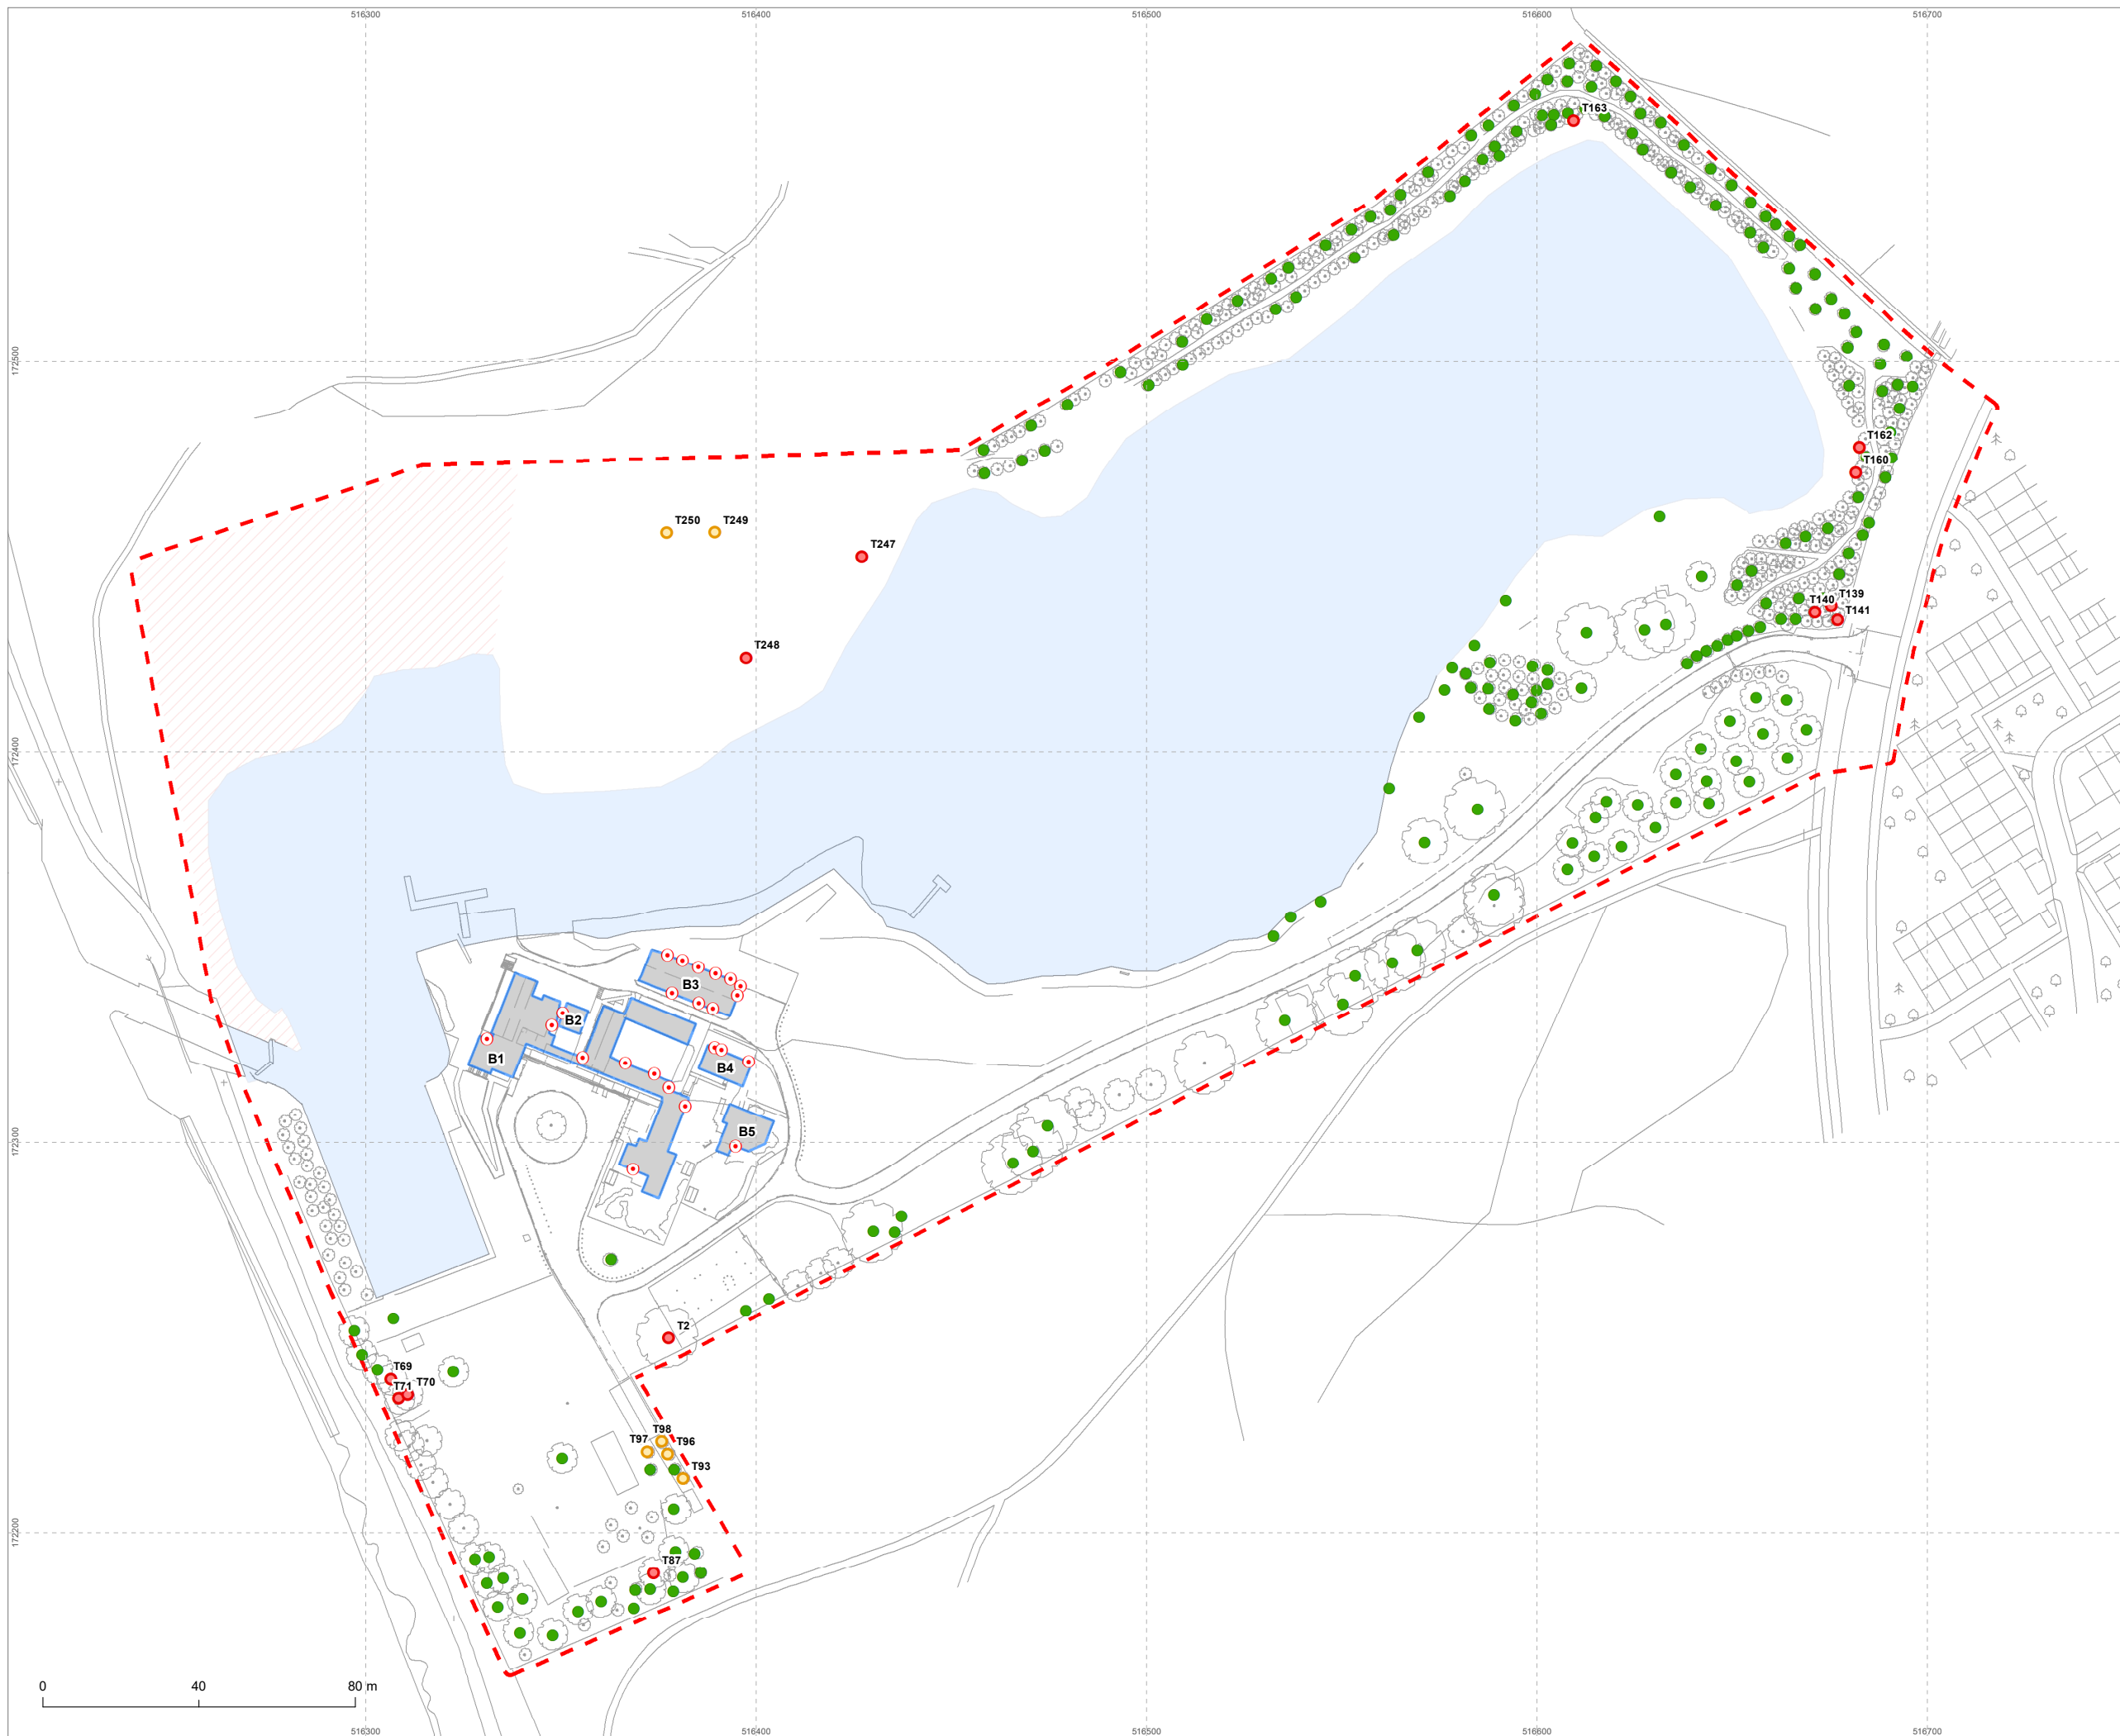
Drawing **Preliminary Roost Assessment**

Buildings 1, 2, 3, 4 and 5 were identified as having low potential to support roosting bats. Bat Surveys: Good Practice Guidelines, published by the Bat Conservation Trust (Collins, 2016), recommends for structures with low bat roosting potential that at least one survey (consisting of either a dusk emergence survey or a dawn re-entry survey) be undertaken during the peak season for emergence/re-entry surveys (May to August) to determine the presence/absence of roosting bats within the structures. Should this survey confirm the presence of roosting bats, it will be necessary to undertake additional surveys in order to inform a Natural England licence application. In addition, should the survey identify the presence of significant levels of bat activity at the site, it may be necessary to undertake further survey visits to comprehensively assess the value of the site to bats.
