# Arboricultural Impact Assessment

St Margaret's Business Centre 3<sup>rd</sup> November 2022

Report No:	Date	Revision	Author	Checked	
13340_R02e	3 <sup>rd</sup> November 2022	Е	Jamie Pratt, BSc (Hons) MArborA	Jack Jewell, BA (Hons), MLA, CMLI

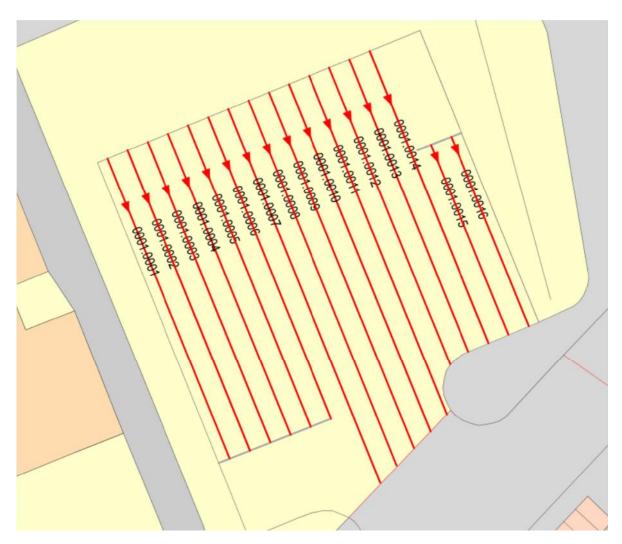
Plan 1 – extract from TRUK 0206 TR showing the survey area. Do not scale. North is vertical.

Red lines are the scan lines.

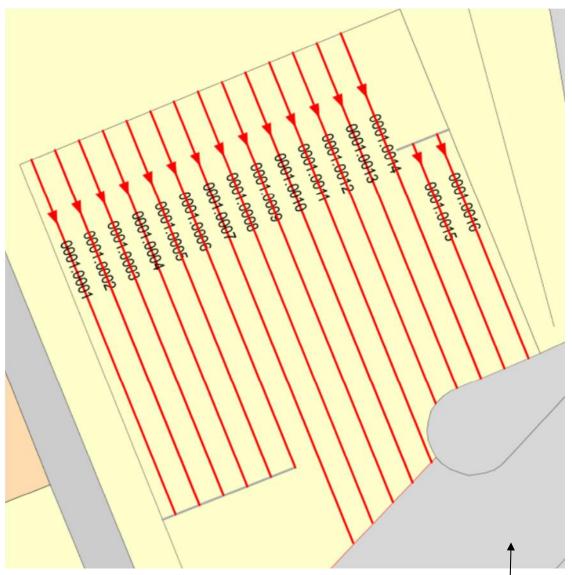
Plan 2. Extract from TreeRadar plan TRUK 0206 TR showing location of scan lines 0001.0001-0016. Do not scale.

4.1. Scan lines 0001.0001-0016 – Scan lines 0001.0001-0016 are a series of parallel lines running roughly north west to south east, starting 0.5m from the northern kerb line of the car park and ending at the southern edge of the asphalt, or where a parked van blocked the passage of the scanning cart. Scan line 0001.0001 is located 0.5m from the western kerb line and runs parallel to it, with each subsequent line located an additional 1m from the western kerb in turn. Scan lines 0001.0015-0016 start late due to a mound of debris. An extract from the tree radar plan TRUK 0206 TR below shows the locations of the scan lines.

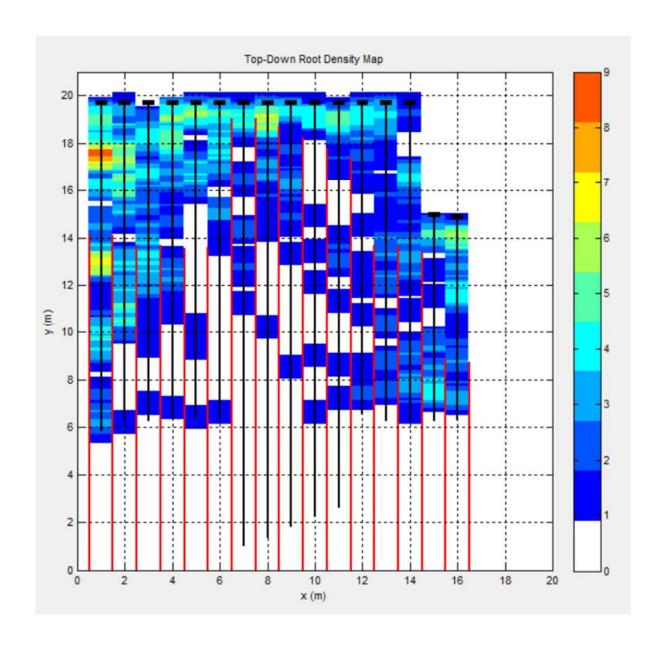
## Scan lines 0001.0001-0016 - Roots (with a diameter greater than 20 mm) at all

#### **DEPTHS - DIAGRAMMATIC REPRESENTATION OF ROOT DENSITY.**

RED = RELATIVELY HIGH, BLUE = RELATIVELY LOW
