REPORT 61351/S/1

SHELDON HOUSE, TEDDINGTON

INVESTIGATION OF MASONRY WALLS

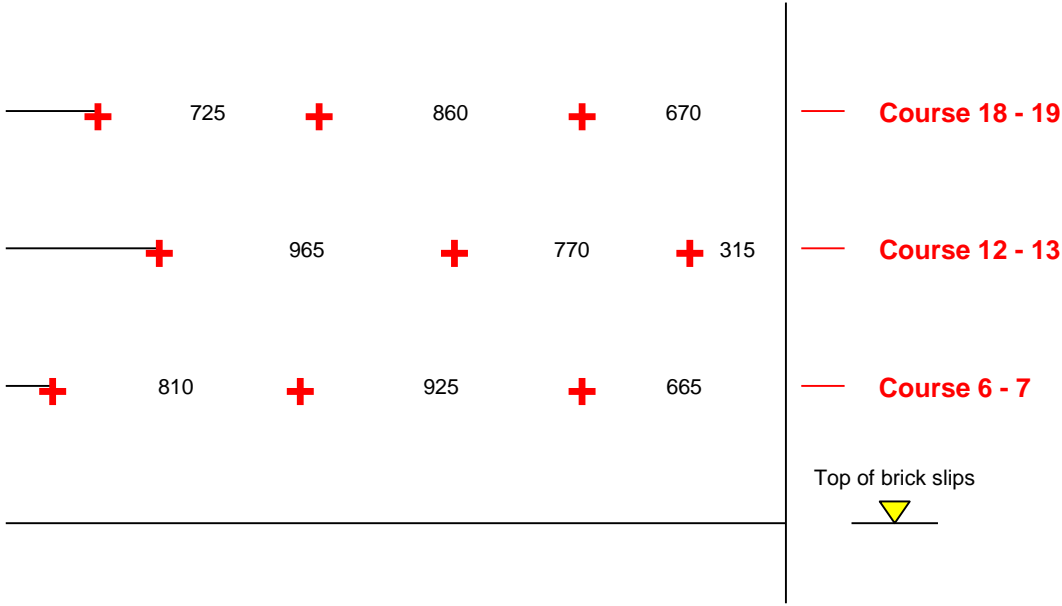
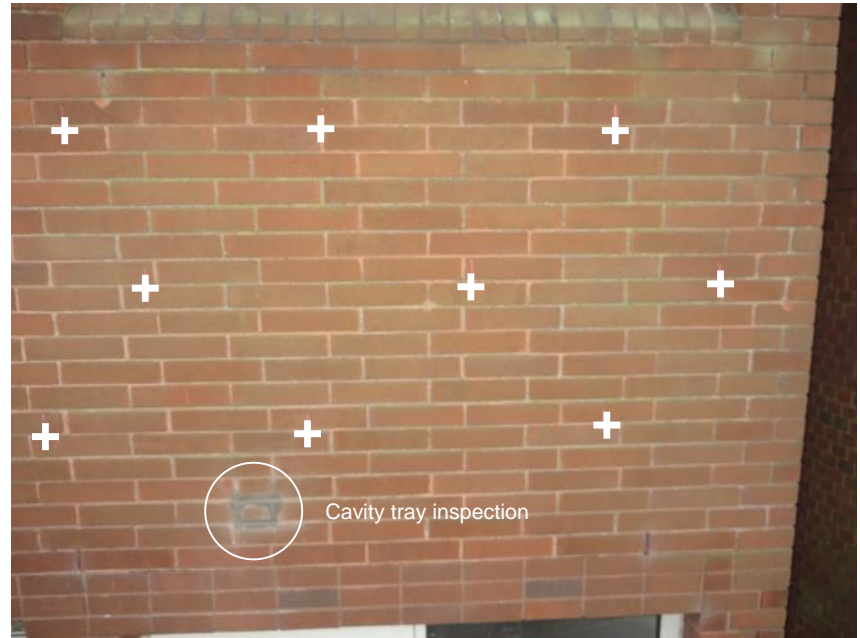
Figure 21. Wall Tie Map. Front Elevation. Fifth Floor.

At one location a brick was removed to inspect a wall tie. The tie was a twisted fishtail type (Figure 20). The tie was clean and unbridged, but poorly embedded in the inner leaf and could be moved about. A small map of the ties (Figure 21) found them to be evenly and well distributed. At a second location above the lintels, an expanded metal lath was found in a horizontal brickwork joint (Figure 22).
